# GeoShield Verification Report

## VERIFICATION ITEM ONE

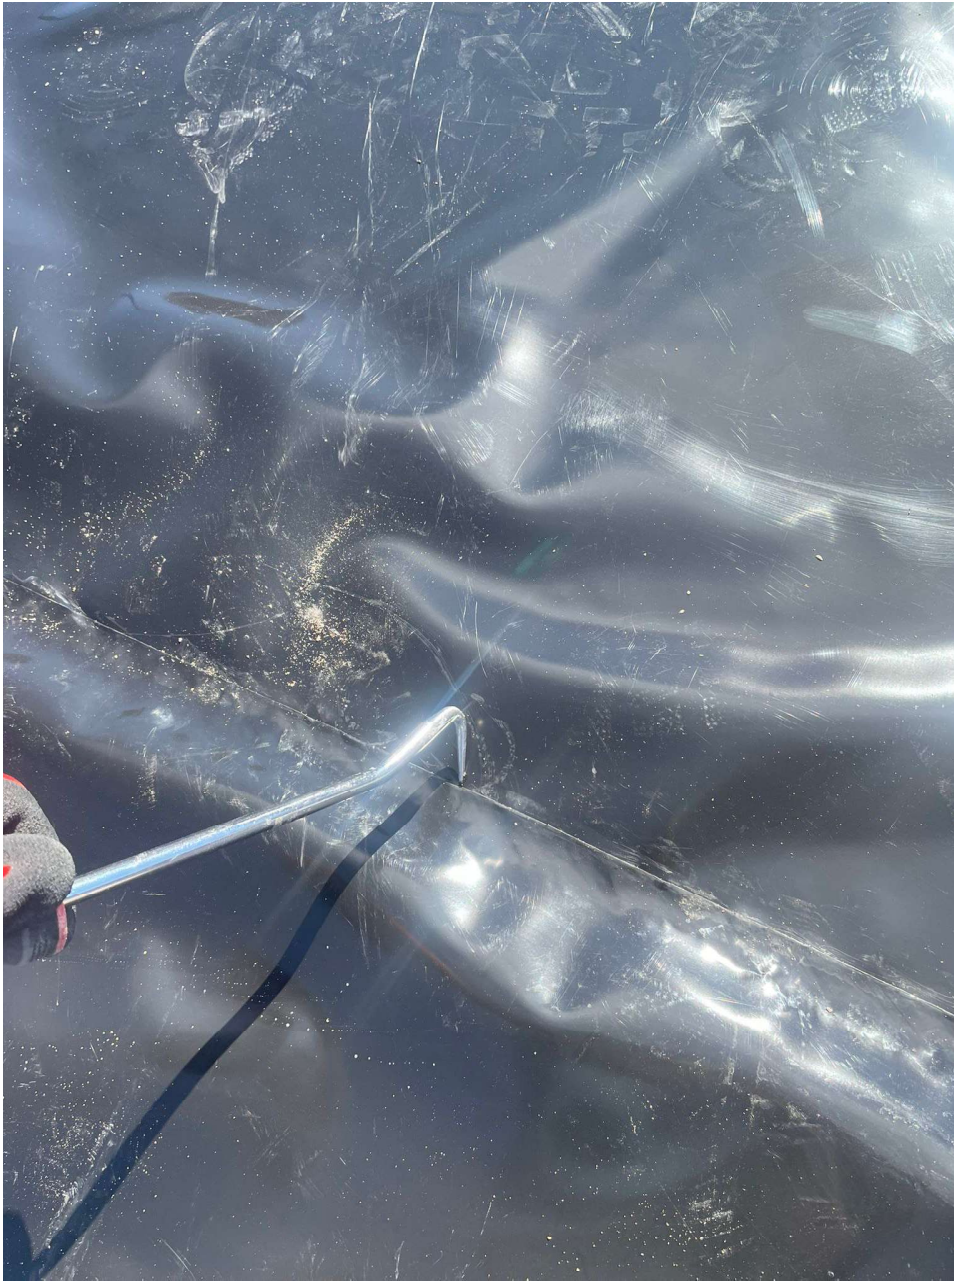
The above photograph displays a mechanical point stress test, also known as a pick and probe test, being conducted upon a welded lap joint of the RTEC 4 Gas Membrane. All lap joints were subjected to thorough pick and probe testing throughout the installation where no faults or defects were identified. Tested and verified in accordance with CIRIA 735.

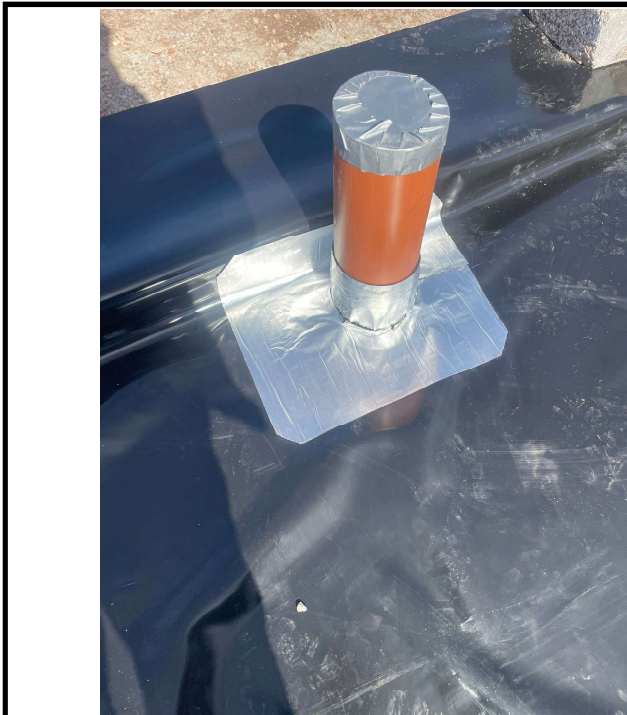
### Sealed Details - Pipe Penetrations

Throughout the complete line out installation of the RTEC 4 Gas Membrane to the referenced plots, a number of pipe penetrations have been sealed using RTEC GRSAM, which is a gas resistant self adhesive membrane. The installers have first cut the RTEC 4 Gas Membrane tight around the base of each pipe to

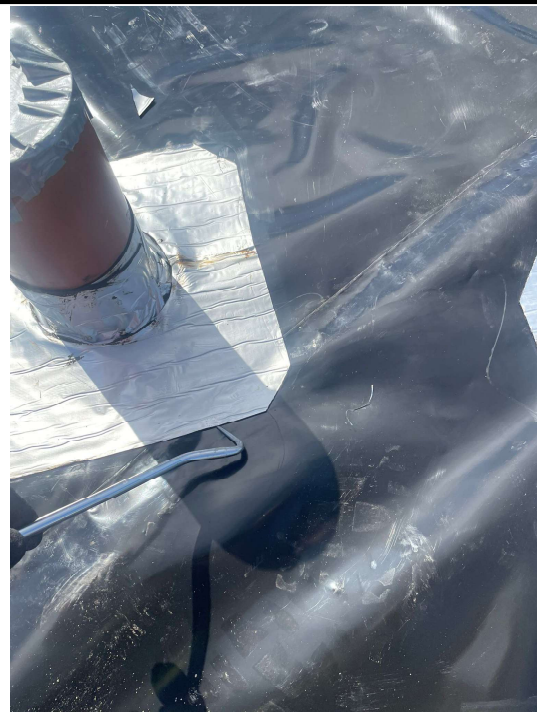
minimise gaps. Next, patches of RTEC GRSAM are placed intricately in a top hat formation around the pipe and onto the RTEC 4 Gas Membrane. Heat and rolled pressure is applied to ensure the RTEC GRSAM has fully bonded to the RTEC 4 Gas Membrane. Mechanical point stress testing identified no faults or defects.

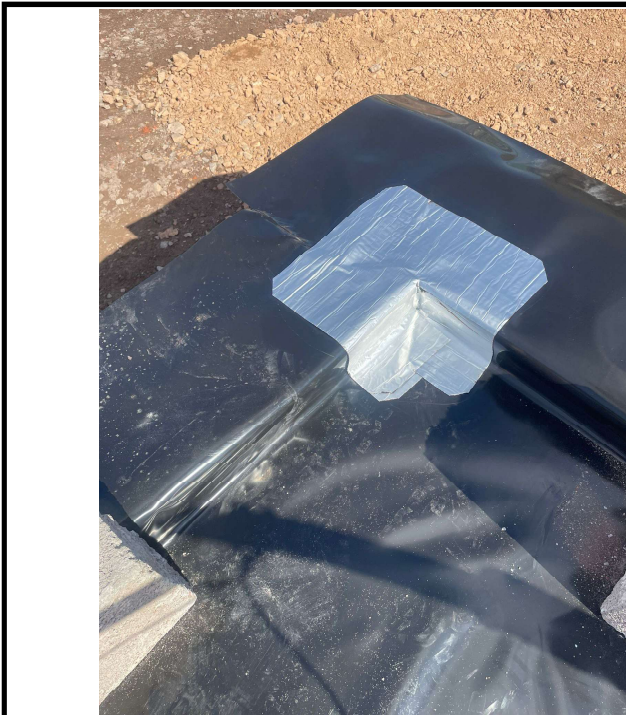
### Sealed Details - Corners & Thresholds

A number of corners and thresholds throughout the referenced plots have also been sealed correctly using RTPC GRSAM. Where the RTPC 4 Gas Membrane has been cut to minimise voided areas and gaps across the footprint of the plot, each corner and threshold junction has been reinforced by heating

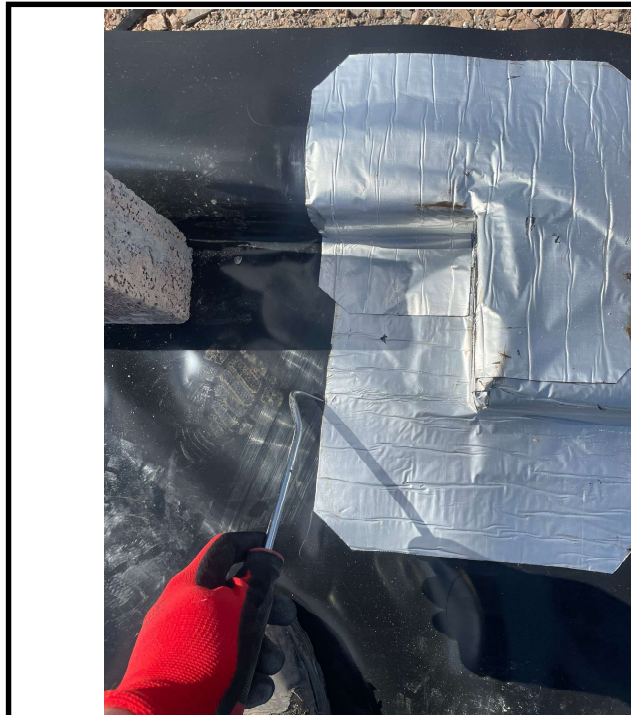
strips of RTPC GRSAM and placed into position around each corner and threshold, onto the RTPC 4 Gas Membrane. Firm rolled pressure is applied with a silicone roller to aid in the adhesion ensuring the RTPC GRSAM has fully bonded. Mechanical point stress testing identified no faults or defects.

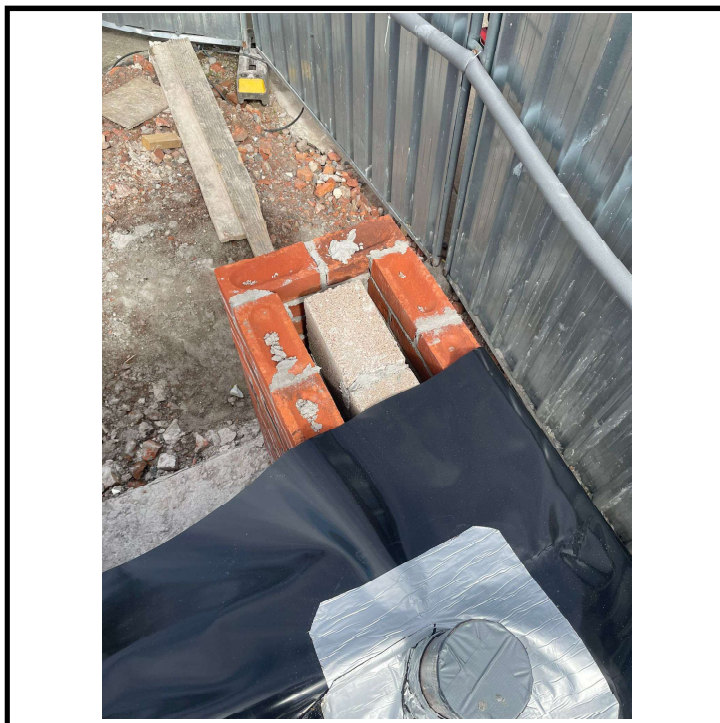
### Fault Identified & Remediated

During the visit today one small area around the perimeter cavity wall was identified where the RTEC 4 Gas Membrane had not been installed over the cavity wall, as shown in the first photograph above. This was brought to the attention of the installers and remediated on site in the presence of GeoShield.

The installers installed an additional section of the RTEC 4 Gas Membrane to extend over the cavity wall and sealed the lap to the existing RTEC 4 Gas Membrane using strips of RTEC GRSAM, heat and rolled pressure applied to aid in the adherence.

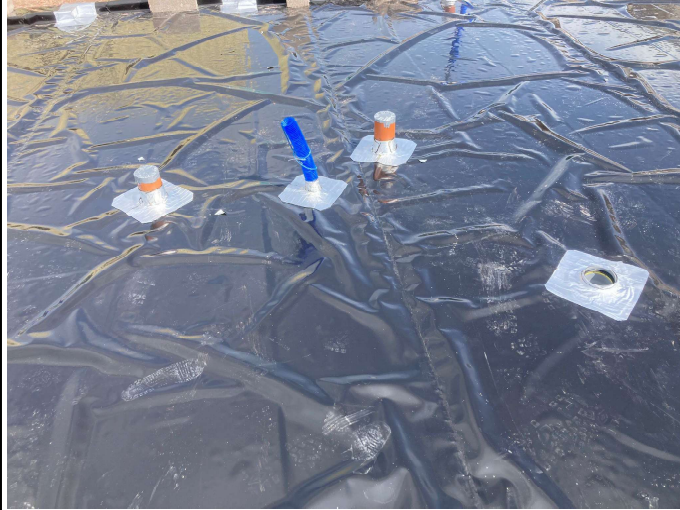
Sealed pipe penetrations.

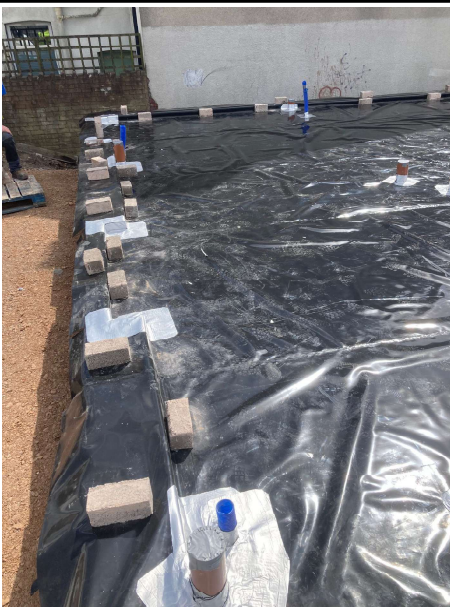
The RTEC 4 Gas Membrane taken over the perimeter block work.

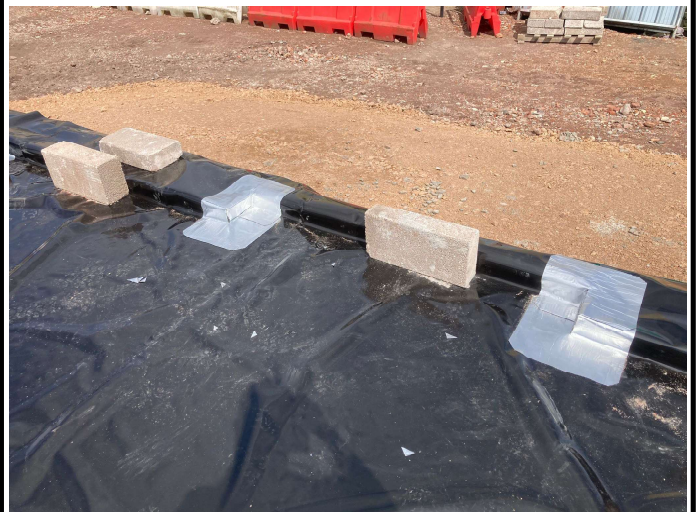
A sealed threshold.
