# GeoShield Verification Report

## VERIFICATION SUMMARY

This was the first visit to the site where verification was required for the complete line out installation of the RTEC 4 Gas Membrane to Plots 1, 2, 3, 4, 5, 6, 7, 8 & 9.

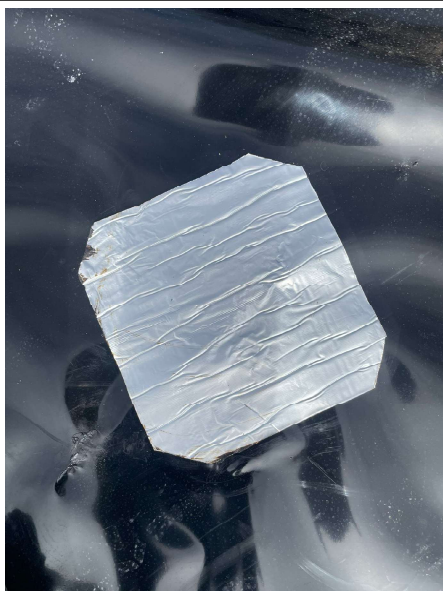
A patch repair carried out.

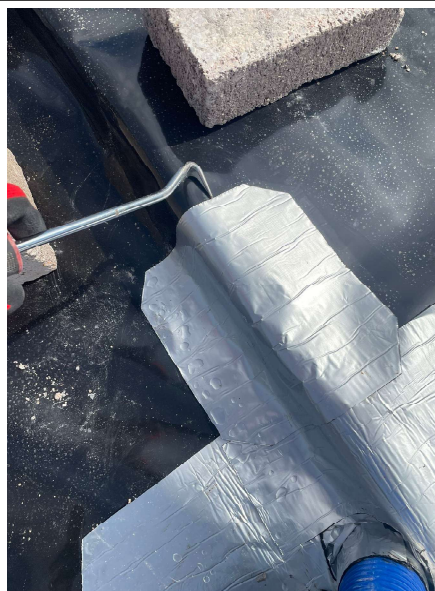
A pick and probe test being carried out upon a sealed corner detail.

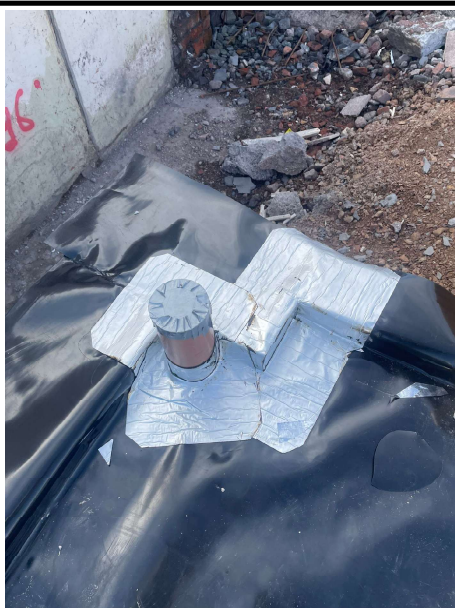
A sealed corner and pipe penetration.

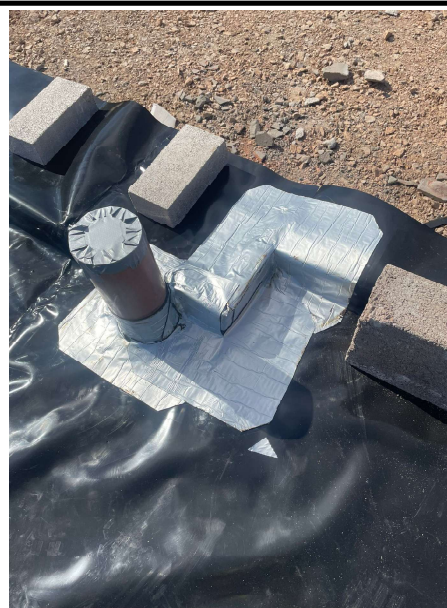
A sealed corner and pipe penetration.

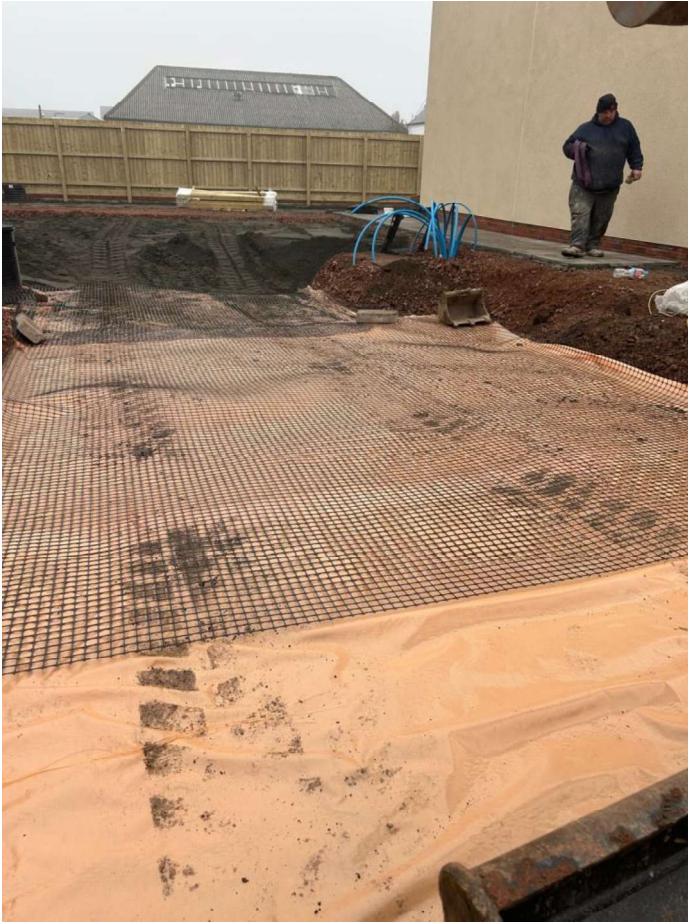
Plot 3 and Plot 4 – Membrane & No Dig Mesh looking towards Plots 5 to 7

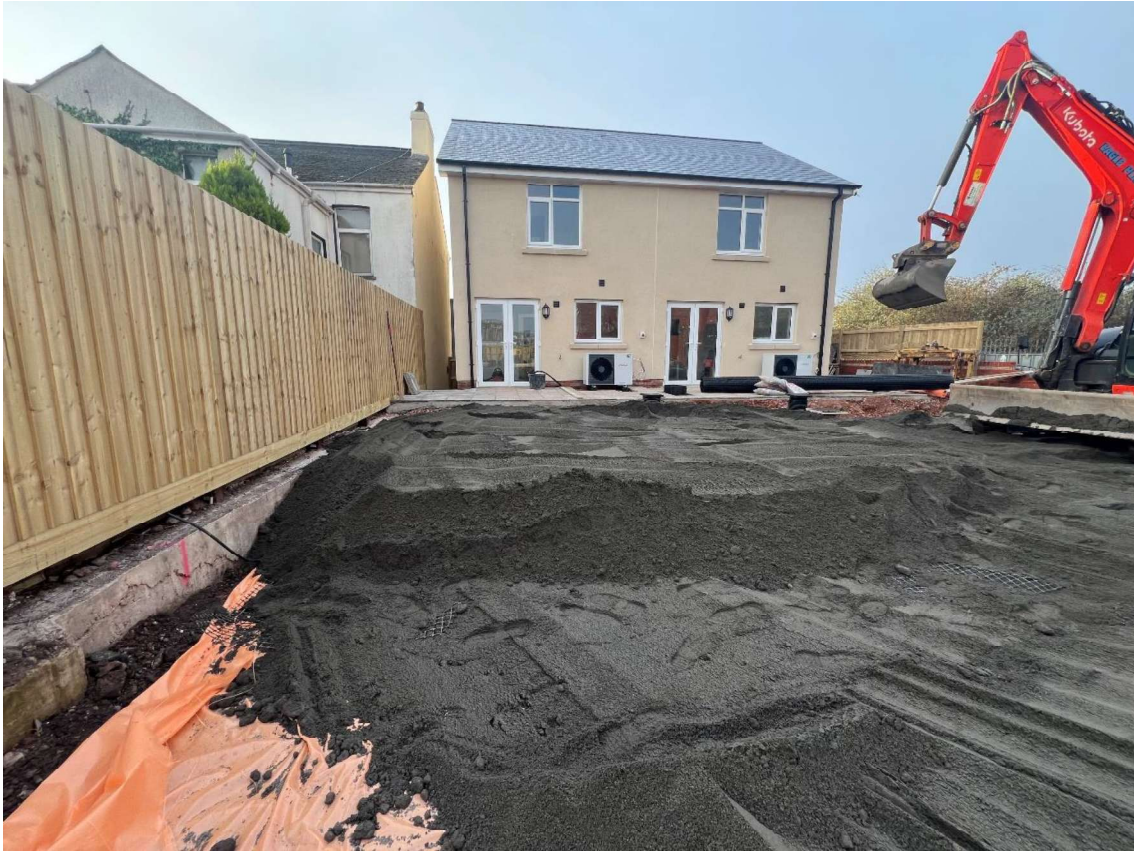
Rear Plot 9 (Left) and Plot 8 (Right) – Membrane & No Dig Mesh with Top Soil
