# Concrete Condition Survey

Newport Civic Centre  
Newport

Make safe &  
Hammer tap testing

BB24140

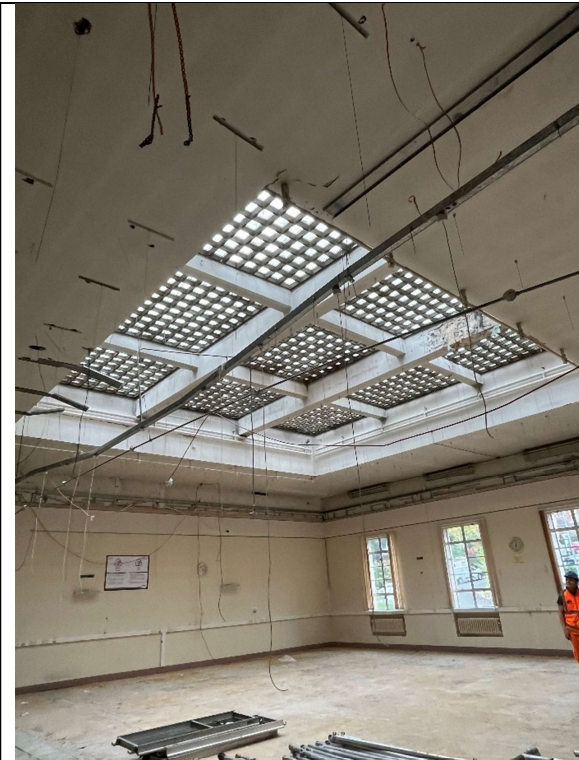
Photo 1. General view of the structure

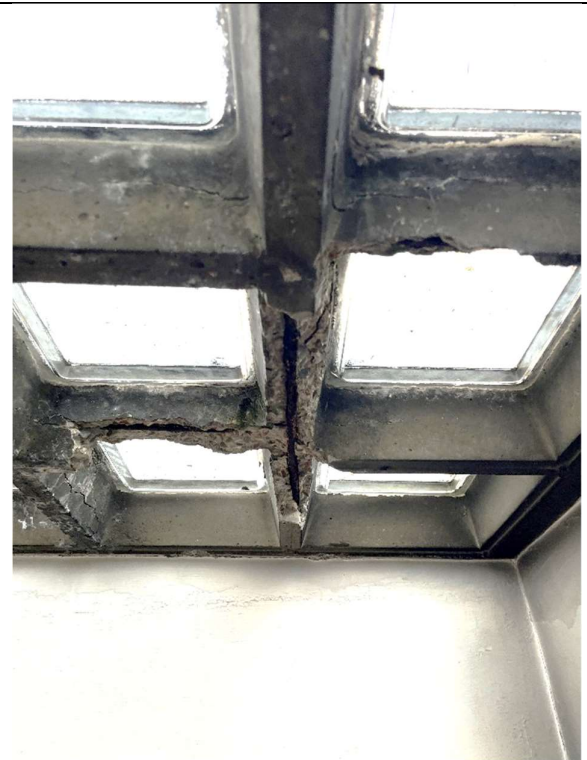
- Water leakage  
The waffle structure was found to have numerous cracks which have provided an avenue for water to track inside the soffit. Further to this seal between the building structure and concrete waffle frame has failed.

Photo 2. Waffle concrete frame failed

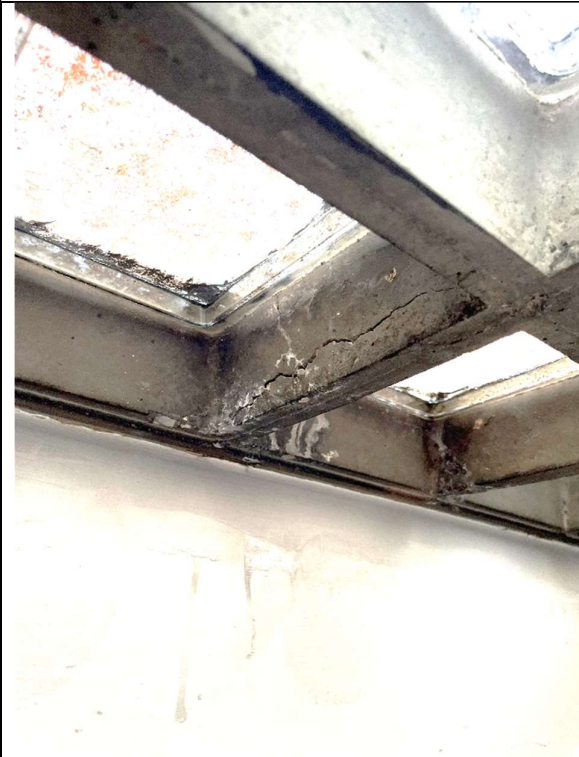
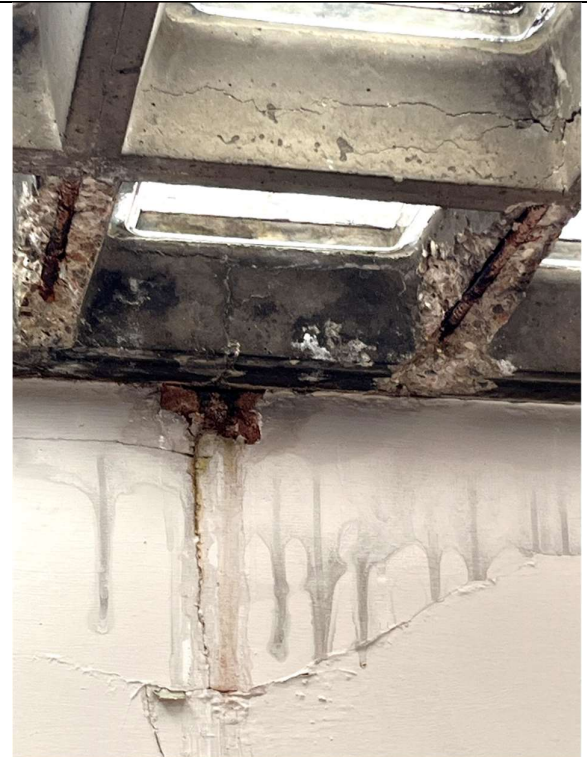
Photo3. Cracks on structure

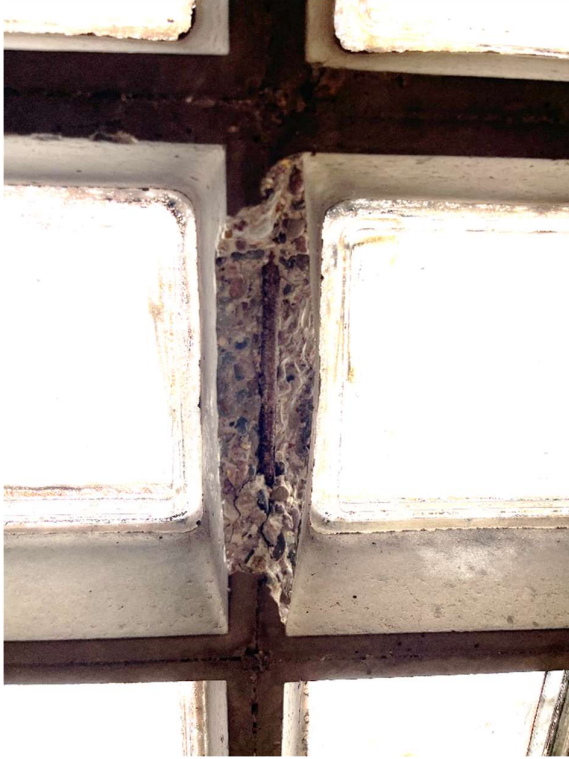
Photo 4. Water ingress, rebar corrosion

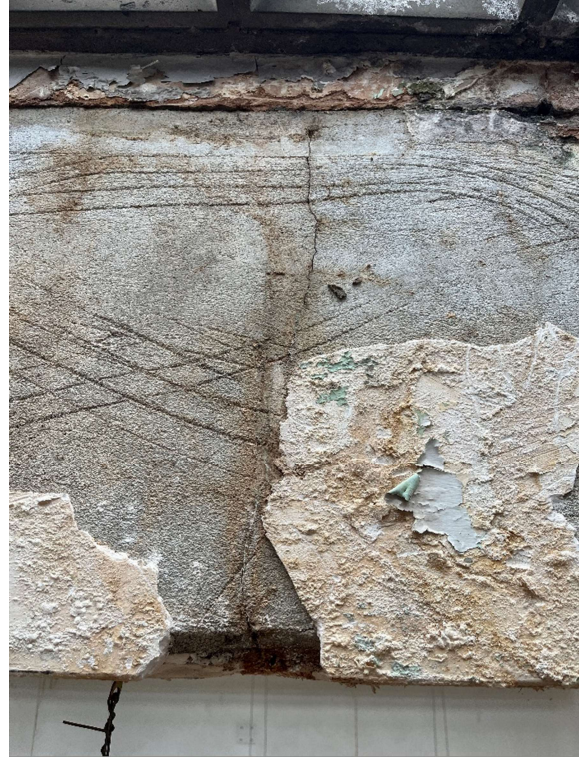
Photo 5. Spalling concrete

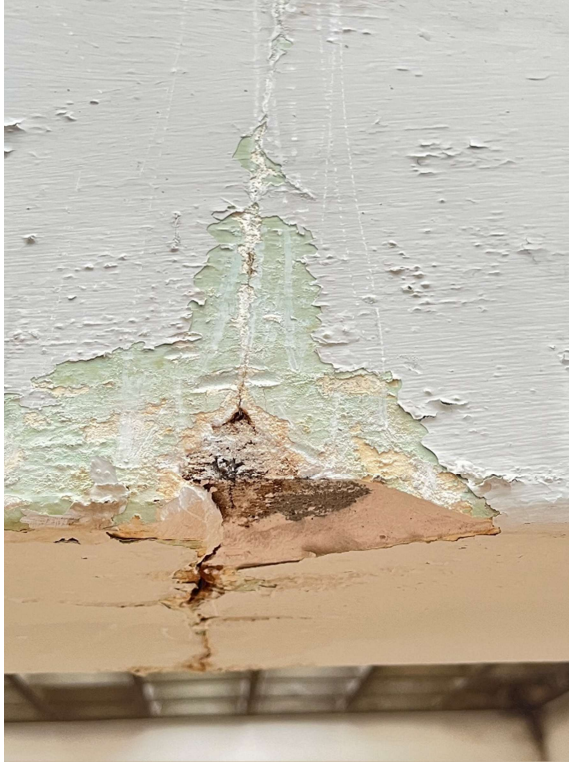
Photo 6. Cracks on beams

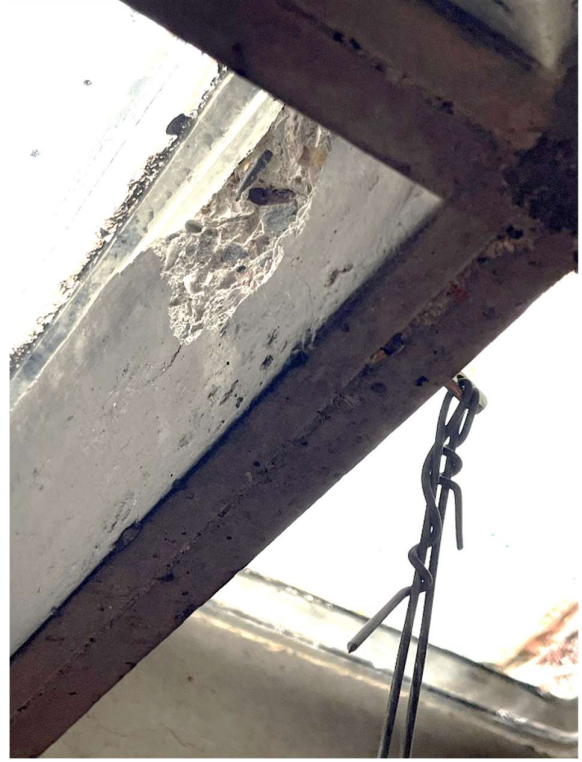
Photo 7. Cracks on beams

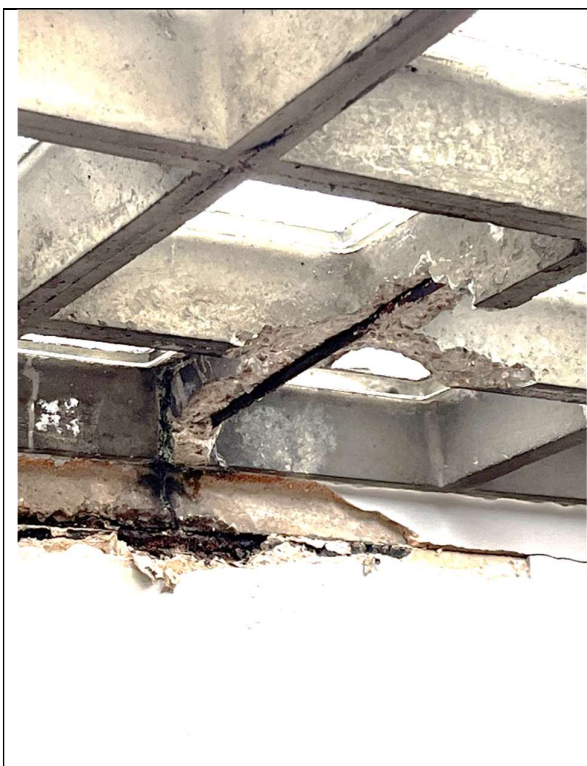
Photo 9. Water ingress, rebar corrosion

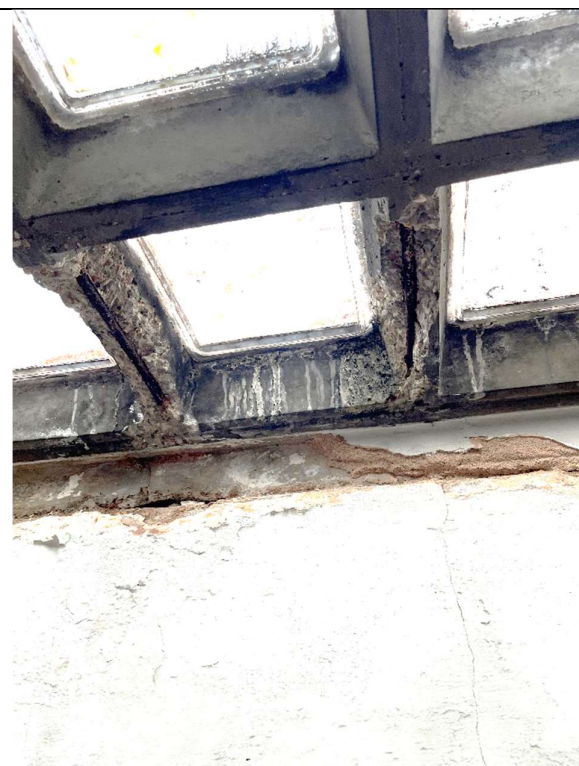
Photo 10. Water ingress, rebar corrosion

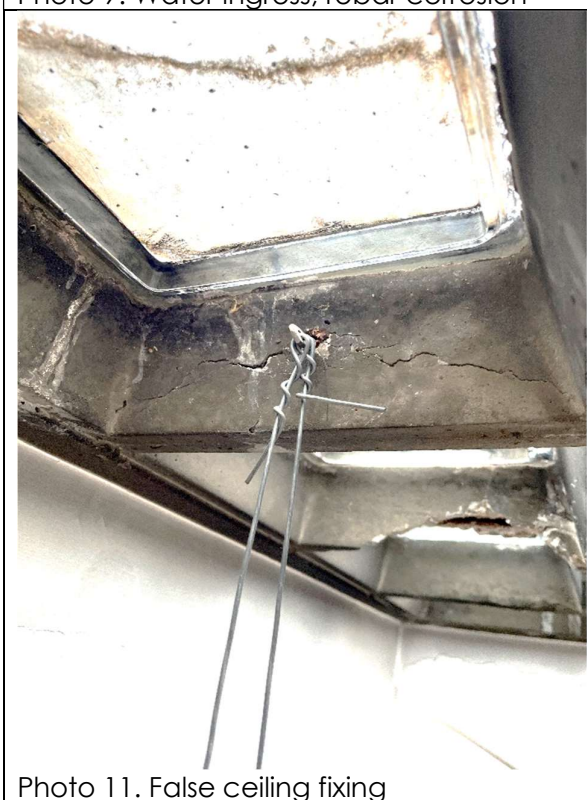
Photo 11. False ceiling fixing

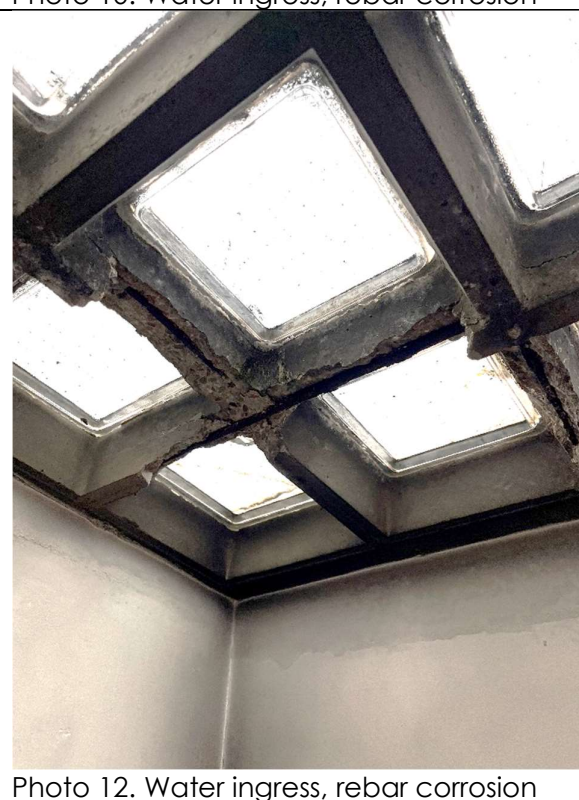
Photo 12. Water ingress, rebar corrosion
