# **Whitehall Farm Barn**

## **Structural Appraisal Report**

### **279-RP-001**

Revision 1 – 1<sup>st</sup> June 2026

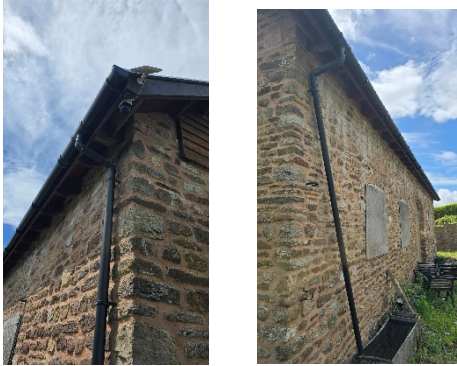
| REF | LOCATION | OBSERVATION | PHOTOGRAPH |
|---|---|---|---|
| 2 | EXTERNAL - GUTTERING | IN GOOD CONDITION, 2 NO. DOWN PIPES NORTH AND SOUTH WALL. NO OBVIOUS CONNECTION POINT FOR DISCHARGE | |

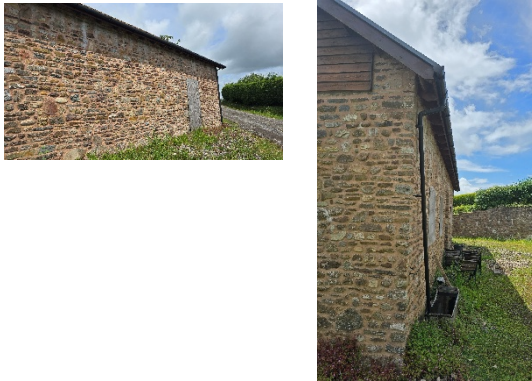
There are no signs of movement/cracking in the walls, with all pointing to stone face being in very good condition. Walls are true and plumb with no signs of roof spread or differential settlement.

| REF | LOCATION | OBSERVATION | PHOTOGRAPH |
|---|---|---|---|
| 4 | EXTERNAL - WALLS | ALL PLUMB AND TRUE. POINTING IN GOOD CONDITION. NO VISIBLE CRACKING OR MOVEMENT. STONE WORK IN GOOD CONDITION. EXTERNAL TIMBER CLADDING TO TOP OF GABLE END WALLS IN GOOD CONDITION | |

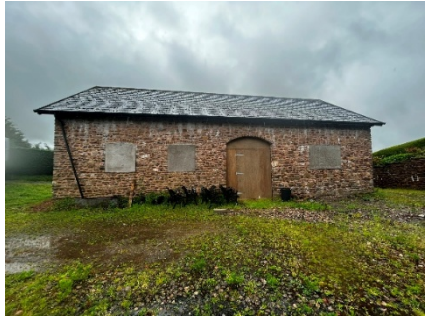
Externally there are no signs of ridge deflection issues, timbers are in good condition internally. Facias to east and west are missing, and exposed timbers are showing signs of deterioration.

| REF | LOCATION | OBSERVATION | PHOTOGRAPH |
|---|---|---|---|
| 5 | EXTERNAL ROOF | ROOF TILES / RIDGE IN GOOD CONDITION. NO SIGNS OF SPREAD OR MOVEMENT. TILES IN GOOD CONDITION, SLIGHT MOSS BUILD UP. TIMBER SOFFIT OVERHANGS AND TIMBER FASCIAS IN GOOD CONDITION. | |

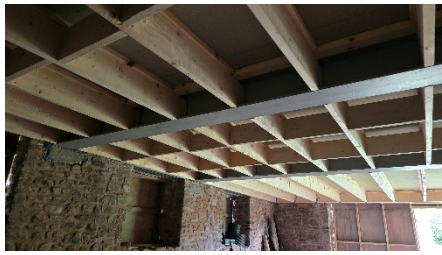
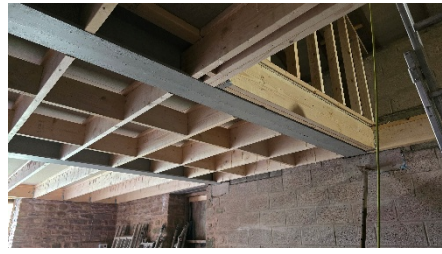
| REF | LOCATION | OBSERVATION | PHOTOGRAPH |
|---|---|---|---|
| 8 | INTERNAL<br>GROUND FLOOR<br>– MEZANNINE<br>FLOOR<br>UNDERSIDE | NO CEILINGS. NO OBVIOUS SERVICES. TIMBER JOISTS AND WALL PLATES ALONG WITH INTERCONNECTED STEELS VISIBLE. NO OBVIOUS FLEXURE, CRACKING, TORSION IN ANY OF THE MEZANNINE FLOORING STRUCTURE. | |

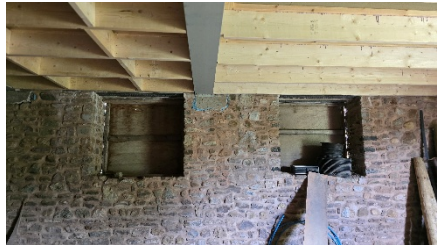
Lintels over doors and windows were mostly either steel (Catnic) or timber. There was a masonry arch over the northern access point. All lintels and the archway were in good condition.

| REF | LOCATION | OBSERVATION | PHOTOGRAPH |
|---|---|---|---|
| 9 | INTERNAL<br>GROUND FLOOR<br>– WINDOW<br>OPENINGS | NO GLAZING PRESENT. ALL WINDOW OPENINGS OPEN, WITH BOARDED COVERINGS. LINTELS SIT OVER OPENINGS. APPEAR TO BE 2NO CATNIC OR SIMILAR STEELS WITH CONCRETE LINTEL INFILLS. | |

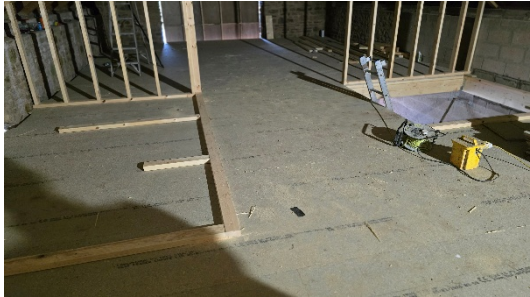
| REF | LOCATION | OBSERVATION | PHOTOGRAPH |
|---|---|---|---|
| 13 | INTERNAL MEZANNINE LEVEL – FLOORING | TOUNGE AND GROOVE PANEL FLOORING. ALL ALIGNED, NOT WARPING/WATER DAMAGE. | |

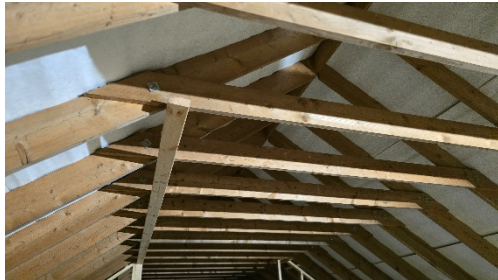
Internally the A-Frame construction is in good condition with all principal timbers and connections showing no signs of defects / movement.

| REF | LOCATION | OBSERVATION | PHOTOGRAPH |
|---|---|---|---|
| 14 | INTERNAL ROOF | ROOF STRUCTURE VISIBLE INTERNALLY. NO INSULATION, BOARDING. A FRAME TIMBER ROOF FRAMING, WITH FELT IN GOOD CONDITION. | |
