Issued by email  
07<sup>th</sup> November 2024

**RE: Visual Structural Inspection of Glass block Rooflight at Newport Civic Centre**

## Appendix A – Site Photographs

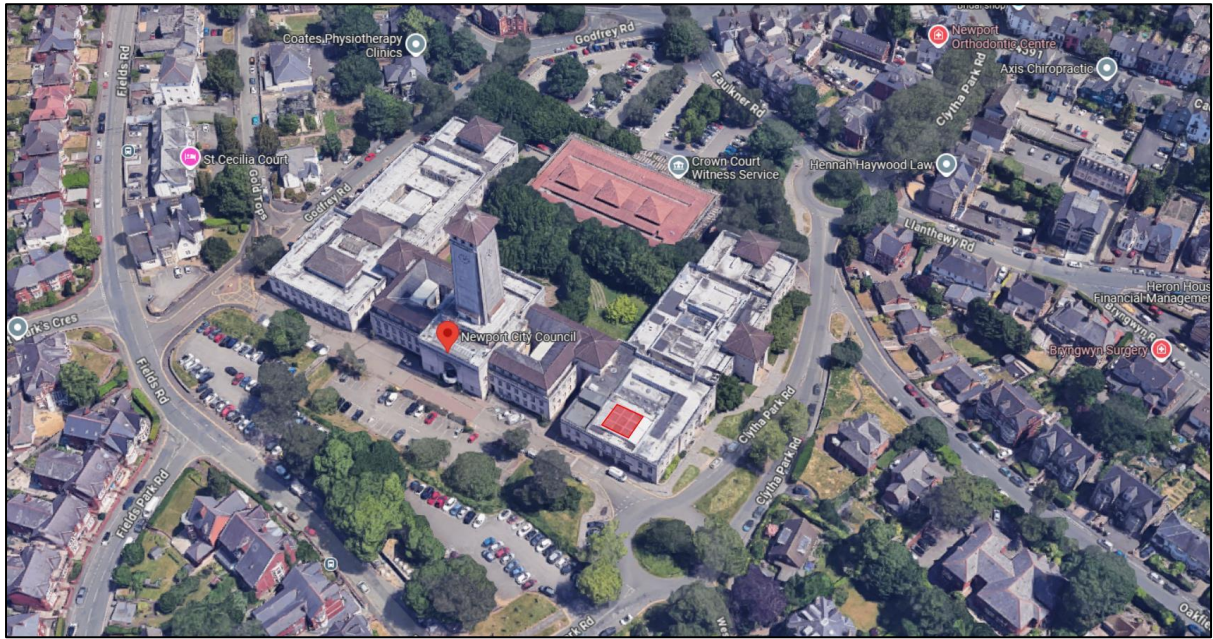
The area in Figure 1 which has been shaded red, is the location of the glass rooflight.

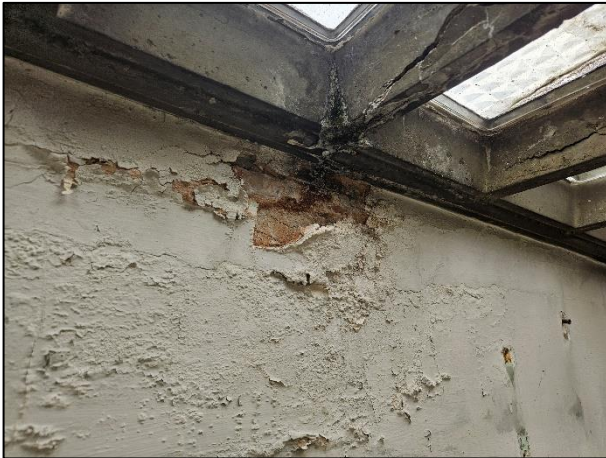
*Photograph 3 – Deterioration to main RC beams*

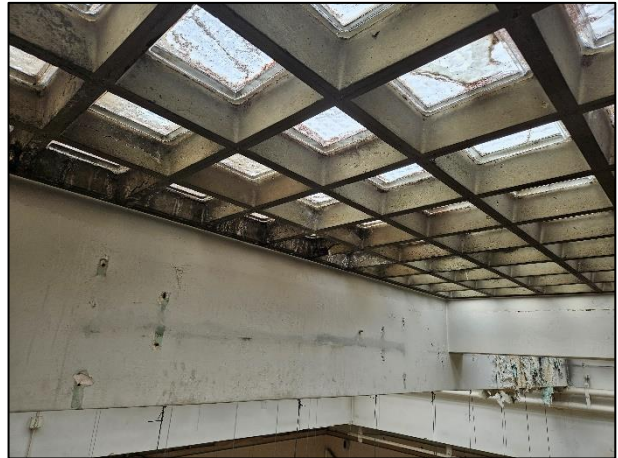
*Photograph 4 – Showing section of Glass Rooflight*

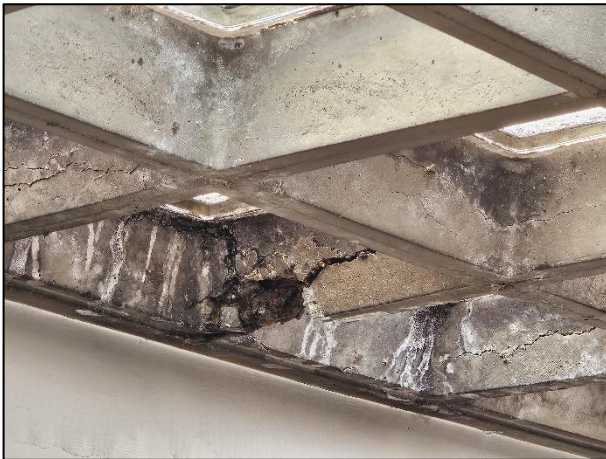
Spalling has also been noted to these members in area there is a loss of section of up to 50%. The rebar has also deteriorated, and a loss of section has additionally been noted to the reinforcement bars. **See Photos 5,15.**

*Photograph 5 – Large section of concrete missing from concrete rooflight frame*

Patchwork repairs are recommended to all cracked or spalled concrete. Many products are available within the UK such a manufacturer of a product is Sika (OSA) and are available for the proposed concrete repairs and protection of the beams from further deterioration.

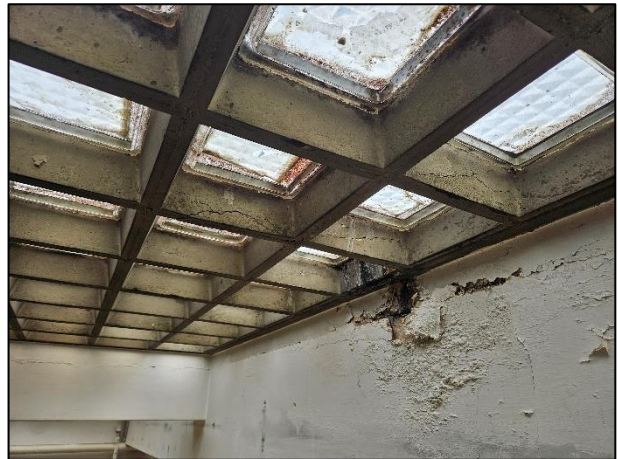
Water ingress has been identified to the structure which has caused areas of damp and likely the culprit to the cause for spalling is such a substantive extent. **See Photos 6,12-13.**

*Photograph 6 – Water ingress to main RC beam*

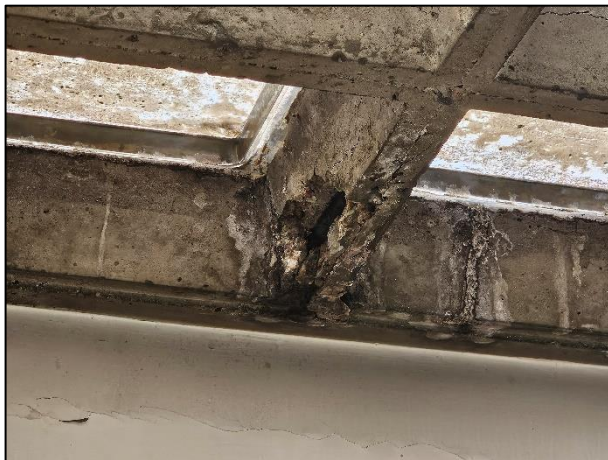
Photograph 15 – Close up of spalled area concrete from rooflight frame

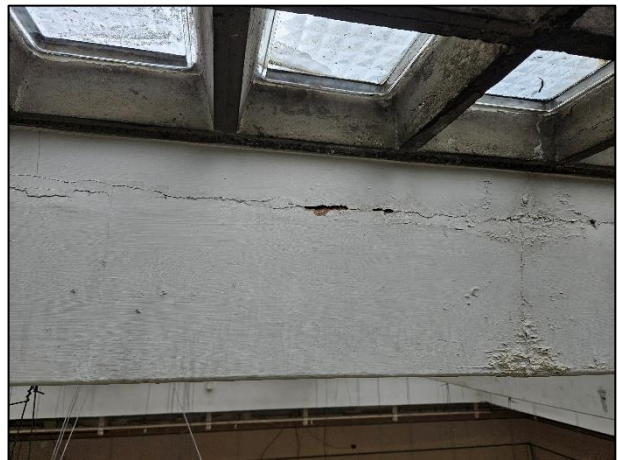
There is cracking noted to the primary RC beams additionally. **See Photos 16-17.**

Photograph 16 – Cracking to the RC beam horizontally

It would be advised that the removal of any external coatings (plaster) to the RC beams as to ascertain if there are any additional cracks to the underside of the beams. Any areas where there are cracks should be addressed and if there is any exposed rebar the methodology below should be followed.

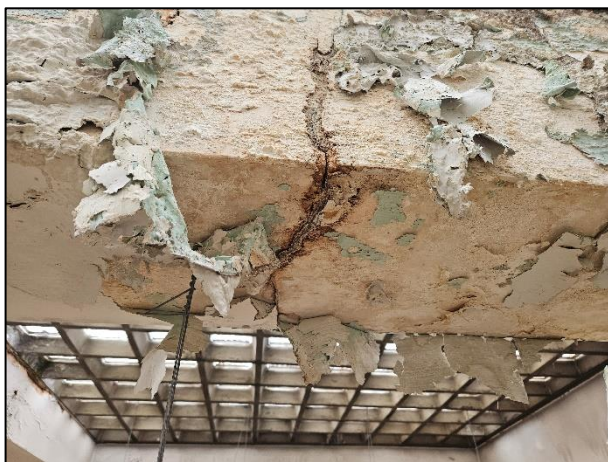
Photograph 17 – Large crack in RC beam up close

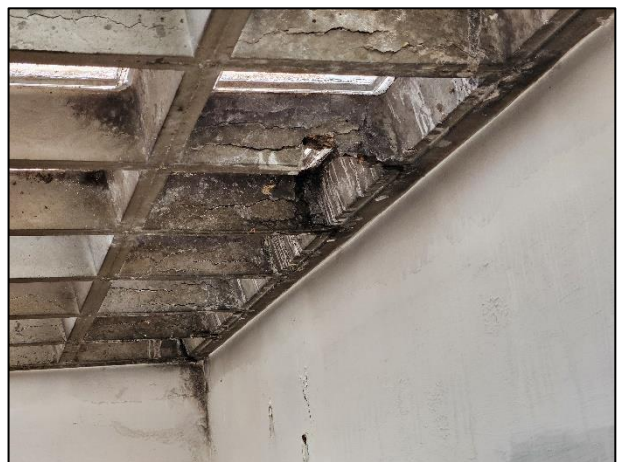
Photograph 18 – Spalling and cracking to Rooflight frame
