**Zanzibar, Newport**

**Retained Façade Condition Survey**

**March 2025**

| <b>Document Title</b> | 2479-PHG-RP-S-0001_ Retained Façade Condition Survey |

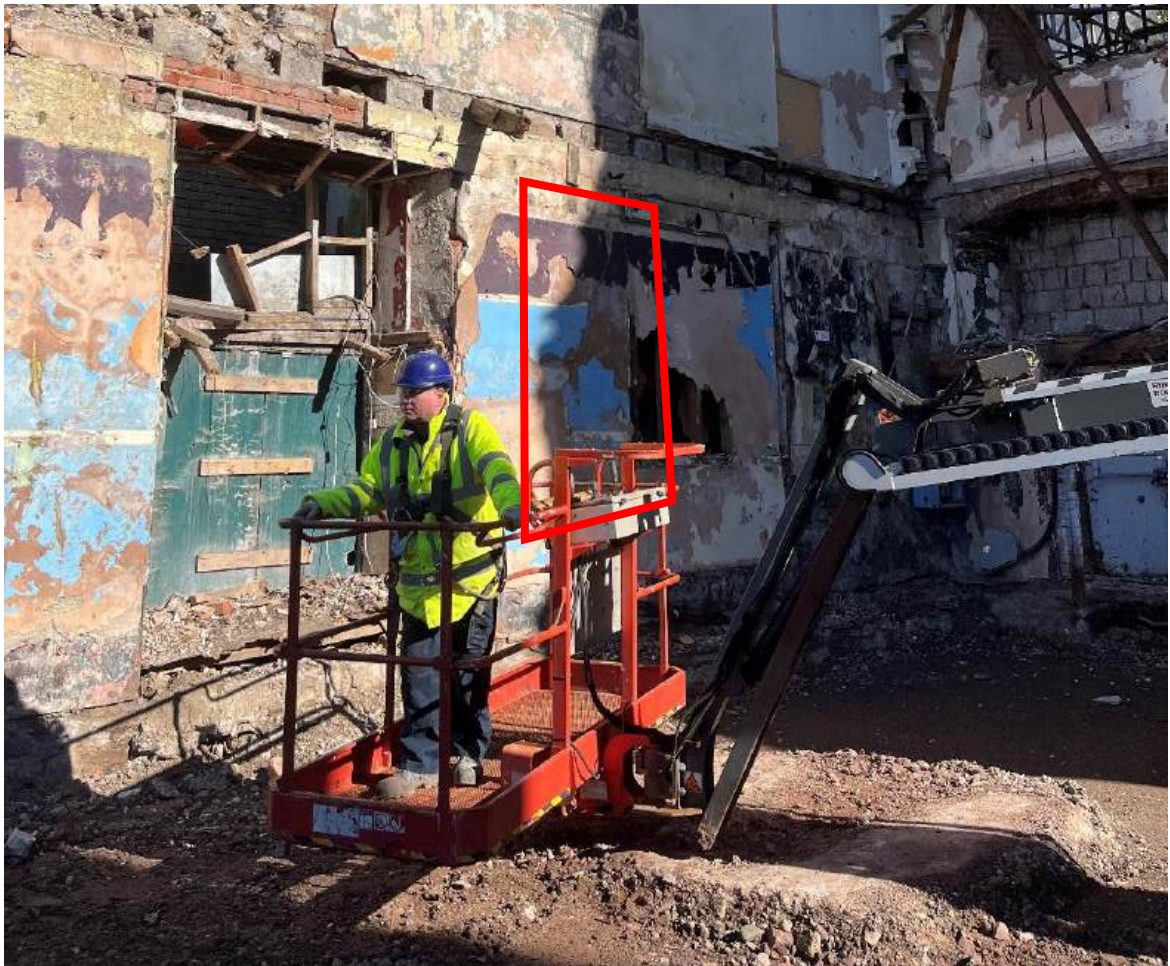
Photo 06 – Showing basement doorway.

An existing doorway / recess has timber studs infill and has been plaster boarded over.

***Remove plasterboard and timber studs. If there is a timber lintel, check condition and replace like for like if necessary. Block up the opening with matching infill brickwork using lime mortar.***

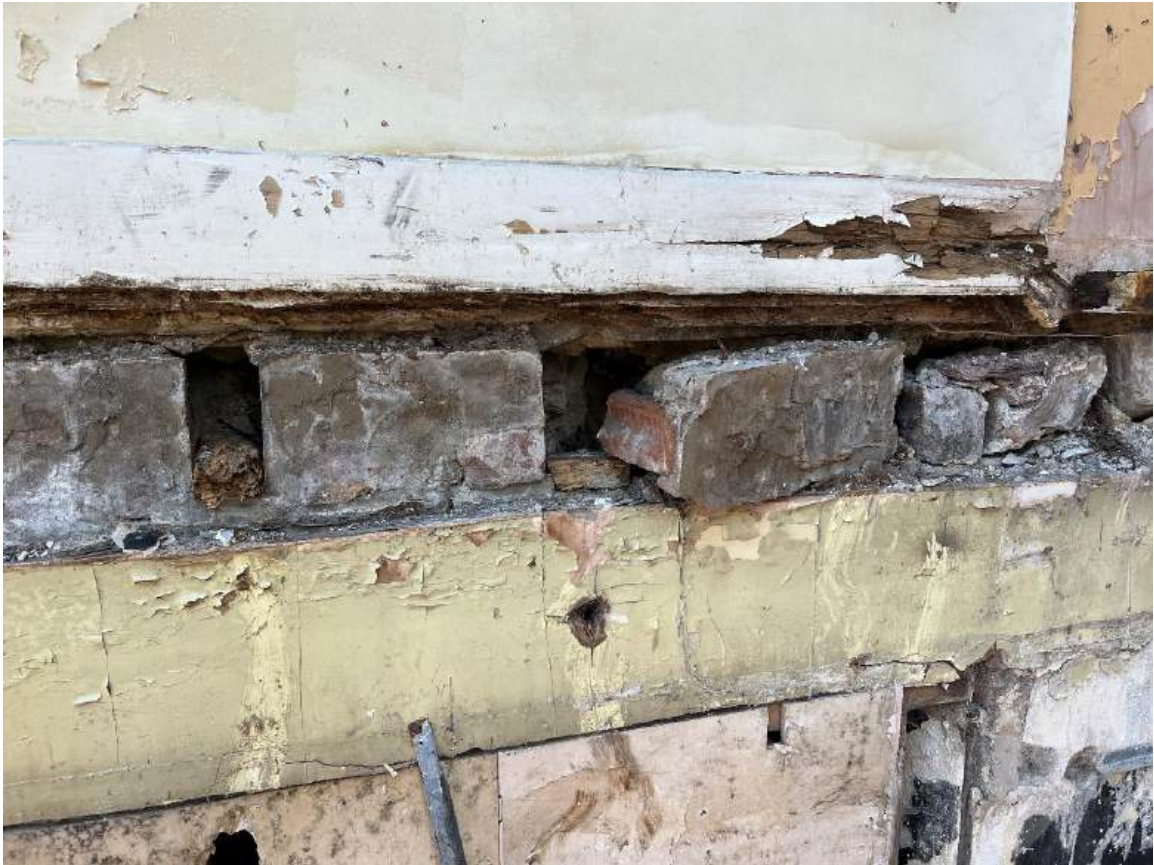
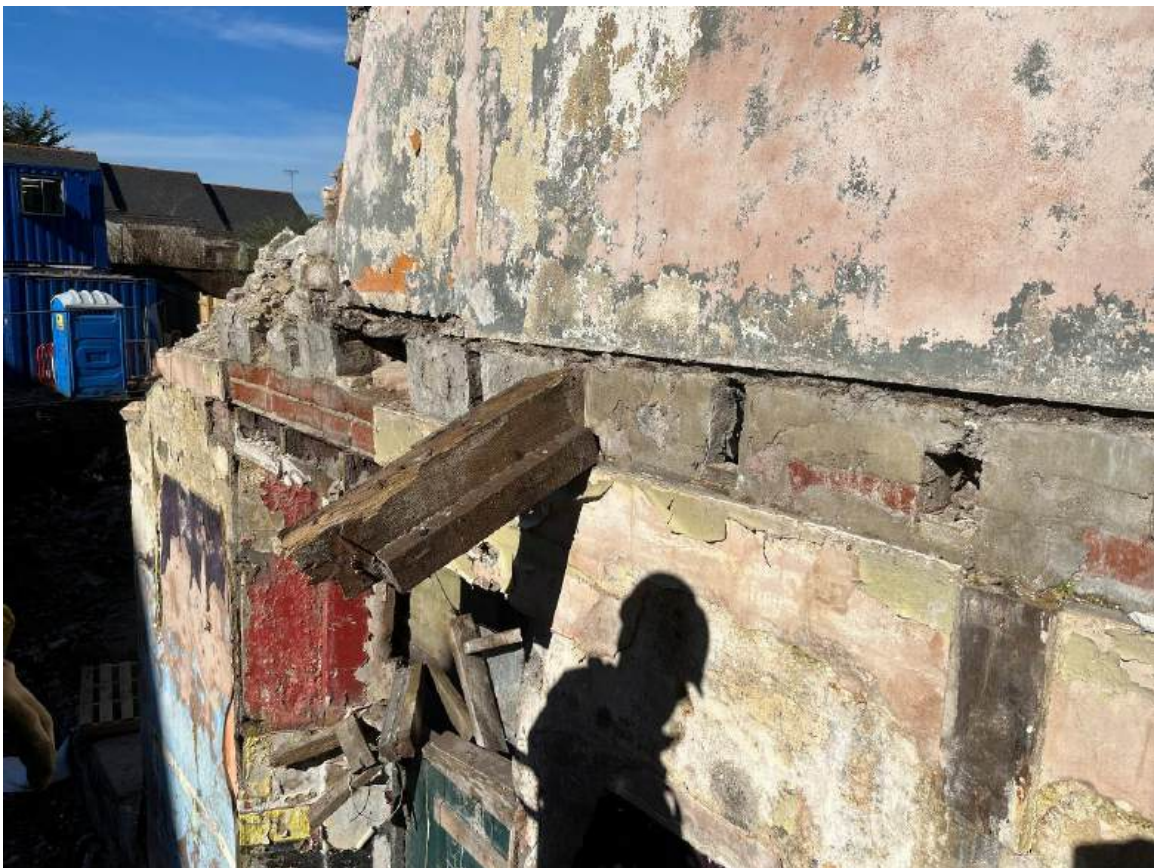
**Photo 07 – Showing ground floor level timber floor notches in wall.**

**Photo 08 – Showing ground floor level timber floor notches in wall.**

Photographs 07 and 08 show some of the remaining voids (or pockets) in the façade from the ground floor joists that had been built into the masonry.

***Remove loose masonry and any remaining timber from within the openings. Clean the openings such that they are free from dust, debris or any loose matter. Infill the voids with fully mortared brickwork.***

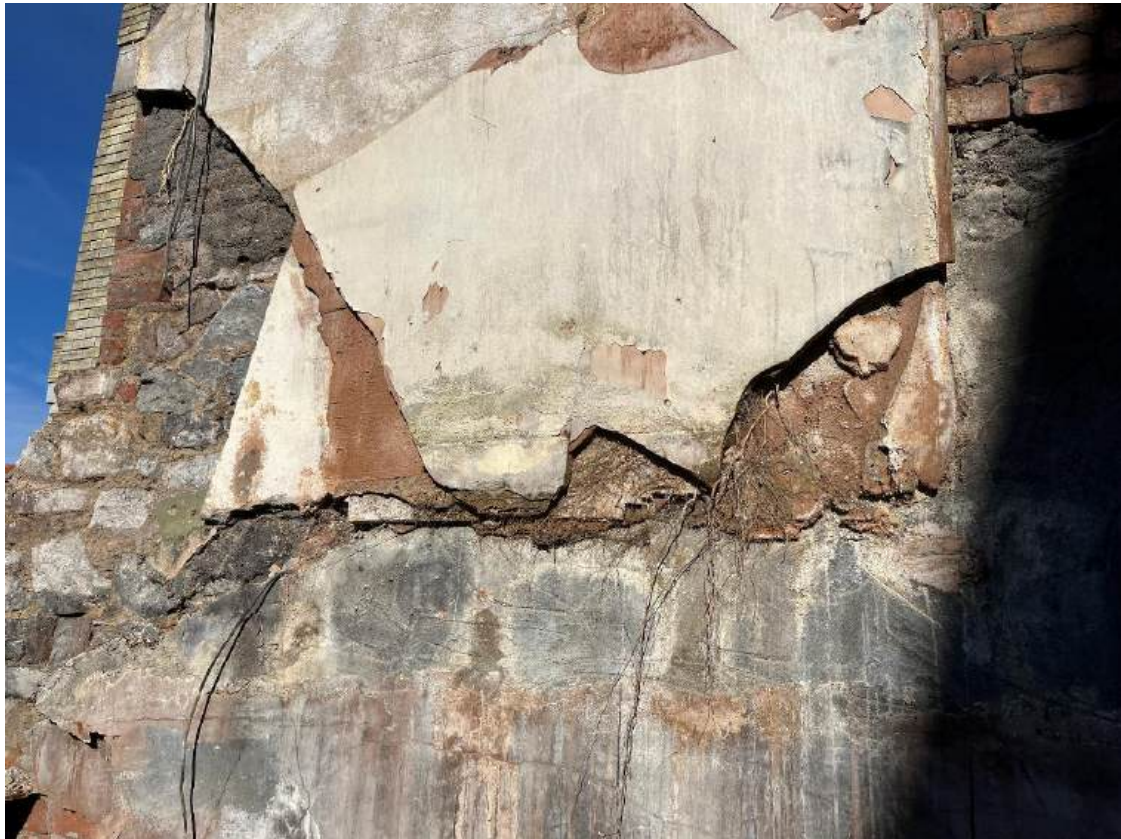
**Photo 10 – Showing render with vegetation behind.**

During the survey it was not possible to closely inspect this render.

***Remove all render and vegetation. Review masonry behind. Re-point all bed joints with lime mortar and make good any loose or missing bricks by infilling with fully lime mortared brickwork as required.***

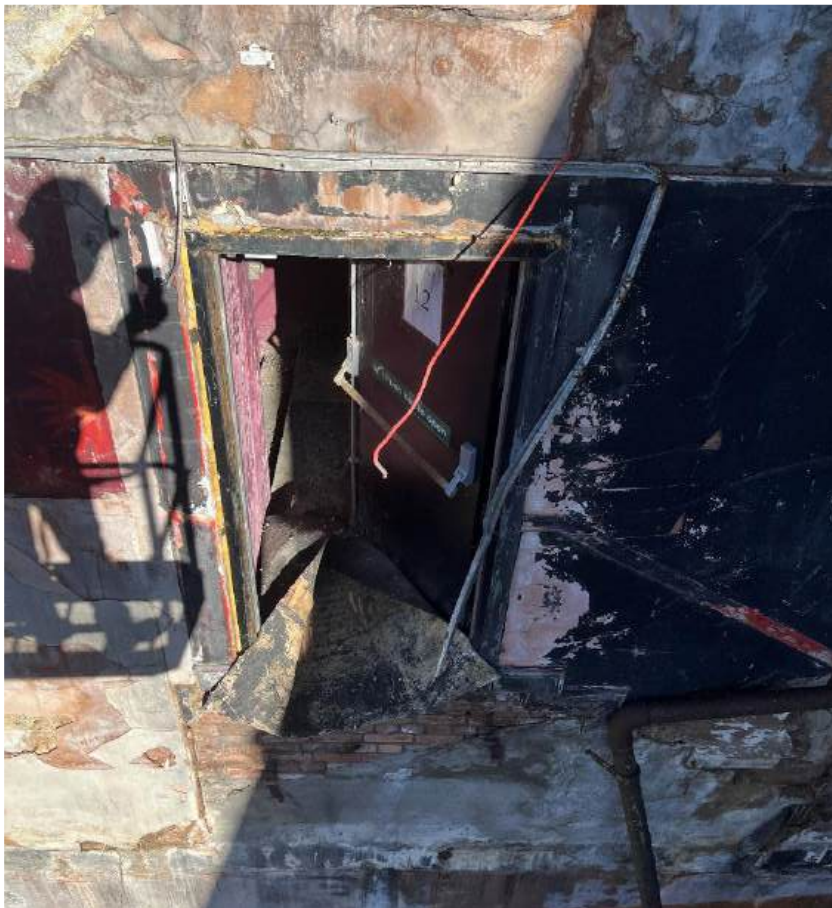
**Photo 12 – Showing high level fire escape door.**

A portion of wall under a high level door has been infilled with brickwork. But the bricks have not been constructed flush and are out of line on the one side. The existing stair stringer can be seen with vegetation growing behind.

***Remove all render and electrical conduit. Inspect lintel over door, check condition and replace like for like if necessary. Remove timber cill and remaining stair stringer, then infill door opening and any other voids with fully lime mortared brickwork.***

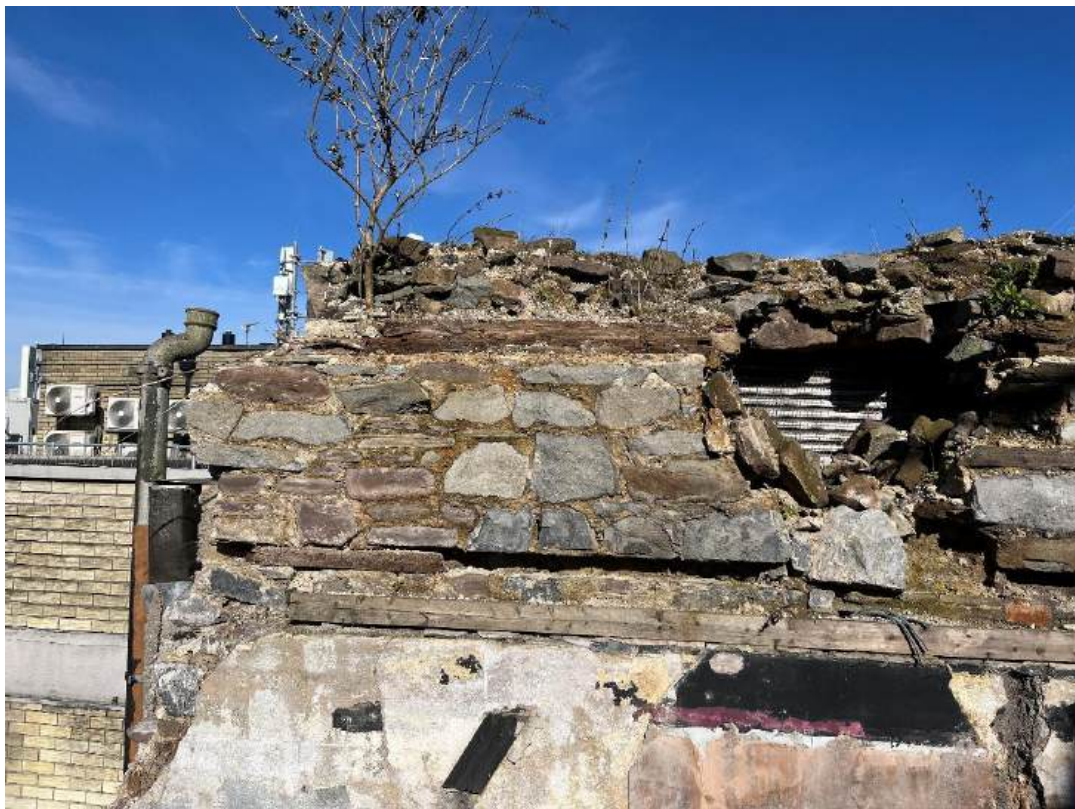
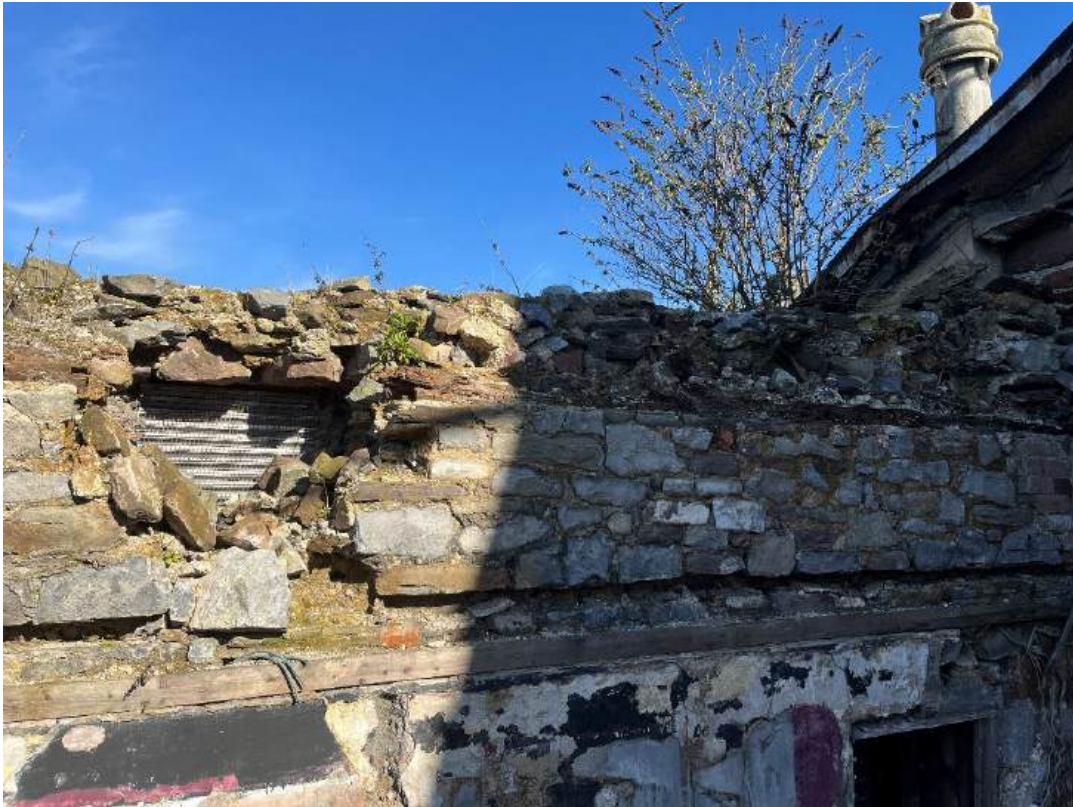
**Photo 13 – Showing top of the wall with uneven stonework and vegetation growth**

**Photo 14 – Showing top of the wall with uneven stonework and vegetation growth**

The top portion of the wall is very uneven and covered in vegetation. Original timbers that were built into the original façade are missing leaving recesses in the wall. Where new extract vents were added no lintels were installed and the masonry above those openings remains unsupported.

***Remove rotten timber that has been built into the wall and infill void with new masonry using lime mortar.***

***Remove render, cables and downpipe.***

***All vegetation needs to be removed and treated to prevent regrowth.***

***Remove all loose masonry and replace with new brickwork with lime mortar.***

***Block up redundant extract vent with infill masonry using lime mortar.***

***Ensure the new top of wall level is made satisfactory smooth to accept the new roof construction and SFS frame.***

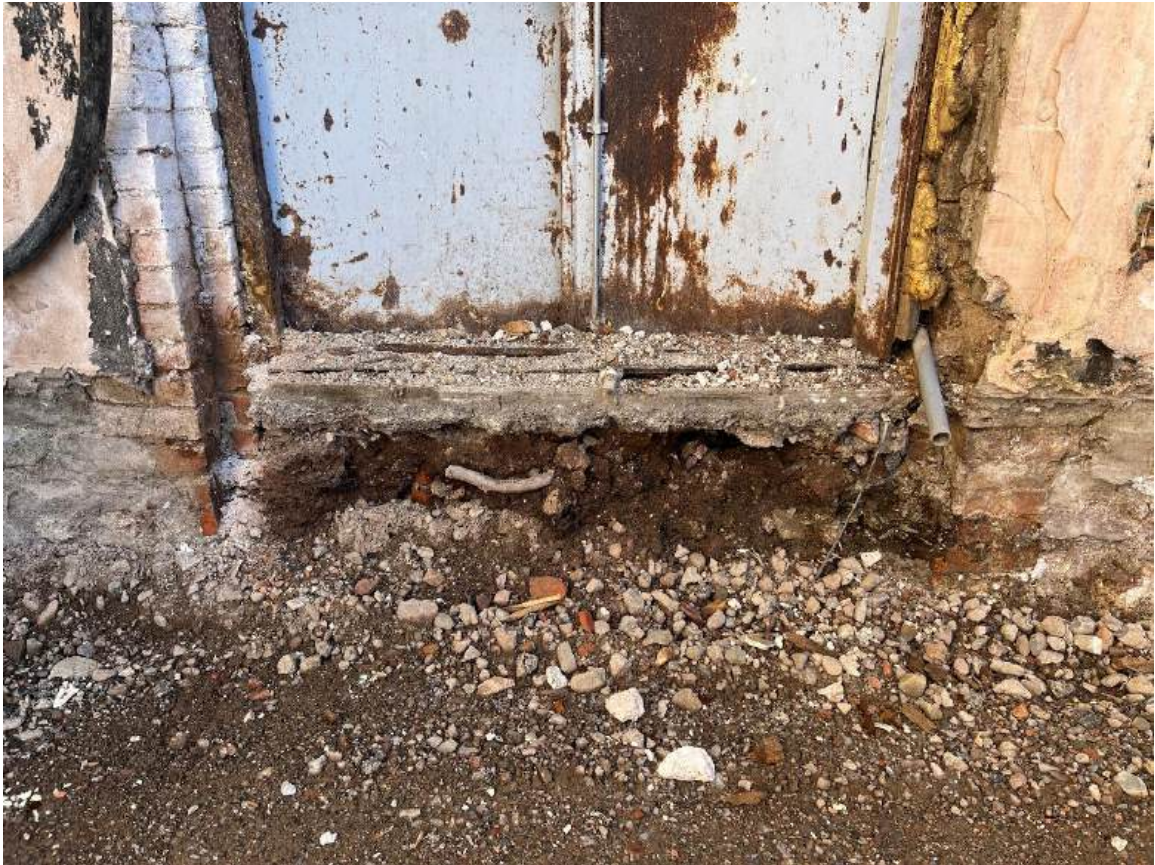
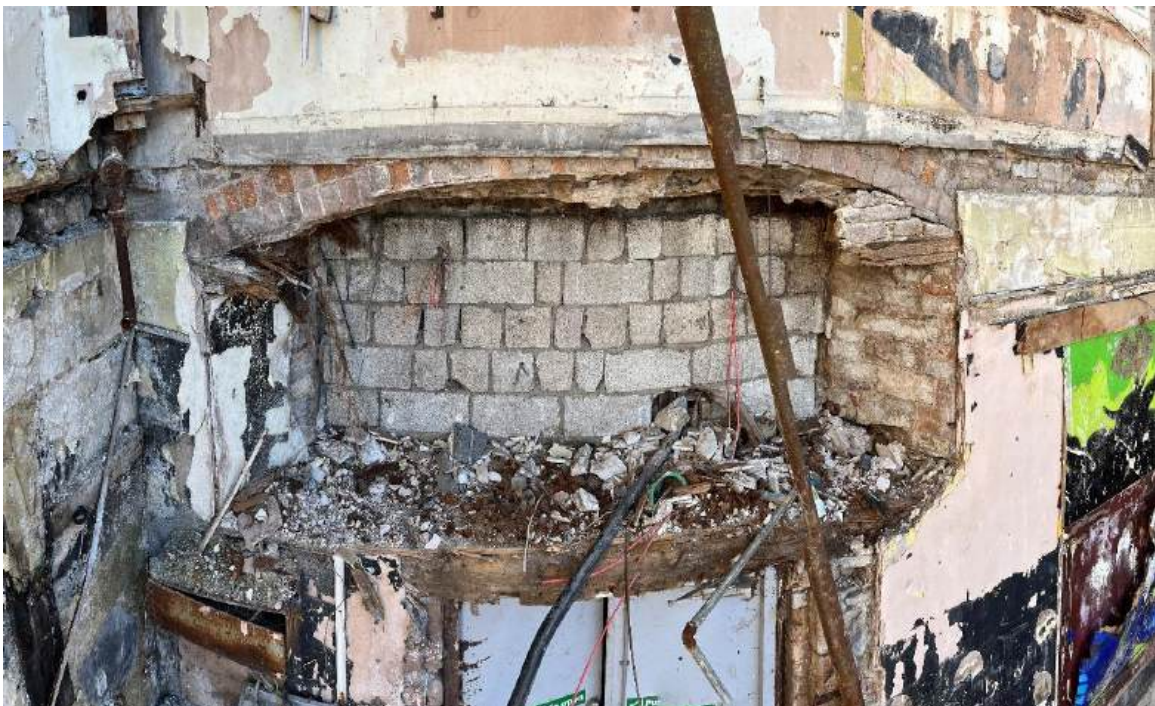
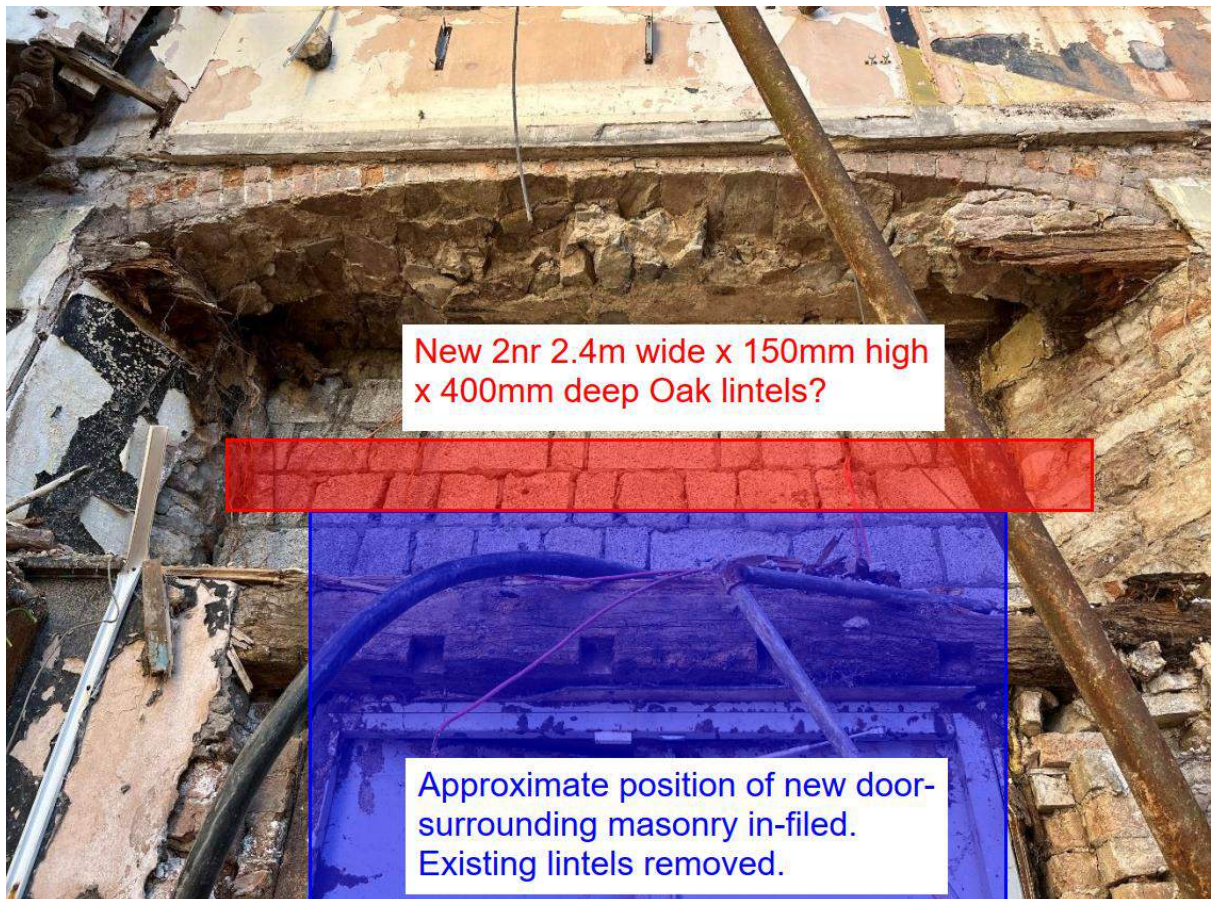
**Photo 15 – Showing underside of fire escape door**

**Photo 16 – Showing void over door lintels**  
(four photos stitched together)

**Photo 17 – Showing underside of brick arch**

The basement fire exit has been partly blocked up over an old timber lintel. The underside of the door appears to have been built off ground. Under the brick arch the existing timber lintel is damaged with only the ends bearing into the walls remaining.

***Remove door and loose material to the underside of the door threshold.***

***Remove timber lintel over the door and loose brickwork either side.***

***Remove the ends of the timber lintels under the arch. The arch may require propping if the ends are being undermined during the removal of the timbers.***

***Install 2 nr 3800x140x400mm oak lintels (air dried) and brick up tight to the underside of the arch.***

***Remove any loose masonry to the underside of the arch.***

***Block up the doorway flush with the inside face of the façade with masonry and lime mortar.***

***The full thickness of the arch above needs to be fully filled with masonry right up to the underside of the arch for long term stability of the façade.***

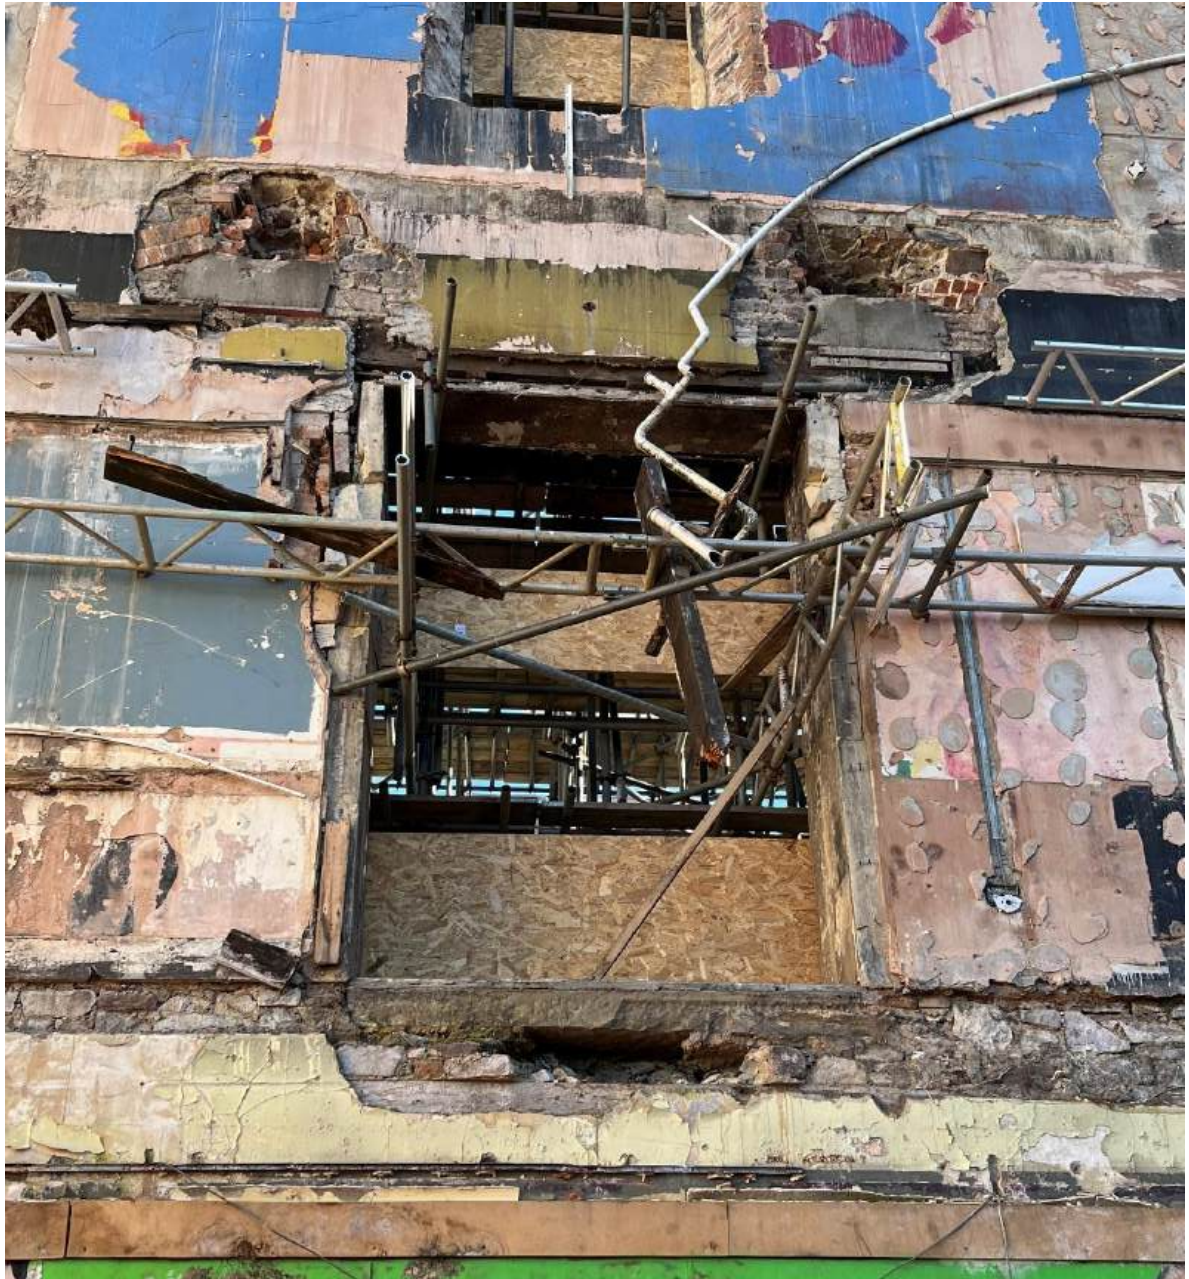
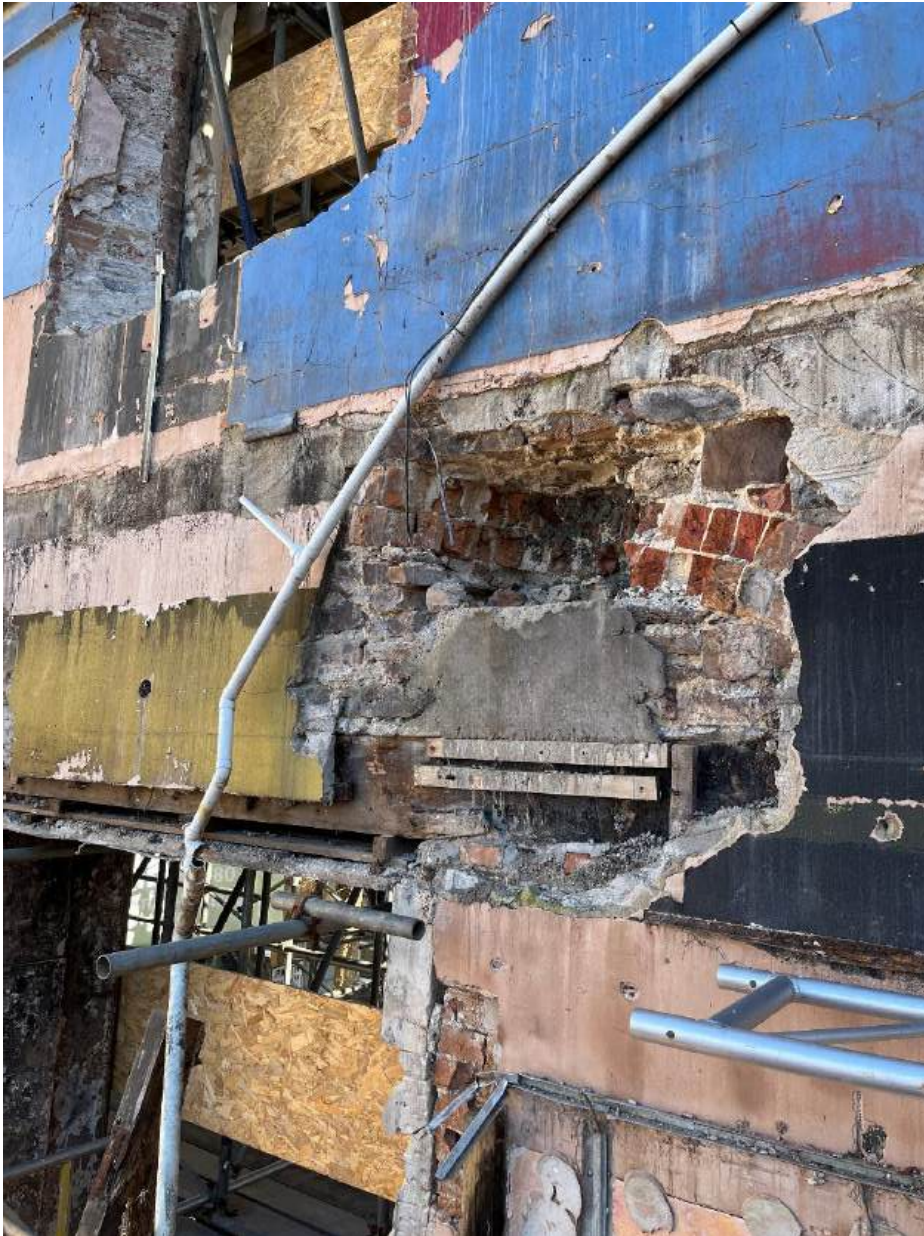
**Photo 18 – Showing main entrance doorway**

**Photo 19 – Showing main entrance doorway**

There is stonework missing from under the door threshold stone slab, along with electrical items and timber attached to the façade. There are two large openings in the façade from the installation of the steel frame structure.

***Remove render and auxiliary items. Review the quality of the masonry, and repair any poor quality masonry areas using lime mortar.***

***Block up the void under the threshold stone with infill brickwork and lime mortar. Review all mortar joints once render has been removed and re-point accordingly with lime mortar.***

***Repair all loose masonry in and around the openings and brick up.***

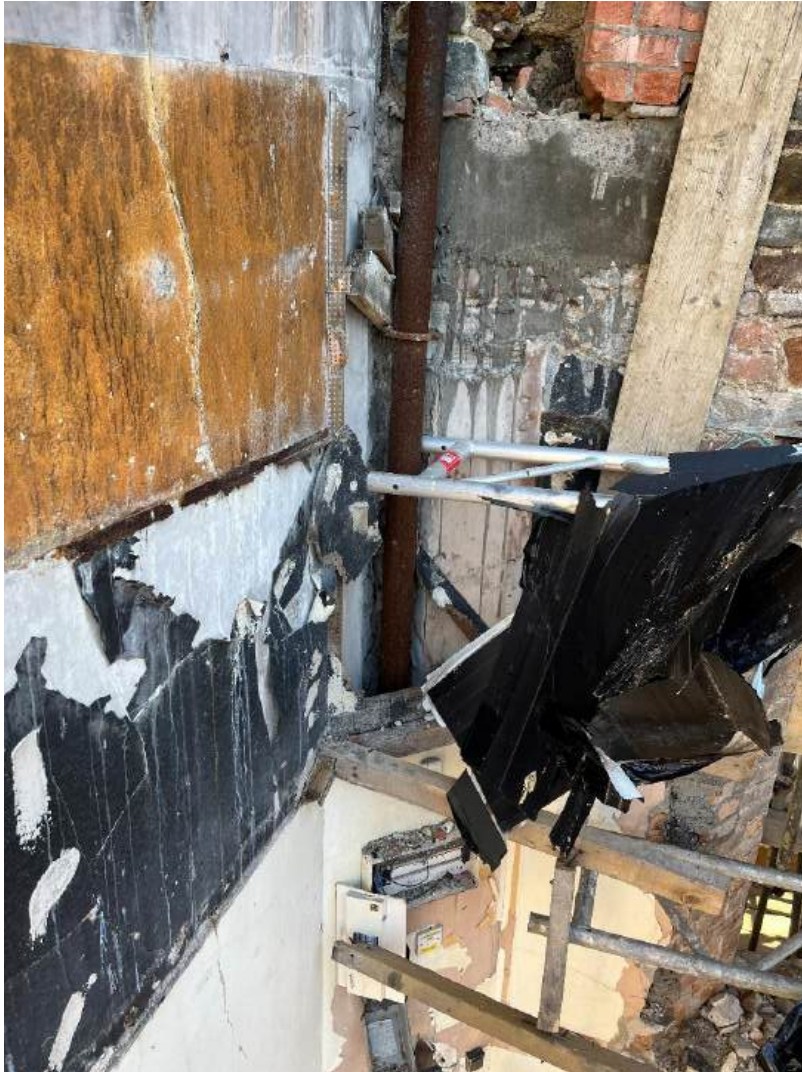
**Photo 20 – Showing internal fixtures and façade retention system**

The demolition and removal of the collapsed elements of the existing building only involved the removal of debris that was detached from the façade. Therefore, the façade still needs to be stripped of the remaining non-structural elements, drainage pipes and electrical conduits etc. There is debris on the façade retention system that is left over from the removal of this material.

***Remove cast iron downpipe and electrical equipment.***

***Remove render.***

***Take care to avoid damaging the façade retention system while removing the material and make good any remaining holes after removal.***

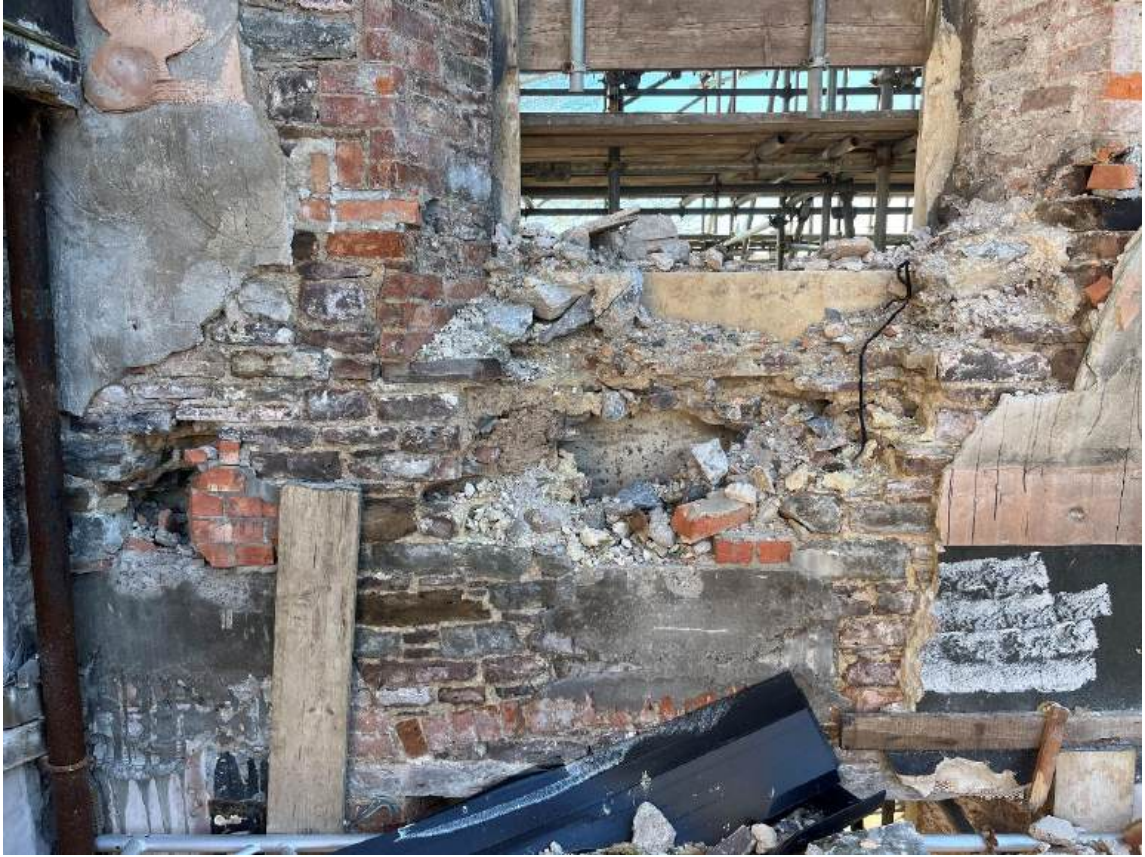
**Photo 21 – Showing damaged masonry under the window**

When the internal steel frame was originally installed into the wall, large pockets were cut out in the façade and large concrete padstones were cast to sit the steels on. Now that the beams have been removed, they have left large openings in the façade with lots of loose masonry.

***Remove all loose masonry and render. Review the condition of the masonry behind.***

***Brick up all openings in the wall to window cill level using lime mortar. (refer to Architects details for level).***

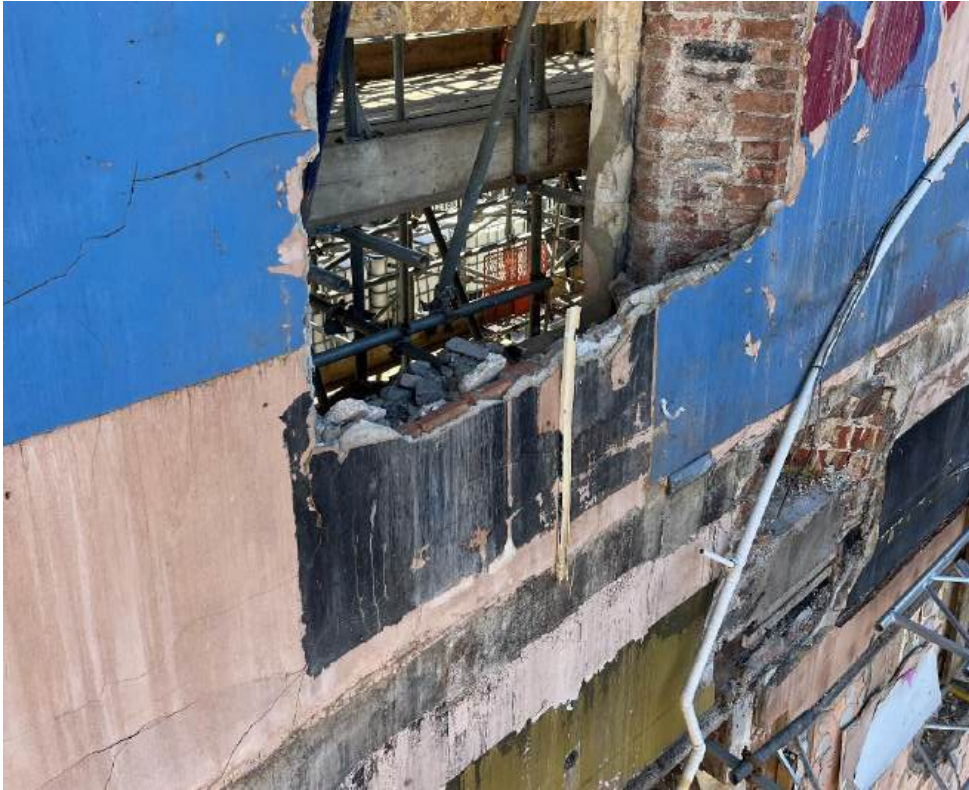
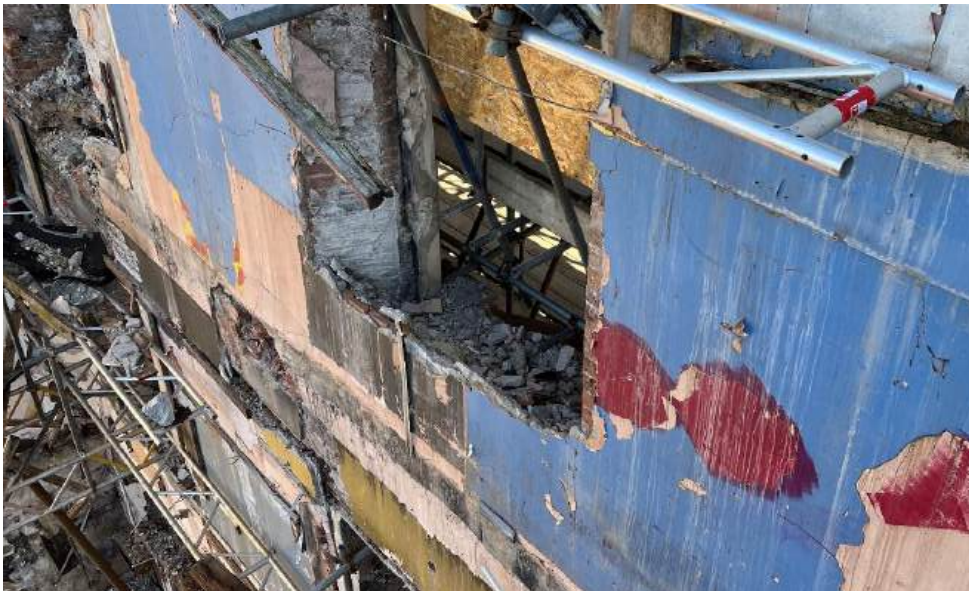
**Photo 22 – Showing loose masonry around window cill**

**Photo 23 – Showing loose masonry around window cill**

The internal skin around the window cill is higher than the outside skin and may come loose when the internal render is removed. This window cill level is higher than the adjacent window. It therefore might be worth considering removing the higher masonry on this window so they line through with the more consistent lower levels.

***Remove all loose masonry and render. Review the condition of the masonry behind and make good. Repoint with lime mortar as required.***

***Refer to architect's details to determine the final level of the internal masonry. Rebuild inner skin to the correct height or re-point with lime mortar if masonry comes loose during works.***

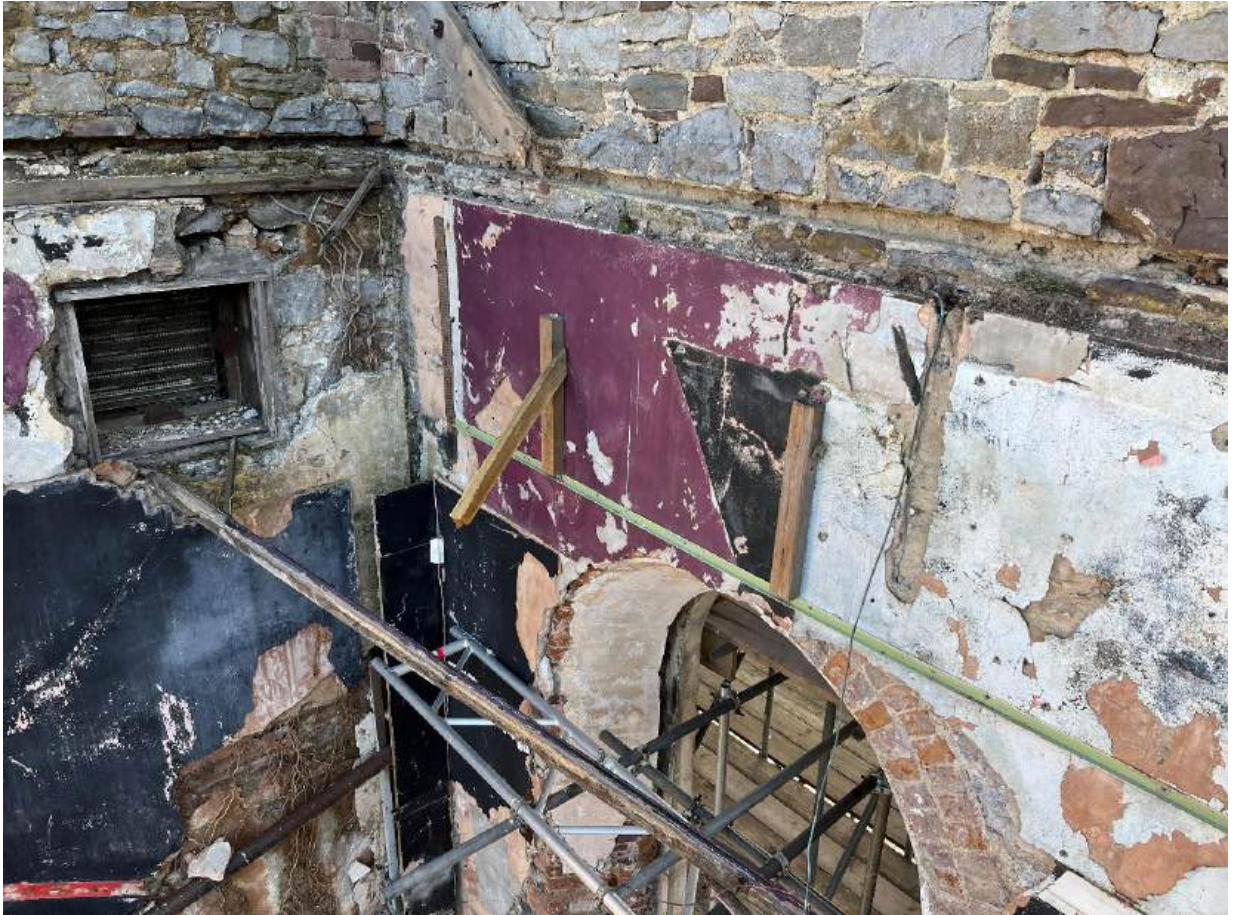
**Photo 24 – Showing corner of elevation 1 and 2a**

Large opening in the masonry from elevation 1 which has been added into the façade without a lintel. The timber that was built into the façade during construction has been removed leaving a horizontal void around the façade. Vegetation can be seen growing behind the render on the wall.

***Remove all render and vegetation. Review the condition of the masonry behind.***

***Treat wall to prevent future re-growth of vegetation.***

***Remove the timber around the opening and brick up the openings using lime mortar.***

***Brick up the channel in the wall where the timber batten was, using lime mortar.***

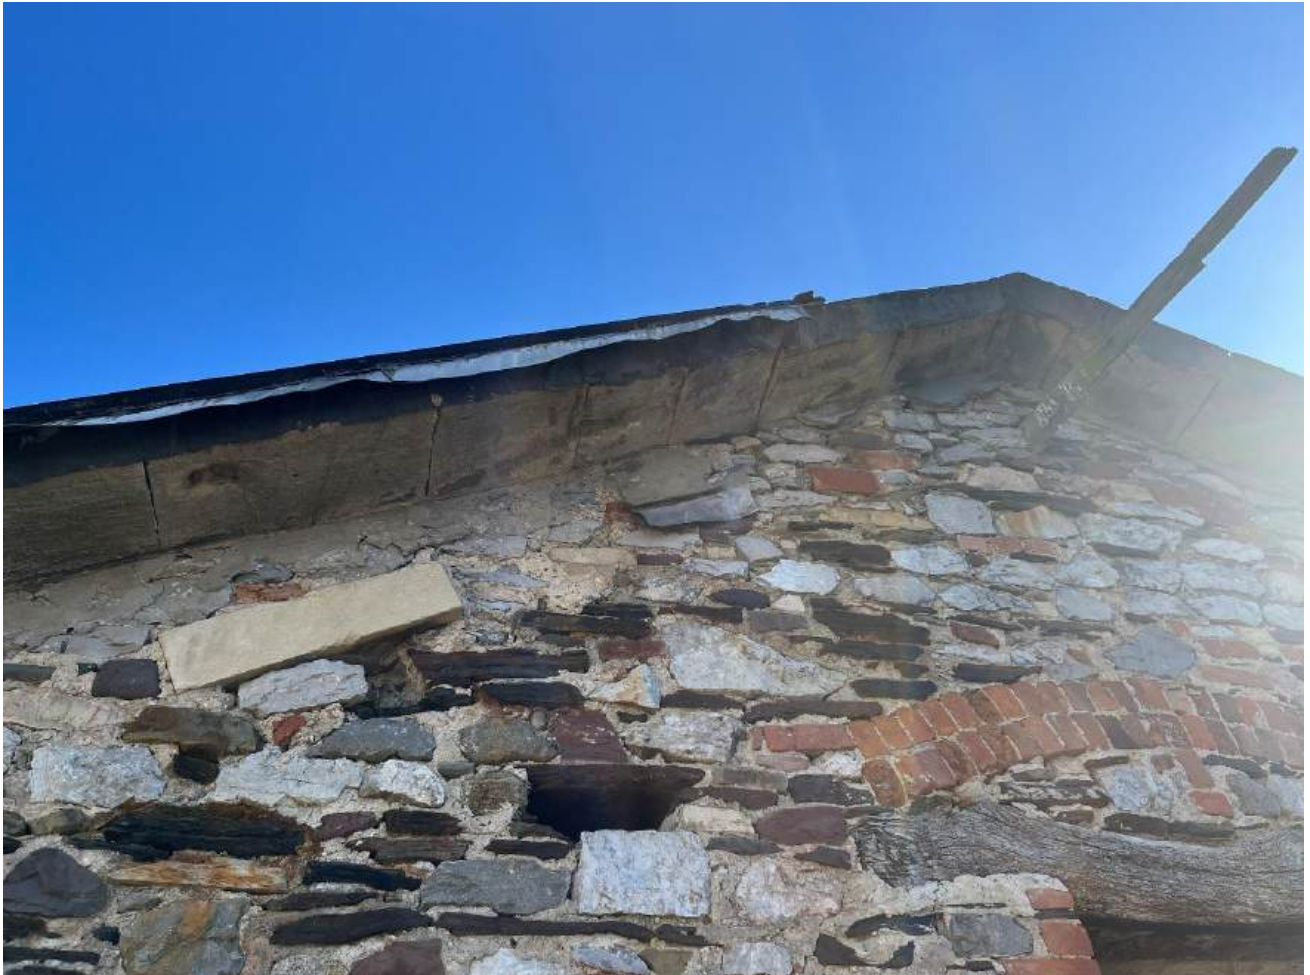
**Photo 25 – Showing missing stonework in the façade**

***Fill all openings in the façade with masonry using lime mortar, ensuring the masonry is packed tight.***

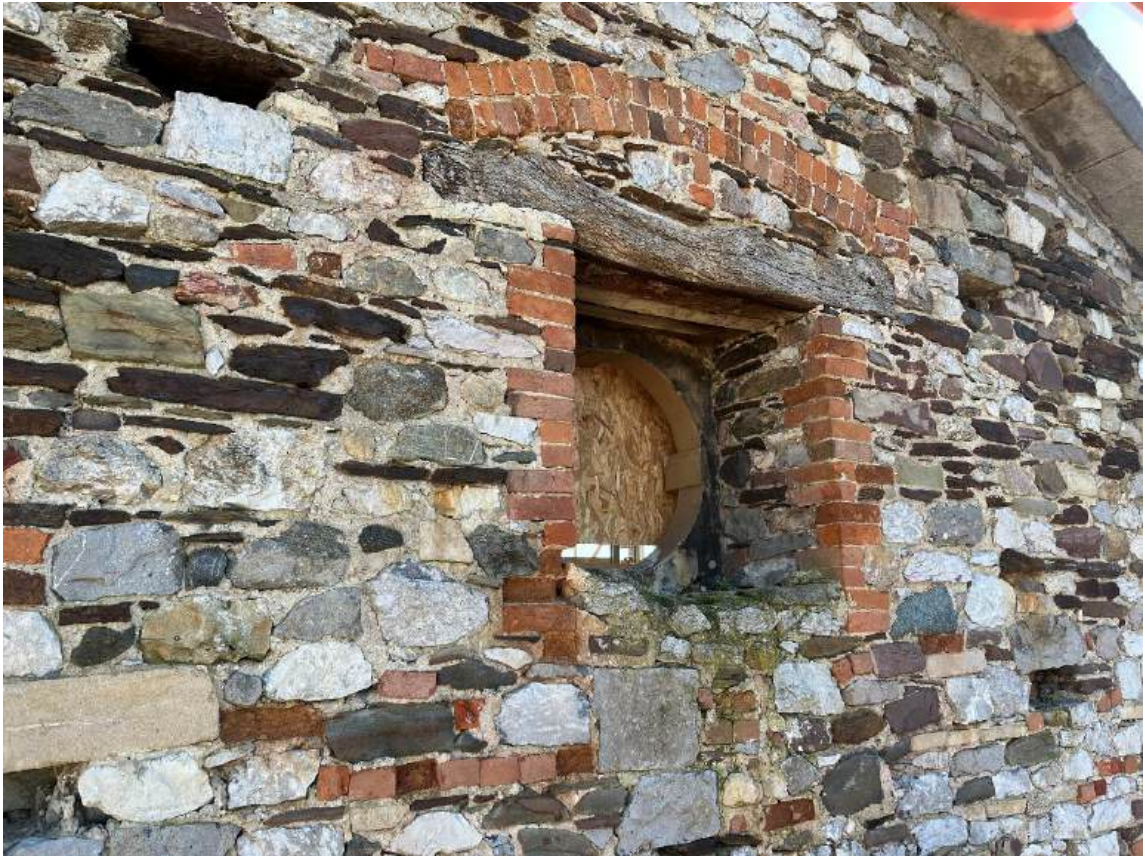
**Photo 26 – Showing timber lintel over feature opening in façade**

There are a few openings in the masonry but generally the condition of the façade is good.

***Review all mortar beds and repoint as required.***

***Fill holes in masonry.***

***Note this lintel is solid and does not require replacement.***

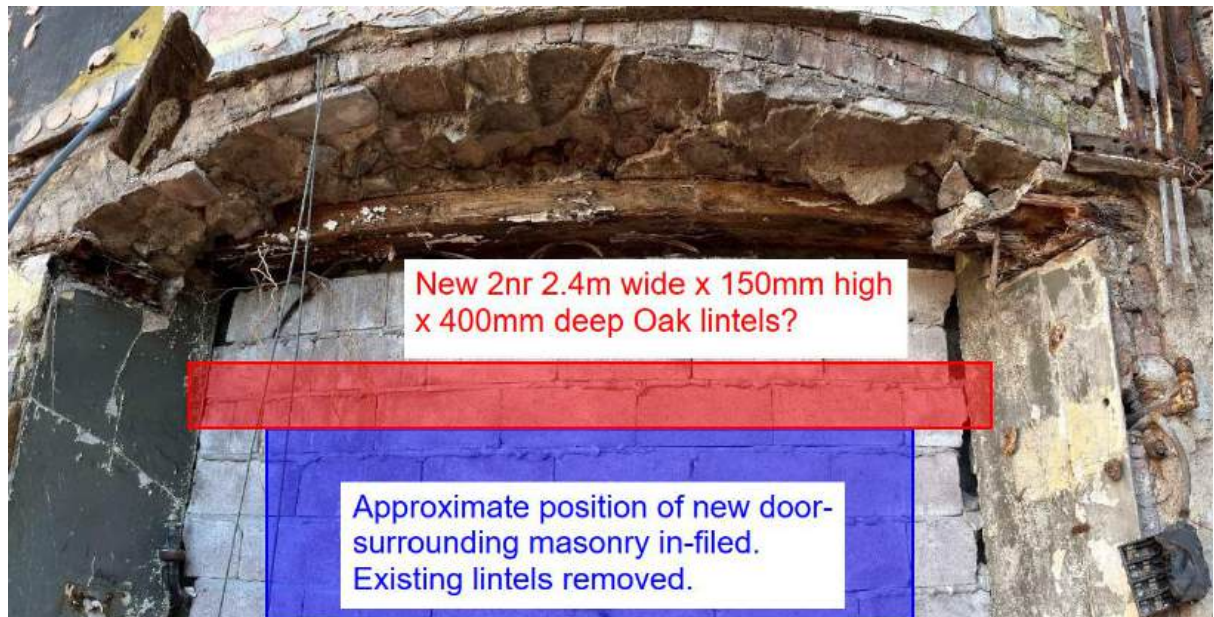
**Photo 27 – Showing ground floor window partly blocked up**  
(three photos stitched together)

The ground floor window has been blocked up towards the front of the façade. The blockwork does not appear tight to the underside of the lintels, which are timber. Some of the timber lintels have been removed with the ends of the lintels still fixed within the wall.

Services are still attached to the wall and some electrical cables are behind the render.

***Remove all attached services and render.***

***Remove timber lintels, including the timber in the supports and infill opening to form proposed access doors. Install new oak lintels over new opening (2nr 3800x140x400mm oak lintels air dried). Infill above new oak lintel to underside of existing arch with masonry using lime mortar.***

There are some areas of large infill that are also very deep (Photo 27) These should be infilled with brickwork as per the smaller openings. From a practical viewpoint, if there are some large lintels to be removed from some of these openings, by building up the thickness of walls in this manner from the inside out, it will allow the numerous corresponding lintels to be removed sequentially without any need for any temporary works. If there is any confusion with respect to this aspect of the work, please contact the Engineer. Mortar used must be as per item 1 and all brickwork to be collar jointed and fully toothed into surrounding brickwork using traditional methods. Refer to item 4 below with respect to timber lintels.
