**Zanzibar, Newport**

**Retained Façade Condition Survey**

**March 2025**

| <b>Document Title</b> | 2479-PHG-RP-S-0001_ Retained Façade Condition Survey |

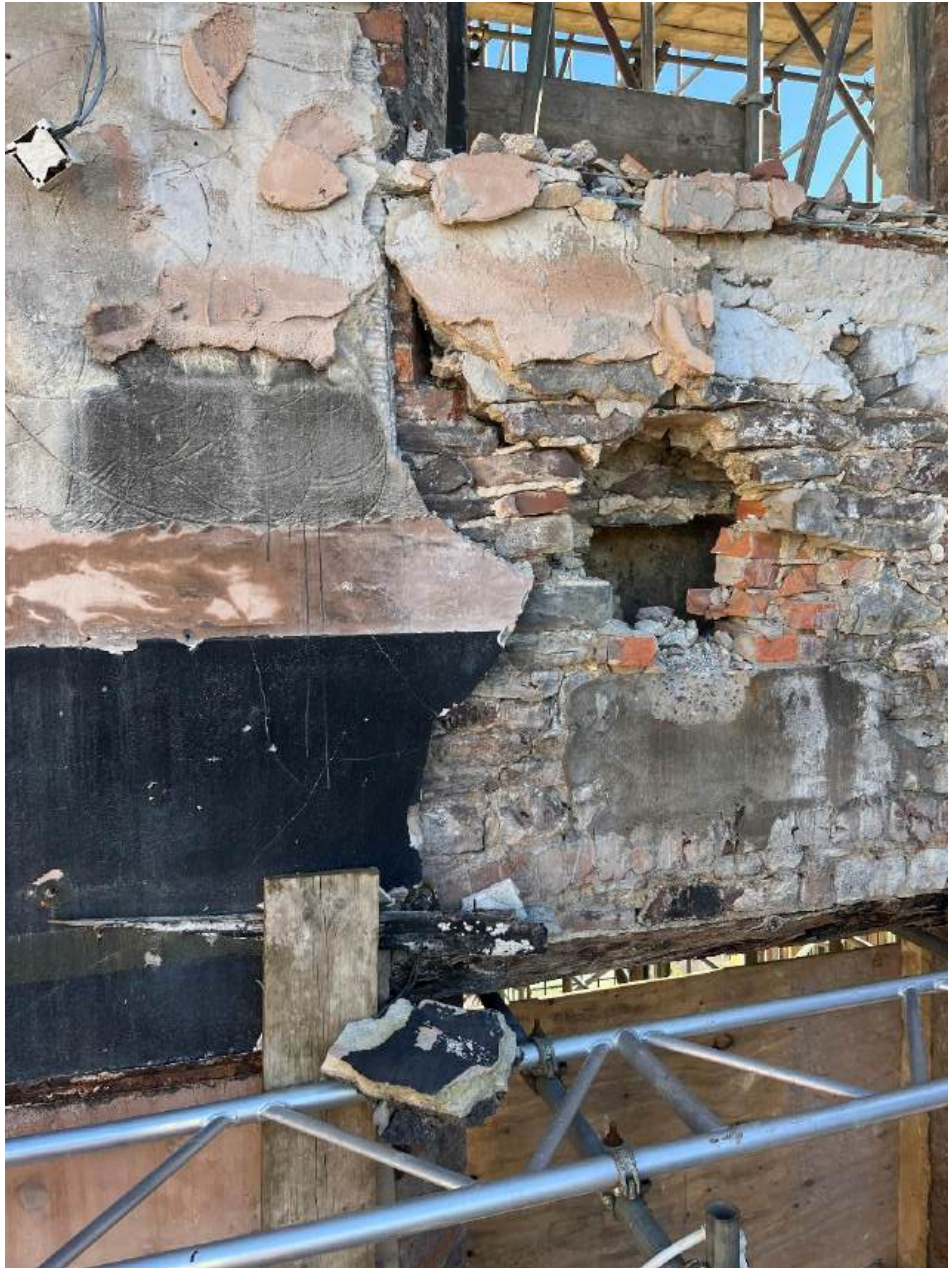
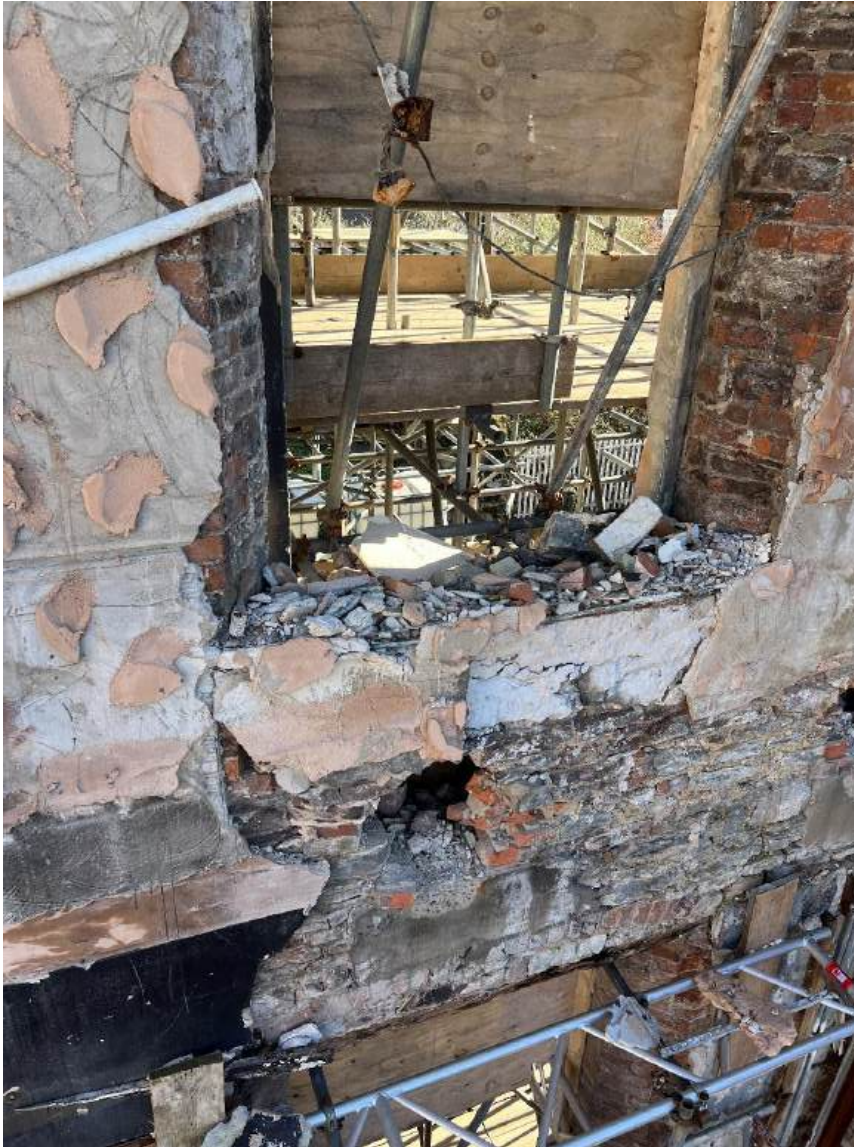
**Photo 28 – Showing damaged masonry from steel frame**

**Photo 29 – Showing damaged masonry from steel frame**

Large opening in the masonry from the internal steel frame. It appears that the masonry was damaged during the collapse of the steel frame caused by the fire, or possibly from when steel beam was removed. Either way, the masonry around the beam became dislodged and is coming away from the structure. The render also appears loose. There is a considerable amount of debris on the window cill.

***Remove all loose masonry and render. Review the condition of the masonry behind.***

***Brick up all voids in the wall and re-point the masonry using lime mortar. Lintel above to be replaced with 2 nr 2200x140x250mm oak.***

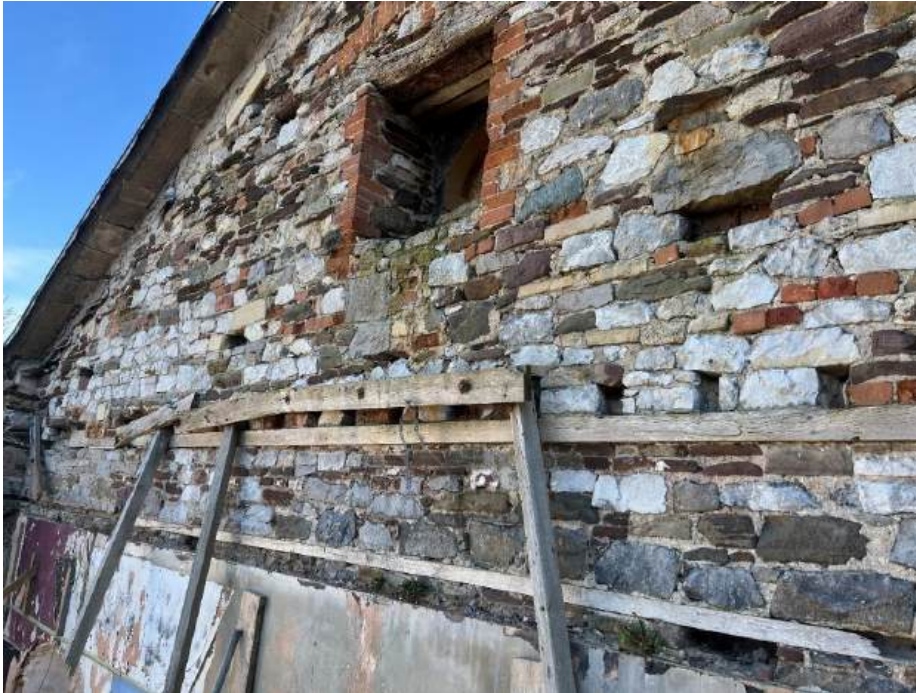
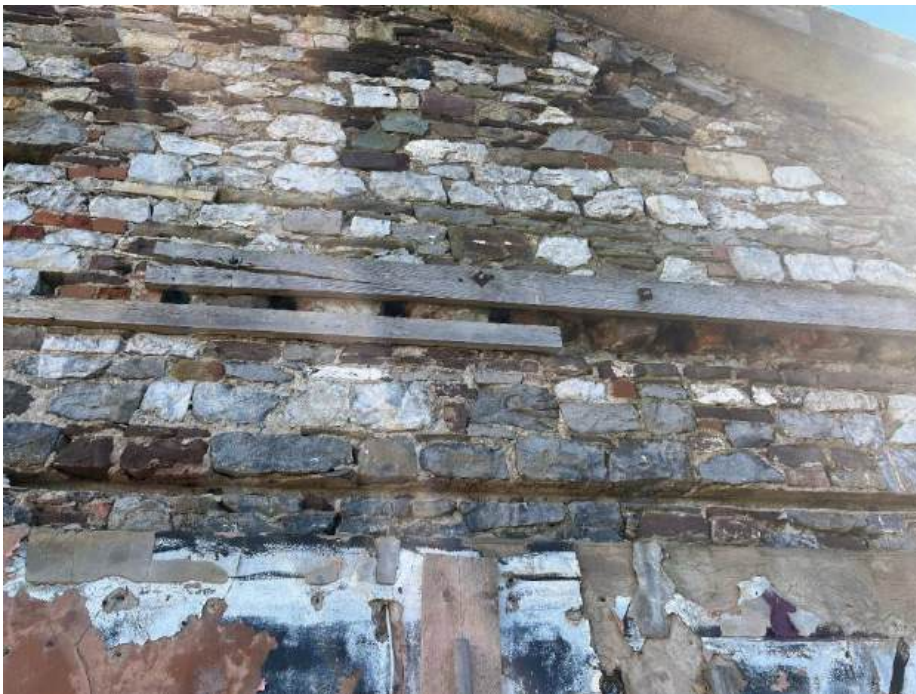
**Photo 30 – Showing holes from the built-in timber ceiling joists.**

**Photo 31 – Showing holes from the built-in timber ceiling joists.**

There is still timber fixed to the façade and there are openings from the ceiling joists within the façade.

***Remove all timber and fill all holes with masonry.***

***Fill all gaps in the masonry using lime mortar.***

***Review the mortar beds throughout and repoint as required using lime mortar.***

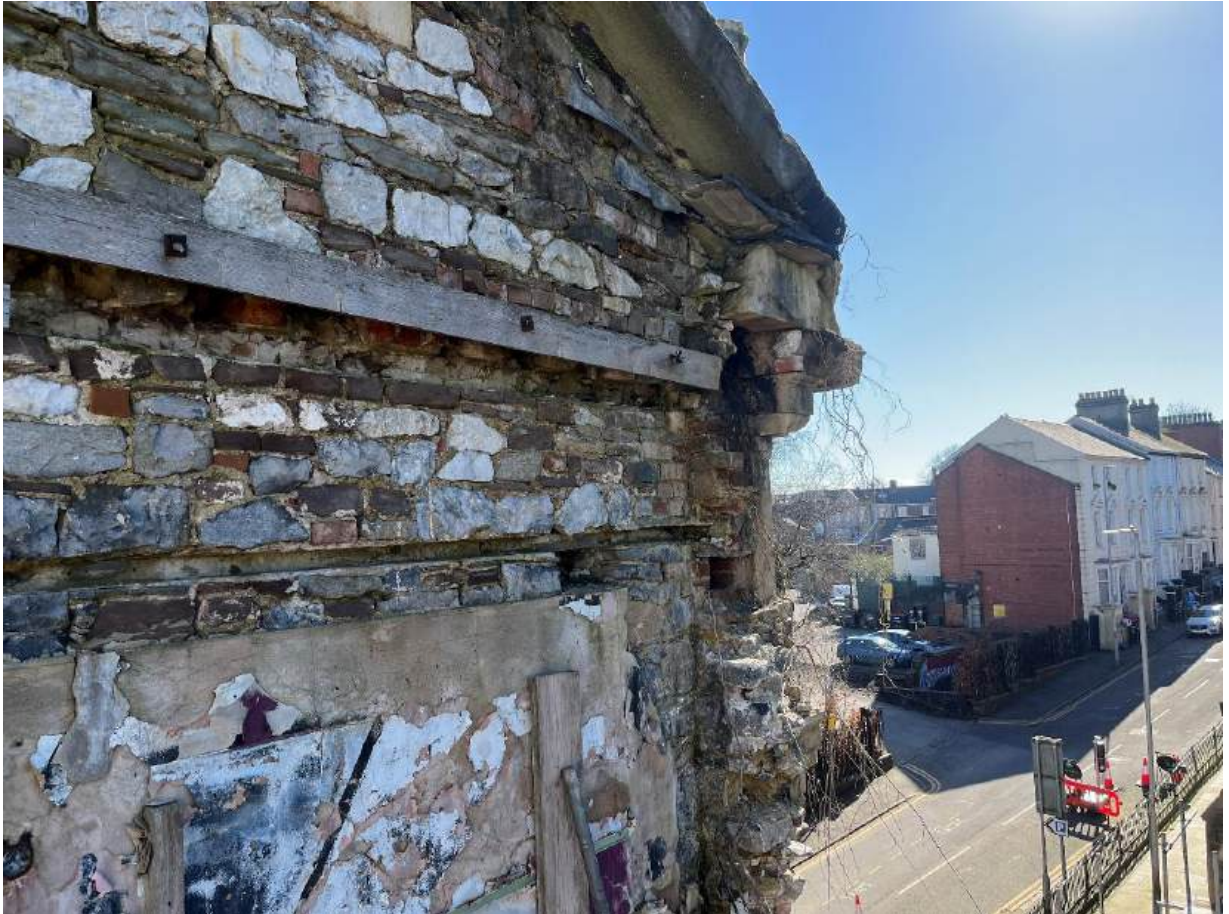
**Photo 32 – Showing the remainder of the wall with plant growth**

The part remaining wall is uneven and has considerable vegetation growth.

***Remove all plant growth and treat as necessary.***

***Due to the large high level stone, we suggest removing all the loose stonework below and rebuilding 300-400mm of the wall in brickwork. Keying the brickwork into the front façade.***

***Repoint any existing mortar joints if required using lime mortar.***

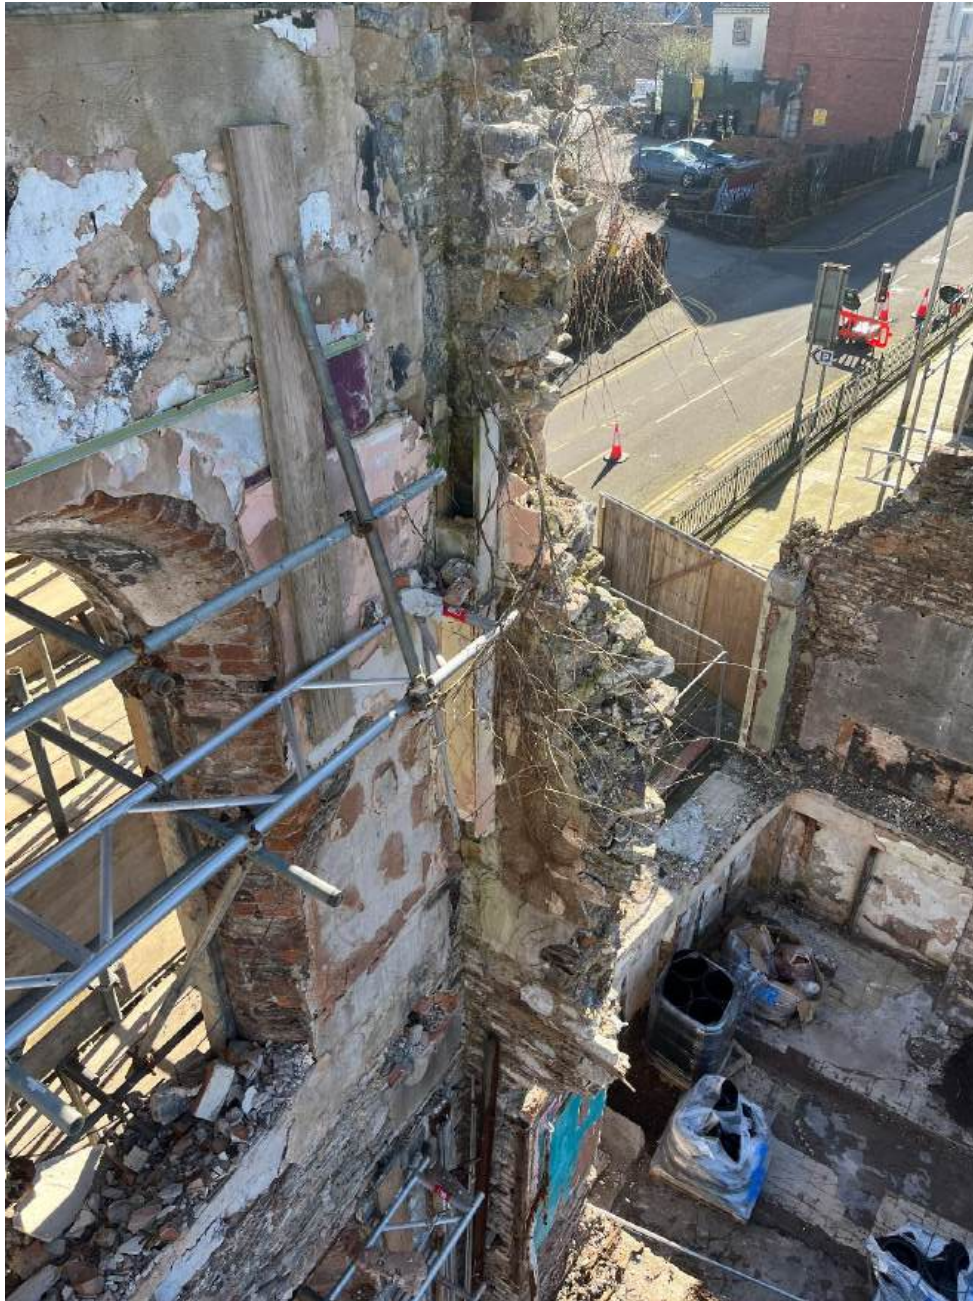
**Photo 33 – Showing loose and uneven stonework.**

The left-over wall from the gable is uneven and has considerable vegetation growth.

***Remove all plant growth and treat as necessary.***

***Removing all the loose stonework below and rebuild 300-400mm of the wall in brickwork.***

***Keying the brickwork into the front façade. Where the existing stonework protrudes further than new brickwork, the stonework can be used provided it is in good condition, keyed into the existing façade and the bed joints are also in good condition.***

***Repoint any existing mortar joints if required using lime mortar.***

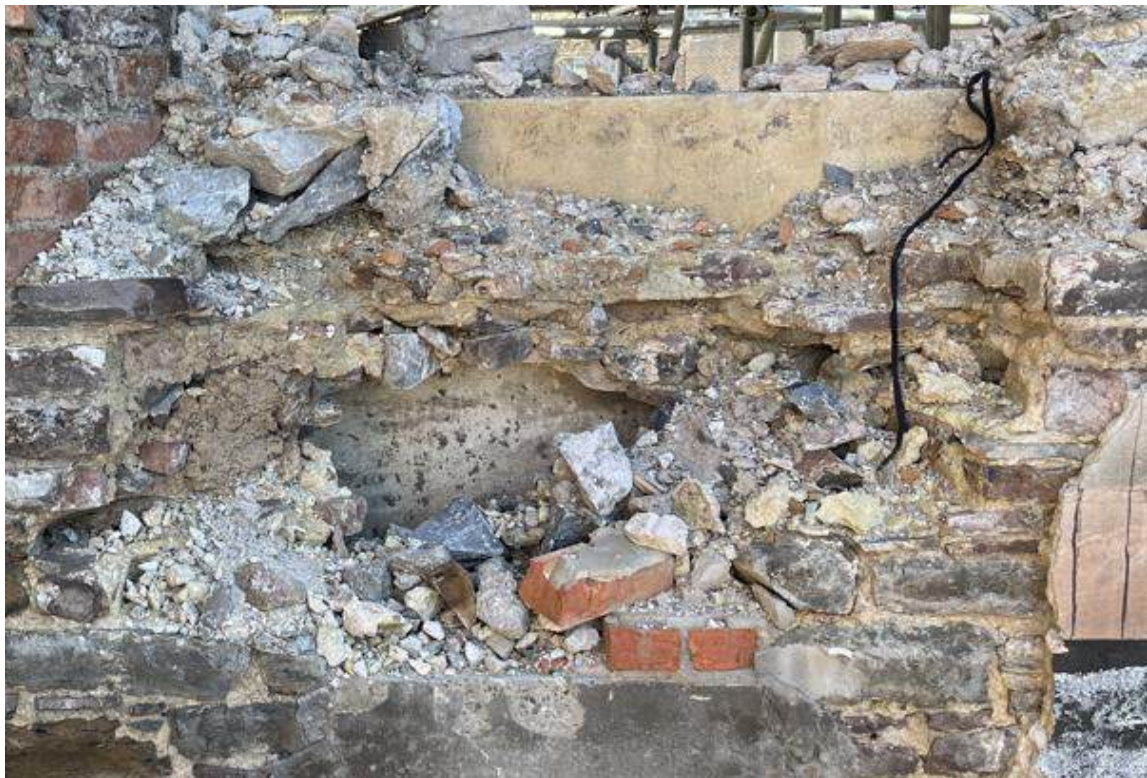
While reviewing the photographs taken during the survey there appears to be a large opening behind the internal skin of stonework. It needs to be determined whether this was caused during the installation of the steel frame and is isolated; or whether it is a standard detail throughout the façade. If it is common throughout it will affect the connection detail of the SFS frame as this will need to ensure both skins are adequately tied together.

**Photo 36 – Showing opening in stone façade**
