**Former Zanzibar nightclub****Proposed Methodology of works****Cleaning**

**Revision 1 – 25.03.2025**

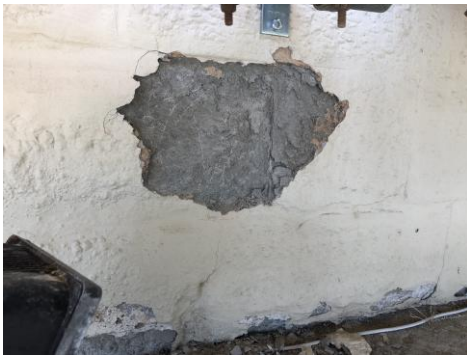
The face retained stone façades at 40 Stow Hill is constructed from dimensioned Pennant sandstone with a bush hammered feature face combined with dressed Bath stone features to openings, pilaster features and pediment. The façade is heavily painted and the true make up of the underlying stone work cannot be fully confirmed at this point.

The dimensioned Pennant sandstone has suffered badly from frost damage due to the painted coatings and the feature finish of the stonework where exposed has been lost to lamination. Whilst the obvious method of removing these coatings would be the DOFF and / or TORC systems, the initial removal could be carried out by hand to identify sound and defective areas. It is clear at this point that the original surface finish has been lost in the majority of areas.

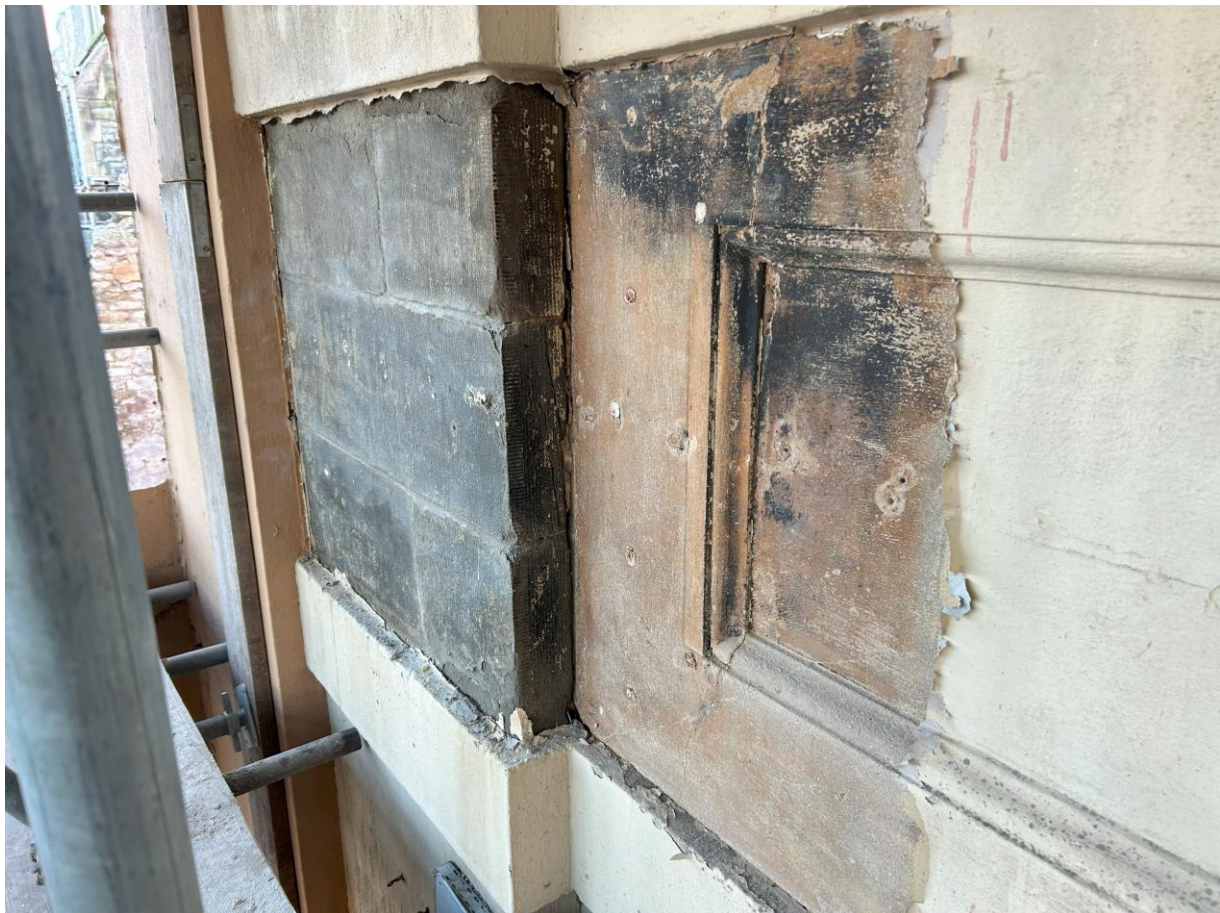
Samples of this systems have been carried out successfully and inspected on this façade. The following is a photo of the sample on both the Pennant and Bath stone features.

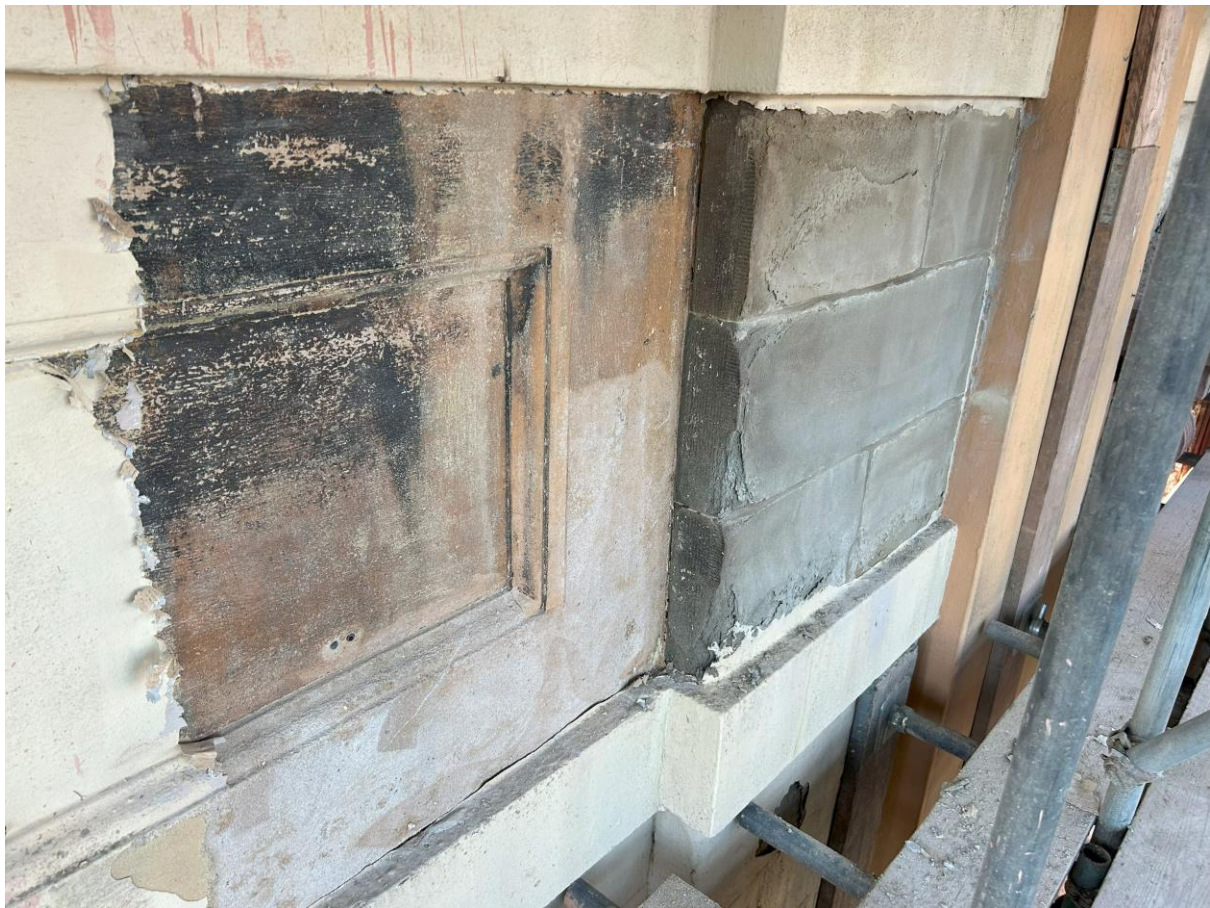
Samples of this systems have been carried out successfully and inspected on this façade. The following is a photo of the sample cleaning on both the Pennant and Bath stone features. Only the lower section of Bath has been TORC cleaned to remove carbon

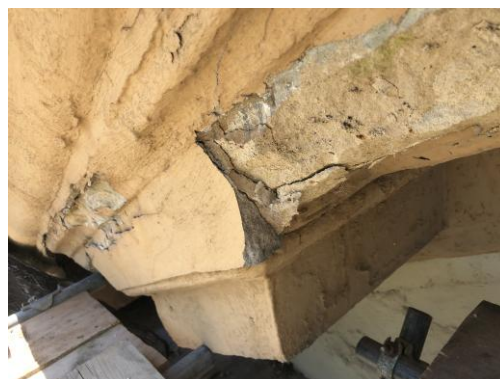
The main pediment has been covered with a felt or similar membrane which has broken down and will need to be removed or replaced dependant on the stone condition beneath. Various sections of the front moulding have failed or been replaced in a mortar repair and will need new stone indents or replacements.

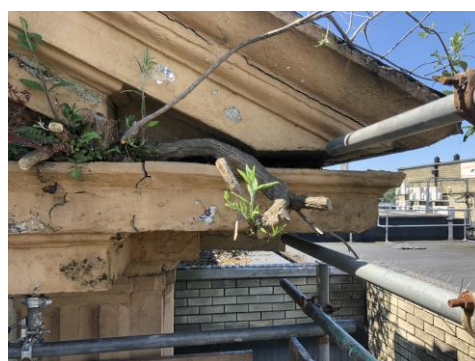
The buddleia root to the Right-hand side of the Tympanum has cause considerable damage both lifting the coping and forcing the area below out of line. To reset and or replace these sections will require suitable craneage.
