The Fields, Llanwern, BS5837 2012 Tree Information

Land adjacent to:
The Fields
Milton Hill
Llanwern

Data Sheets - site survey carried October 2013, updated July 24

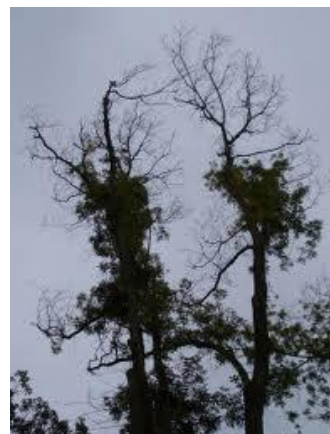
The picture to the right shows the die back of foliage several years after the completion of a development site. Machine operators will often mention how they have dug roots or driven over them. This is what happens once they leave site.

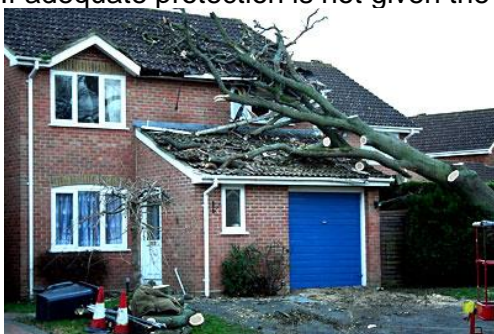
If adequate protection is not given the disaster below is not far behind!
