BS5837 2012
Arboricultural impact assessment

Client: Townscape Homes LTD

Site: Kensington Court, Newport.

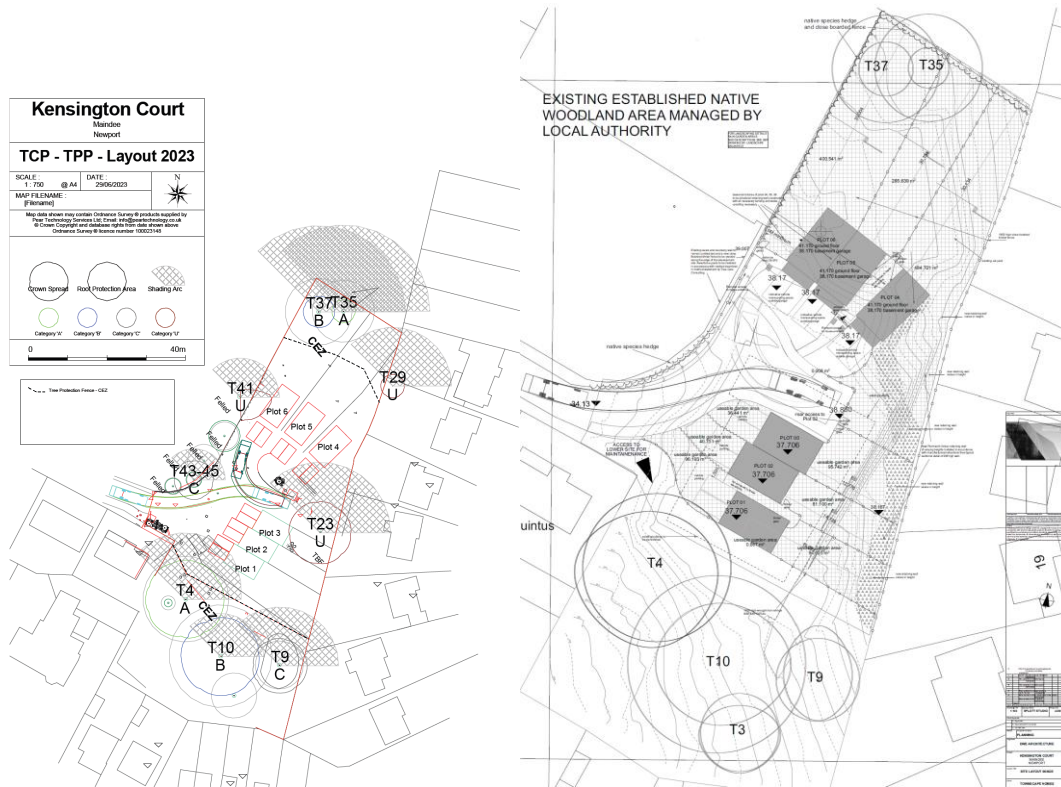
T4 Oak. An A Cat tree with no major defects. There is dead wood in the crown (easily removed). The tree has been historically buried during construction of the derelict day centre across the north root plate up to the main stem by NCC. The Theoretical RPA of T4 extends under the garden edge of plot 1 on plan but in reality, the RPA is several metres below the current ground surface. Current ground surface is patio. This hard surface will be removed to become garden and with no detriment to T4 north rooting area as no deep excavation is taking place that could affect roots in original soil levels. Tree protection fencing will be required however to protect the trees stem rooting area and crown. Shade will affect plot 1 southern garden strip at mid-day but morning and afternoon sun will reach front and rear gardens. Tree is located at a much lower level so shade fall is greatly reduced to the site. Placed within CEZ during development.

T9 Cherry. A C Cat tree in reasonable condition at the time of assessment. No issues in relation to development. Tree protection will be required during the development phase. My suggestion is that this is done by installing garden boundary fences at an early stage. On-going assessment is recommended. Placed within CEZ during development.

T10 Copper beech. A B category tree. Dead wood to be removed. RPA and shade away from plot 1. Tree is located at a much lower level so shade fall is greatly reduced. Placed within CEZ during development.

T23 Oak. A U Cat tree recommended for removal/replacement. 50%+ crown is dead leaving an unbalanced and poor form tree. Tree can be replaced in final landscaping without contravening TAN 5, TAN 10 and GP5 due to the tree being in the dying/dangerous exemption of the TPO. Due to removal, there are no trees issues relating to the site.

T29 Western red cedar. Off-site U Cat private tree high on the bank. Tree recommended for removal due to poor condition. Site owner to hold discussion with tree owner regarding removal to reduce liability to site from falling trees. Replacement should be offered with a more suitable species for the location such as field maple or Turkish hazel.

T35 Coastal redwood. An A Cat tree. Rooting area outside of plot 8 and with buffer possible. Plot 8 is located in the existing hard surface car park area. And AWB may be required for lifting the existing hard surface edge closest to the tree before installing tree protection fencing again. Remove any dead wood. Shade fall goes to the west and north of this tree and does not affect plot 8. The tree is close to plot 8 but is adjacent to the gable end and therefore minimises influence on the plot visually from within. Placed within CEZ during development.

T27 Coastal redwood. A B Cat tree. The tree has stem bark damage. There is a query regarding internal stem decay noted in the BS5837 tree report. This tree can be assessed using Picus 3 sonic tomography and PD500 microdrill to establish if decay is present or not. This information can be made known to any potential residents of plot 8. Rooting area outside of plot 8 and with buffer possible. Plot 8 is located in the existing hard surface car park area. And AWB may be required for lifting the existing hard surface edge closest to the tree before installing tree protection fencing again. Remove any dead wood. Shade fall goes to the west and north of this tree and does not affect plot 8. Placed within CEZ during development.

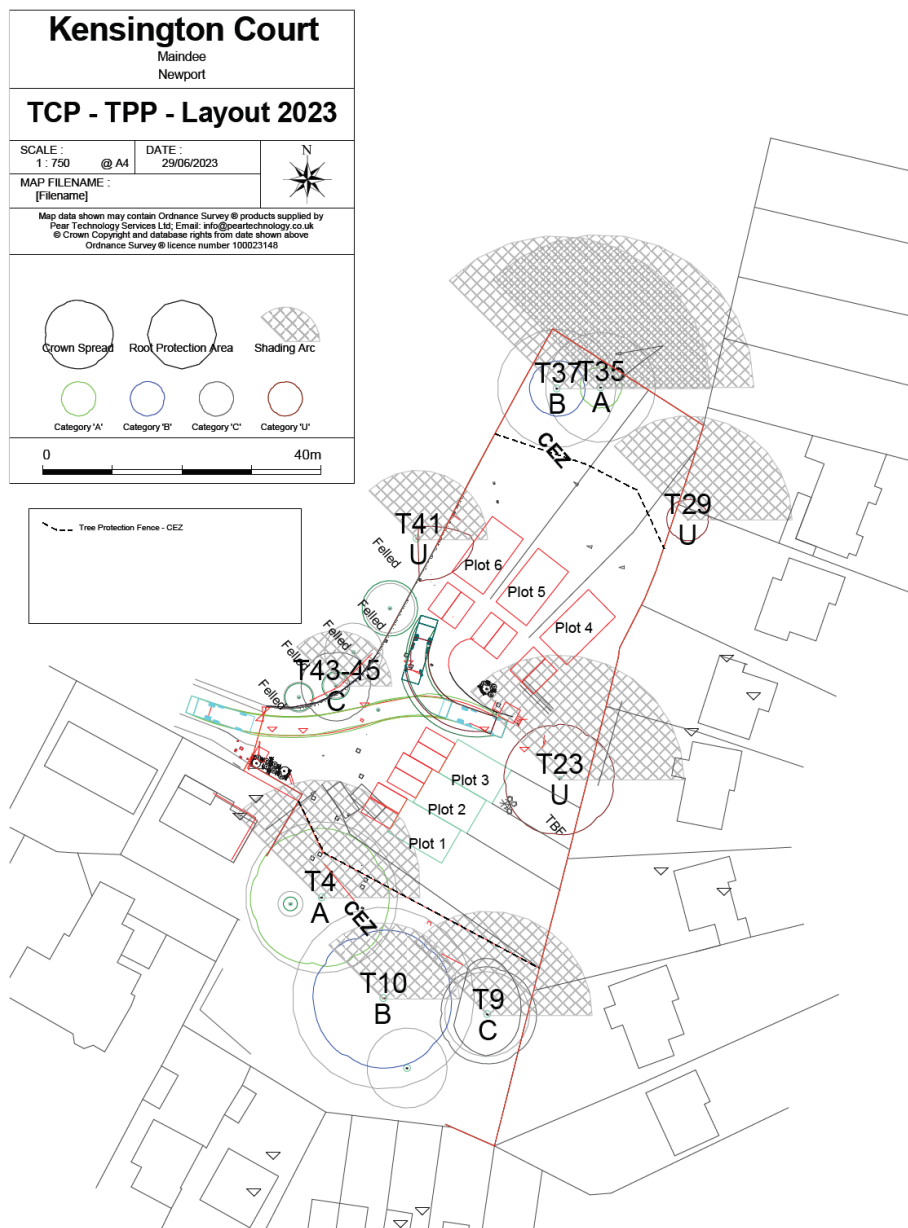
Shading Plan

T4 has some potential for shading but the 2025 layout has moved the plot back and further away from the shade quadrant.

T10 little shade influence to the proposal.

T9 little shade influence to the proposal.

T23 No shade influence to the proposal due to the tree being removed due to advanced crown decline (50%) dead.

T29 little to no shade influence to the proposals.

T35 & T37 No shade influence to the proposals.
