## Bats & Trees Survey Report

Project: Traston Road, Newport

Instructed by: Bron Afon Community Housing Ltd

Author	Checked	Date	Version
Lee Gregory	Aislinn Harris	17th December 2025	V1.0

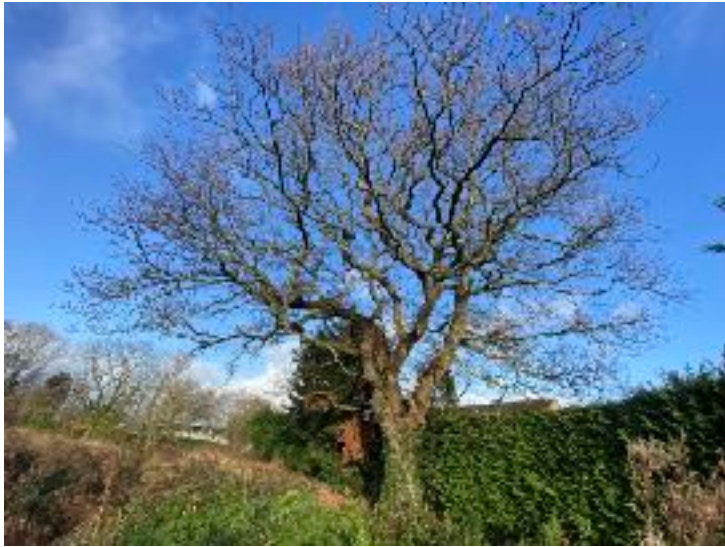
T4 Pedunculate Oak - PRF-I

Trees T4, T12 and T24 were categorised as PRF-I as they had one feature suitable for bat roosting use, namely a small knot hole which appeared to extending into the branch to trunk. Due to the small size of the knot hole the PRF was thought only suitable for an individual bat or low number of bats. T4 and T24 are not currently listed for removal to make way for development. T12 Crack Willow tree is listed as unsafe for retention in the Arboricultural Impact Assessment (AIA) report.

Trees T4 and T24 are also categorised as PRF-I bat roost trees but are not currently listed for removal to make way for development. If plans change these trees must be felled during the winter when bats are least likely to be present.

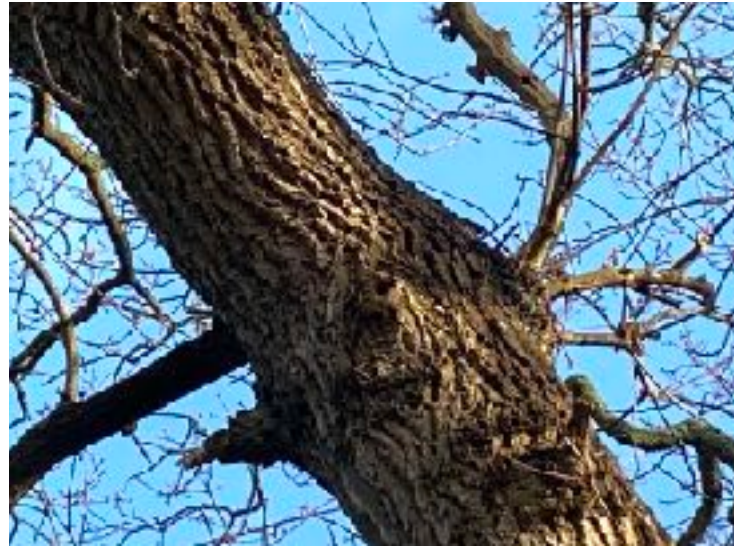
T4 Small knot hole, 4m high on south aspect of tree

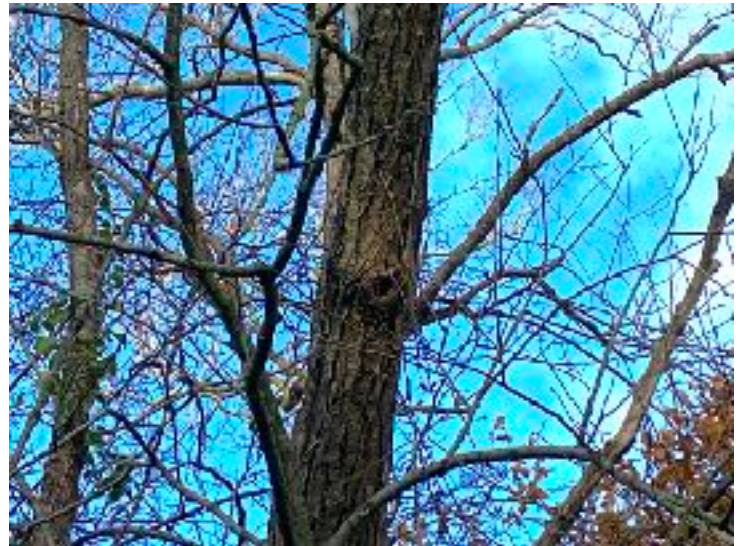
T12 Small knot hole, 4m high on east aspect of tree

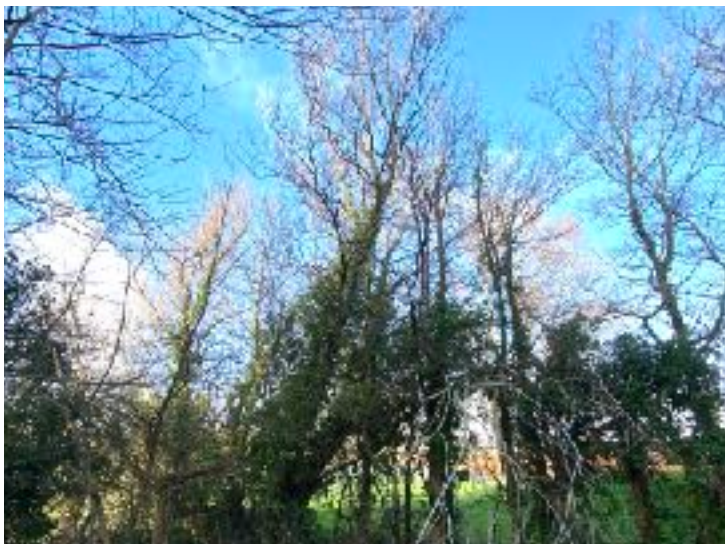
T13 Crack Willow - PRF-I

Trees/Tree Groups - T13, T25, T26, G27, T43, G44, T50 and G51 were categorised at PRF-I as they had one feature suitable for bat roosting use, namely Ivy growing up the trunks which had thick intertwined stems potentially suitable for an individual bat caught out in bad weather to roost behind. T13, T25, T26, T43, G44 and G51 Crack Willow trees/tree groups

Trees T12, T13, T25, T26, T43, G44, T50 and G51 are categorised as PRF-I bat roost trees due to having one feature visible which bats could be used for roosting purposes. PRF-I categorised trees must be felled during the winter when bats are least likely to be present.

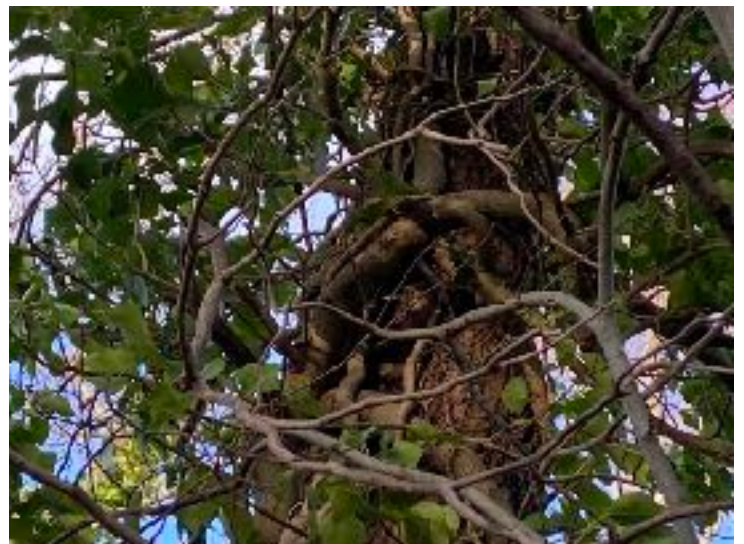
T13 Example of thick intertwined ivy stems up trunk

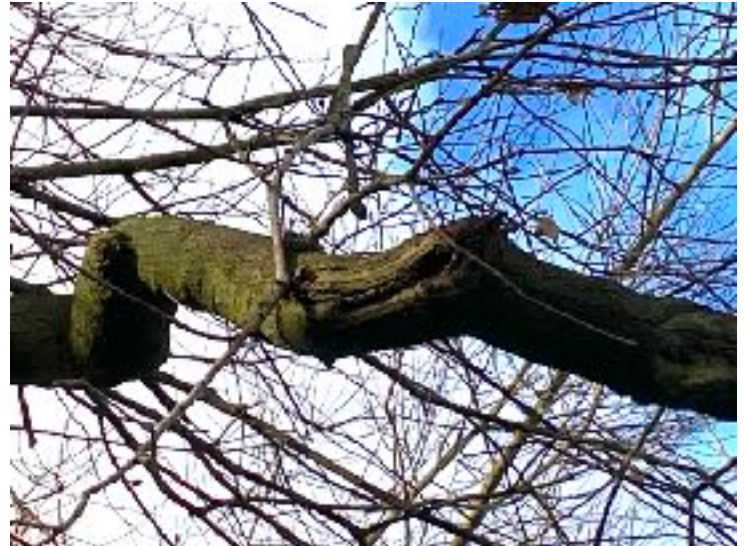
T24 Small hole, 4m high on north aspect of tree

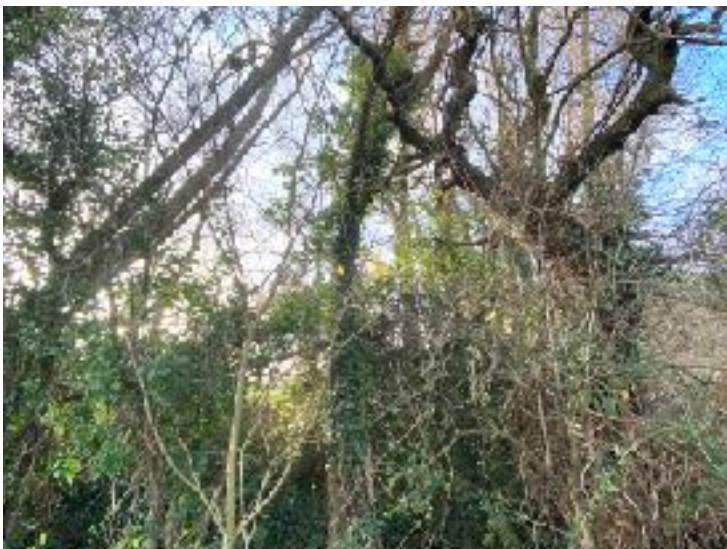
T25 Crack Willow - PRF-I. Much thick intertwined ivy stems up trunk

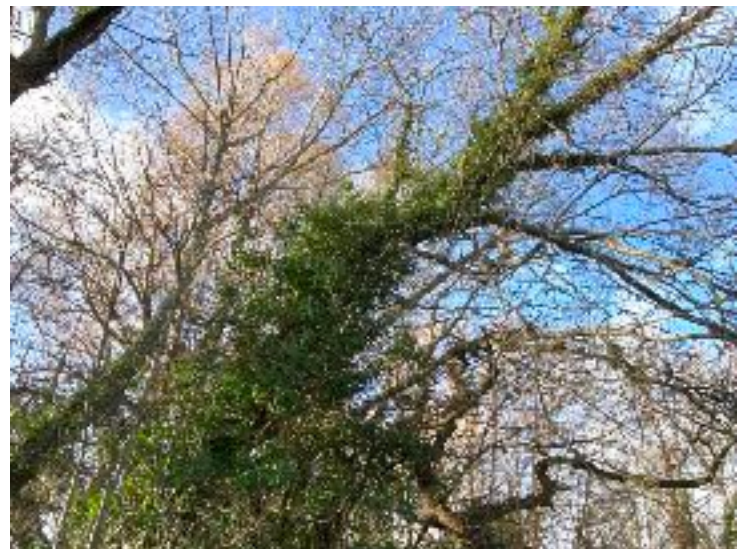
T26 Crack Willow - PRF-I. Much thick intertwined ivy stems up trunk

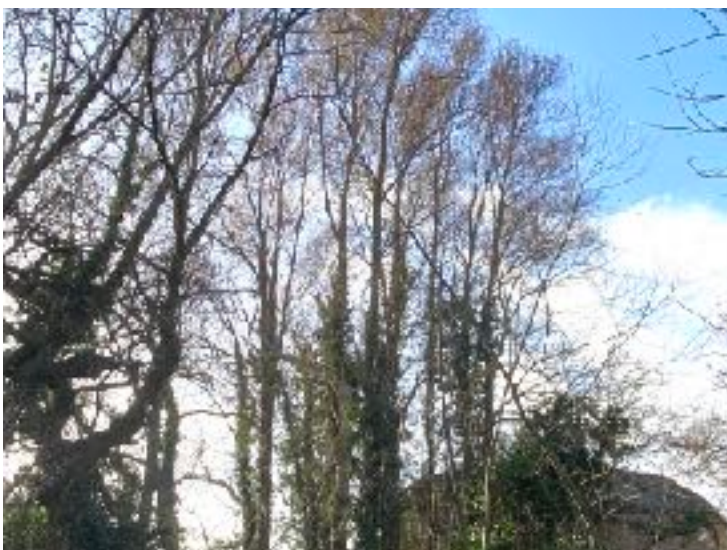
G27 Crack Willow, Elm and Hawthorn - PRF-I Off site trees

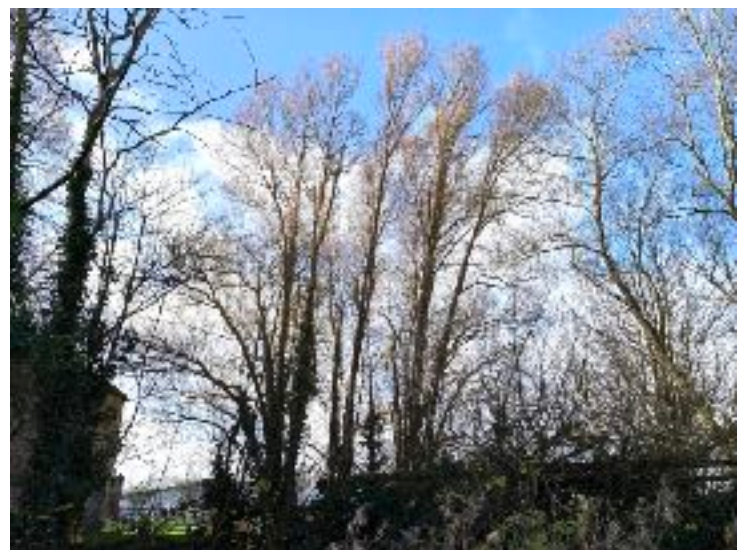
G27 Much thick intertwined ivy stems up most trunks

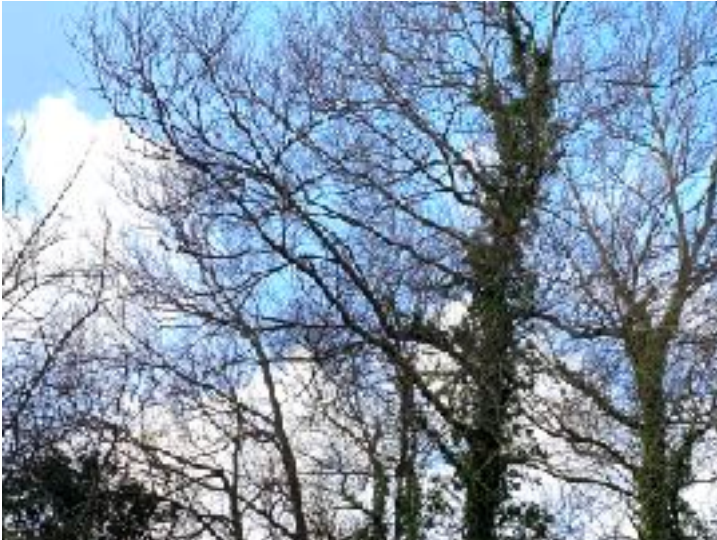
T43 Crack Willow - PRF-I. Much thick intertwined ivy stems up trunk

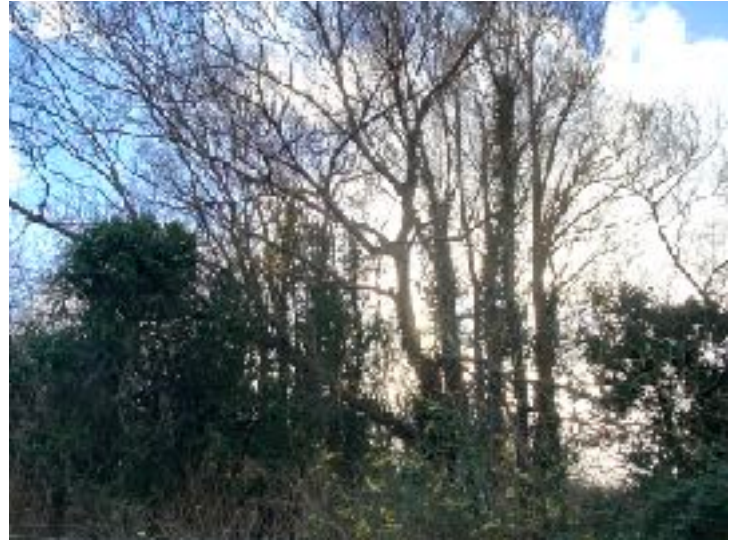
G44 Crack Willow - PRF-I. Much thick intertwined ivy stems up trunk

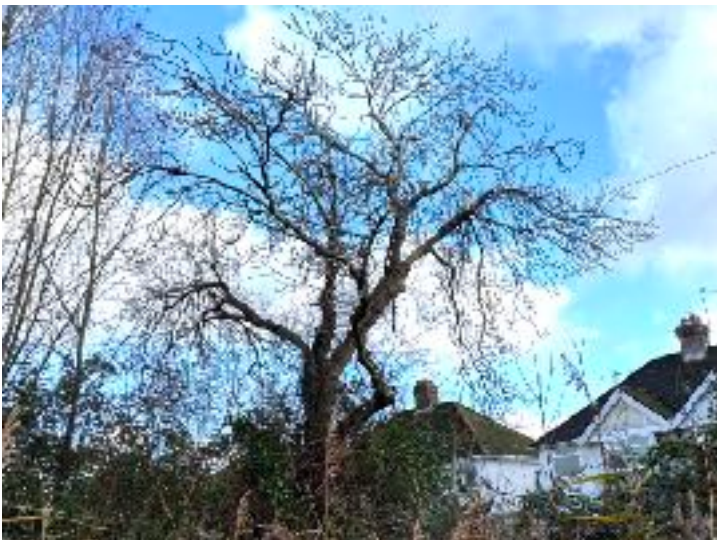
T50 Ash - PRF-I. Much thick intertwined ivy stems up trunk

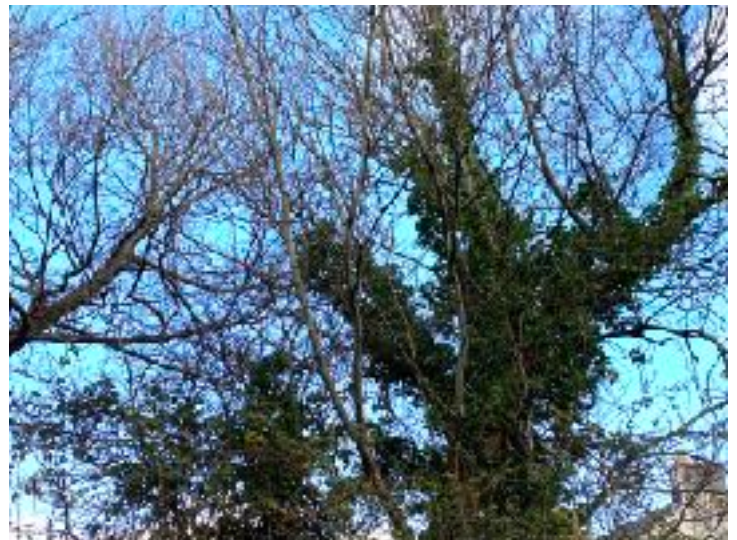
G51 Crack Willow - PRF-I. Much thick intertwined ivy stems up trunk

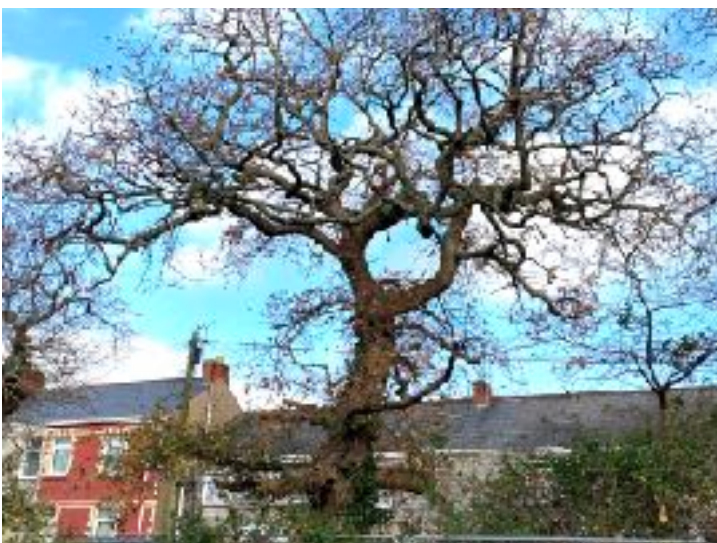
T58 Pedunculate Oak - FAR

T58 Oak tree was categorised as FAR as it had lots of dead branches in the canopy, no PRF's were visible from ground level but owing to the large amount of dead wood it was thought likely that PRF's may be present just not visible from ground level. T58 is not currently listed for removal to make way for development.

T58 Oak tree was categorised as FAR but is not currently listed for removal to make way for development. If plans change this tree must be felled during the winter when bats are least likely to be present.

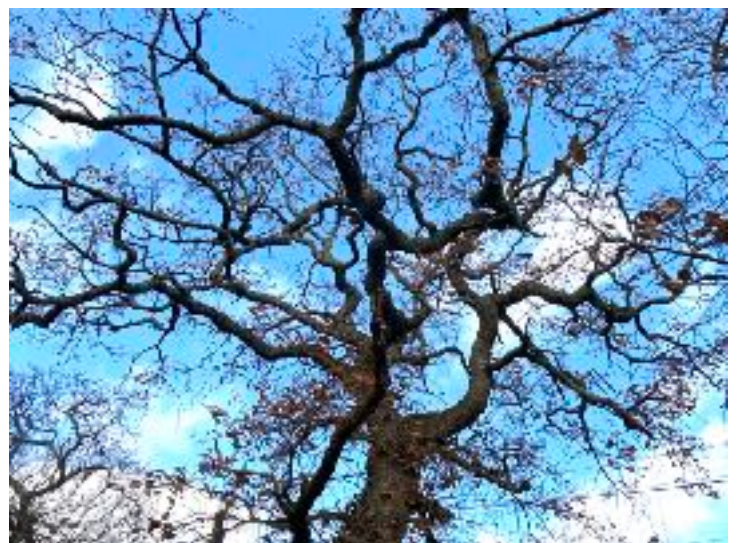
T58 Lots of dead branches in canopy, thought likely hidden PRF's present but none visible from ground level.
