# The Fields, Llanwern, BS5837 2012 Tree Information

Land adjacent to:  
The Fields  
Milton Hill  
Llanwern

### Data Sheets - site survey carried October 2013, updated November 23

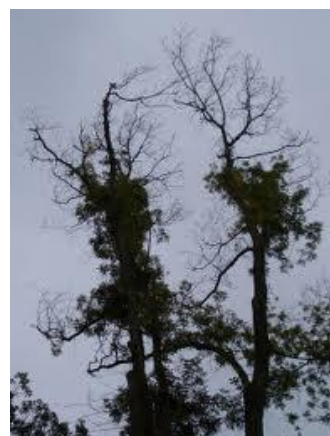
The picture to the right shows the die back of foliage several years after the completion of a development site. Machine operators will often mention how they have dug roots or driven over them. This is what happens once they leave site.
