# Tree Technical Note

**Client:** Mr Hagerty

**Site Address:** 36 The Nurseries, Langstone, Newport, NP18 2NT

**Date:** 21.03.2025

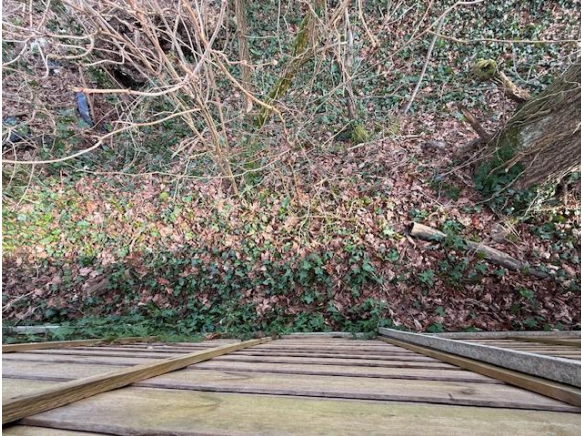
Above images shows the east side of the fence.

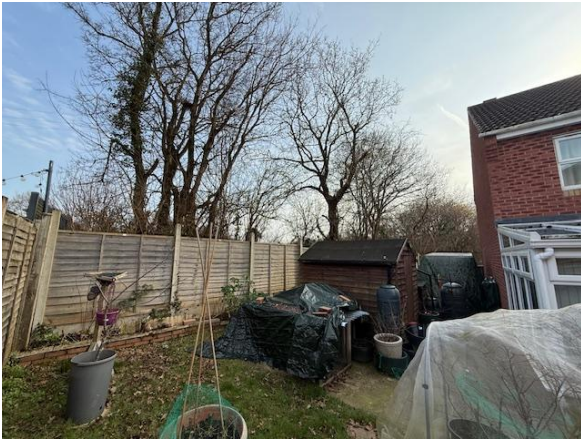
Above image shows the trees proximity to the existing.

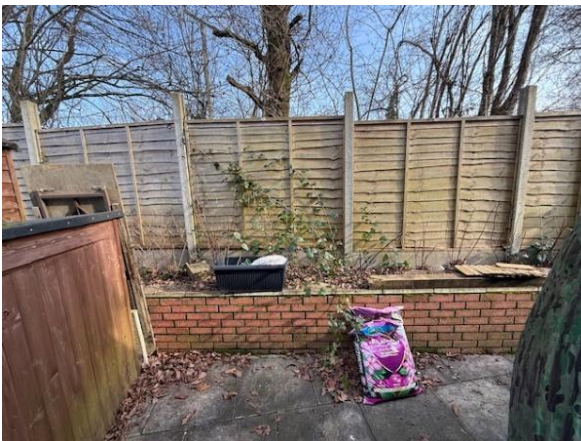
- The low garden retaining wall within the garden of No36 serves as a tree root protection barrier.
- The low retaining wall sits approximately 1m + into the site away from the tree stems, it appears that the wall is located where the original bund met the previous use land. Roots are expected to be in the bank and not at the lower-level ground within the garden of No36.

Above image shows the existing low garden retaining wall.

1. No removal of the boundary fence or garden retaining wall within the curtilage of No36 as this serves as tree protection measures on site.
2. Careful excavation of trenches to the required depth. This should be overseen by an arboriculturist and a photographic record be made available to NCC to demonstrate careful working.
3. If found, no roots are to be cut if in excess of 10mm diameter. The site arboriculturist should be informed and work halted until the significance of roots be discussed and a resolution found.

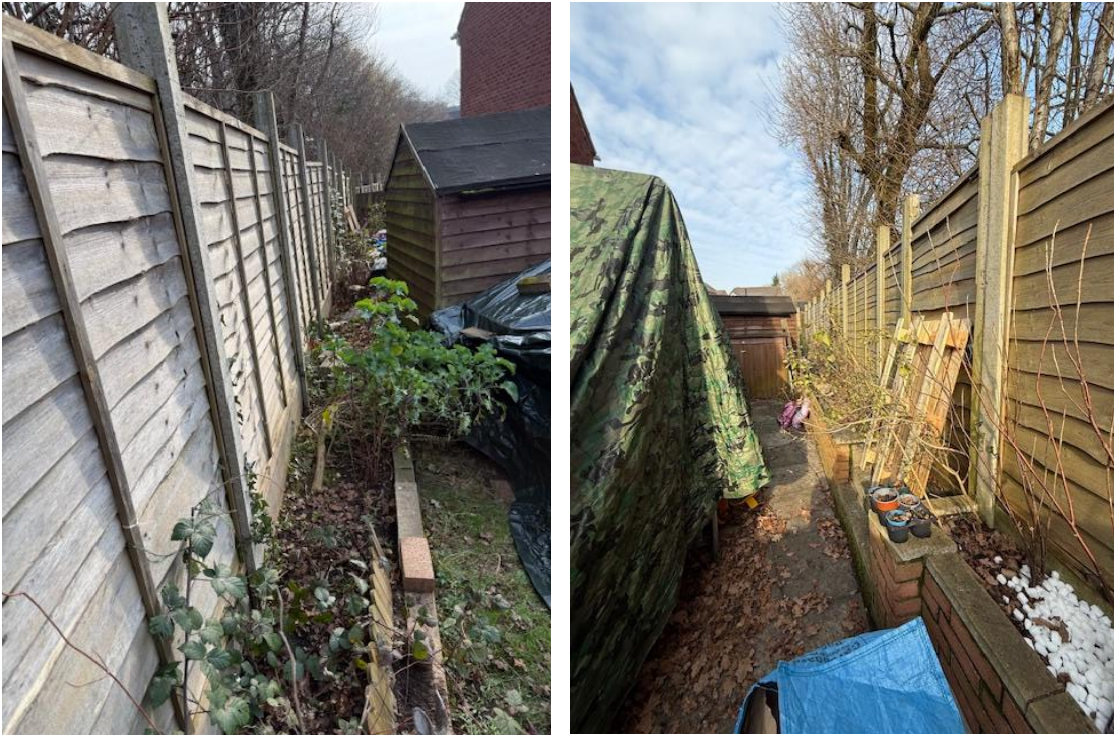
In order to build the proposed, the trenches for the foundations would need to be excavated within the curtilage of No36. This would be under the existing patio surface area alongside the existing house. This ground has been excavated before to lay the existing patio surface sub base and also build the existing house. On this basis I have no concerns over tree roots being within this area and I can see no reason why a standard strip foundation can't be used.

The above images show the wall, fence and lower level patio area where foundations can be placed without risk to tree roots in the bank.
