# NEWPORT CIVIC CENTRE: ROOF WORKS BELOW THE TOWER

## HERITAGE IMPACT STATEMENT

Newport City Council

05/08/26

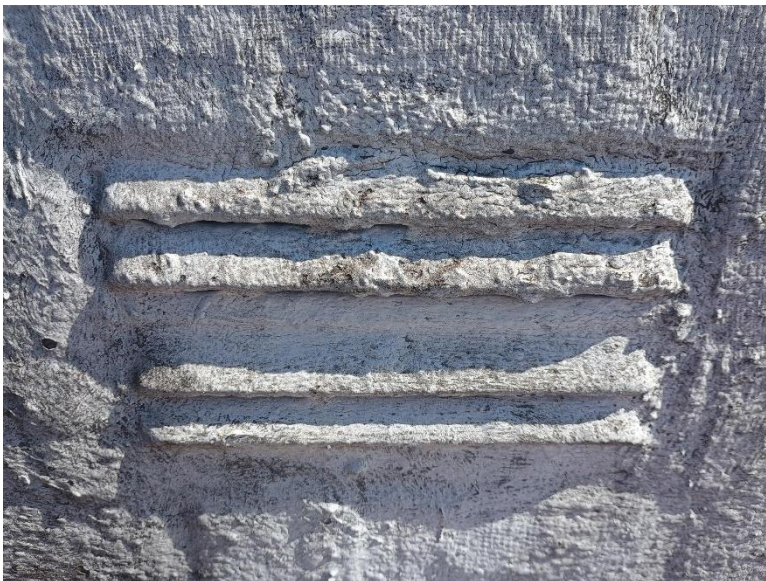
*The proposed boarding arrangement will accommodate the vents and maintain their function. As most are blocked by layers of paint/ coating systems and are no longer fulfilling their original purpose, their careful cleaning will help reinstate ventilation whilst retaining existing fabric.*

**Left:** typical image of existing cavity vents blocked by waterproof coatings.

3.2.2. Existing cavity vents are to be carefully cleaned and retained in situ.

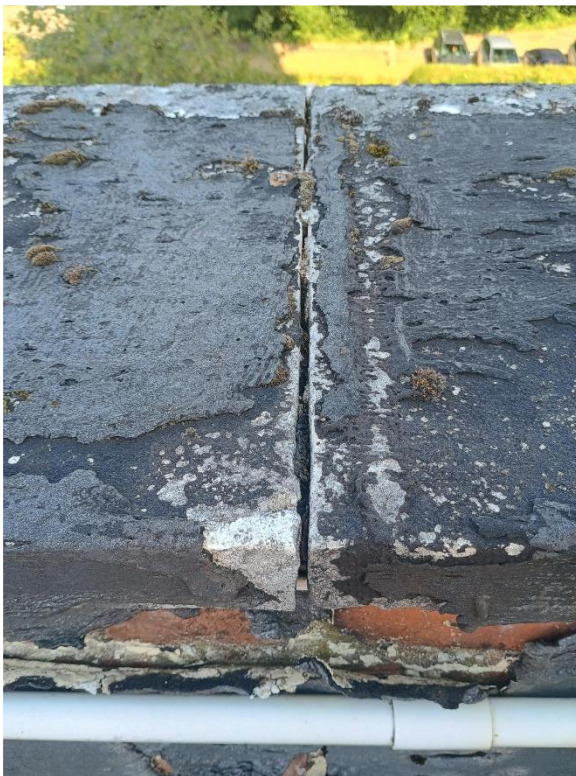
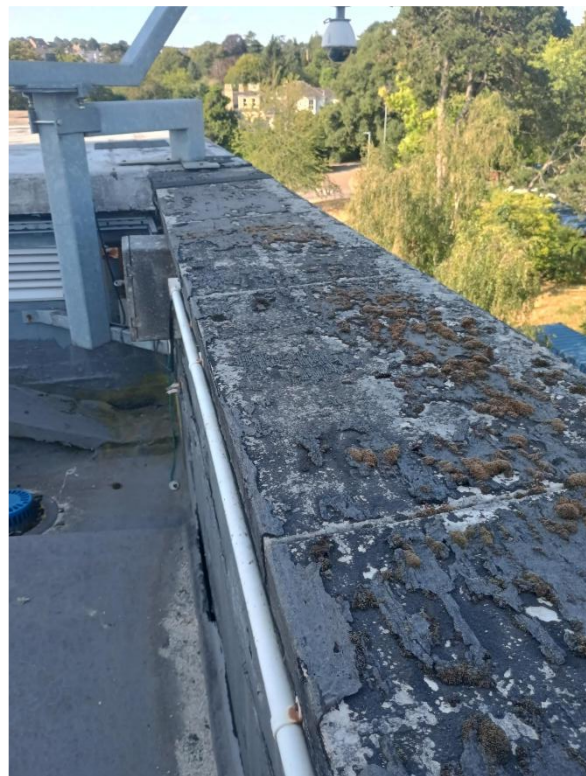
*The existing concrete coping stones are coated with a waterproof surface treatment that has deteriorated and is now peeling. In addition, numerous open and defective joints are present between the copings, increasing the potential for water penetration. Loose coating material and moss will be carefully removed by hand scraping and brushing (plastic or natural bristle). Coping joints will then be repointed in NHL 3.5 lime mortar to restore the weathertightness of the parapet.*

**Above:** images showing typical condition of copings

3.2.3. Existing coping stones are to be cleaned, raked out and repointed using an NHL 3.5 lime mortar.

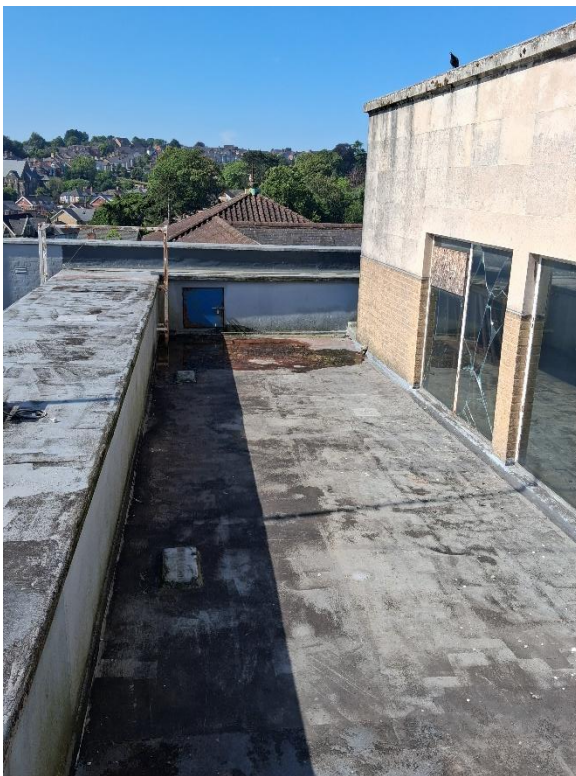
**Left:** view of roof with inadequate falls and drainage.

*The works are required to improve drainage falls and address significant historic ponding. Insulation will be specified to achieve compliance with the energy efficiency requirements of Building Regulations Part L, resulting in an additional improvement in the thermal performance of the roof construction. The build-up will be designed and detailed in accordance with BS 5250 to manage condensation risk, including the provision of a suitable vapour control layer.*

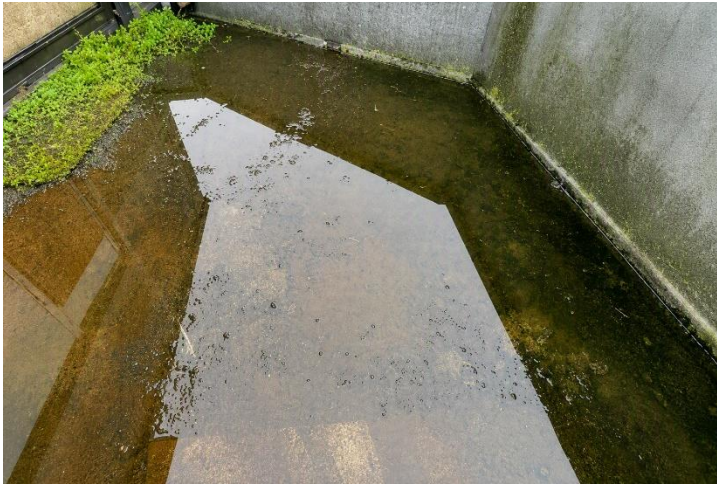
**Left:** typical image of ponding.

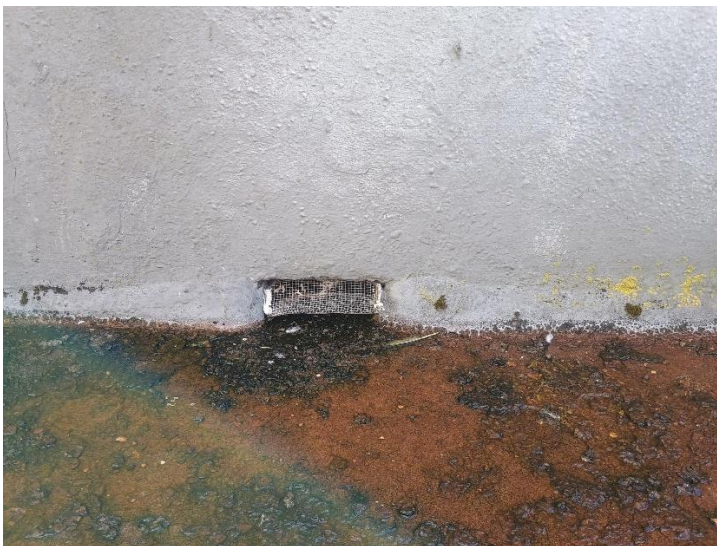
**Left:** image of the existing sub-standard drainage arrangement.

- 3.5.1. Existing drainage outlets are to be replaced with a new sumped gutter detail.

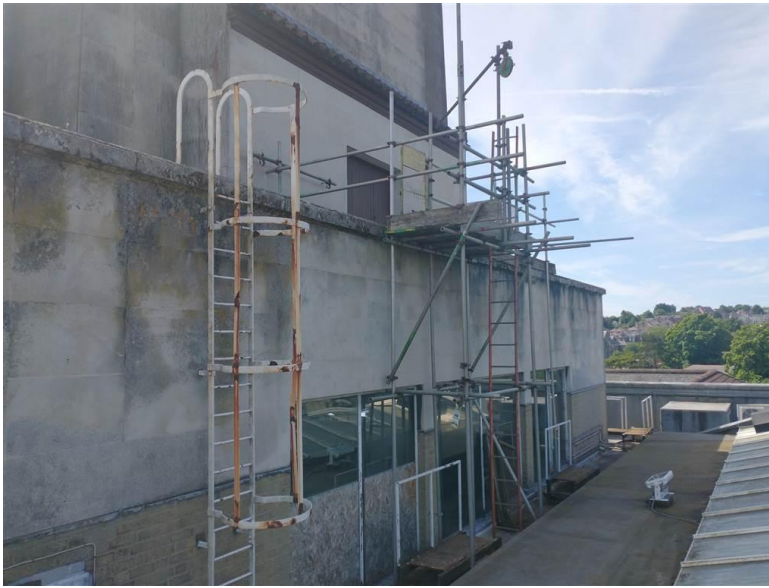
*These ladders are significantly corroded, making them unsuitable for safe access and increasing the likelihood of historic fabric being lost due to lack of routine maintenance. Their embedded fixings are also corroding, resulting in localised spalling to adjacent masonry. The new ladders will comply with current British Standards and dispense with the need for costly temporary access scaffold when carrying out maintenance and inspection. The*

**Left:** existing badly corroded cat ladder.

- 3.4.1. A cat ladder on this section of roof will be replaced with new ladders (Roof-Pro high strength galvanised mild steel cat ladders) finished in polyester powder coated (PPC) Oyster White (RAL 1013) to blend in with the surrounding Portland Stone. It will be provided with a vertical lifeline system to facilitate access onto the roof at the base of the tower.

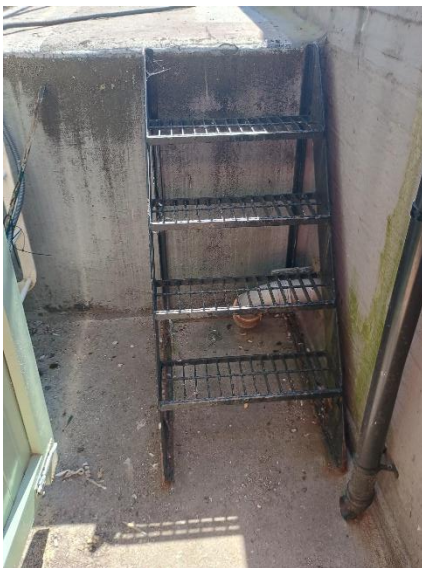
*The existing steps are not original to the building and are therefore considered of limited heritage significance. Their removal is required to facilitate the installation and use of the new cat ladder and associated platform. The replacement steps will incorporate a handrail and provide improved safe access for maintenance, reducing the risk of deterioration to the historic fabric.*

**Left:** existing steps.

3.4.2. It is proposed to replace the existing steps serving the main access/egress door with a new set of steps.

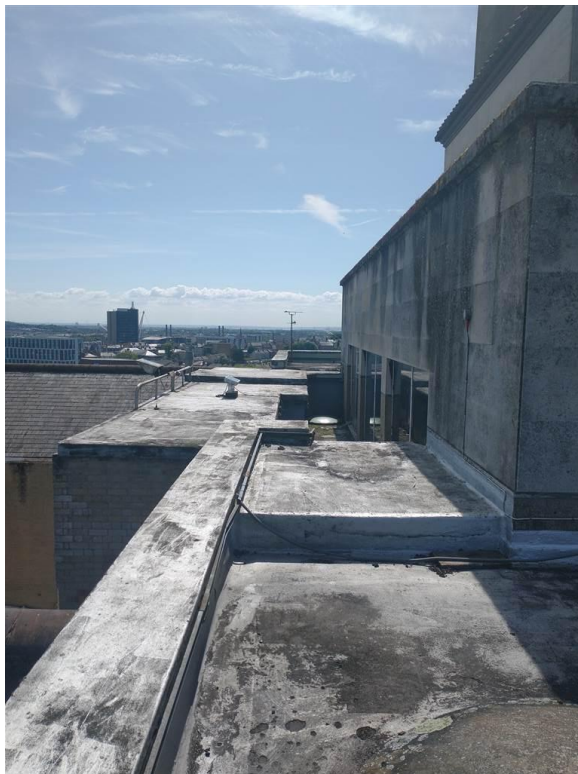
*The parapet walls in places are of insufficient height to provide compliant edge protection and are therefore classified as unguarded edges. Installation of a new horizontal lifeline system will provide a safe means of access for inspection and maintenance activities, facilitating the ongoing upkeep of the building. The proposed system will connect with the lifeline incorporated within the new cat ladder arrangement and extend to the lifeline located at the base of the tower, creating a continuous and secure access route across the roof. The system is lightweight and unobtrusive in appearance, minimising any impact on the character of the building.*

**Left:** typical view of unguarded edges.

- 3.4.4 A new horizontal lifeline system will be installed at several locations where parapet walls are of insufficient height to provide edge protection and are therefore classified as unguarded edges.

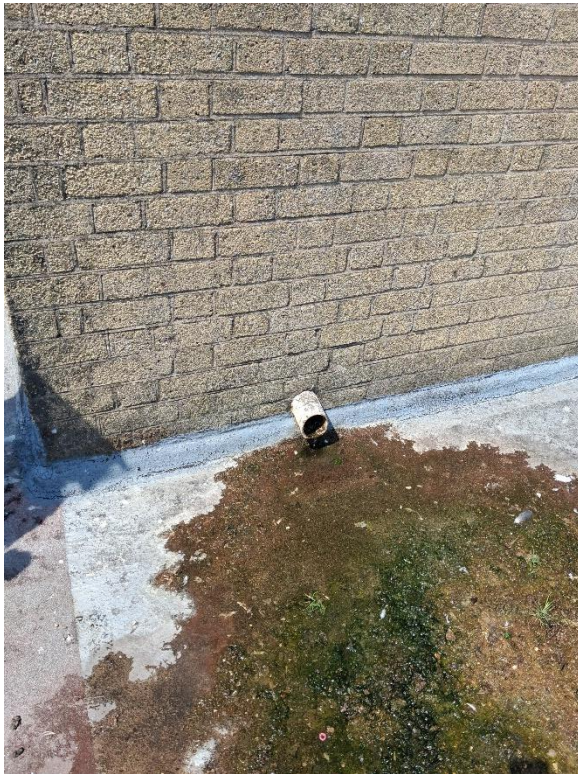
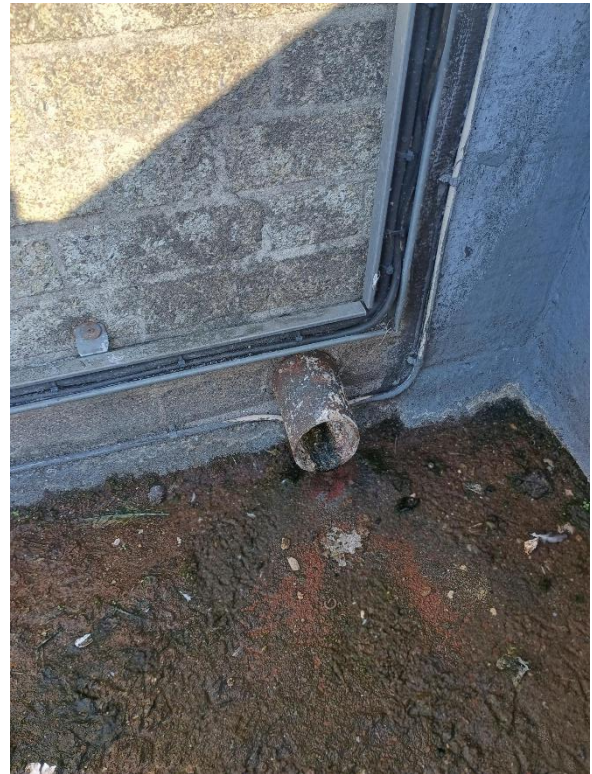
*This work is necessary to ensure that the outlet inverts remain above the finished roof level and maintain adequate drainage falls. Without this modification, the increased roof build-up would impede the effective discharge of rainwater, increasing the risk of ponding and premature deterioration of the roof covering.*

**Above:** images showing the two outlet spigots to be raised.

- 3.5.2. Two existing cast iron rainwater outlet spigots will require raising to accommodate the proposed tapered insulation build-up.

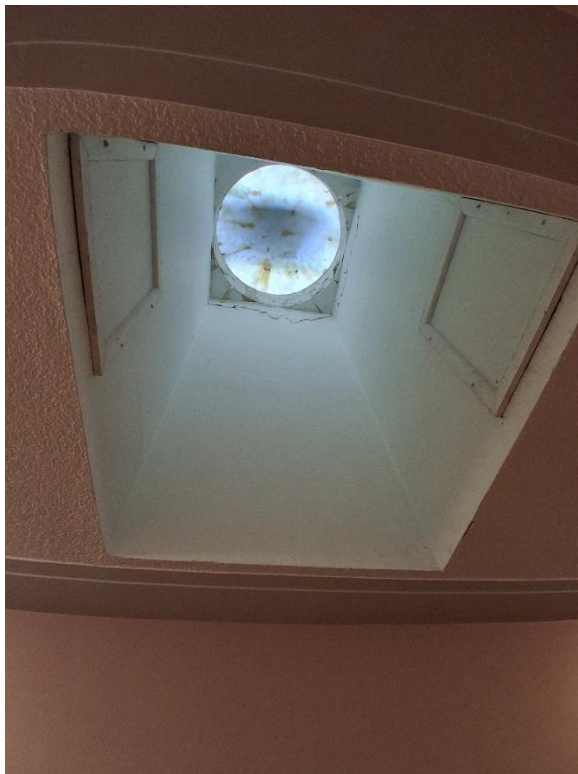
*Four of these rooflights have already lost their original glazing and have been covered with fibreglass domes, which are relatively opaque and therefore admit very little natural light into the spaces below. The fifth rooflight retain its original glazing; however, due to its limited size and the difficulty of accessing this area to clean, its contribution to daylighting is similarly modest and is no longer required to support the use of the corridor below. Internally, the rooflights are formed with deep reveals. These will be preserved, thereby retaining a clear record of the rooflights' former presence and safeguarding the legibility of this aspect of the building's historic development.*

**Left:** typical internal view of rooflights.

3.6.1. Five rooflights and their associated kerbs/upstands are proposed for removal, with the resulting openings infilled flush with the surrounding roof deck. The modern, and badly corroded, metal walkway gantries above four of these will also be dismantled and carted away.

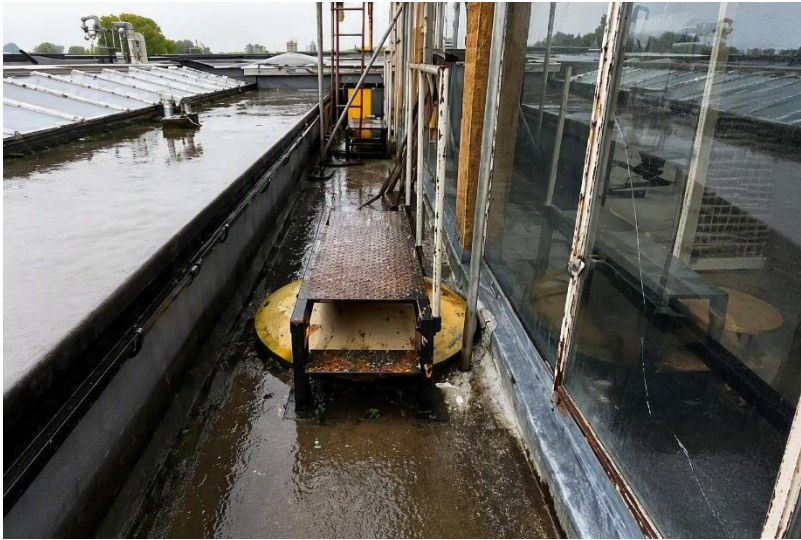
*The removal of the modern walkway gantries, which are in a hazardous condition, will allow for level and uninterrupted access across this section of roof.*

**Left:** typical view of rooflight and walkway gantry arrangement.

*As all five rooflights are surplus to operational requirements, their removal and overboarding is recommended. This approach represents a more cost-effective solution and will also enhance the overall weathertightness of the roof. Potentially vulnerable roof penetrations will be designed out, with the affected areas then incorporated within the manufacturer's roofing warranty.*

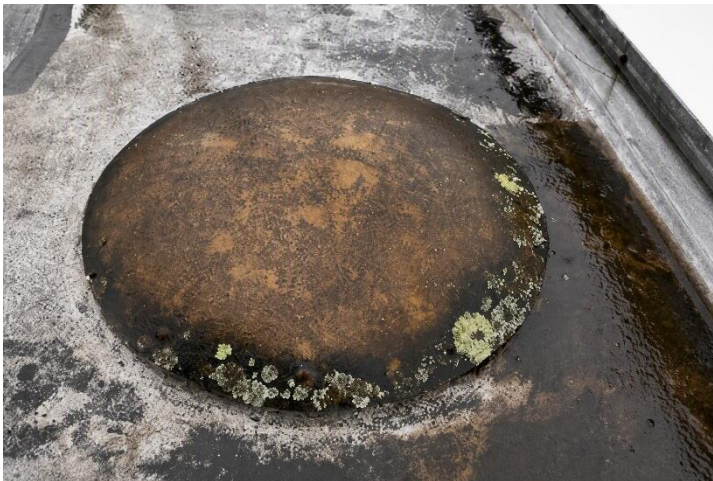
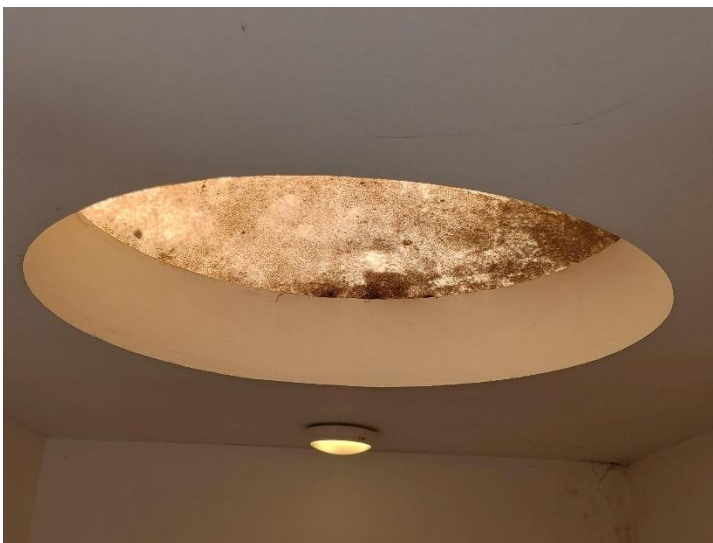
*This work is necessary since the existing rooflight is admitting very little natural light into the stairwell below. The original glass dome has, at some stage, been replaced with a relatively opaque fibreglass covering. A new clear rooflight will significantly increase the amount of natural daylight reaching the stairwell below, improving the quality of the internal environment and restoring the opening's intended function as a source of natural illumination.*

**Left:** external view of rooflight to be replaced.

**Left:** internal view of rooflight to be replaced.

- 3.7.1. A rooflight at the north corner of the core of the building is to be replaced with a modern unit to match the established form of the existing.

The proposed rooflight, a C6 A-Range Alumasc unit, will adopt the established form of the existing rooflight whilst remaining identifiable as a modern intervention. As such, it will preserve the legibility of the building's evolution and avoid unnecessary reconstruction. It will be formed from robust, low-maintenance materials, including a polycarbonate dome with substantially greater impact resistance than traditional glazing. This will enhance durability, reduce the likelihood of breakage during future maintenance operations and support the building's long-term management and upkeep.

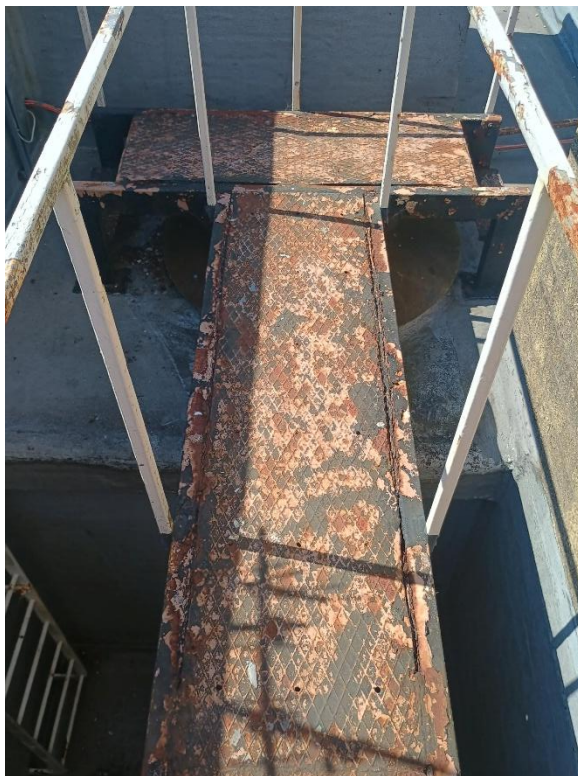
*This work is necessary to facilitate level and uninterrupted access at this location. It will rationalise the roof layout and contribute to improved drainage in an area currently affected by longstanding drainage deficiencies.*

**Left:** typical view of walkway gantry above roof well.

*The existing walkway gantry will be removed and 18mm OSB boarding will be laid on suitably sized timber joists and proprietary joist hangers to create a stable and durable subfloor construction. Joist hangers will be mechanically fixed to the adjacent brick walls using the minimum number of fixings necessary. This represents the least invasive means of achieving the required structural support. The works will result in only a negligible loss of historic fabric and, should the structure be removed in the future, the fixing holes could be readily filled and made good. Given that the brickwork is painted and the works are located within a discreet location, the intervention would be visually reversible.*

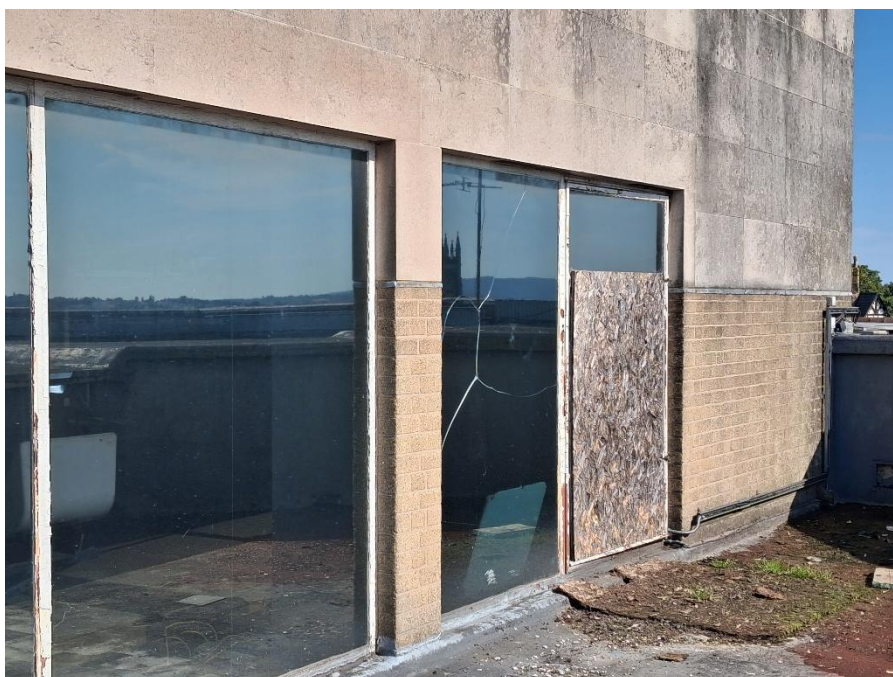
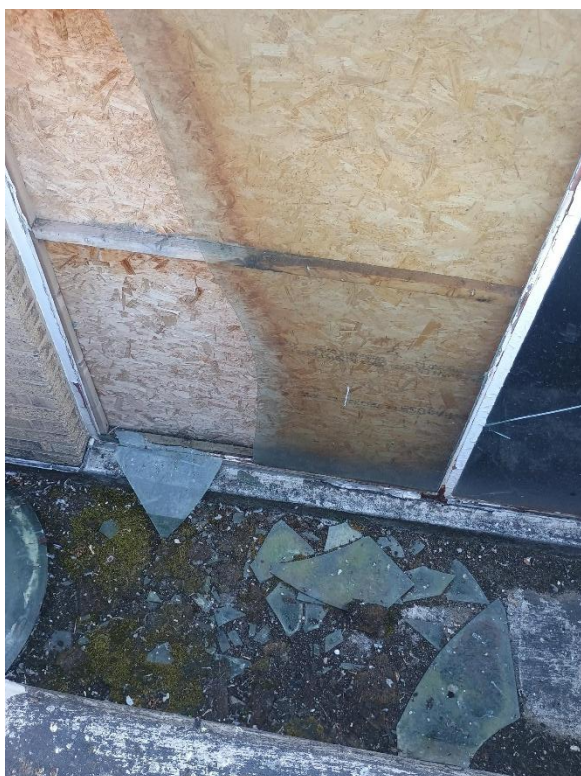
*This work is necessary since the existing windows and doors are beyond economic repair and have reached the end of their useful serviceable life. Significant corrosion, distortion of the frames and widespread cracking of the glazing have compromised their weathertightness, resulting in water ingress into the Lantern Room. Continued deterioration and moisture penetration pose a risk to the historic fabric and the murals below.*

**Left:** typical view of existing condition of Lantern Room windows.

**Left:** image showing extent of deterioration to Lantern Room windows.

3.10.1. The existing windows and pivot doors of the Lantern Room are to be replaced with new heritage-style units.

*The proposed aluminium replacement units have been selected in preference to like-for-like steel windows and doors due to their enhanced corrosion resistance, improved thermal performance and reduced maintenance requirements. They adopt a heritage-inspired design that reflects the character of the existing glazing whilst remaining identifiable as a modern intervention. Finished in Oyster White (RAL 1013) and installed within the existing openings, they will preserve the appearance of the elevation and minimise visual impact.*

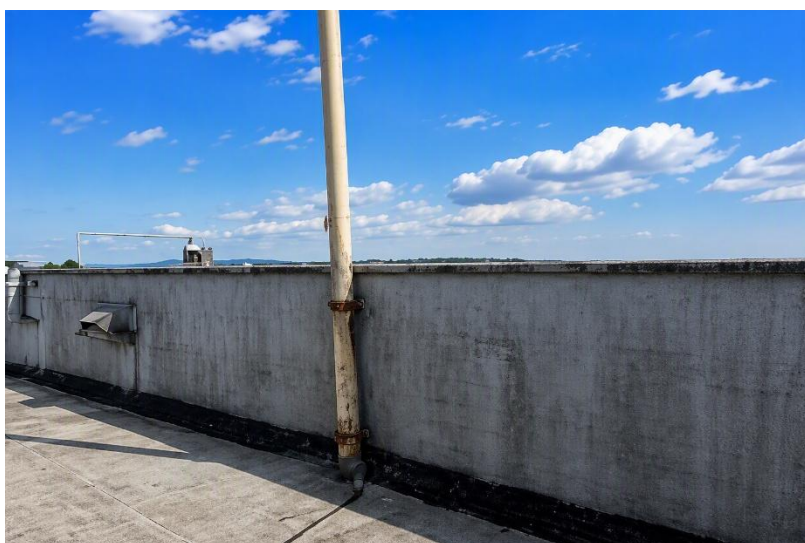
*The existing flagpoles are not original features and do not contribute to its special architectural or historic significance. Having reached the end of their serviceable life, they are no longer capable of safely flying flags. The replacement flagpoles will be installed in the same locations, matching the existing scale and appearance, and will utilise existing fixing points wherever possible. This will avoid unnecessary intervention to the historic fabric and, as such, the works constitute a minor maintenance intervention that will preserve the significance of the building.*

**Left:** view of one of the flagpoles.

3.11.1. Three broken and relatively modern flagpoles are proposed to be replaced on a like-for-like basis.

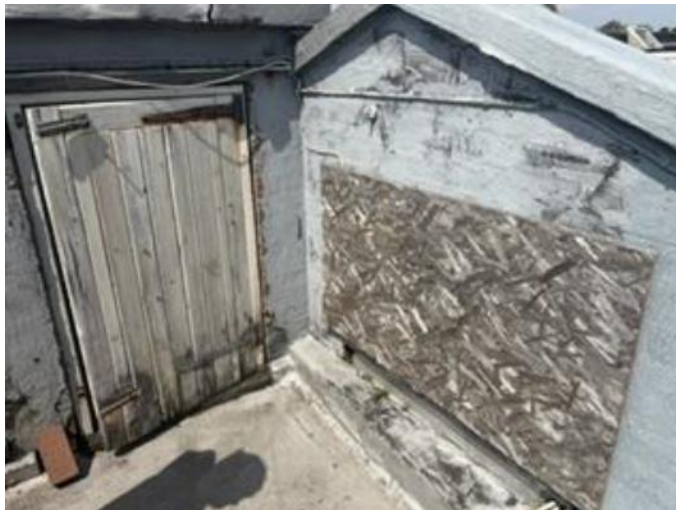
*The existing softwood doors are not original. They are in poor condition and providing a route for water-ingress and pigeons. Replacement provides an opportunity to increase the height of inadequate upstands and introduce a more robust and durable material (PPC aluminium).*

**Left:** image showing typical condition of service duct doors and frames.

3.13.1. Service duct doors and frames will be replaced with new weather-stripped PPC aluminium doorset (Oyster White – RAL 1013) complete with barrel bolt to slave leaves and lock to main leaves.

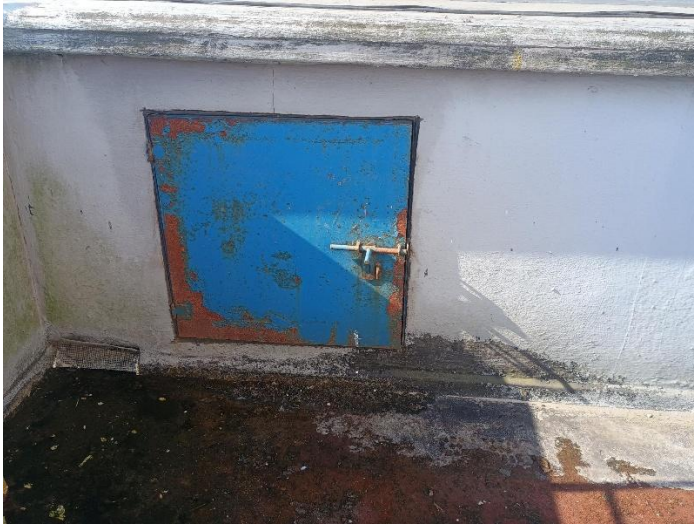
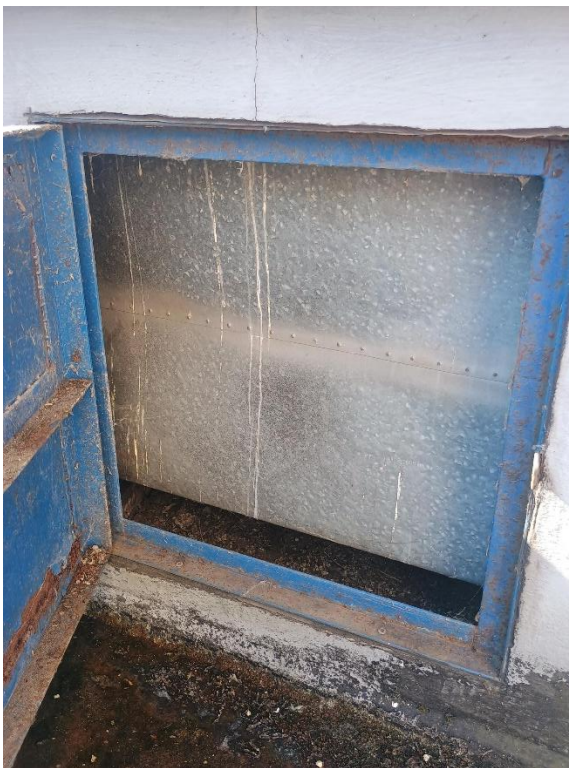
*The door and frame are associated with a later services installation and provide access only to enclosed ductwork associated with an air handling unit. As a non-original intervention, they do not contribute to the architectural or historic significance of the building and their removal is therefore considered justified. Removal will also facilitate the uninterrupted installation of the waterproof membrane and eliminate a potential vulnerability within the roof covering.*

**Left:** view of redundant door to air-handling ductwork.

**Left:** internal view of redundant door to air-handling ductwork.

3.13.2. One redundant metal door and frame will be carefully removed and the opening boarded over prior to the installation of the waterproof membrane.
