# **Tree Technical Note**

**Site Address:** 15 Ridgeway, Newport, NP20 5AF

## **Planning Application – 15 Ridgeway supplementary notes**

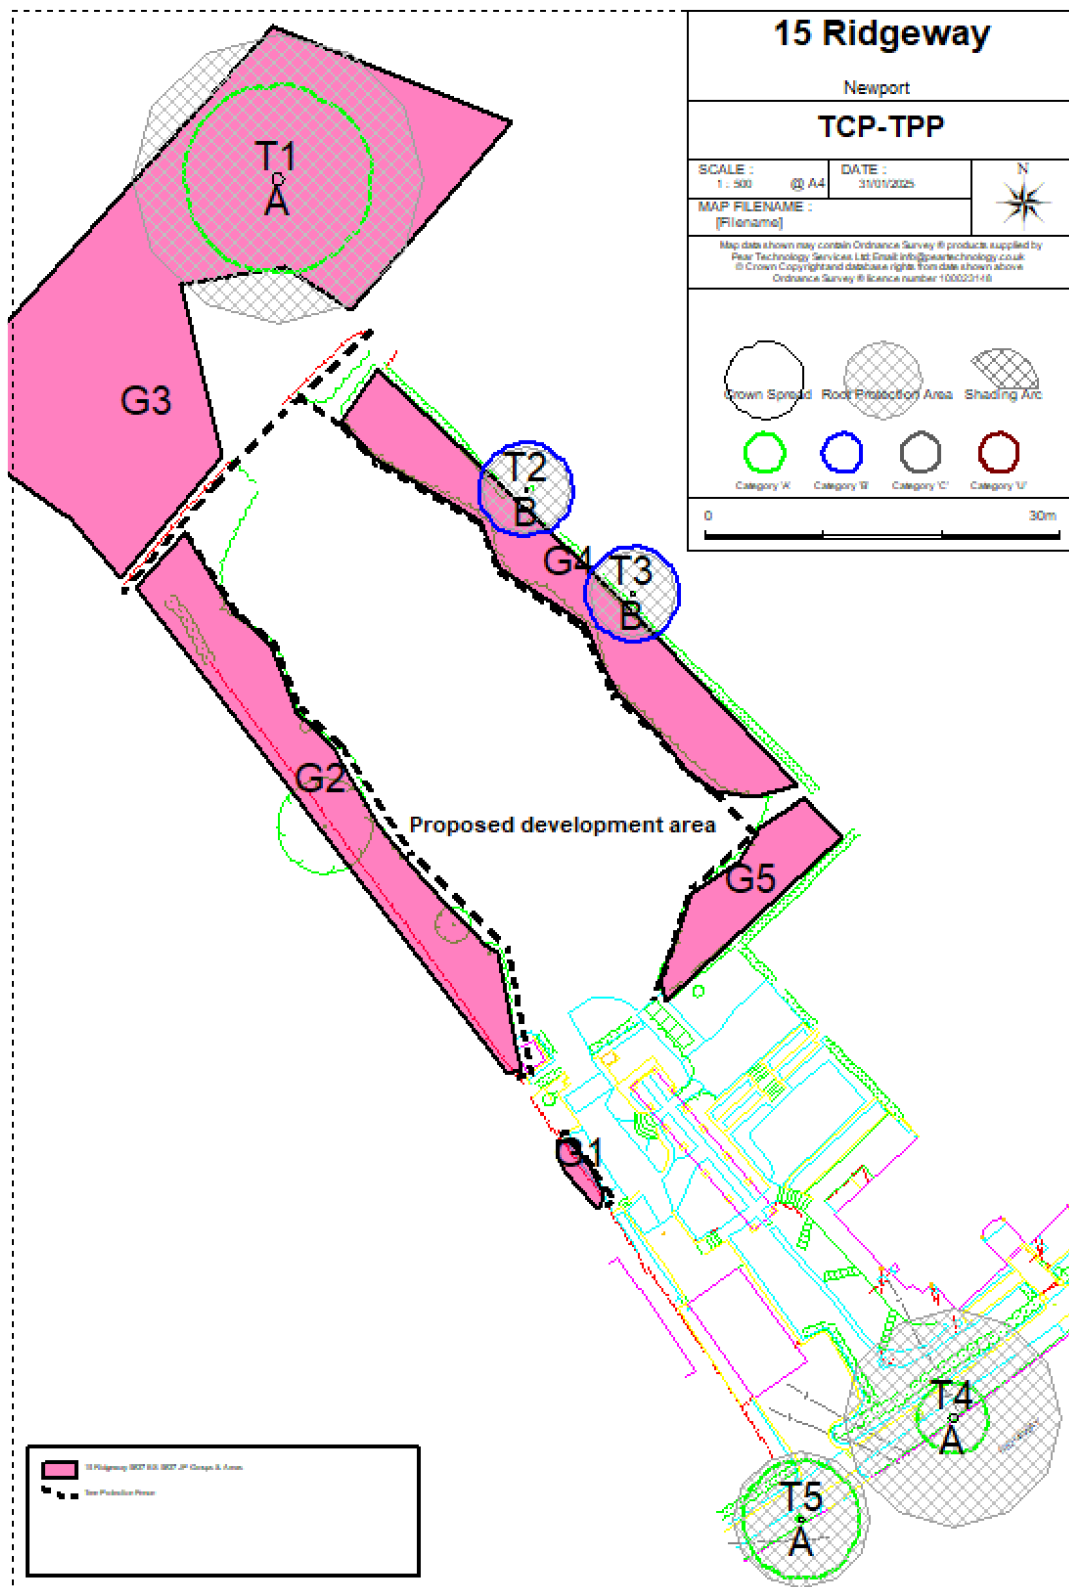
## 7. Site Plan

The site plan included in the BS5837 2012 Tree Report remains the same and is shown on the rear page. The proposed development area is now smaller and more central with no significant impact on any trees or borders. The Arboricultural Impacts Assessment remains largely unchanged but for ease of reference it is detailed again, updated where necessary.

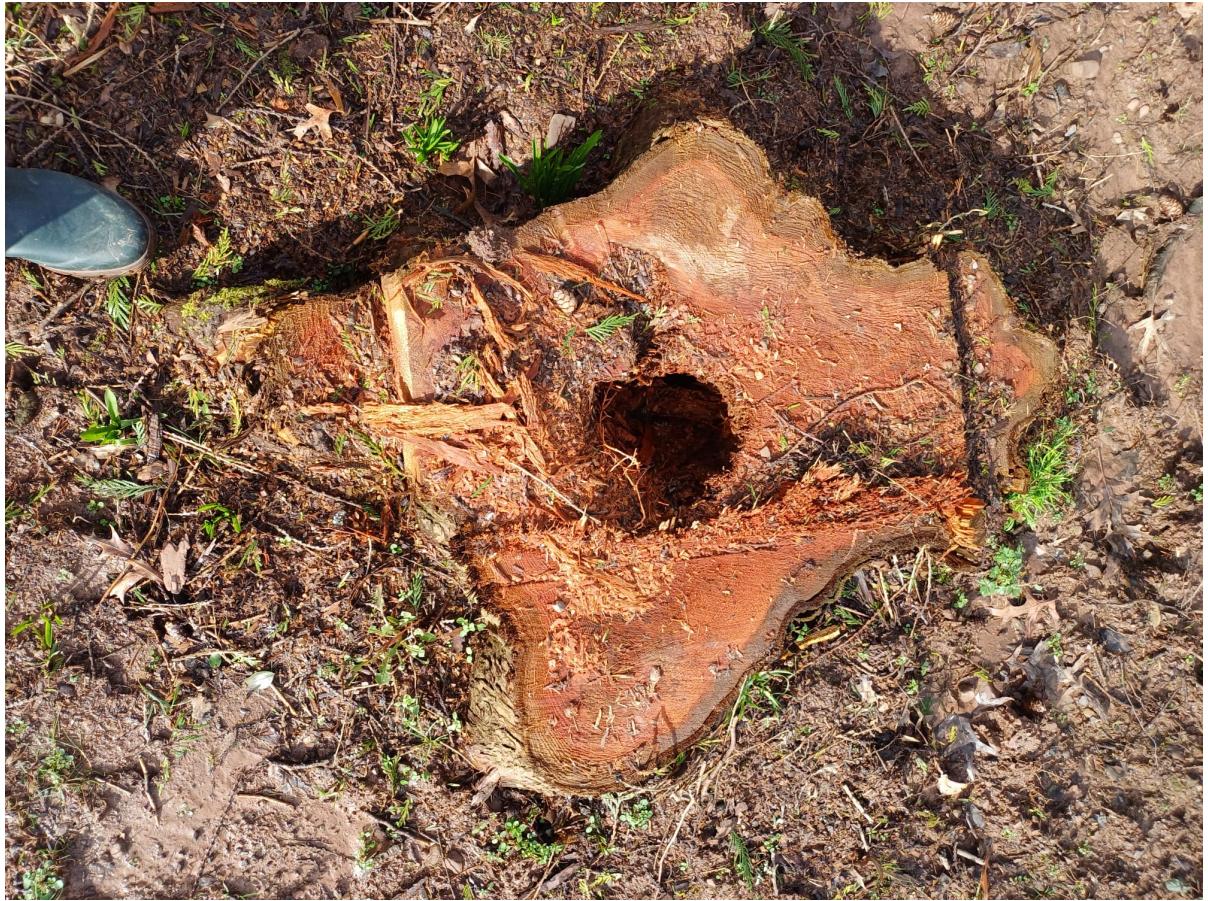
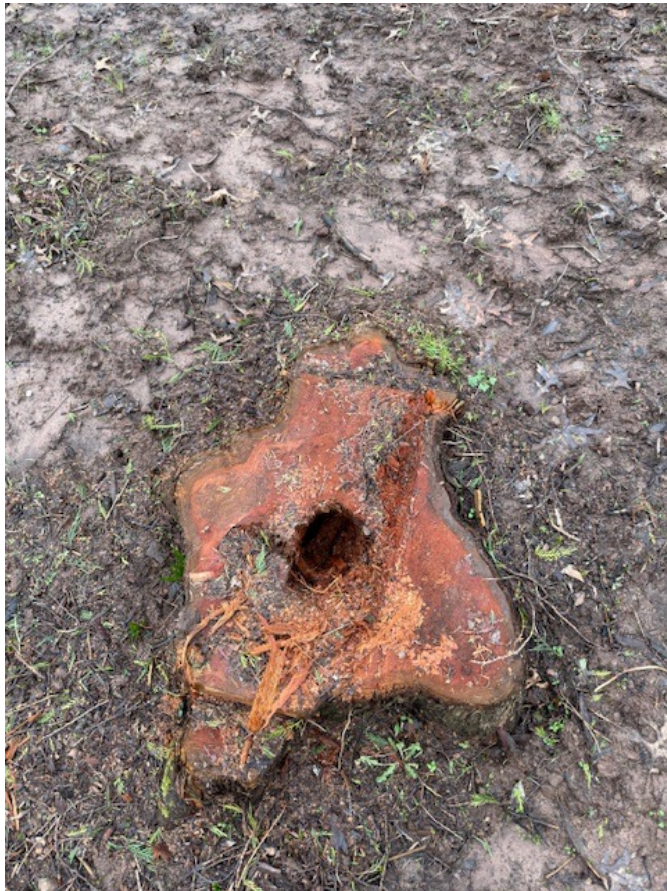
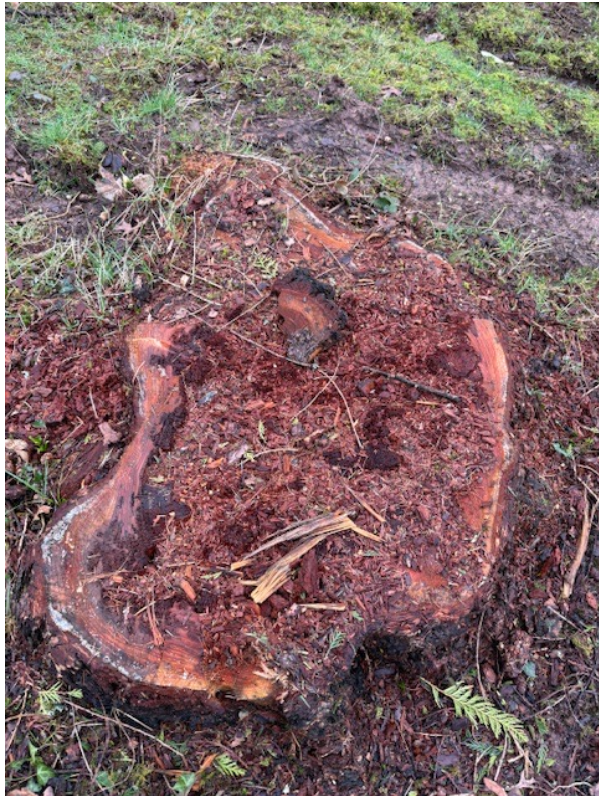
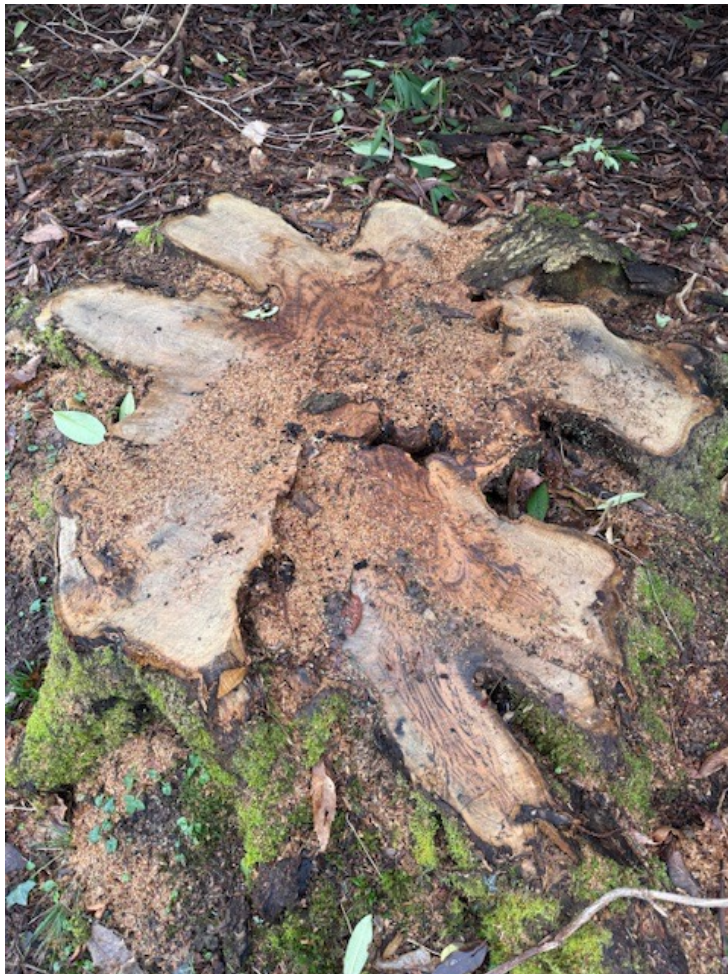
sample of photographs of the stumps from the felled trees. In nearly all of the stumps there were obvious signs of major defects. These defects are cavities/hollowing, decay/rot and other basal defects. Their loss was inevitable and not as part of any development proposal. The removal of previous trees was because they were either dead, dying or dangerous and therefore exempt of TPO, Conservation Area or Forestry Act methodology. My client has a duty of care under the Occupiers Liability Act 1957/84 that had to be met, the trees had to be removed.
