Llanwern Hot Mill

TITLE: Figure 8:  
B16 Location of Bat Boxes

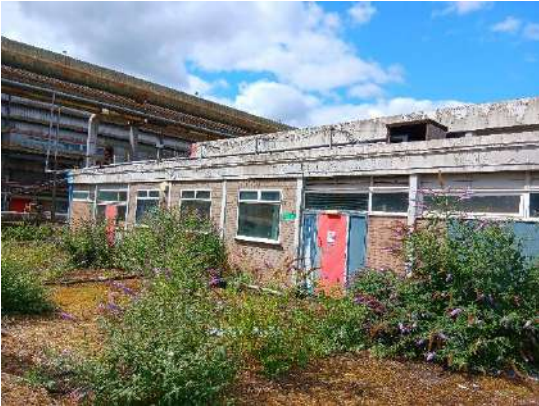
| Building No. | Photograph | Description of building<br>Potential Roost Features and any evidence of bats seen | Categorisation |
|---|---|---|---|
| B1 | | <p>Single storey brick-built office building with flat bitumen felt roof. Soffit present on all elevations and generally well-sealed however there are sections of damaged soffit on all elevations that would provide access to roof structure on all elevations.</p> <p>Classified as moderate potential as could support multiple bats but unlikely to support roost of high conservation status. Recommend surveys in 2026/2027 ahead of demolition in 2028.</p> <p>No evidence of bats found.</p> | Moderate |

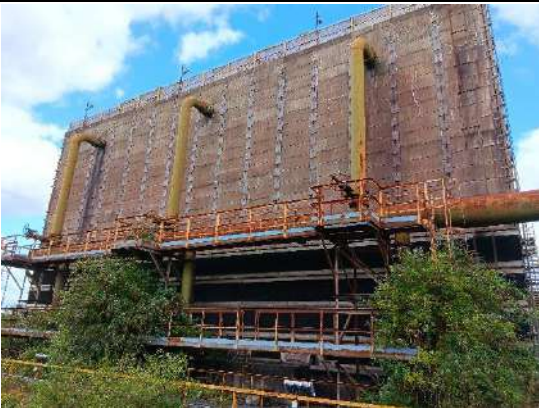
| Building No. | Photograph | Description of building<br>Potential Roost Features and any evidence of bats seen | Categorisation |
|---|---|---|---|
| B2 and B6 | | <p>Two almost identical cooling towers. Four storey buildings constructed of interlocking concrete panels. It looks like there are lots of crevice between panels but on close inspection there are no gaps. Potential for bats to get into interior from behind vents on southern elevation. Large industrial fans on flat roof. Low potential overall. Recommend survey in 2026/2027 ahead of demolition.</p> <p>No evidence of bats found.</p> | Low |

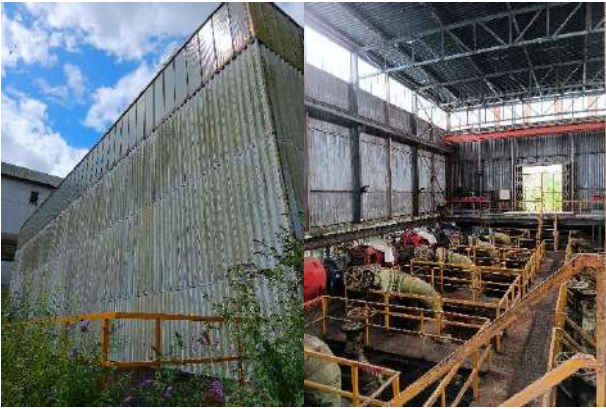
| Building No. | Photograph | Description of building<br>Potential Roost Features and any evidence of bats seen | Categorisation |
|---|---|---|---|
| B3A | | <p>Two storey pump house next to settlement pond. Concrete base concrete base with single skin metal clad walls and flat metal roof. Windows on all elevations at top of walls. Internally open plan, used as old pumping station. Large access on southern elevation and gate on northern. Negligible potential as no potential roost features (PRFs).</p> <p>No evidence of bats found.</p> | Negligible |

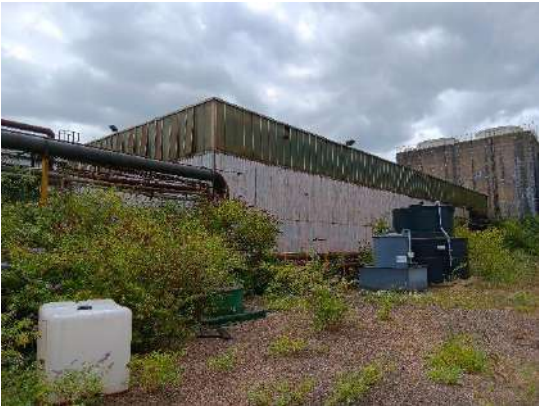
| Building No. | Photograph | Description of building<br>Potential Roost Features and any evidence of bats seen | Categorisation |
|---|---|---|---|
| B3B | | <p>Large metal warehouse style building. Machinery inside.</p> <p>No evidence of bats found.</p> | Negligible |

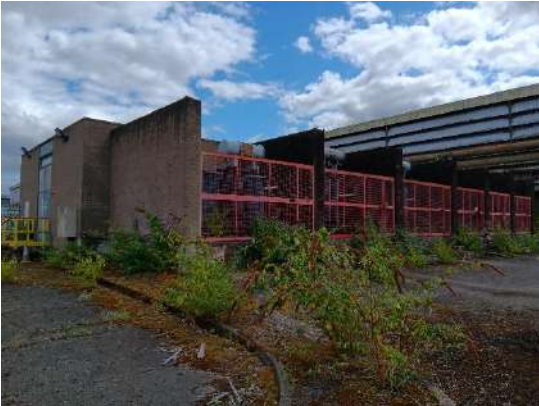
| Building No. | Photograph | Description of building<br>Potential Roost Features and any evidence of bats seen | Categorisation |
|---|---|---|---|
| B4A | | <p>Single storey brick-built substation. Six open bays on western elevation. Eastern half of building has internal areas, but these are well-sealed.</p> <p>No evidence of bats found.</p> | Negligible |

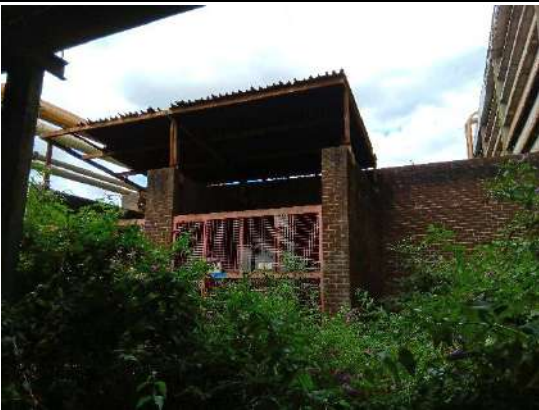
| Building No. | Photograph | Description of building<br>Potential Roost Features and any evidence of bats seen | Categorisation |
|---|---|---|---|
| B4B | | <p>Single storey brick-built substation with metal extensions on north. Open bays on west with no ceiling. Central interior room (not accessed) on eastern elevation, 15 vent bricks present at approx. 3.5m. May give access to cavity wall (if present).</p> <p>Recommended endoscope inspection initially to see if gap goes anywhere.</p> <p>No evidence of bats found.</p> | Low |

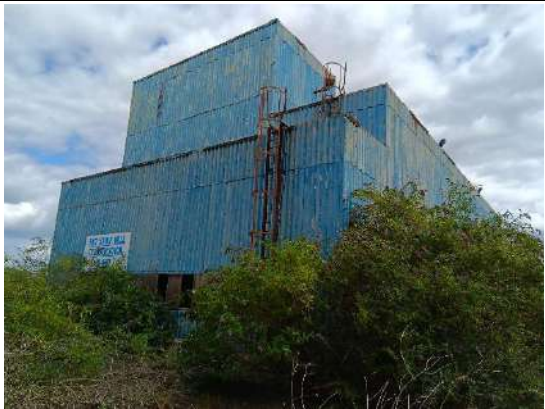
| Building No. | Photograph | Description of building<br>Potential Roost Features and any evidence of bats seen | Categorisation |
|---|---|---|---|
| B5 | | <p>Two storey building with metal cladding. Broken windows on most elevations provide access to internal areas. Internal areas are two rooms with machinery. Both areas are open plan and have light ingress.</p> <p>No evidence of bats found.</p> | Negligible |

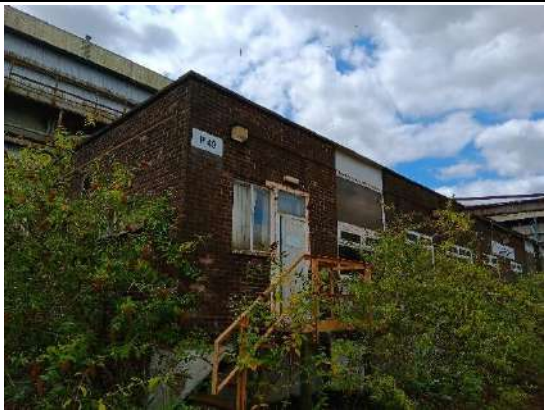
| Building No. | Photograph | Description of building<br>Potential Roost Features and any evidence of bats seen | Categorisation |
|---|---|---|---|
| B7 | | <p>Two storey brick-built office building with flat felt roof. Open door on north elevation leads into sealed room. Small bit of lifted bitumen on west elevation but doesn't seem to go anywhere. Otherwise well sealed.</p> <p>No evidence of bats found.</p> | Negligible |

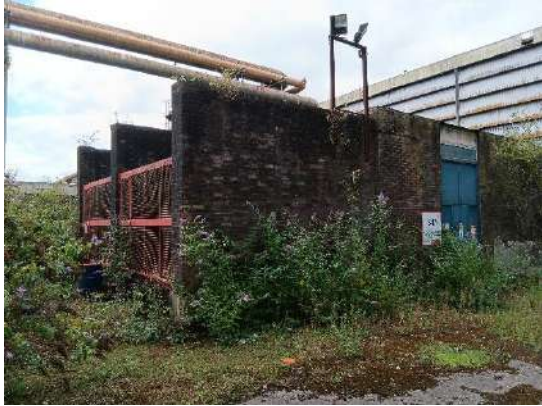
| Building No. | Photograph | Description of building<br>Potential Roost Features and any evidence of bats seen | Categorisation |
|---|---|---|---|
| B8 | | <p>Single storey brick-built substation with tarmac felt covered flat roof and two electrical bays on northern and southern elevations. Central section has internal areas. To west of south-west corner is a concrete tunnel leading to a chamber. Inspected via torch and no evidence (not gone inside due to rubbish on floor).</p> <p>Identified as low due to concrete tunnel and chamber on western side. Can be inspected with torch prior to demolition.</p> <p>No evidence of bats found,</p> | Low |

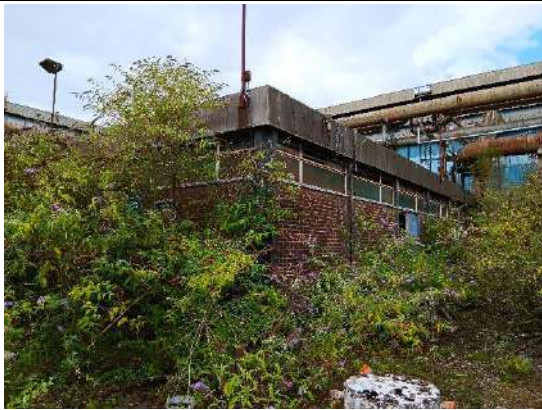
| Building No. | Photograph | Description of building<br>Potential Roost Features and any evidence of bats seen | Categorisation |
|---|---|---|---|
| B9A | | <p>Single storey brick built disused office building. Bitumen flat roof. Metal fascias and uPVC windows. False inner ceilings panels and ceilings are lined internally with wooden cladding.</p> <p>Soffits on all elevations. Open door on northern elevation gives access to interior, as well as open window vents on same elevation. Interior well-lit with no roof voids. Primary PRF is damaged soffit on east and north granting access to gap behind soffits. Moderate potential as could support multiple bats.</p> | Moderate |

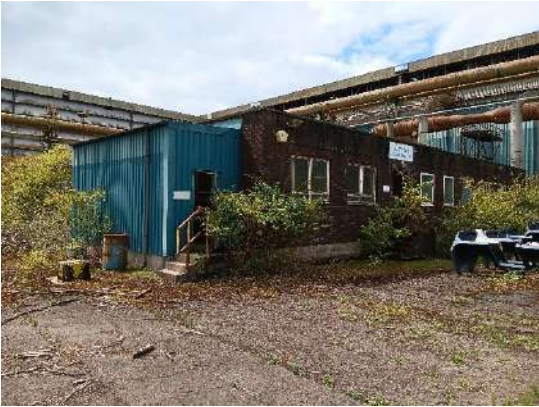
| Building No. | Photograph | Description of building<br>Potential Roost Features and any evidence of bats seen | Categorisation |
|---|---|---|---|
| B9B | | <p>Single storey brick-built disused office building. Bitumen flat roof. Corrugated metal extension and uPVC windows. False inner ceiling panels and ceilings are lined internally with wooden cladding.</p> <p>Generally, well-sealed but has open doors on eastern elevation provides access. Evidence of bats in the form of droppings of a size, shape and consistency for lesser horseshoe were identified within a corridor on the northern side of the building, accessed via an open doorway on the eastern elevation. Approximately 30 droppings were identified concentrated under a light fitting, in the only room in the building not to have a window. Likely day roost of individual or small numbers.</p> | Confirmed |

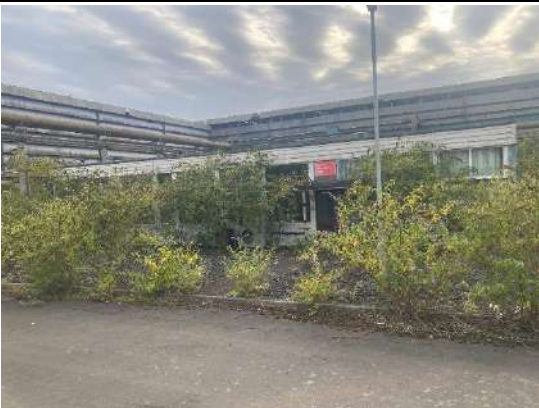
| Building No. | Photograph | Description of building<br>Potential Roost Features and any evidence of bats seen | Categorisation |
|---|---|---|---|
| B9C | | <p>Single storey brick built disused office building. Bitumen flat roof. Metal facias and uPVC windows. False inner ceiling panels and ceilings are lined internally with wooden cladding. Large ventilation box in the roof areas with open vents.</p> <p>On southern elevation open door leads to electrical cupboard. Two concentrations of lesser horseshoe bat droppings were found inside, one in first room approx. 20, approx. 50 in second room under pipes. Likely day/night roost for individuals or small numbers.</p> | Confirmed |

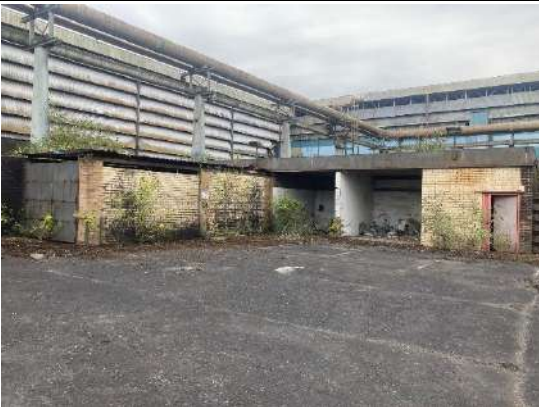
| Building No. | Photograph | Description of building<br>Potential Roost Features and any evidence of bats seen | Categorisation |
|---|---|---|---|
| B9D | | <p>Brick built sheds with tarmac flat roof and corrugated metal roof. Two open bays with two internal rooms. One long room couldn't be inspected as double doors wedged with metal. Roof appears to have multiple gaps but dark cupboard at end needs inspection.</p> <p>Full internal inspection recommended before demolition, but no dusk surveys recommended.</p> | Low |

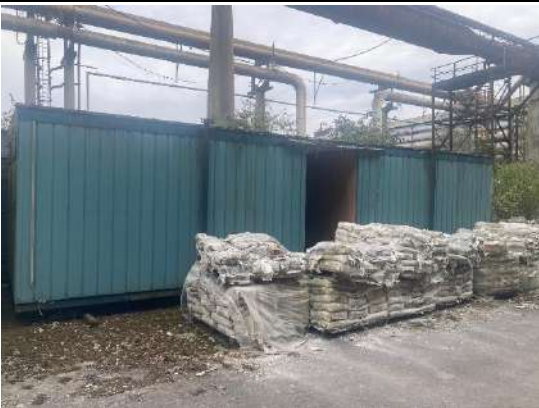
| Building No. | Photograph | Description of building<br>Potential Roost Features and any evidence of bats seen | Categorisation |
|---|---|---|---|
| B9E | | <p>Two disused containers.</p> <p>No evidence of bats found.</p> | Negligible |

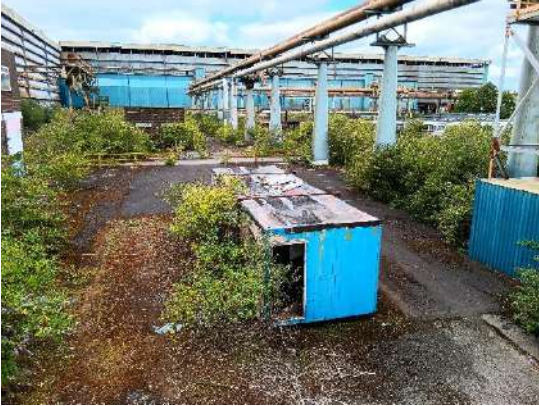
| Building No. | Photograph | Description of building<br>Potential Roost Features and any evidence of bats seen | Categorisation |
|---|---|---|---|
| B9F | | <p>Disused porta cabin with partially collapsed inner ceiling.</p> <p>No evidence of bats found.</p> | Negligible |

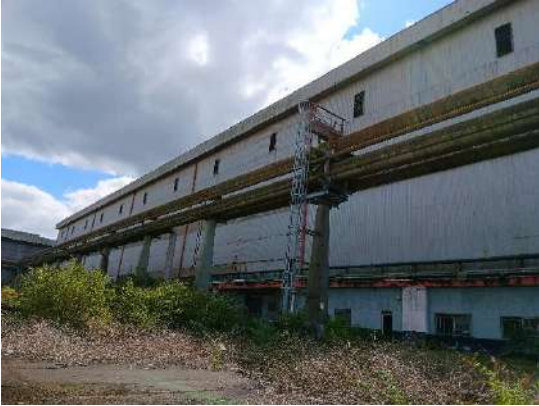
| Building No. | Photograph | Description of building<br>Potential Roost Features and any evidence of bats seen | Categorisation |
|---|---|---|---|
| B10A | | <p>Hot Mill – Main Body</p> <p>Complex internal layout with an upstairs main hall (that has one one-storey and two two-storey buildings inside), ground floor 'basement level', and inaccessible service tunnels underground in the southern (horizontally) half.</p> <p>There is an upstairs main hall, a ground floor 'basement level' and underground cellars in the northern (horizontally) half.</p> <p>The footprint of the building covers about 11 hectares.</p> <p>Please see Figure 12 for location of bat roosts.</p> | Confirmed |

- 5.1.5 EPSL must be in place prior to start of demolition works.
- 5.1.6 **Building 10A:** As the building is being used a hibernation roost, **the start of the works will be restricted** to avoid the period of core hibernation period of **November to March inclusive** in areas where bats may be hibernating, these areas include the Hot Mill motor rooms and the Northern cellars (both within 10A). Due to the size of the building, it will be possible to put a 50m buffer around these areas and continue with works outside of these areas in these months.

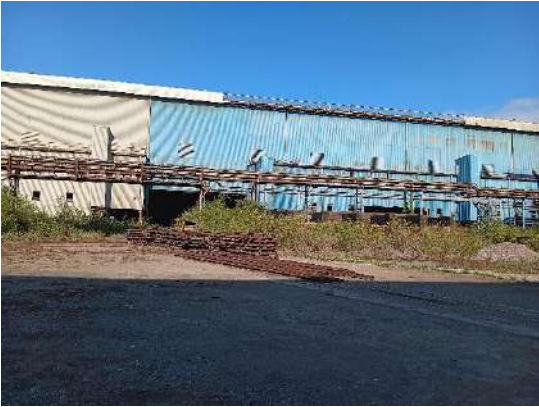
| Building No. | Photograph | Description of building<br>Potential Roost Features and any evidence of bats seen | Categorisation |
|---|---|---|---|
| B10B | | <p>Hot Mill – Discharge Bay</p> <p>Corrugated metal hangar style building with metal cranes, train tracks and machinery inside.</p> <p>No basement or cellars.</p> | Low |

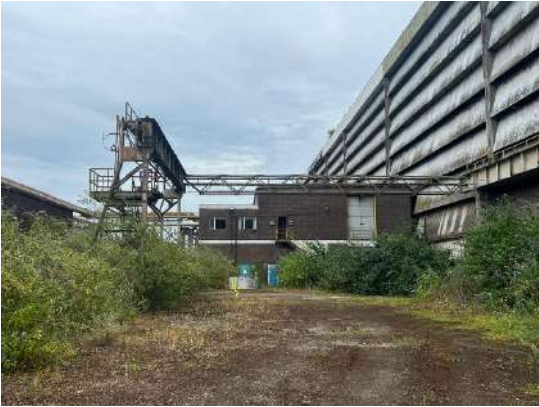
| Building No. | Photograph | Description of building<br>Potential Roost Features and any evidence of bats seen | Categorisation |
|---|---|---|---|
| B10C | | <p>This is an Extension of the Hot Mill building B10A and has internal access into the building.</p> <p>Two storey brick-built office building with bitumen covered flat roof.</p> <p>vidence of bats in the form of droppings of a size, shape and consistency for lesser horseshoe were identified in a kitchenette and a shower room. Approximately 100 droppings were identified with about 50 droppings fresh being found inside the kitchenette and 50 older droppings inside the shower room. In addition, c. 10 chewed peacock and lesser tortoise shell butterfly wings (typical of bat insect prey) were found inside one of the office rooms. The roosting areas are believed to be in the void (c. 1m internal height) above the false inner ceiling panels. These areas could not be fully surveyed due to risk of asbestos. Flight access into the building which is an extension of the Hot</p> | Confirmed roost |

| Building No. | Photograph | Description of building<br>Potential Roost Features and any evidence of bats seen | Categorisation |
|---|---|---|---|
| | | Mill is via a broken window but is also internally connected to the main hall of the Hot Mill; | |

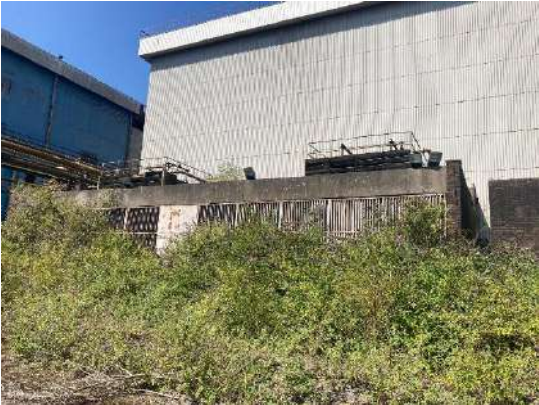
| Building No. | Photograph | Description of building<br>Potential Roost Features and any evidence of bats seen | Categorisation |
|---|---|---|---|
| B10D | | <p>Two storey brick-built substation with two large open vents at west and east sides. This building has been disused since the 1970's.</p> <p>This is an extension of the Hot Mill building B10A and has internal doors into the slab mill motor rooms basement with access into the building.</p> <p>Categorised as confirmed roost as internally connected and close proximity to identified bat roost inside slab mill motor rooms basement.</p> | Confirmed |

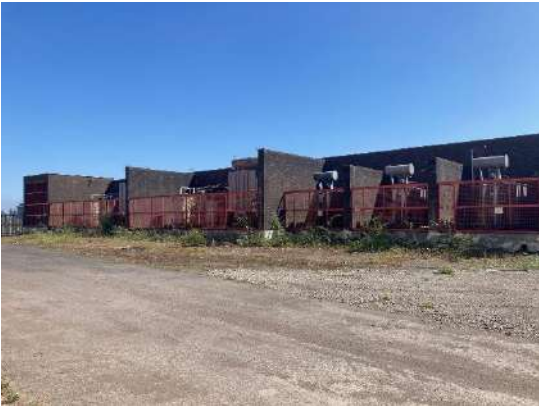
| Building No. | Photograph | Description of building<br>Potential Roost Features and any evidence of bats seen | Categorisation |
|---|---|---|---|
| B11 | | <p>Single storey brick-built electrical substation with flat concrete roof. Open bays on northern elevation with electrical equipment. southern half has internal rooms. Only one PRF seen, hole around wire on western elevation.</p> <p>Recommended endoscope inspection initially to see if gap goes anywhere.</p> <p>No evidence of bats found.</p> | Low |

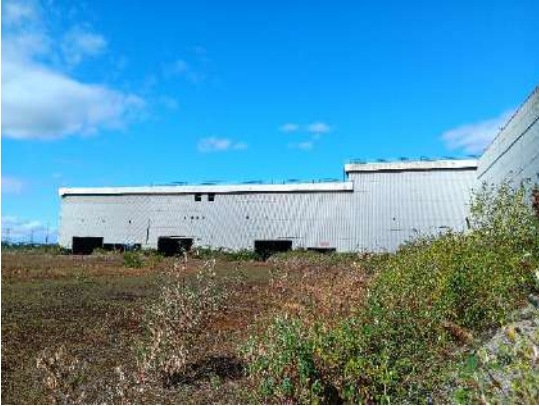
| Building No. | Photograph | Description of building<br>Potential Roost Features and any evidence of bats seen | Categorisation |
|---|---|---|---|
| B12 | | <p>Hot Mill – Slab Yard</p> <p>Corrugated metal hangar style building with metal cranes and machinery inside. No basement or cellars.</p> <p>Metal cladding walls on east and west with only partial covering on southern elevation. Metal roof covers majority of area. Cranes and steel beams present otherwise internally largely open plan. where Hot Mill and slab yard meet with no internal wall.</p> <p>Furnaces are present with flumes and ash bays which provide some suitable roosting features. Internally there are rooms and tunnels which lead under sections which can't be fully inspected due to asbestos, oil and general unsafe conditions</p> | Confirmed roost |

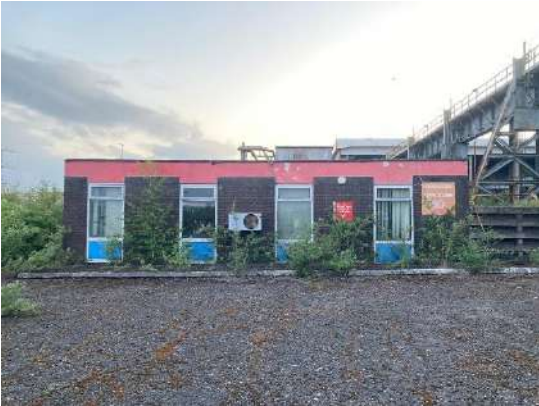
| Building No. | Photograph | Description of building<br>Potential Roost Features and any evidence of bats seen | Categorisation |
|---|---|---|---|
| B13 | | <p>Single storey brick built flat roofed office building that is currently in use. The building has uPVC fascias, windows and doors. This building has false inner ceiling panels and a small ventilation box in the roof areas.</p> <p>One common pipistrelle bat emerged 21:48 during the first dusk survey 22 May 2025. The access point is a gap under the fascia on the North facing side.</p> | Confirmed roost |

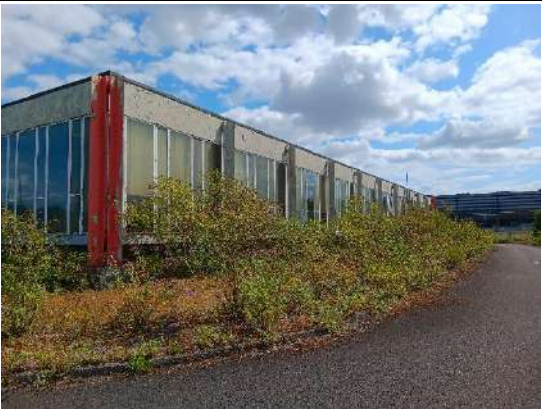
| Building No. | Photograph | Description of building<br>Potential Roost Features and any evidence of bats seen | Categorisation |
|---|---|---|---|
| B16 (located outside CDM area) | | <p>Single storey brick and concrete block building with bitumen covered flat roof. Glass panels make up most of walls. Disused lab with broken windows: two western elevation, two eastern elevation, two facing west in the internal courtyard, and one broken door on eastern elevation. Windows also open with strong winds and are closed again by security.</p> <p>Approx. 100 LHS bat droppings found inside three different rooms with concentrations under open panels (indicating use of void above) and smaller numbers of scattered droppings elsewhere inside Rooms 17, 19 and 20. Rooms are connected via false inner ceiling void and multiple ceiling panels have fallen down.</p> | Confirmed roost |

- 5.1.11 B16 has been shown to be used as a day roost by small numbers of lesser horseshoe bats and common pipistrelle.
- 5.1.12 B16 The Lab has a close resemblance in structure and materials to building 10C The Reheat Furnace offices, which has been found to be a favoured area used by the lesser horseshoe bats. However, building 16 is currently well lit during the day as large windows are present on every elevation, including on those walls facing the internal courtyard.

- 5.1.13 In order to enhance the building to make it more suitable to be used as a bat roost, the following features will be installed:
- Windows will be boarded up / covered to create more dark areas within the building (as large parts of the walls consists of window panes);

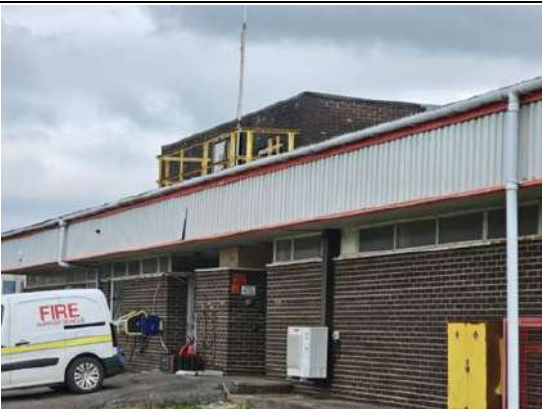
| Building No. | Photograph | Description of building<br>Potential Roost Features and any evidence of bats seen | Categorisation |
|---|---|---|---|
| B17 (located outside CDM area) | | <p>Single storey flat roofed brick built with tarmac covered flat roof.</p> <p>Medical centre currently in use. Picture from 2024.</p> <p>No evidence of bats found.</p> | Low |

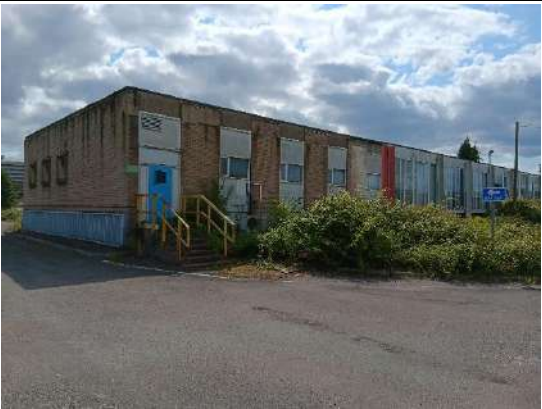
| Building No. | Photograph | Description of building<br>Potential Roost Features and any evidence of bats seen | Categorisation |
|---|---|---|---|
| B18<br>(located outside CDM area) | | Single storey brick and concrete block building with tarmac covered flat roof. Glass panels make up most of walls. Generally, well-sealed with one broken window on northern block into courtyard by northwest corner. There is a broken door which is only partly boarded. leading into an electrical cupboard which could not be fully inspected. Some doors are internally locked so couldn't inspect all rooms. There is a partially open door from courtyard into the northern block, with missing ceiling panels above. Previously confirmed as a roost (bat droppings found externally 2024) but no evidence seen (within limitations) 2025. | Confirmed roost |

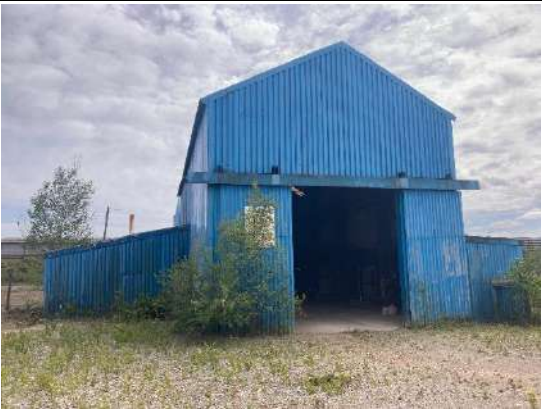
| Building No. | Photograph | Description of building<br>Potential Roost Features and any evidence of bats seen | Categorisation |
|---|---|---|---|
| B19<br>(located outside CDM area) | | Large metal warehouse with open doorway at one end. Open to the apex inside.<br><br>No evidence of bats found. | Negligible |

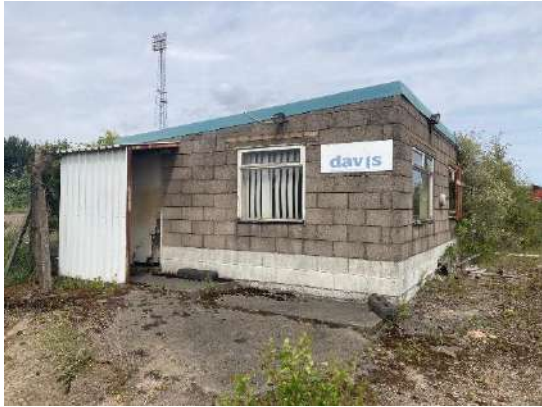
| Building No. | Photograph | Description of building<br>Potential Roost Features and any evidence of bats seen | Categorisation |
|---|---|---|---|
| B20<br>(located outside CDM area) | | <p>Single storey breezeblock with flat bitumen roof and wooden fascias. Disused office building,</p> <p>Bat droppings were found inside offices 2024.</p> | Confirmed roost |

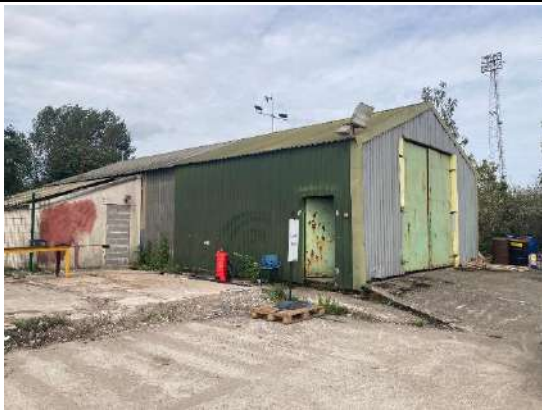
| Building No. | Photograph | Description of building<br>Potential Roost Features and any evidence of bats seen | Categorisation |
|---|---|---|---|
| B21<br>(located outside CDM area) | | <p>Large metal garage space adjacent to single storey brick building with tiled gable roof and plastic soffit boxes. Currently in use.</p> <p>No evidence of bats found.</p> | Negligible |

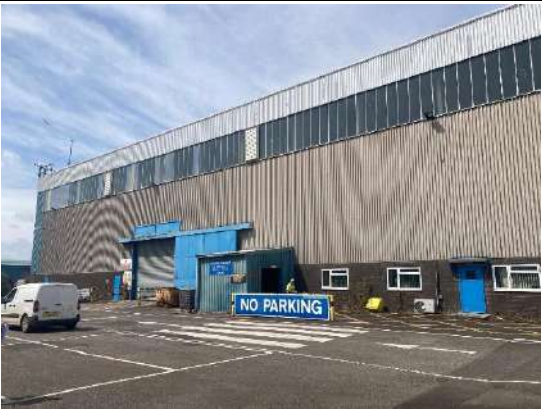
| Building No. | Photograph | Description of building<br>Potential Roost Features and any evidence of bats seen | Categorisation |
|---|---|---|---|
| B22<br>(located outside CDM area) | | <p>Large, corrugated metal warehouses with pitched corrugated metal roofs with Perspex skylights and an adjacent two storey brick office building with a flat bitumen roof.</p> <p>Dead common pipistrelle bat found inside 2025.</p> <p>Bat droppings found 2024.</p> <p>Reports of bat activity inside from staff 2024 and 2025.</p> | Confirmed roost |

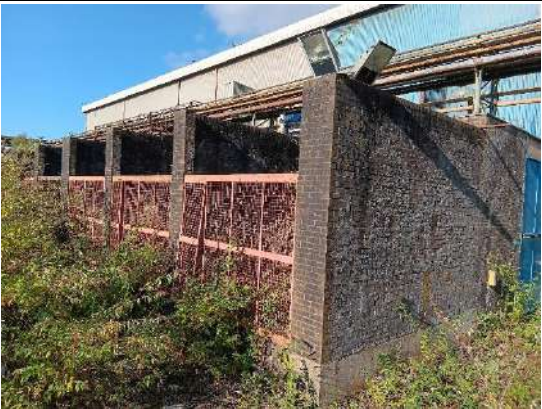
| Building No. | Photograph | Description of building<br>Potential Roost Features and any evidence of bats seen | Categorisation |
|---|---|---|---|
| B28A | | <p>Single storey brick- built electrical substation with flat roof and five open bays on east elevation. Internal area on west side but sealed with no obvious bat access points. Not internally inspected.</p> <p>No evidence of bats found.</p> | Negligible |

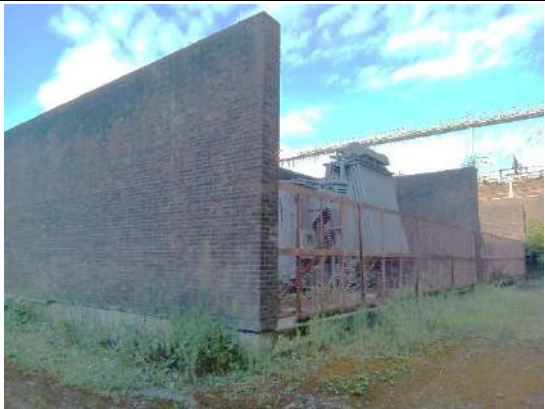
| Building No. | Photograph | Description of building<br>Potential Roost Features and any evidence of bats seen | Categorisation |
|---|---|---|---|
| B28B | | <p>Single storey brick- built electrical substation. No roof and metal fences in front. No suitable bat roosting features found.</p> <p>No evidence of bats found.</p> | Negligible |

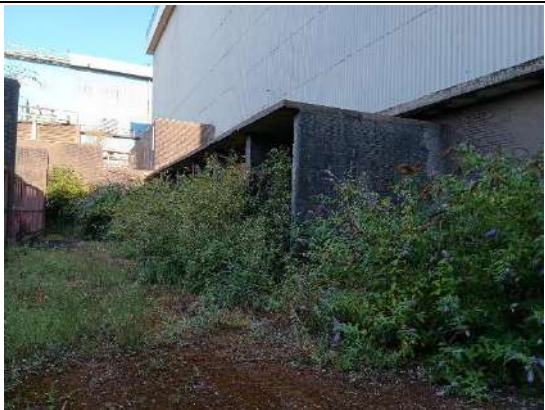
| Building No. | Photograph | Description of building<br>Potential Roost Features and any evidence of bats seen | Categorisation |
|---|---|---|---|
| 28C | | <p>Single storey brick- built electrical substation. Concrete flat roof with six open bays on southern elevation.</p> <p>No evidence of bats found.</p> | Negligible |

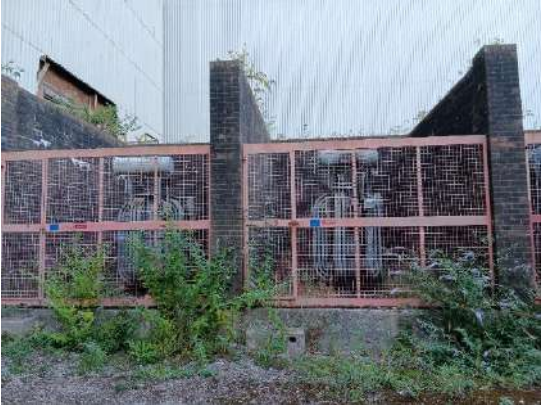
| Building No. | Photograph | Description of building<br>Potential Roost Features and any evidence of bats seen | Categorisation |
|---|---|---|---|
| 28D | | <p>Single storey brick- built electrical substation. Two bays with metal fencing,</p> <p>No evidence of bats found.</p> | Negligible |

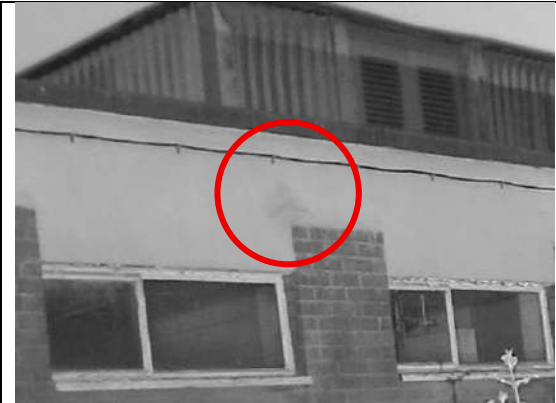
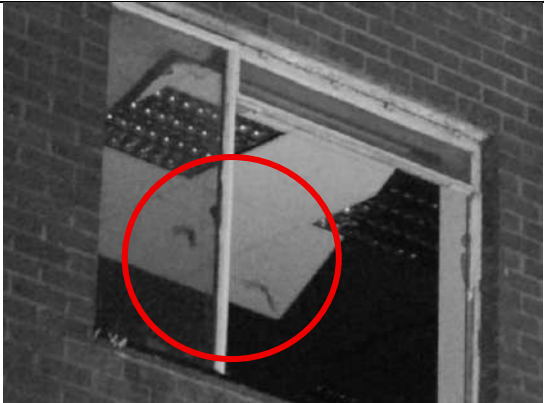
| <p>Plate 31 (22/05/2025): B13 Dusk 1 Com pip emergence NE corner fascia board 21:38</p> | <p>Plate 32 (16/07/2025): B10C Dusk 2 Bat (unknown species, maybe LHS) re-entry 22:23.</p> |

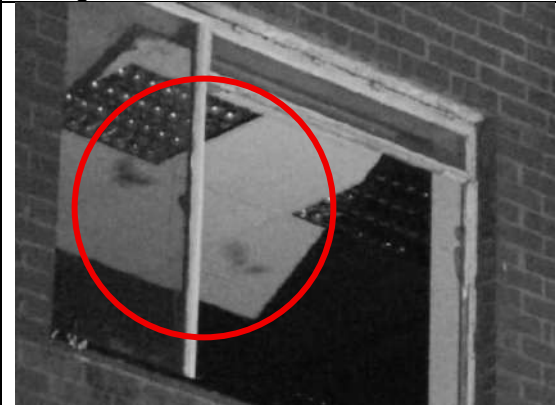
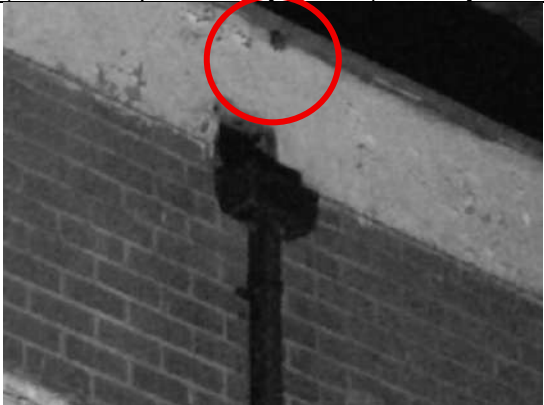
| <p>Plate 33 (16/07/2025): B10C Dusk 2 Bat (unknown species, maybe LHS) exiting and re-entering the window repeatedly. 22:24.</p> | <p>Plate 34 (16/07/2025): B10C Dusk 2 Com pip perching on exterior of building near window. This behaviour was repeated several times. 22:27.</p> |

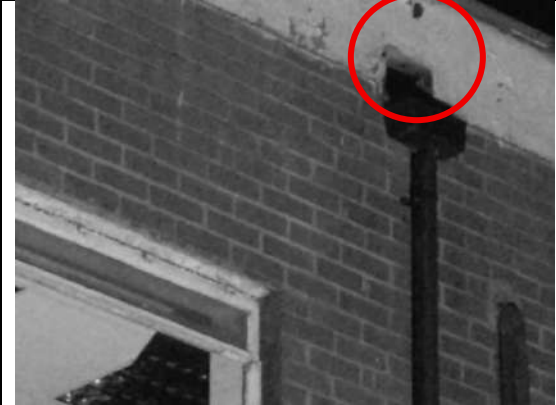
| <p>Plate 35 (16/07/2025): B10C Dusk 2 Com pip perching on exterior of building 22:28.</p> | <p>Plate 36 (24/07/2025): B10A Dawn 3 Com pip re-entering SE Corner Hot Mill 03:29.</p> |

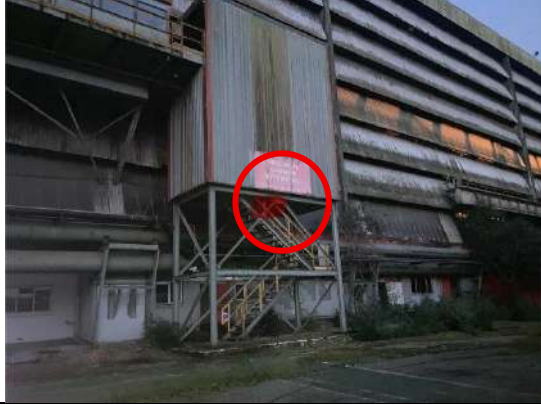
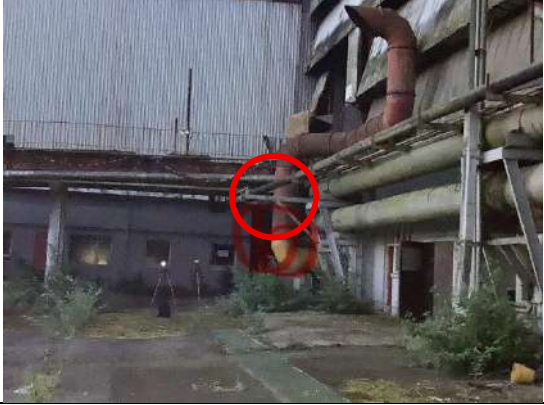
| <p>Plate 61 (16/07/2025): B10A Dawn re-entry showing approximate entry point. One common pipistrelle entry 04:44.</p> | <p>Plate 62 (24/07/2025): B10A Dawn re-entry showing approximate entry point. Three common pipistrelle entry 04:51, 04:53 and 04:54.</p> |

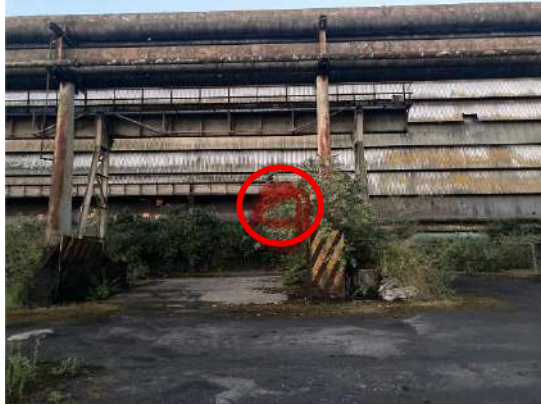
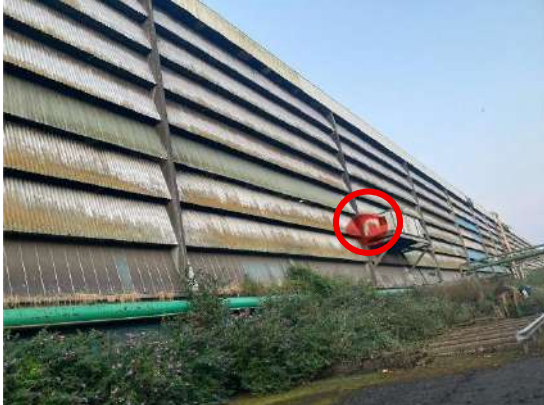
| <p>Plate 63 (16/07/2025): B10A Dawn re-entry showing approximate entry point. One common pipistrelle entry 05:01.</p> | <p>Plate 64 B10A Dawn re-entry showing approximate entry point. Two common pipistrelle entry 05:03 and 05:04.</p> |

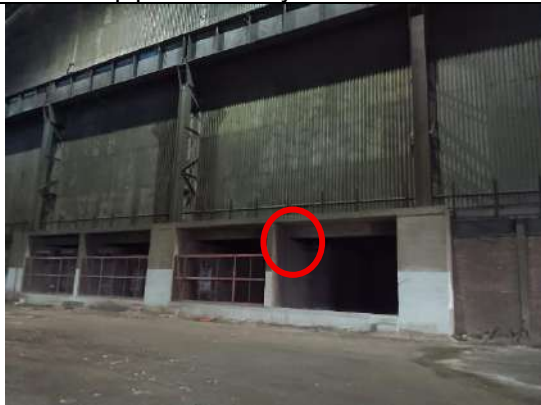
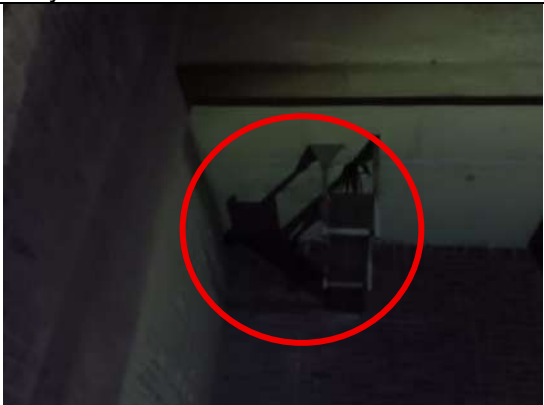
| <p>Plate 65 (16/07/2025): B12 Slab Mill Dawn re-entry showing approximate entry point. One common pipistrelle entry 05:40.</p> | <p>Plate 66 (16/07/2025) B12 Slab Mill close up view of the access point of plate 5 (gap in ceiling for wires).</p> |

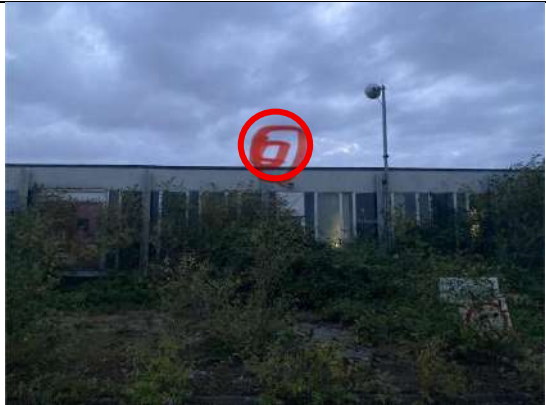
| <p>Plate 67 (17/07/2025). B16 The Lab. Two common pipistrelle emergences 21:47. The location of the access point is unknown but believed to be in the inner courtyard,</p> | |
