## Skerryvore Designs Ltd.

### Heritage Impact Statement

27 Backhall Street, Caerleon, NP18 1AR

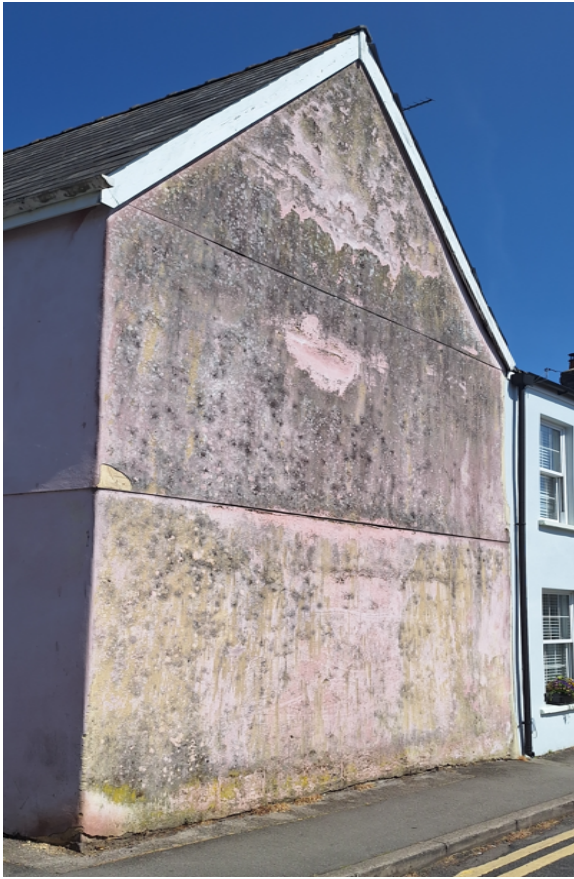
Fig. 2 Side Elevation

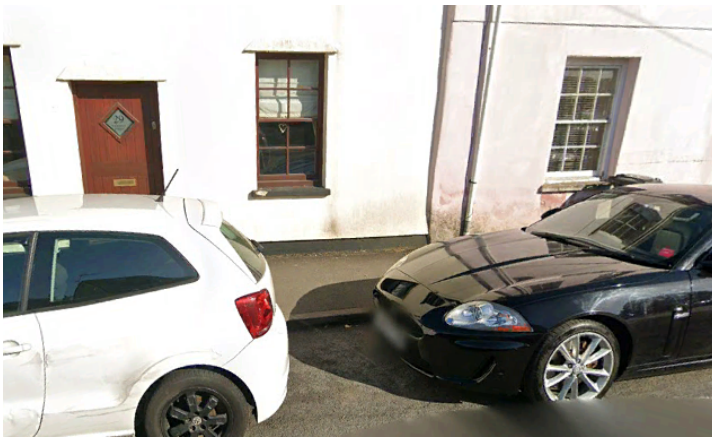
Adjacent property

Fig. 3 Comparison of

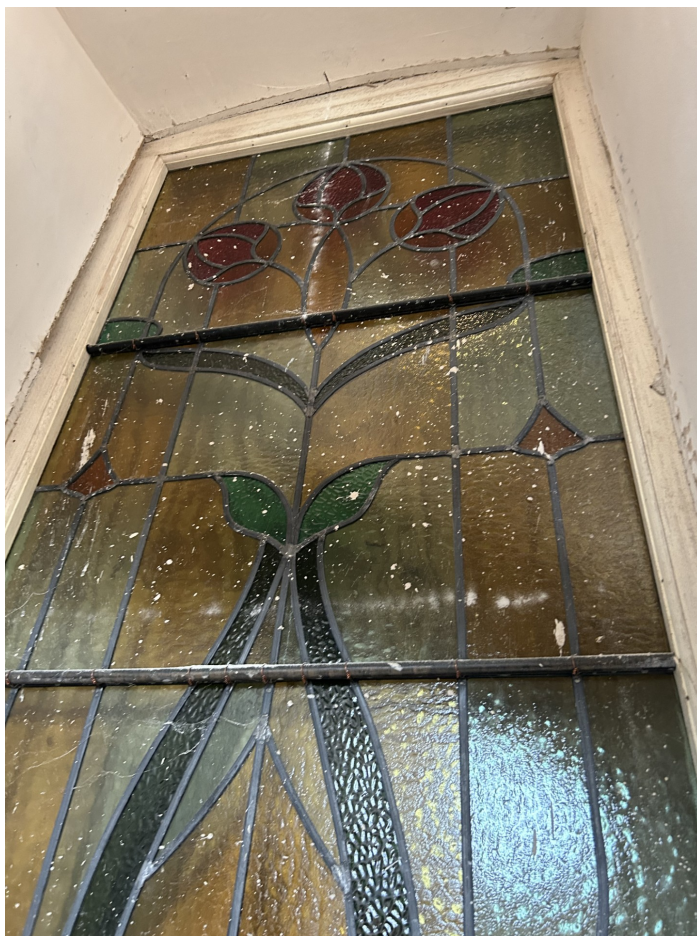
It is proposed to reinstate the window, The careful opening-up has exposed the surviving window. This will be retained but as it sits on the primary staircase providing the means of escape to the ground floor, it will be protected by clear safety glass to prevent damage to it and protect the occupants.

The window will be cleaned and decorated.

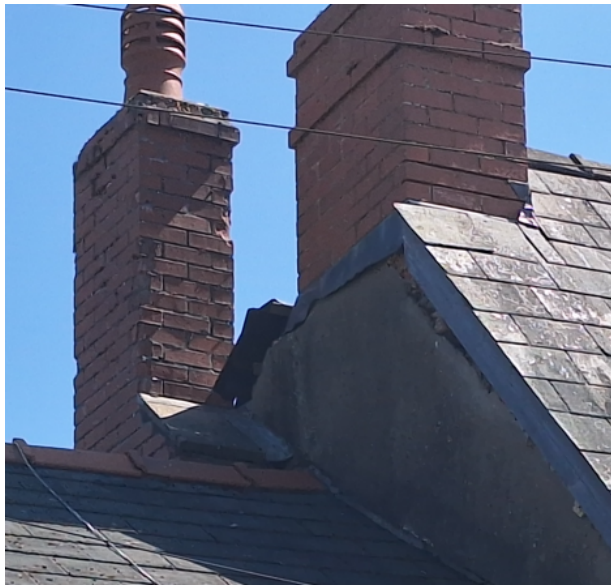
There are issues to resolve at the stack abutment at the left-hand side behind the apex of the ridge, this will be repaired and lead soakers and Welsh slate used to complete the unfinished section.

Stack

Fig. 5 Area of Defective Roof at

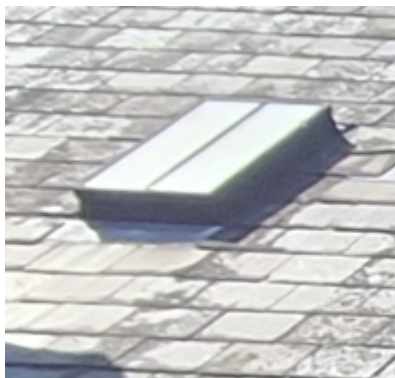
**Fig 5 Existing roof light pattern.**

- i. Introduce a roof light matching the existing roof lights in appearance but only to the rear elevation, to meet with the conservation officers comments. These are low profile heritage roof lights 900 x 600 top hung , **To maximise viable used of the building, it agreed that natural light is required. Whilst a new rooflight to the rear slope would be acceptable where hidden within principal views of the asset.**

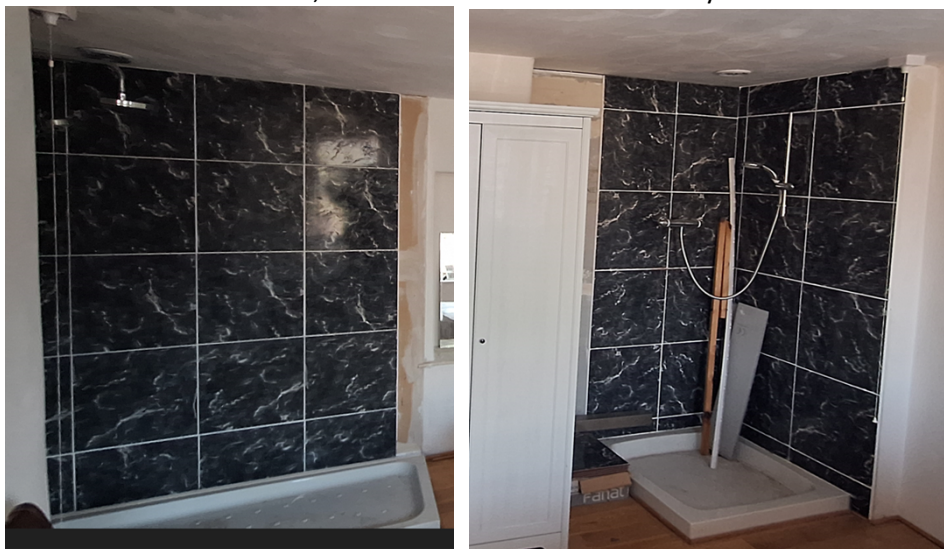
- iii. Completion of the works at hand, there are partly completed ensuite bathrooms installed at first floor level, it is intended to make these fully functional.

Fig 8 & 9 Partially Completed Bathrooms
