| | Contract Name:<br>M4CaN: Docks Enabling Works | | | Client:<br>Welsh Government | | | Borehole ID:<br>BH-M4ABP-Z05-02 | | | | | | | |

M4 Corridor around Newport -  
ABP & Tenant Relocation

## Appendix F

### SITE RECONNAISSANCE PHOTOGRAPHS

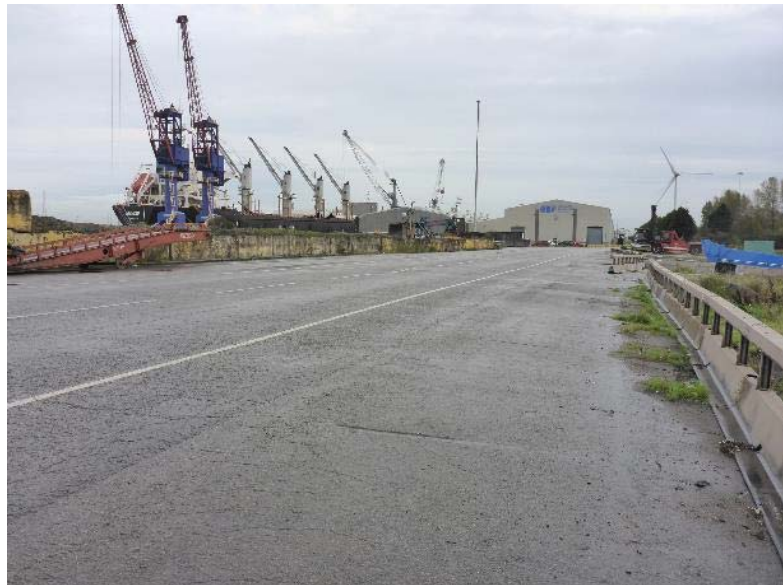
| 1 | 05/10/2023 |

Main access road from east with steel sheds 6 and 7a in the background.

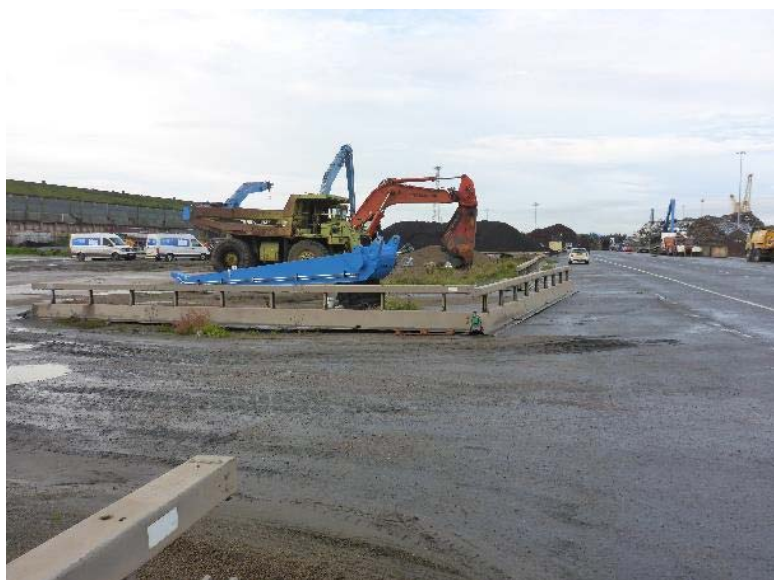
| 2 | 05/10/2023 |

Main access road from east with scrap metal berth in right background and Saica works in left background.

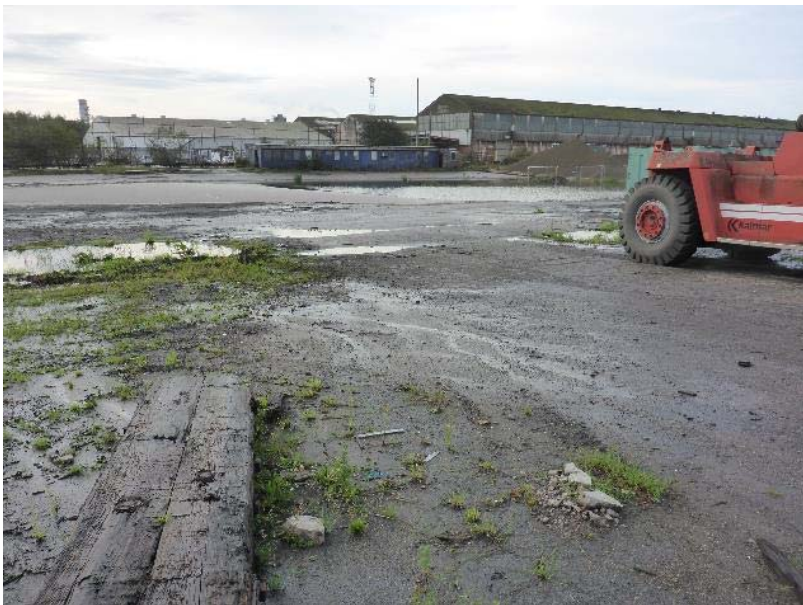
| 3 | 05/10/2023 | |

| Ponded water in east of site towards derelict portacabins | | |

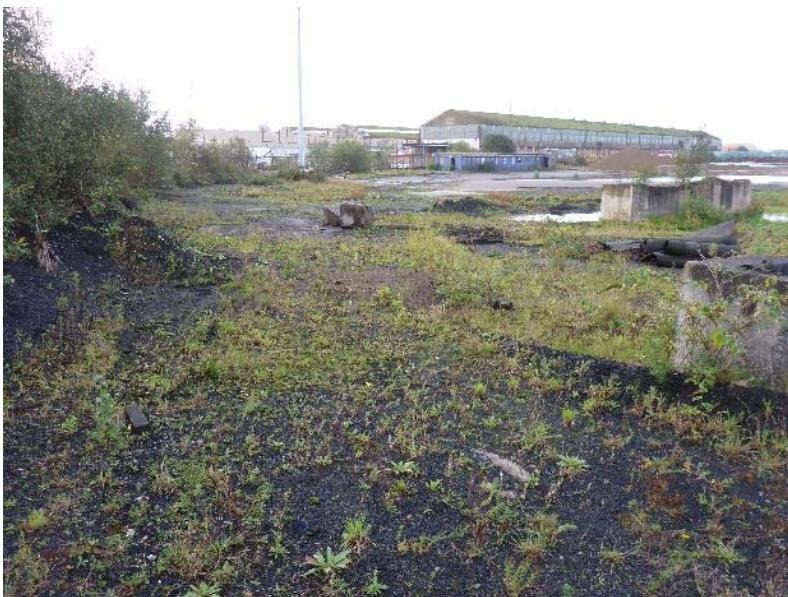
| <b>Photo No.</b><br><b>4</b> | <b>Date:</b><br><b>05/10/2023</b> | |

| <b>Description:</b><br>Rough ground (possibly underlain by hardstanding) with Saica works in background | | |

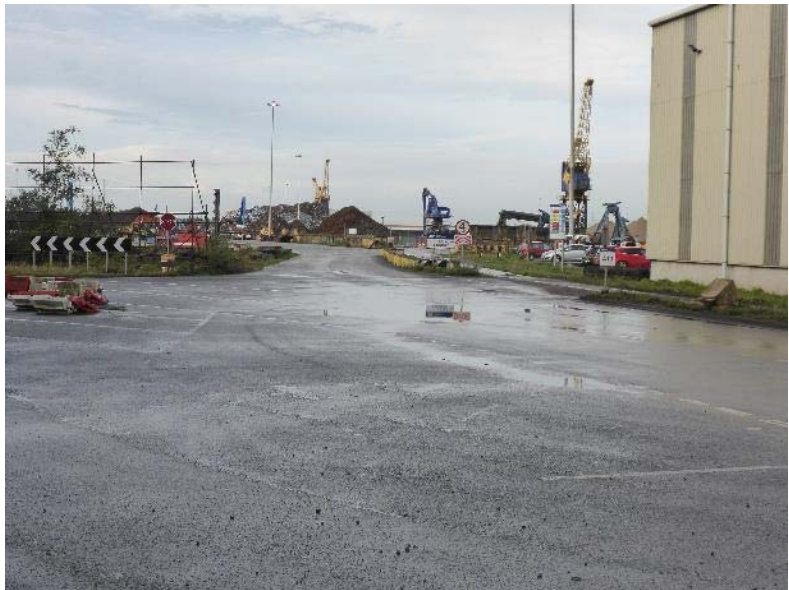
| <b>Photo No.</b><br><br>5 | <b>Date:</b><br><br>05/10/2023 | |

| <b>Description:</b><br>Site access from east | | |

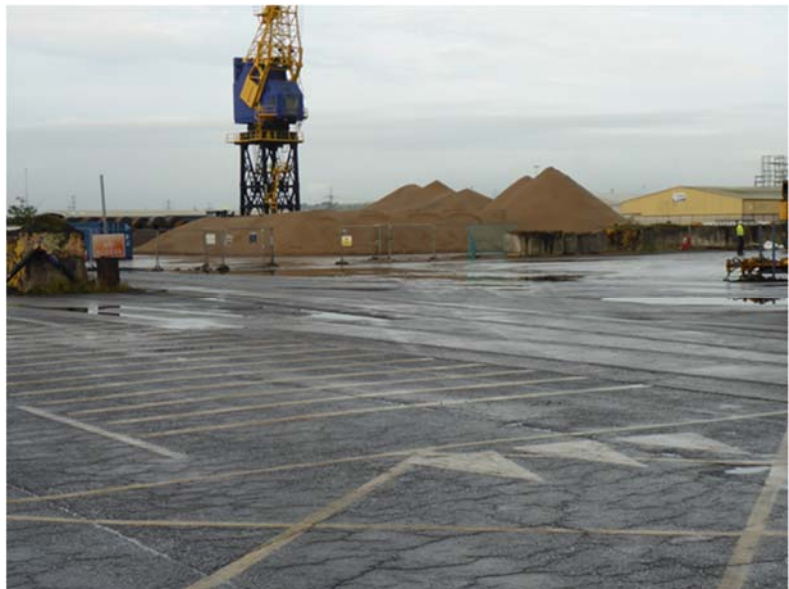
| Photo No.<br>6 | Date:<br>05/10/2023 | |

| Description:<br>Aggregate (sand) berth in north-east of site | | |

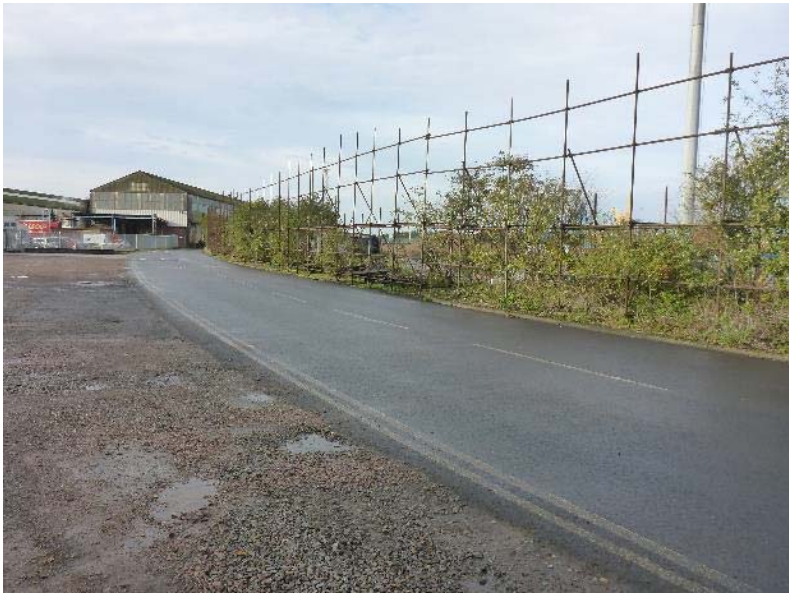
| <b>Photo No.</b><br>7 | <b>Date:</b><br>05/10/2023 | |

| <b>Description:</b><br>Site boundary to right of road marked by scaffolding that used to be covered in netting. | | |

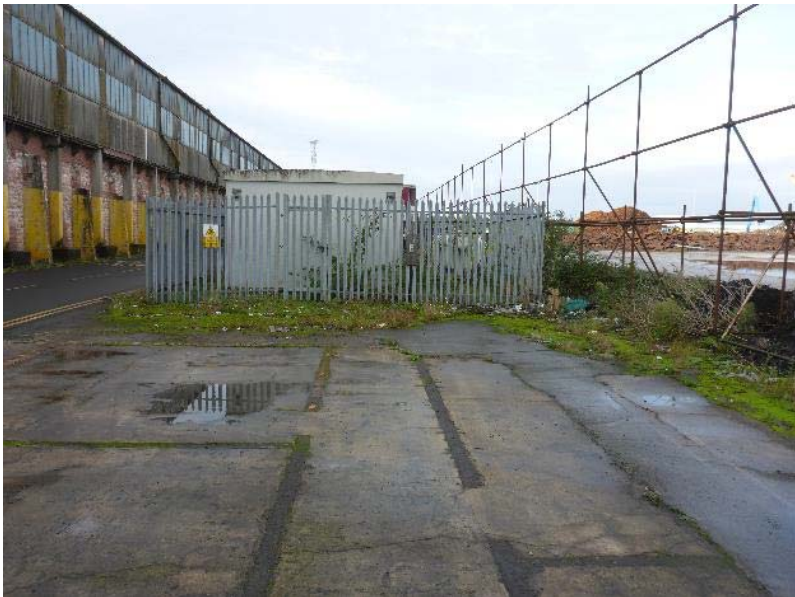
| <b>Photo No.</b><br>8 | <b>Date:</b><br>05/10/2023 | |

| <b>Description:</b><br>Electrical sub-station adjacent to southern boundary, Saica works to the left | | |

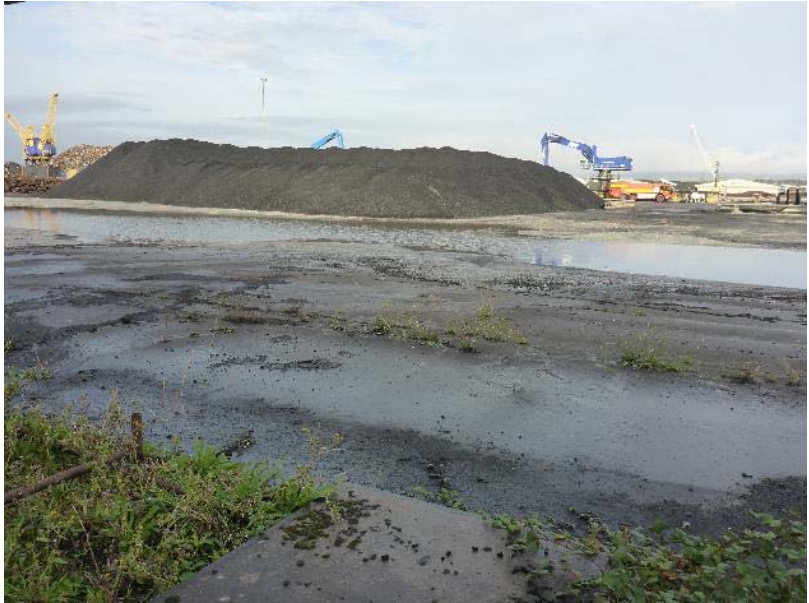
| <b>Photo No.</b><br>9 | <b>Date:</b><br>05/10/2023 | |

| <b>Description:</b><br>Coal stockpile in south-west of site | | |

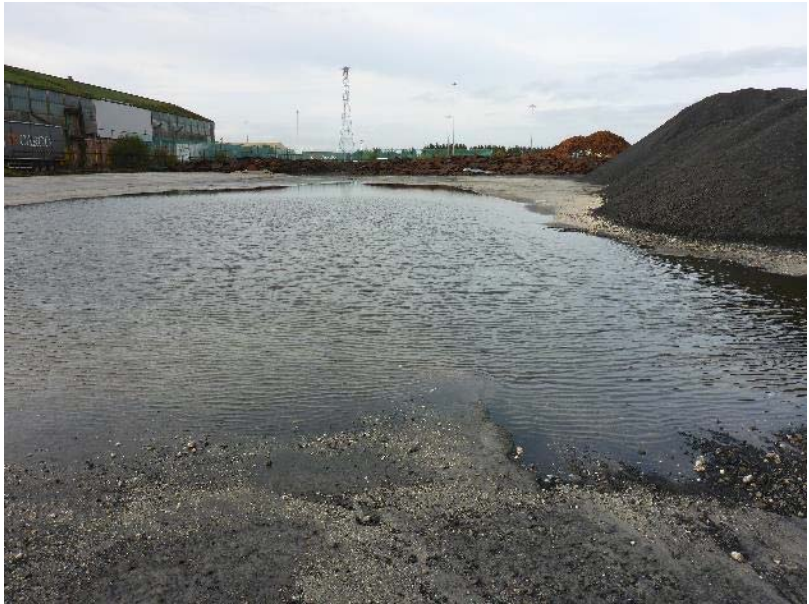
| <b>Photo No.</b><br><br>10 | <b>Date:</b><br><br>05/10/2023 | |

| <b>Description:</b><br><br>Ponded water adjacent to coal stockpile. | | |

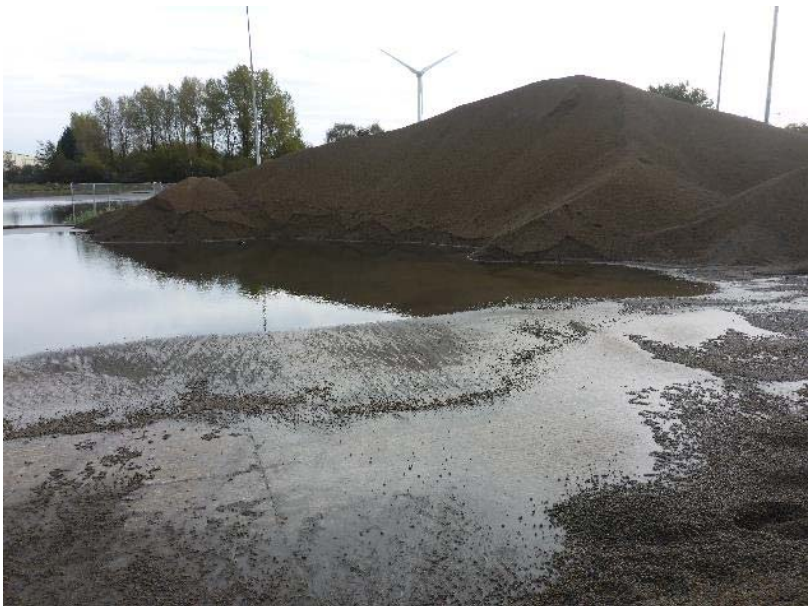
| <b>Photo No.</b><br>11 | <b>Date:</b><br>05/10/2023 | |

| <b>Description:</b><br>Stockpile of expanded clay | | |

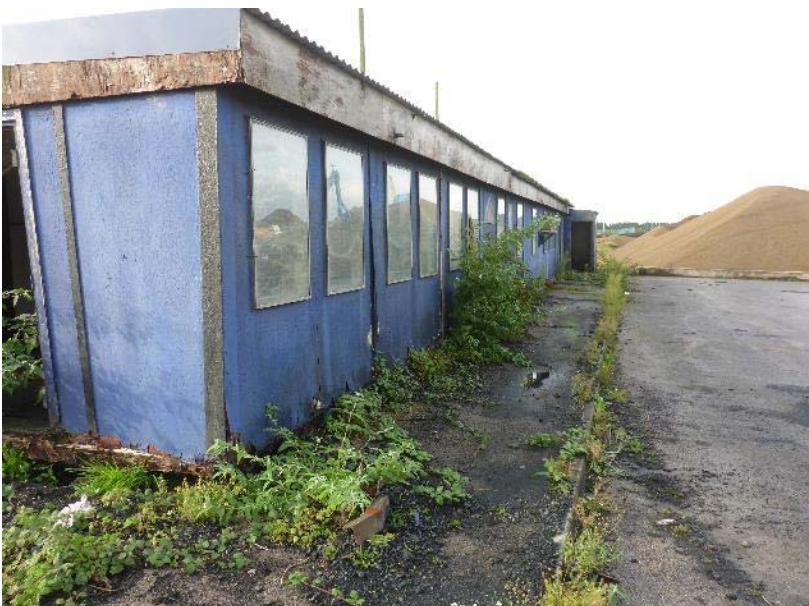
| <b>Photo No.</b><br>12 | <b>Date:</b><br>05/10/2023 | |

| <b>Description:</b><br>Derelict portacabins with expanded clay in the right background | | |

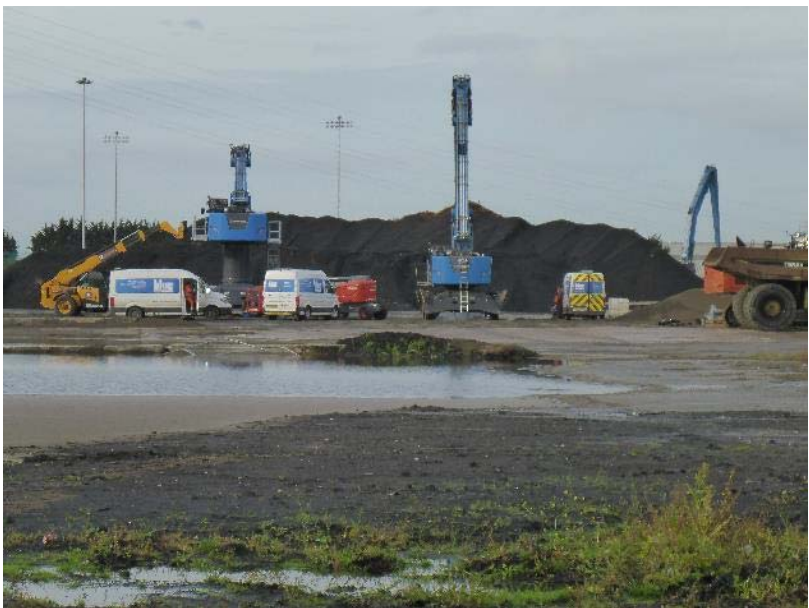
| <b>Photo No.</b><br><br>13 | <b>Date:</b><br><br>05/10/2023 | |

| <b>Description:</b><br>Maintenance work being carried out on plant in central southern part of site | | |

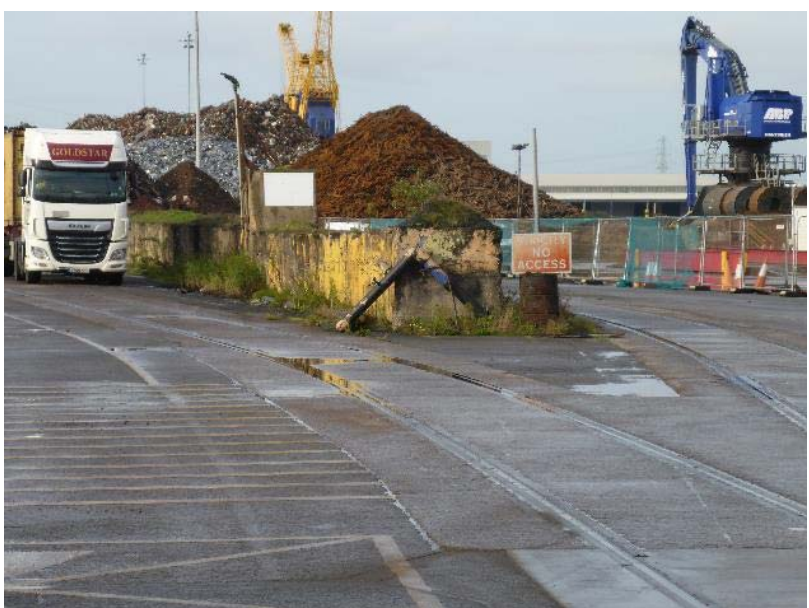
| <b>Photo No.</b><br><br>14 | <b>Date:</b><br><br>05/10/2023 | |

| <b>Description:</b><br><br>Access to berths on the right marked by concrete blocks.<br>Scrap metal berth in the background | | |
