# HERITAGE STATEMENT

## **Samson Court Farm** **Goldcliff, Newport NP18 2PH**

**HFWJ/5997**

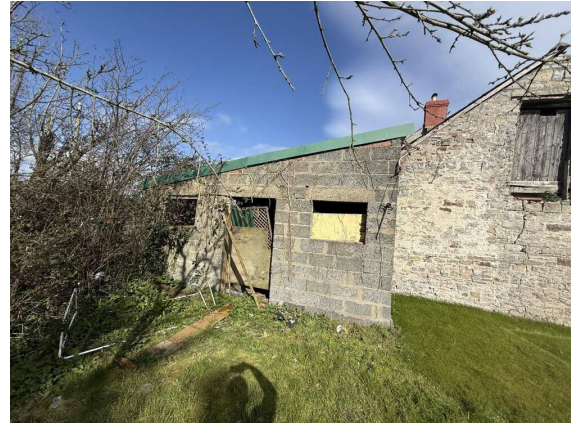
**Plate 2.** The C20 concrete-block shed (Element 4) abutting the stone outbuilding's north (inboard) wall. Of no listed-building significance; proposed for demolition in its entirety.

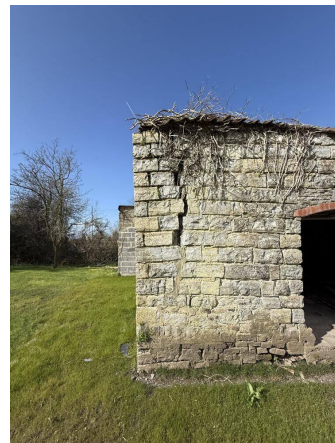
- A substantial vertical crack running the full height of the south stone gable, opening to approximately 80 mm at the parapet, with the crack continuing internally.
- Partial collapse of the central floor joist supporting the hayloft.
- Significant areas of missing slate covering, with consequent water ingress to the roof structure and degradation of timber rafters.
- Sporadic and degraded lime pointing throughout the external walls.
- Disturbance to the lower courses of stone walling consistent with long-standing damp penetration.

**Plate 4.** South gable of the stone outbuilding, showing the substantial vertical crack opening to approximately 80 mm at the parapet (see paragraph 5.4.2).

**7.3.1** The south elevation faces inwards into the farmyard and is not visible from any public viewpoint. The proposals here are to stabilise and, where structurally necessary, partially rebuild the south stone gable; to retain the historic stone fabric to the maximum practicable extent; and to introduce a large fenestrated opening with powder-coated aluminium joinery and bi-fold doors, providing a thoughtful juxtaposition between the historic stone fabric and a crisp contemporary insertion that is clearly legible as a new layer in the building's history. The stonework stabilisation and rebuild detail is annotated on drawing 5997/008. Stonework will be carried out using salvaged stone and an appropriate lime mortar specification matched to the historic substrate.

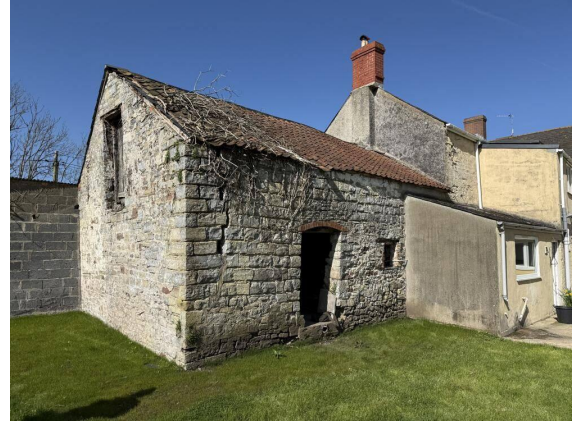
**Plate 6.** Stone outbuilding (Element 3) from the south-east, showing the existing pantile rear (east) slope and south stone gable. The new roof is to be slate to both slopes (see paragraph 7.6).

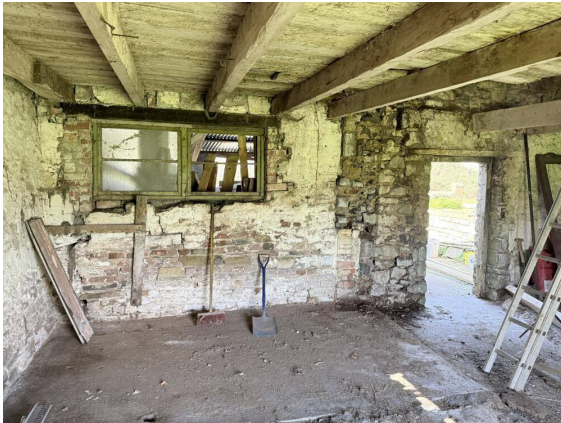
**Plate 7.** Interior of the stone outbuilding showing heavy historic timber floor beams overhead, a small C20 inserted timber window opening (left, to the north inboard wall), and a doorway opening (right) leading out. Wall fabric shows historic stone walling with brick repairs and patching. The carcassing visible above is to be replaced (see paragraph 7.7).

- 7.7.2** A new roof structure is therefore proposed, comprising treated oak asymmetric trusses designed to accommodate the asymmetric rear slope described at paragraph 7.6.2. The choice of solid oak (rather than softwood) reflects the heritage context of the building and is intended to provide a long-life replacement carcassing of comparable quality to the historic structure being lost.

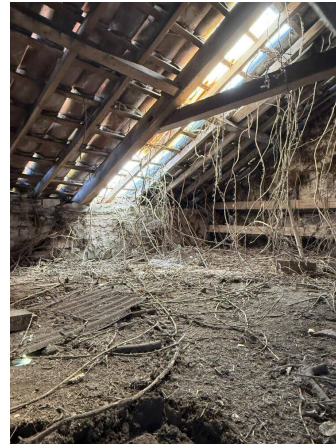
- 7.7.1** The existing roof structure is too degraded to be retained or repurposed. The original collared rafter trusses have suffered prolonged water ingress through the failed slate covering, with rot to the wallplate, rafter feet and tie beam connections; the central tie supporting the former hayloft has partially collapsed (see paragraph 5.4.2). HFWJ Surveyors' inspection has concluded that retention of the existing carcassing is not viable.

**Plate 8.** Existing roof structure from within, showing degraded battens, the underside of the pantile covering, and significant vegetation ingress. Inspection has confirmed the carcassing is not viable for retention (see paragraph 7.7).

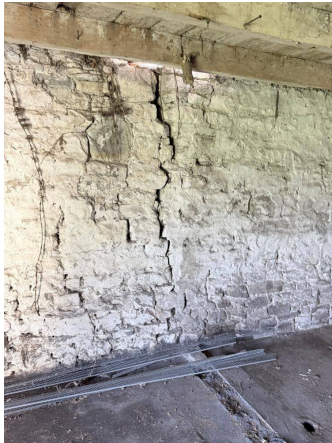
**Plate 9.** *Internal continuation of the south-gable vertical crack, with timber lintel above. To be addressed through stabilisation and partial rebuild (see paragraph 7.3).*
