**Former Zanzibar nightclub****Proposed Methodology of works****Original – 11.09.2024****Revision 1 – 25.03.2025****Revision 2 – 16.09.2025****Revision 3 – 23.09.2025****Cleaning**

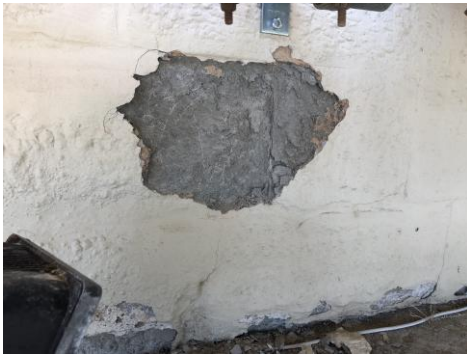
The face retained stone façades at 40 Stow Hill is constructed from dimensioned Pennant sandstone with a bush hammered feature face combined with dressed Bath stone features to openings, pilaster features and pediment. The façade is heavily painted and the true make up of the underlying stone work cannot be fully confirmed at this point.

The dimensioned Pennant sandstone has suffered badly from frost damage due to the painted coatings and the feature finish of the stonework where exposed has been lost to lamination. Whilst the obvious method of removing these coatings would be the DOFF and / or TORC systems, the initial removal could be carried out by hand to identify sound and defective areas. It is clear at this point that the original surface finish has been lost in the majority of areas.

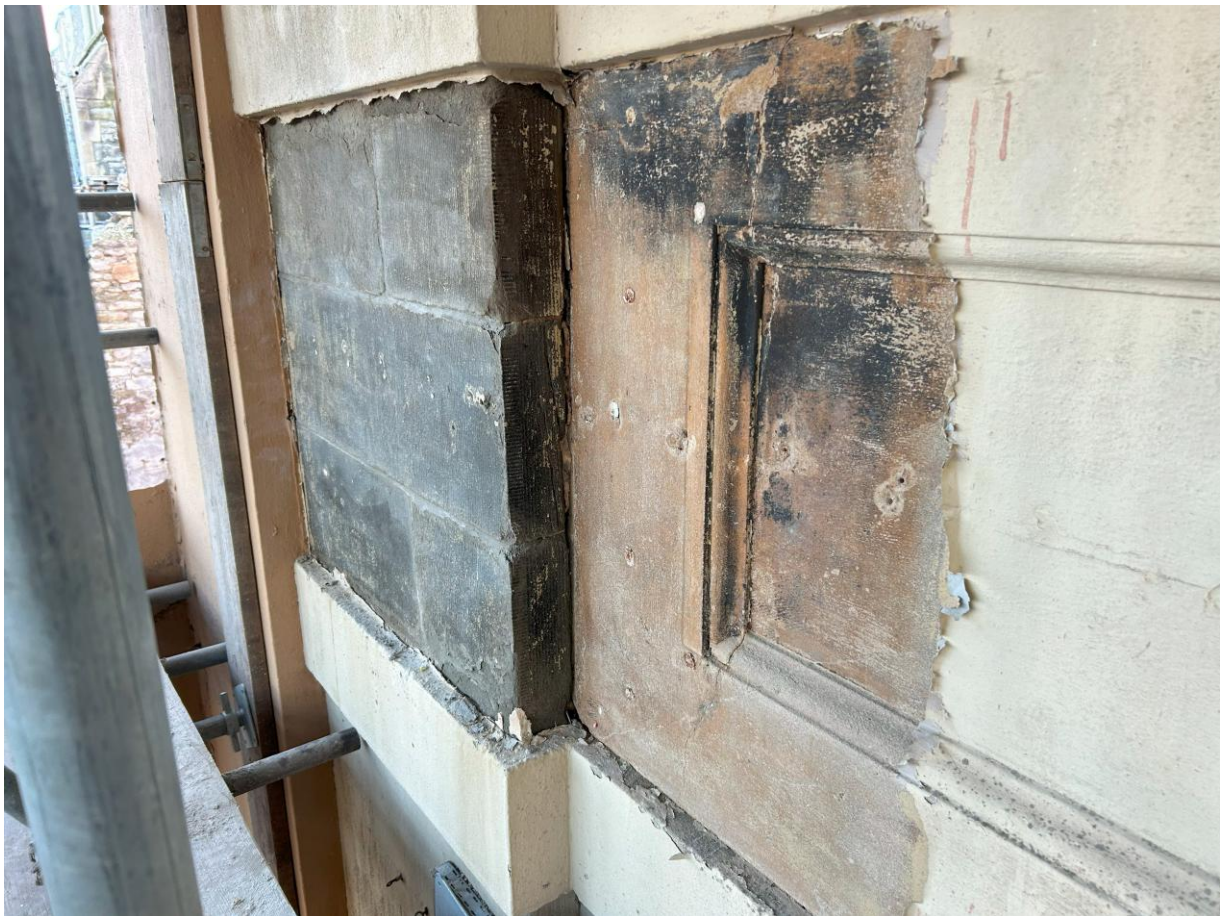
Samples of this systems have been carried out successfully and inspected on this façade. The following is a photo of the sample on both the Pennant and Bath stone features.

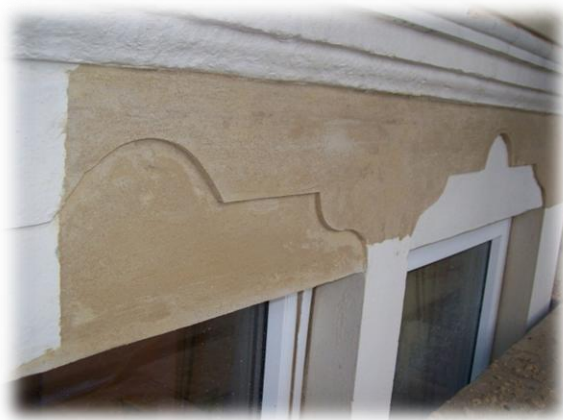
**Repair Finished with Mortar Mix**

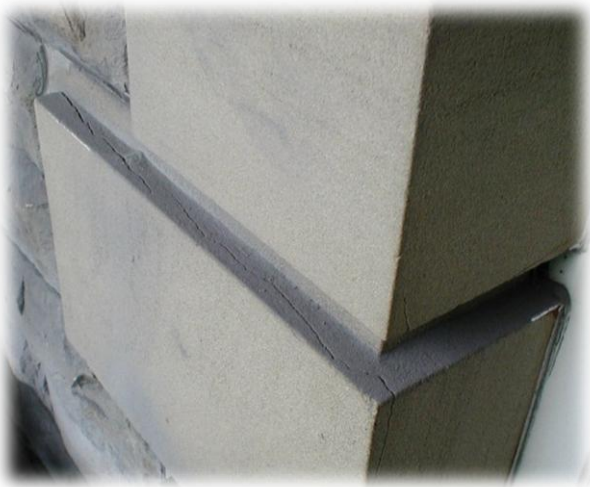
**Typical Method 3. Where Face Has Cracked**

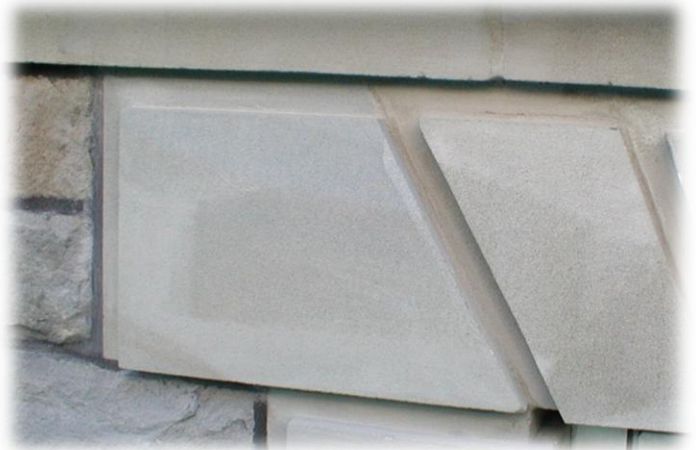
**Typical Method 3. Replacement Face Cut to Suit**
