Ref: LBC/19/00686 – TSD13  
Date: 08/09/2025

## **MATERIAL SAMPLES CONDITION: CONDITION 2 APPLICATION – SHIREHALL REF: LBC/2019/00686**

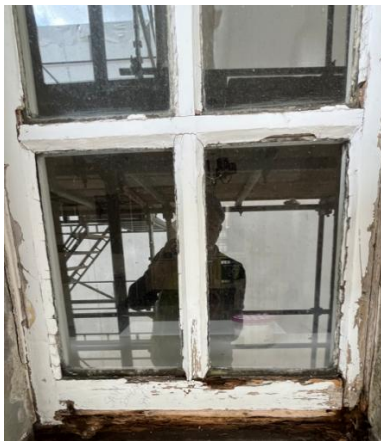
Plate 1: Broken / missing existing putties

Cracked or missing GLAZING PUTTY (all elevations) of Shirehall are to be replaced using traditional linseed oil putty - to exactly match existing in specification, dimensions and fit. All sound original putty remains.

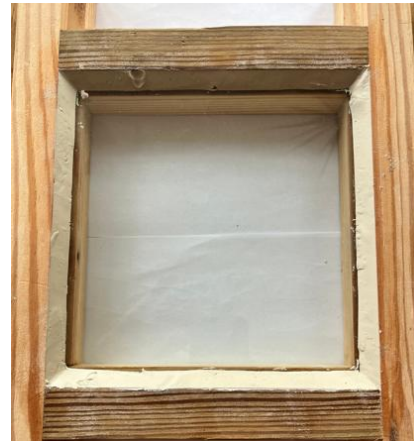
Plate 2: New LINSEED oil traditional putty

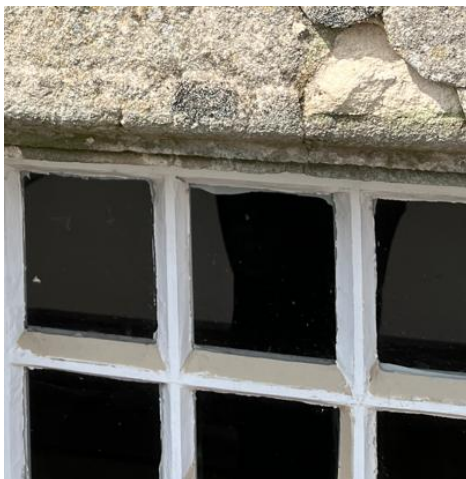
Plate 3: On site fitted and new putties applied

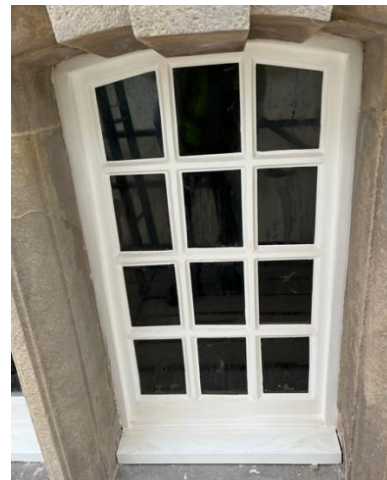
Plate 4: Decorations applied following drying
