## Skerryvore Designs Ltd.

### Heritage Impact Statement

27 Backhall Street, Caerleon, NP18 1AR

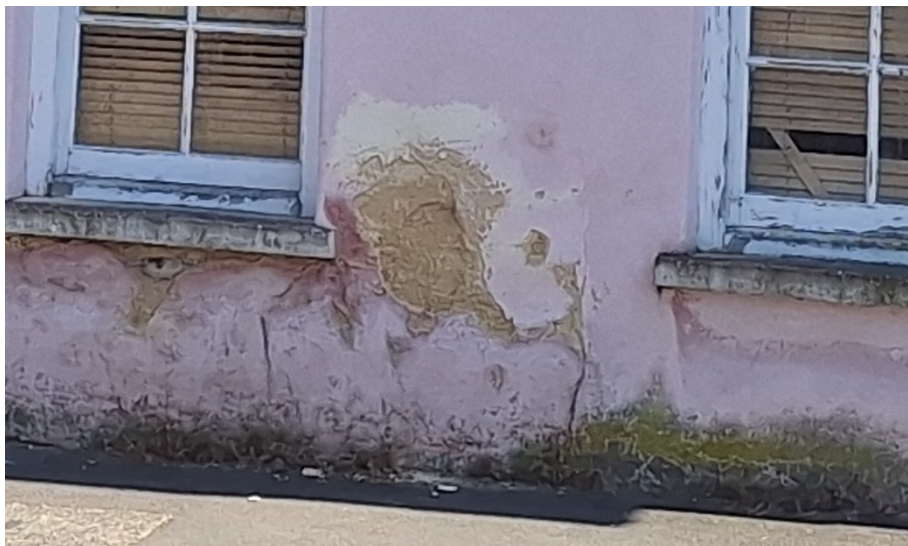
***Whilst much of the damage is clearly due to blocked/faulty rainwater goods, the damage at the base of the front elevation appears to have other underlying causes other than just splashing rainwater. It would appear to me that the lime render in this location has either been subjected to frost damage or was allowed to dry too quickly when applied, reducing its strength and adhesion.***

Fig. 1. Defective Render to front Elevation

***Once rainwater goods have been cleared and repaired etc I would suggest the following:***

- ***Algal growth/staining should be treated with Beeck's fungicide, which can be left in situ, for longer lasting performance - <https://www.lime.org.uk/fungicide-beeck.html>***
- ***On the rear elevations, any patching or re-surfacing repairs should be done using St Astier R100, and subsequently painted with a silicate mineral paint such as Graphenstone GCS or Beeck's Renosil - <https://www.lime.org.uk/our-products/paints-oils-waxes/external/paint.html>***
- ***As we discussed, I would suggest complete removal of the render below window cill level on the front elevation, and replacement using a traditional 3 coat lime render, incorporating a bell cast bead to throw rainwater away from the junction***

- *I would advise undercutting the junction between old and new render so there is not a straight line joint through to the masonry, which could prove to be a weak point in respect of water ingress.*
- *The render can be continued to pavement level as there is no DPC to breach, and the surface of lime will reduce moisture getting into the masonry as well as improving its ability to dry out again.*
- *The render could be re-decorated with a limewash again, or for increased durability and ease of application, you may wish to consider using a silicate mineral paint such as recommended for the rear elevations.*

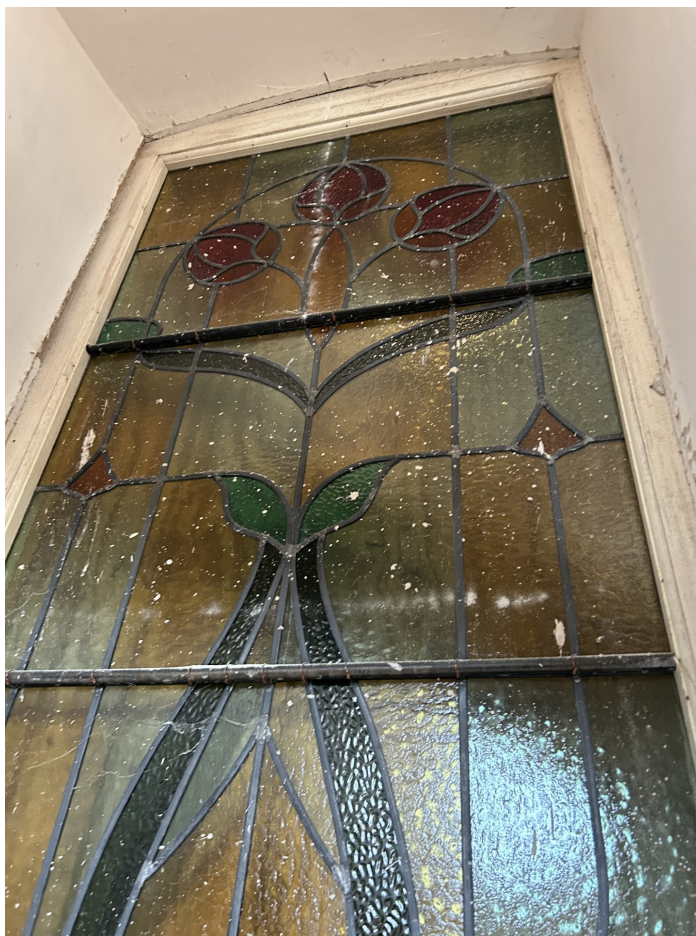
It is proposed to reinstate the window, The careful opening-up has exposed the surviving window. This will be retained but as it sits on the primary staircase providing the means of escape to the ground floor, it will be protected by clear safety glass to prevent damage to it and protect the occupants.

The window will be cleaned and decorated.

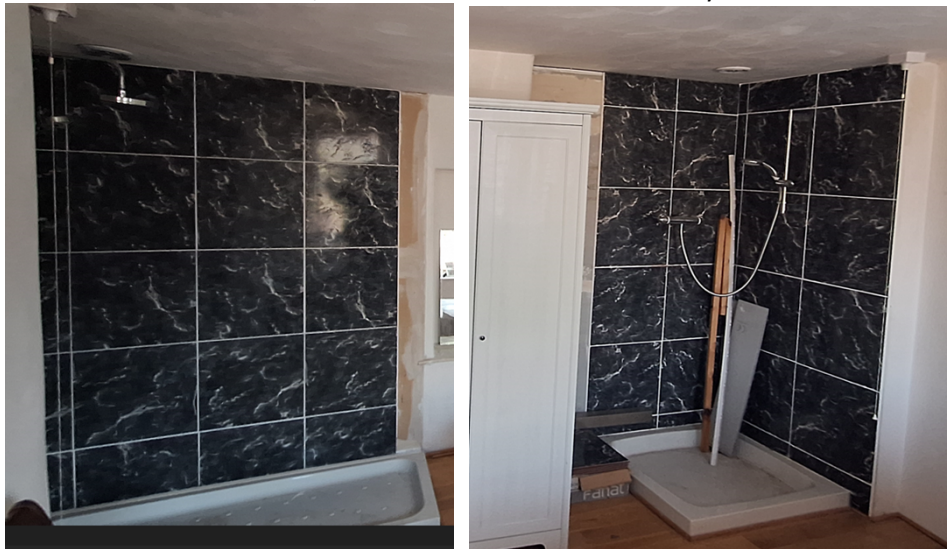
- iii. Completion of the works at hand, there are partly completed ensuite bathrooms installed at first floor level, it is intended to make these fully functional.

Fig 8 & 9 Partially Completed Bathrooms
