## Skerryvore Designs Ltd.

### Heritage Impact Statement

27 Backhall Street, Caerleon, NP18 1AR

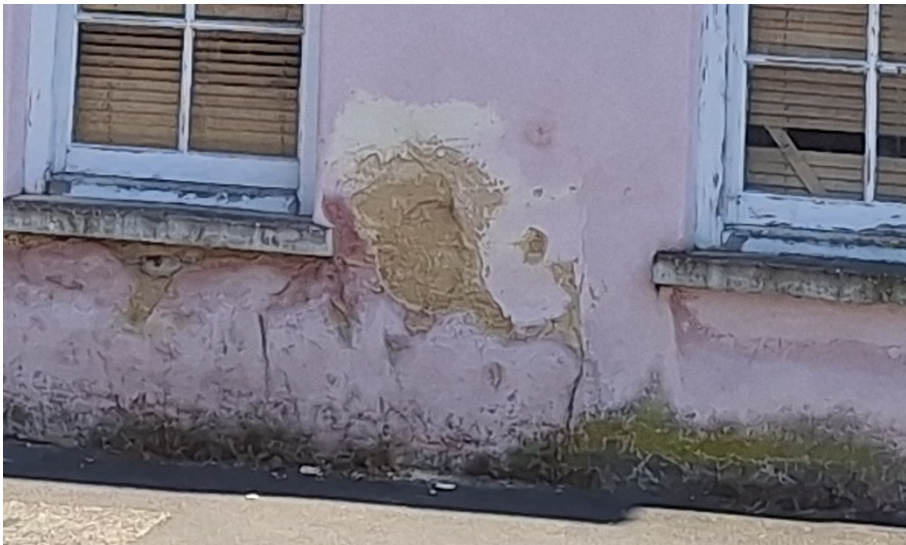
*Whilst much of the damage is clearly due to blocked/faulty rainwater goods, the damage at the base of the front elevation appears to have other underlying causes other than just splashing rainwater. It would appear to me that the lime render in this location has either been subjected to frost damage or was allowed to dry too quickly when applied, reducing its strength and adhesion.*

Fig. 1. Defective Render to front Elevation

- *Algal growth/staining should be treated with Beeck's fungicide, which can be left in situ, for longer lasting performance - <https://www.lime.org.uk/fungicide-beeck.html>*
- *On the rear elevations, any patching or re-surfacing repairs should be done using St Astier R100, and subsequently painted with a silicate mineral paint such as Graphenstone GCS or Beeck's Renosil - <https://www.lime.org.uk/our-products/paints-oils-waxes/external/paint.html>*
- *As we discussed, I would suggest complete removal of the render below window cill level on the front elevation, and replacement using a traditional 3 coat lime*

render, incorporating a bell cast bead to throw rainwater away from the junction with the pavement - <https://www.lime.org.uk/lime-base-coat-plaster-for-scratch-float-coats-natural-fibre.html> & <https://www.lime.org.uk/external-lime-top-coat-finish-plaster.html>

- I would advise undercutting the junction between old and new render so there is not a straight line joint through to the masonry, which could prove to be a weak point in respect of water ingress.
- The render can be continued to pavement level as there is no DPC to breach, and the surface of lime will reduce moisture getting into the masonry as well as improving its ability to dry out again.
- The render could be re-decorated with a limewash again, or for increased durability and ease of application, you may wish to consider using a silicate mineral paint such as recommended for the rear elevations.

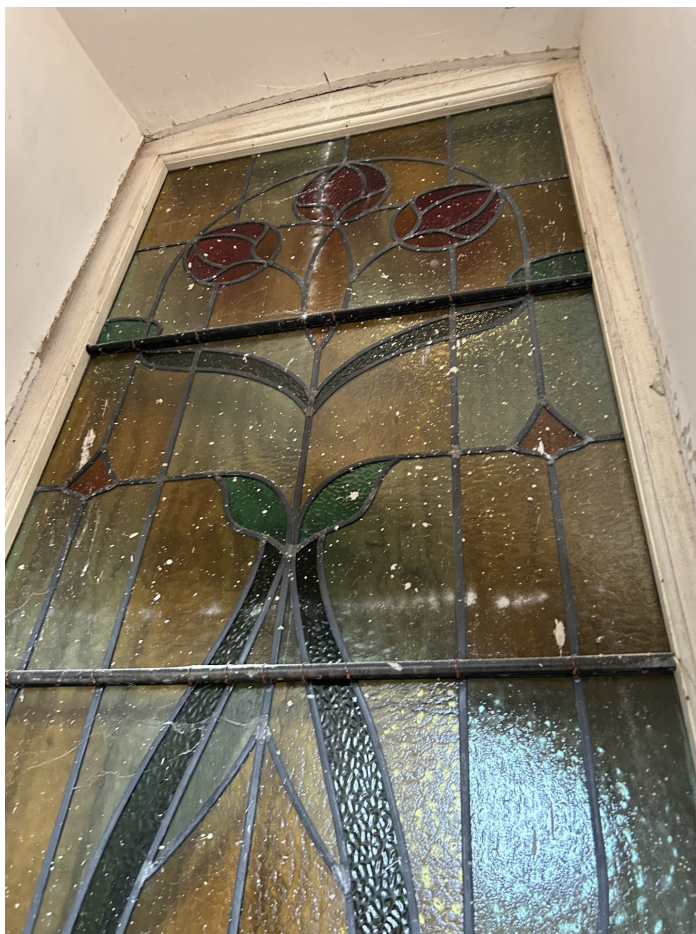
It is proposed to reinstate the window, The careful opening-up has exposed the surviving window. This will be retained but as it sits on the primary staircase providing the means of escape to the ground floor, it will be protected by clear safety glass to prevent damage to it and protect the occupants.

The window will be cleaned and decorated.

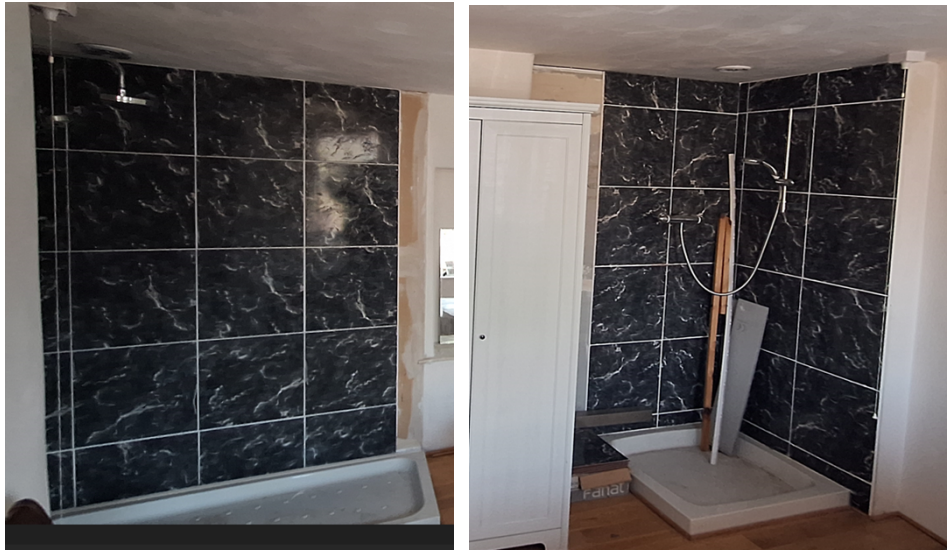
- iii. Completion of the works at hand, there are partly completed ensuite bathrooms installed at first floor level, it is intended to make these fully functional.

Fig 8 & 9 Partially Completed Bathrooms
