**OPEN HEARTH, RINGLAND, NEWPORT**

**Site Investigation Report**

14144/LS/23/SI

**PROJECT:** Open Hearth, Ringland, Newport

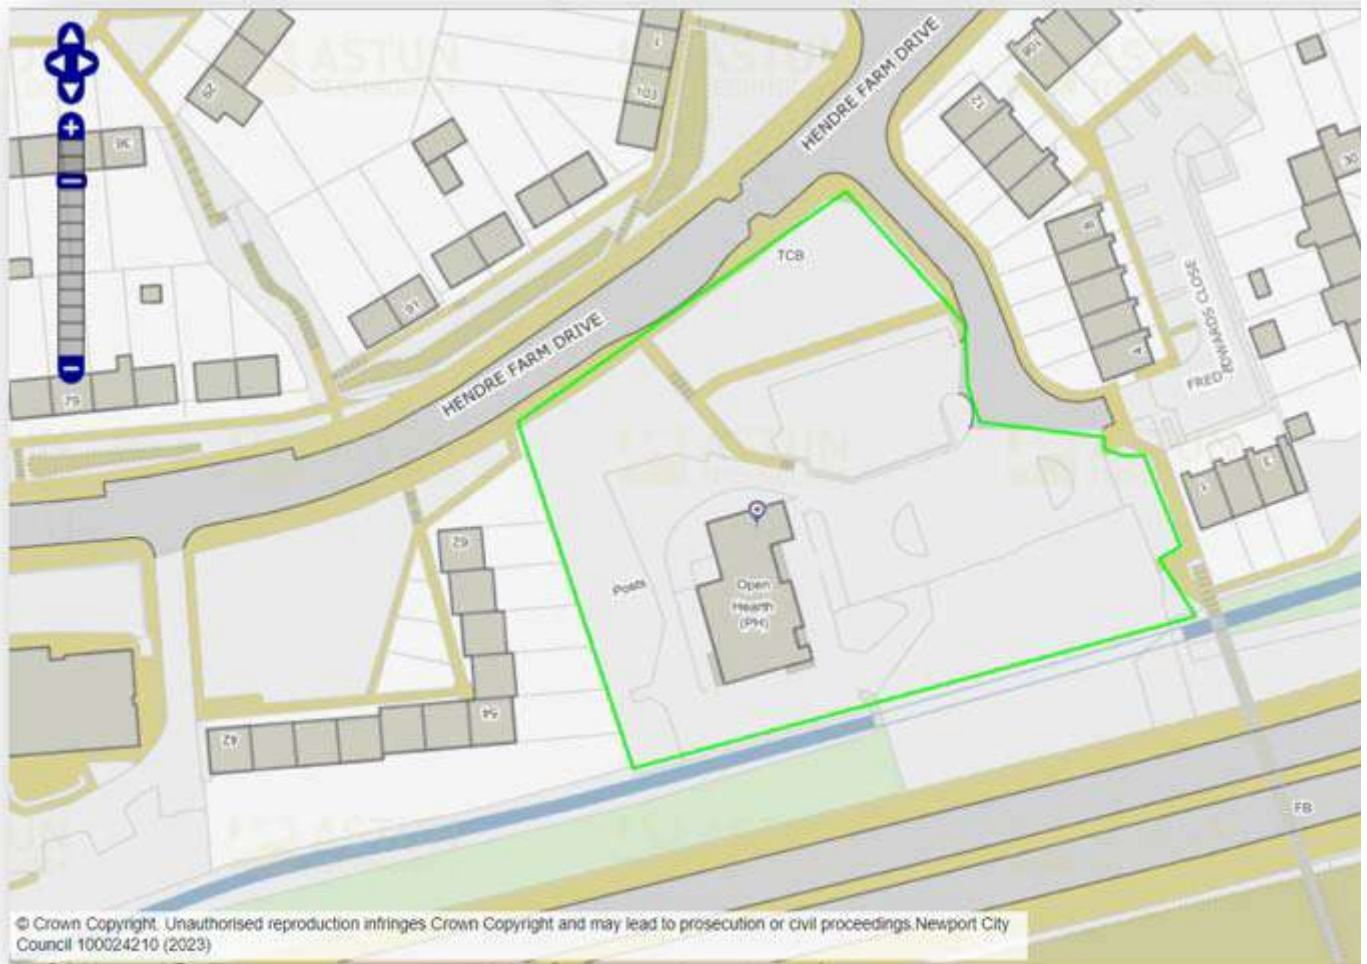
I have looked at the information we hold and can confirm that land at The Open Hearth, Hendre Farm Drive, Newport (outlined in green on mapping below) is not the subject of any contaminated land investigations and has not been determined as contaminated land.

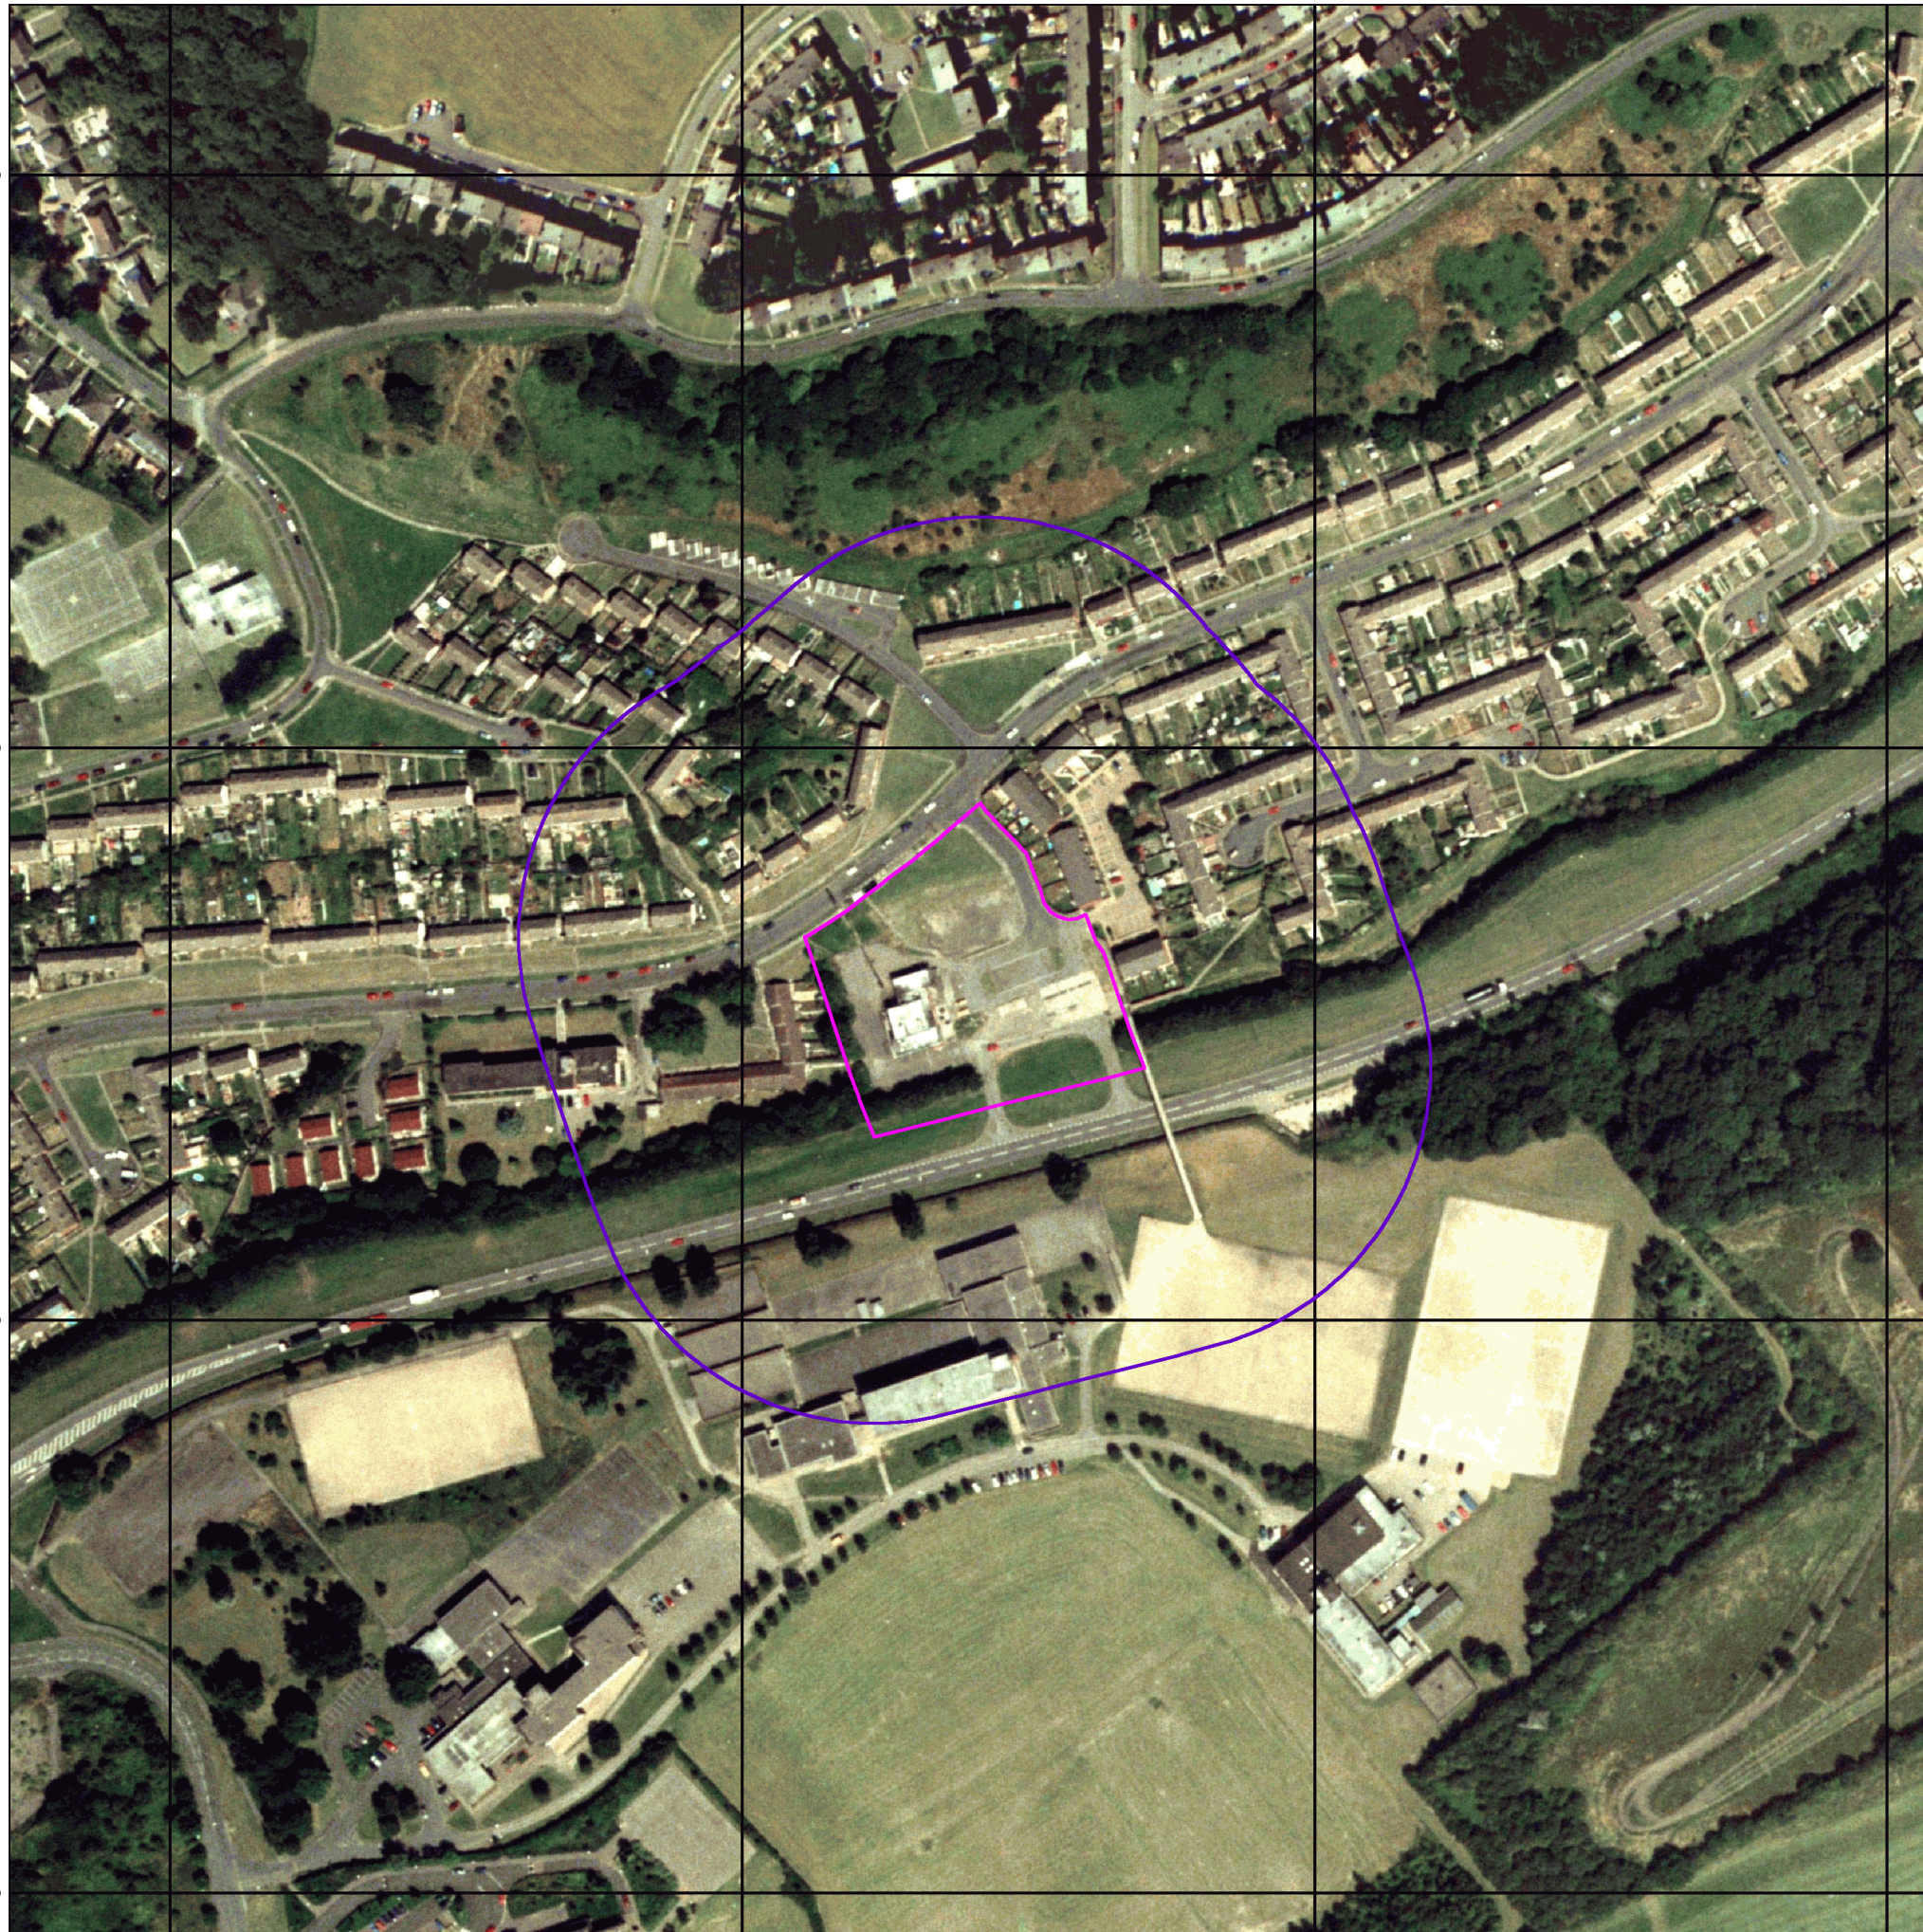
Published 2000

This aerial photography was produced by Getmapping, these vertical aerial photographs provide a seamless, full colour survey of the whole of Great Britain
