Bat Survey: Barn, Coc Y North Lane, Rhiwderin, Newport, NP10 8RR

Instructed by: David Williams Homes Ltd

Reported by: Ecological Services Ltd
 10 Mount Pleasant, Llanelly Hill, Abergavenny, Monmouthshire, NP7 0NT

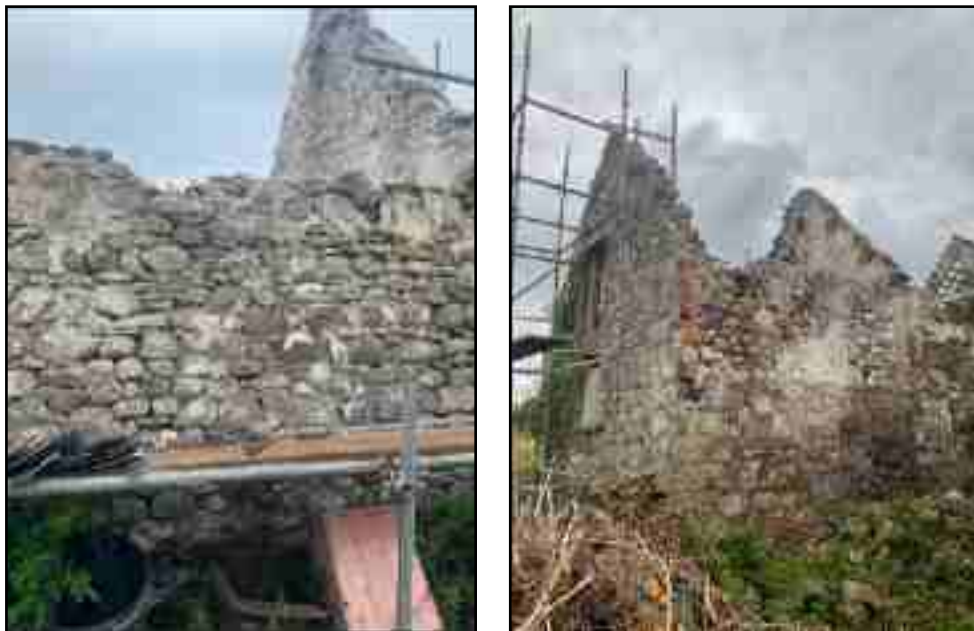
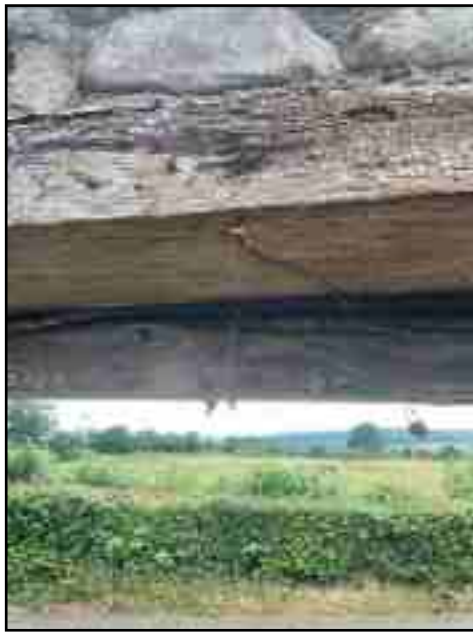
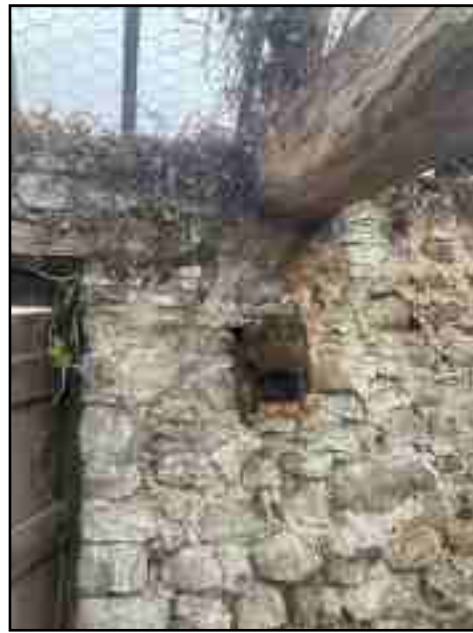
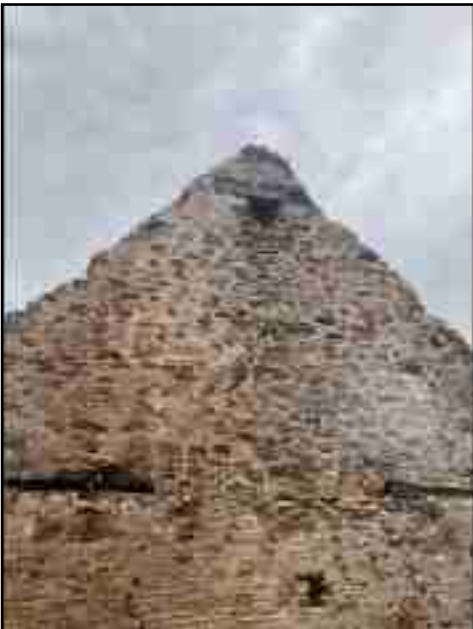
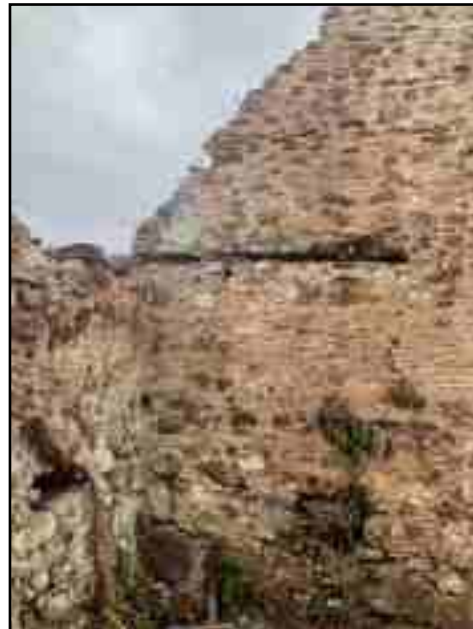
6.6 Examples of apertures allowing access to cavities in the building:

6.3 Due to the poor structural condition of the building, there were a small number of opportunities present for bats to access and use for roosting purposes. Opportunities that were available were deemed as having low potential for roosting bats as they are exposed to the weather. There were a number of gaps and cracks in the stone walls and apertures around the timber work within the building. There was no roof on the building at the time of the scoping survey and therefore the building is now open and exposed.

9.3 The building does offer low hibernation potential for bats. There were a number of apertures and cracks within the stone walls which allow access into the wall structure. However, there was no roof on the building at the time of the scoping survey so the building does not currently provide a thermally stable environment which hibernating bats prefer due to its exposure to the elements.

9.5 The building was classed as having low potential for roosting bats and there were a small number of opportunities present for bats to access and use the building. The gaps and cracks noted in the walls of the building were exposed to the weather making them less desirable to bats.

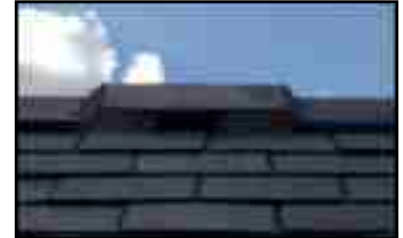
10.3 The raised ridge tiles will have two access apertures measuring 100mm long by 25mm high; one on the front elevation and one on the rear.

10.5 Bats will be restricted to the void in the underside of the ridge tile by using a continuous piece of 1F bitumen felt as a base liner. This will be fixed in location over the top rafters as per adjacent image.

10.6 Breathable membrane is dangerous for bats, therefore it is essential that the detail contained in the adjacent drawing is followed exactly and is to be fitted under direct ecological supervision by a suitably qualified ecologist.
