BRYNGLAS HOUSE ANNEX: DEMOLITION PRE CONTRACT INFORMATION

Newport City Council

19/02/2025

Issue 01

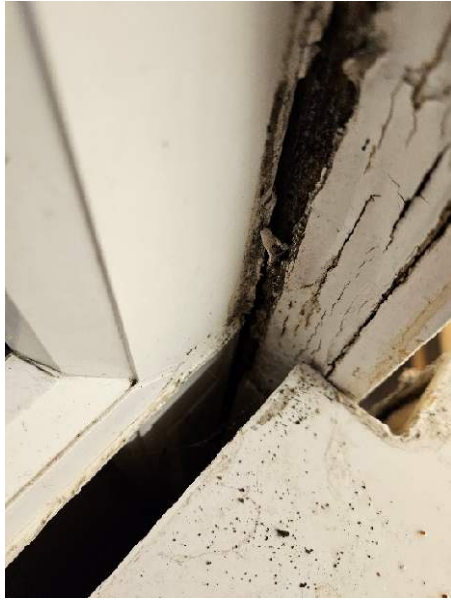
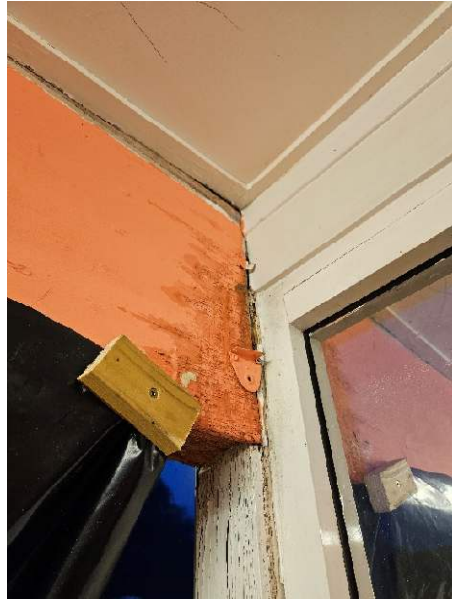
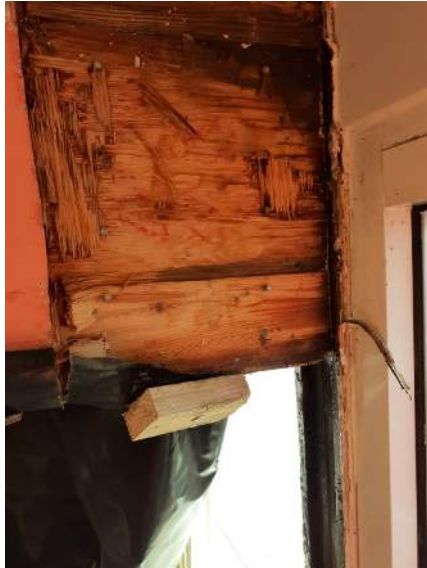
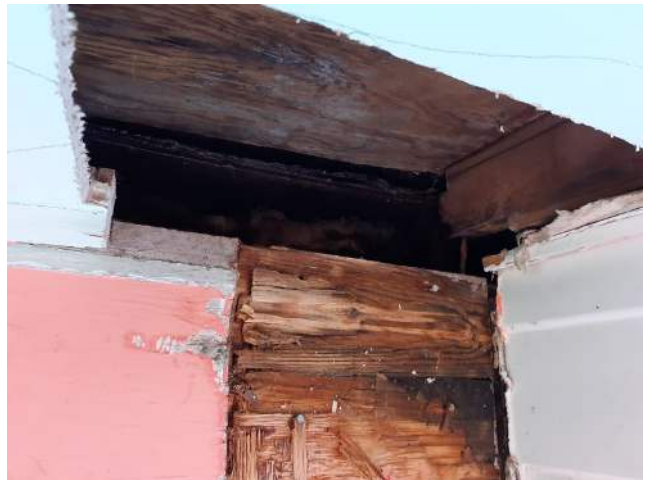
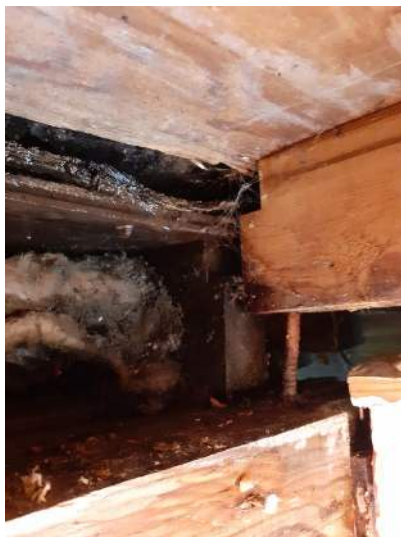
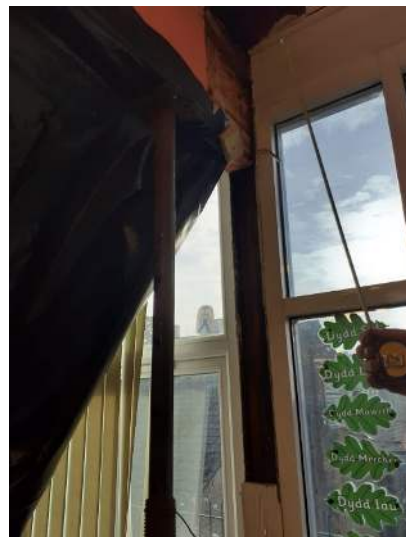
1. In the first instance the roof leak needs to be repaired. Keep the acro props in for the foreseeable future, particularly if people are on the roof. The photos show there is a channel on the roof over the location of the damaged beam. Can this be looked at your end. It looks like there is historic possible liquid applied waterproofing. Could this be reapplied?

2. Confirm exact structural build up of the roof. – Can you please confirm you agree this is the buildup based on your inspection earlier today
 - a. Main timber (glulam) beams

- b. Secondary beams spanning between main glulam beams
 - c. Board
 - d. Insulation (Appeared to show insulation in one of the photos)
 - e. Board
 - f. Felt Roof (or rubber looking roof)

4. Once we have confirmed the existing timber sizes (beam and column) are acceptable. We will then complete remedial design calculations and sketches for the decayed timber beam. It will either be through introducing additional timbers to strengthen the beam and column. Or possibly full beam/column replacement.

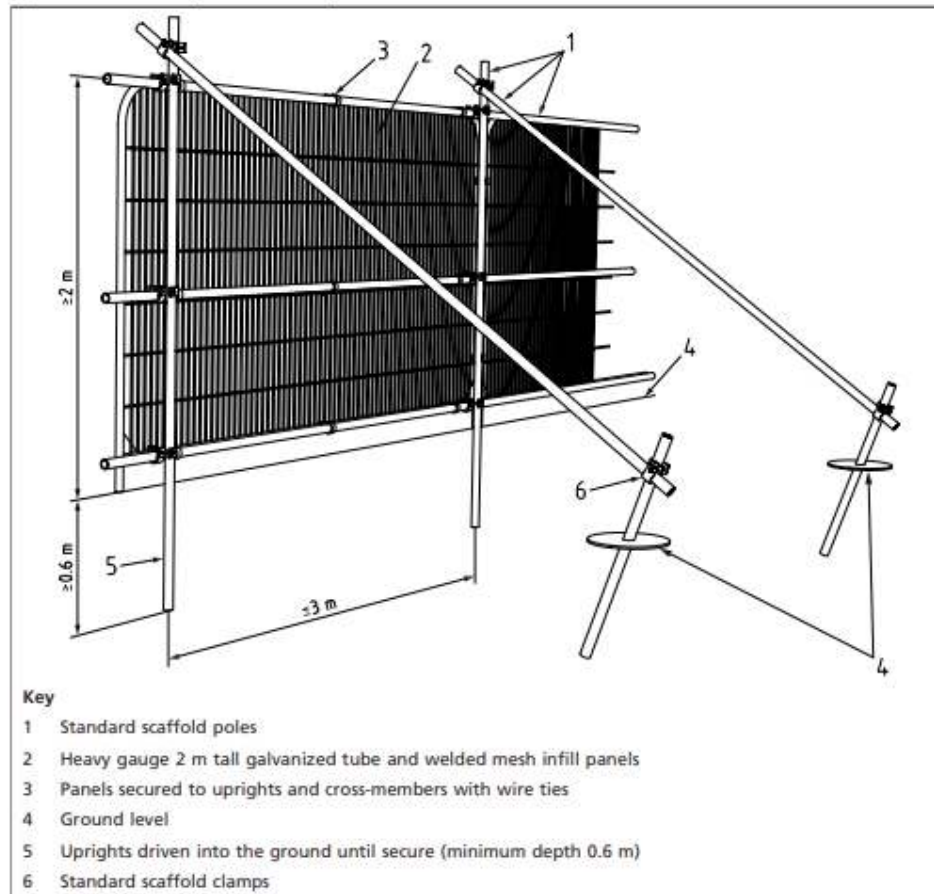
Figure 2 Default specification for protective barrier

As on site there are no fundamental issues regarding this project, the ash marked A on the below plan may be removed based on its location and condition this needs to occur before any works commence. However to protect the remaining trees a fence compliant with BS 5837:2012 must be installed see below specification on the fence.

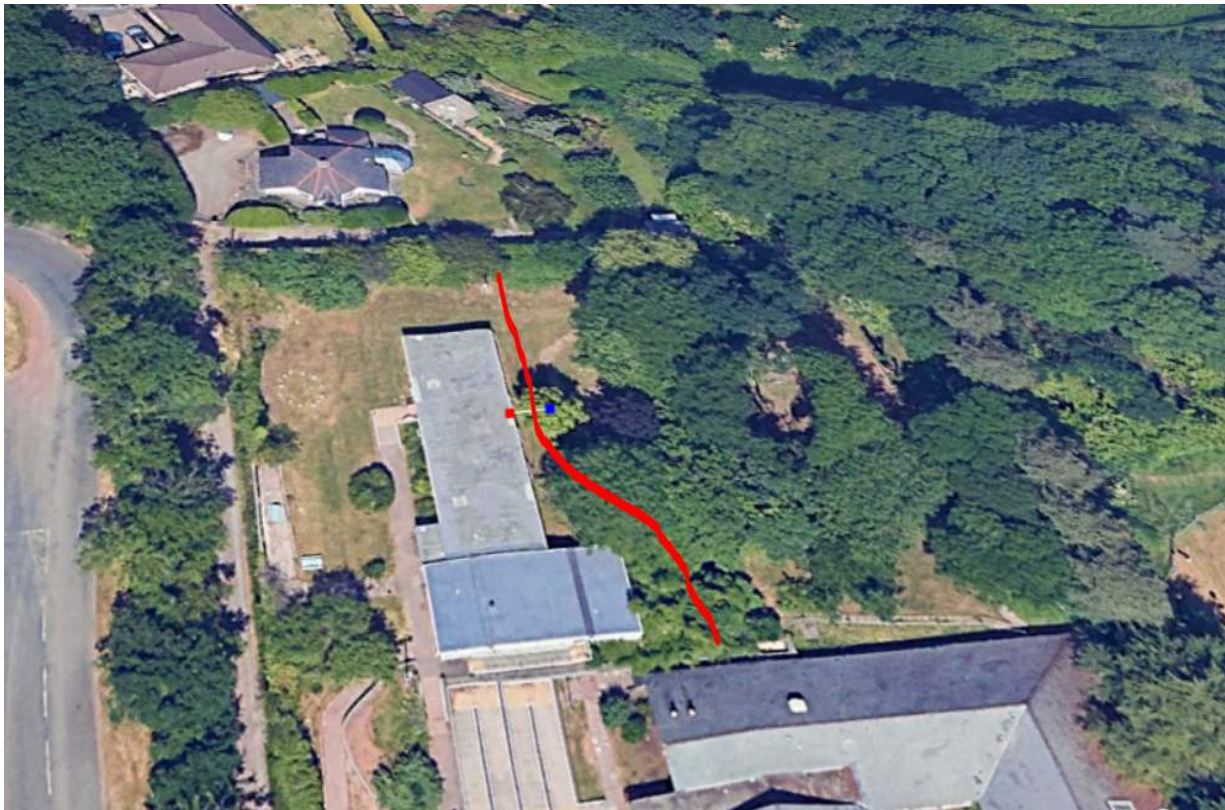
The fence line needs to be at 1.5m from the building to allow access until 1m past the tree canopy to the south where it may then extend into the open space at a minimum distance being out of the Root protection area (12 x the circumference of the nearest tree trunk) however I would prefer it to be out of the canopy (drip line).

Map of approximate fence line at 1.5m from the building to allow access until 1m past the tree canopy to the south
