83 COMMERCIAL STREET, NEWPORT– MAINTY
GROUP
PRELIMINARY ROOST ASSESSMENT FOR BATS

PROJECT:	83 Commercial Street, Newport, NP20 1LR
TITLE:	Preliminary Roost Assessment for Bats

PROJECT REF:	383-01-01-25
REPORT No.:	383-01-01.R1

PRELIMINARY ROOST ASSESSMENT FOR BATS

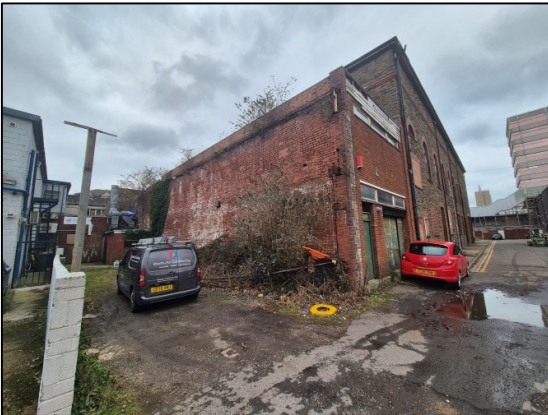
Figure 3 – (SE) Corner of Survey Building, Looking (NW)

Damage was particularly recorded to the exterior brickwork adjacent to the loading bay toward the south-eastern corner of the building, due to the establishment of buddleia and abandonment of the building.

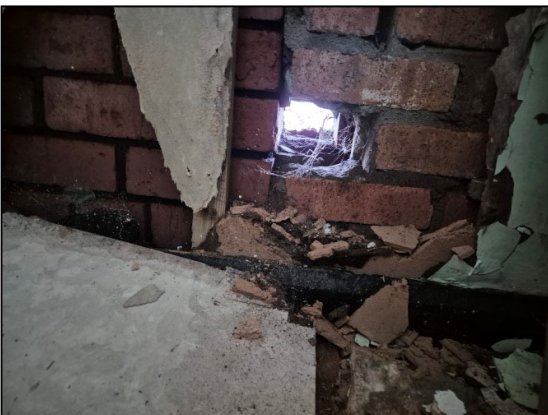
Figure 5 – Hole visible in Figure 4 from Interior of Building. Presence of Cobwebs across Span of Gap Suggests the Potential Access Point is not being Utilised by Bats

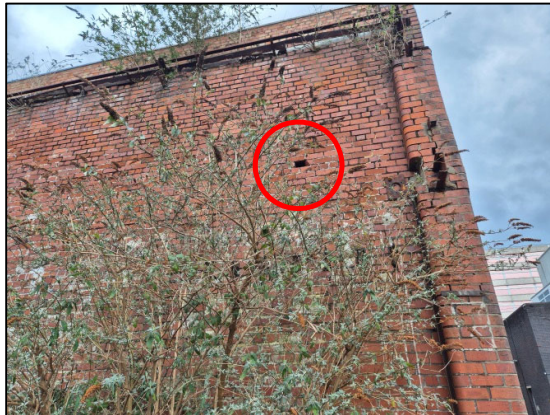
Figure 4 – Closer view of Damaged Brickwork. Hole in Brickwork Enables Access to the Building Interior (Circled)

- **Missing Brick in South-Eastern Corner of Survey Building** – Although in a generally good state of repair, small gaps and breaks were recorded in some of the brickwork / masonry, with this primarily being focused in the south-eastern corner of the building. A missing brick was recorded in this location (Figures 4 & 5) which was of sufficient size to enable both crevice-dwelling and void-dwelling bats to enter the building interior via this avenue;

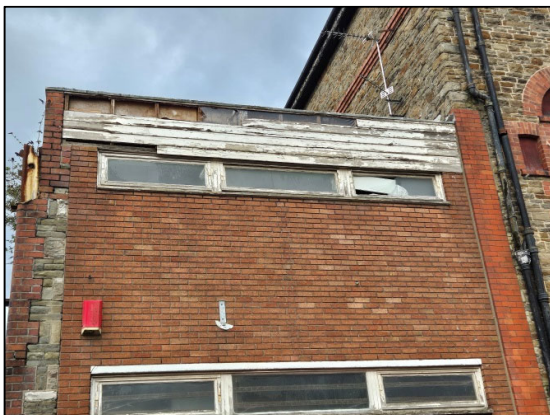
Figure 6 – (E) Wall of Survey Building Looking (W). Damaged Windows and Fascia / Cladding Boards visible, Enable the Potential Access/Egress for Bats to the Building Interior

As previously stated, the building possesses some timber fascia boards, particularly at the apex of the eastern wall of the building. These were observed to be in a generally poor state of disrepair enabling the potential access/egress of crevice-dwelling bats to the building interior. The fascia boards were however assessed to be in too poor a condition to support roosting bats, with the eastern wall and areas behind the fascia boards being too exposed to external elements to be suitable for roosting.

- **Damaged Timber Fascia Boards** – A small number of timber fascia boards are present at the apex of the eastern wall of the survey building. Some damage was recorded to these boards (Figure 6) which enable the potential access/egress for crevice-dwelling bats to the building interior in this location;

Timber fascia boards at the apex of the easternmost wall of the exterior of the building were observed to be in a poor state of disrepair and holes of sufficient size were recorded which may enable both crevice and void-dwelling bats to enter PRFs within the building interior via this avenue. The interior of the damaged soffits and fascias were however assessed to be unsuitable for roosting directly, owing to the exposed nature of the interior features to external elements as a result of the heavy damage.

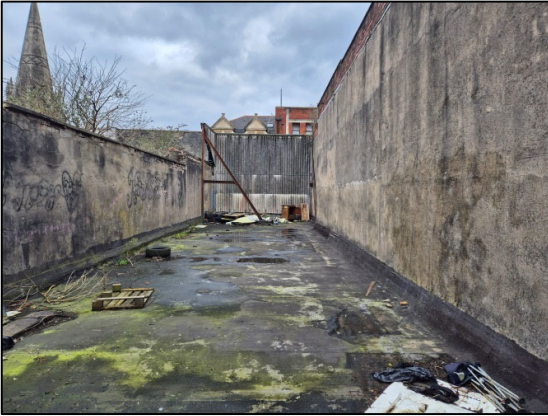
Figure 7 – Flat Roof of Building, Looking (W). Western End of Building is Clad with Corrugated Asbestos Sheetting

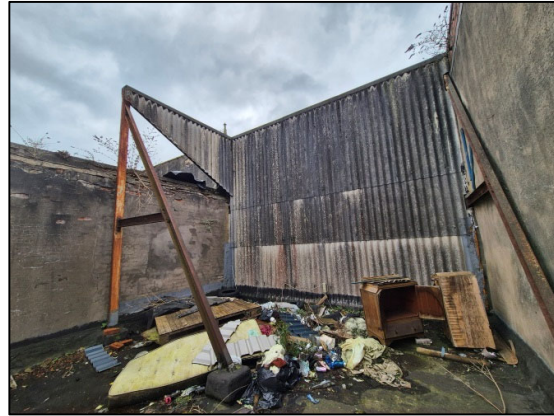
Figure 8 – Single-skinned Asbestos Cladding at Farthest End of (W) Side of Flat Roof. Cladding is in Good Condition with Limited Damage

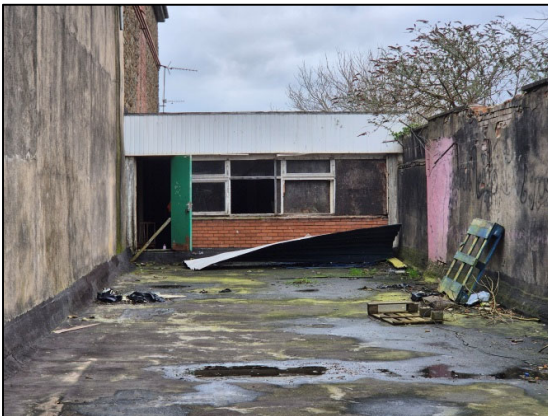
Figure 9 – Damaged Frontage of 1st Floor, as visible from Roof of Building, Looking (E). Broken Windows and Doorways enable the Free Access/Egress for Bats to Building Interior

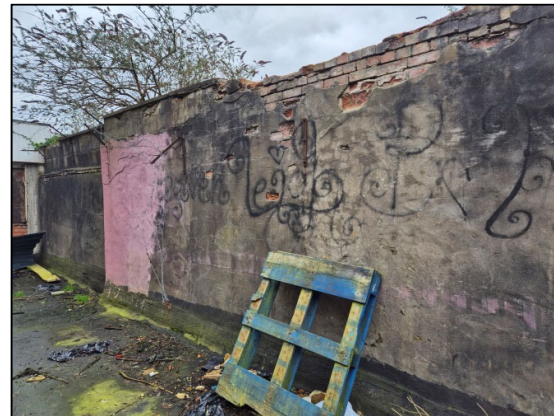
Figure 10 – Damaged Masonry / Render Covering Brickwork on (S) Wall of Flat Roof of Building, Offering Potential Limited Roosting Opportunity for Crevice-Dwelling Bats

As discussed, some small areas of damage were recorded (example of which are visible in Figures 4 & 10) which offers limited potential for crevice-dwelling bats.

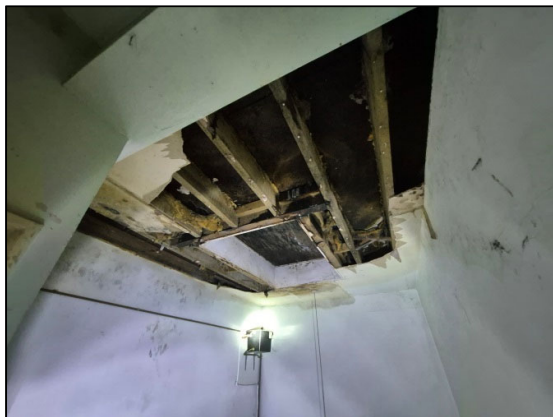
Similarly, the flat roof of the building has also been subjected to some damage, resulting in significant water ingress toward the eastern section of the building interior (particularly at 1st floor level). The ingress of water has caused widespread damage to the building interior, with a large amount of rotten timber being observed in the vicinity of the stairwell toward the eastern side of the building.

Figure 14 – Damage to Underside of Flat Roof as a result of Water Ingress above Stairwell at Far (E) Section of Building Interior.

The roof consists of a timber flat roof finished with roofing felt, interlaced with numerous well-sealed, boarded up skylights. Both the roof structures and boarded up skylights were all found to be damaged allowing ingress of water, although no holes of suitable size were identified through which bats could enter.
