Bat Survey: Wrens Cottage, Tregarn Road, Langstone, Newport, NP18 2JT

Author	Date	Version
Richard Watkins	June 2025	V1.0

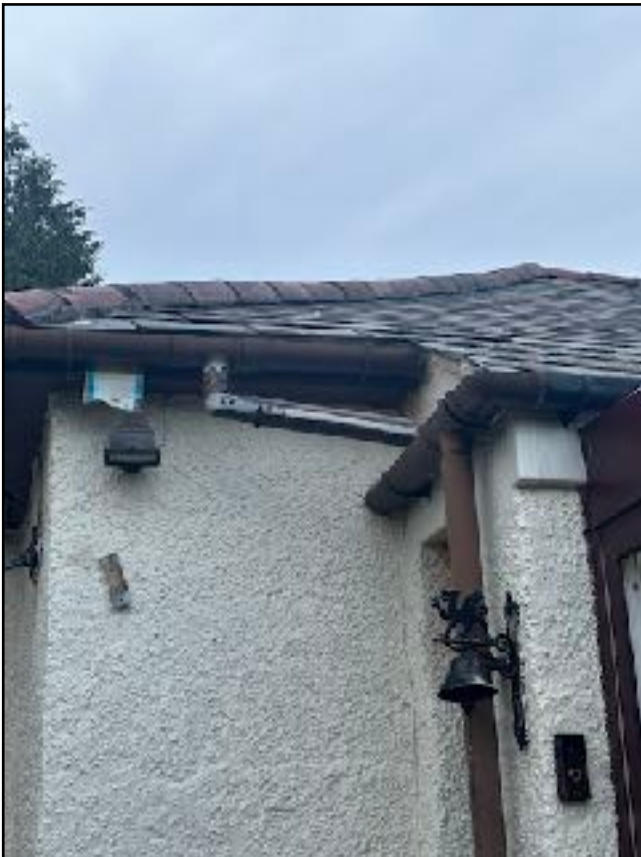
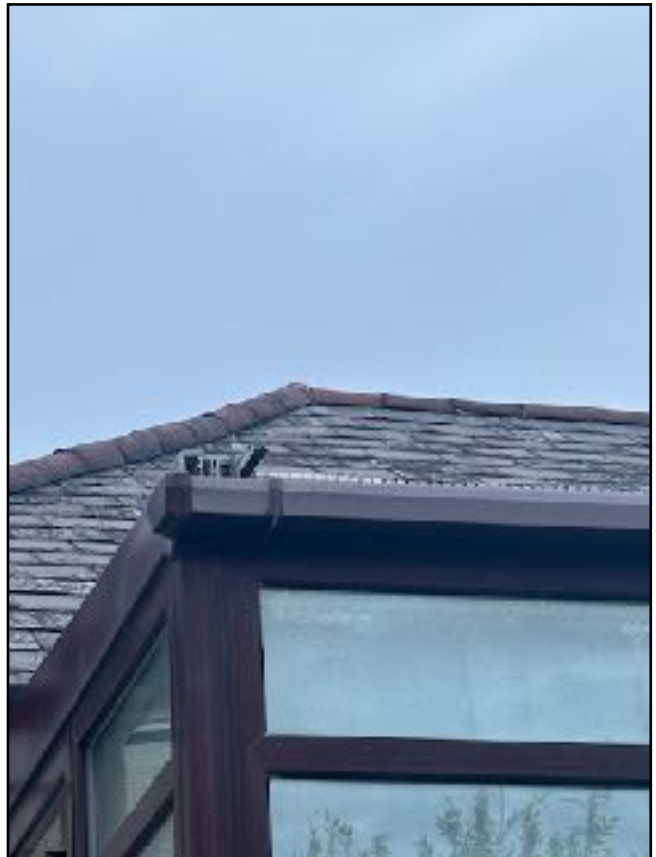
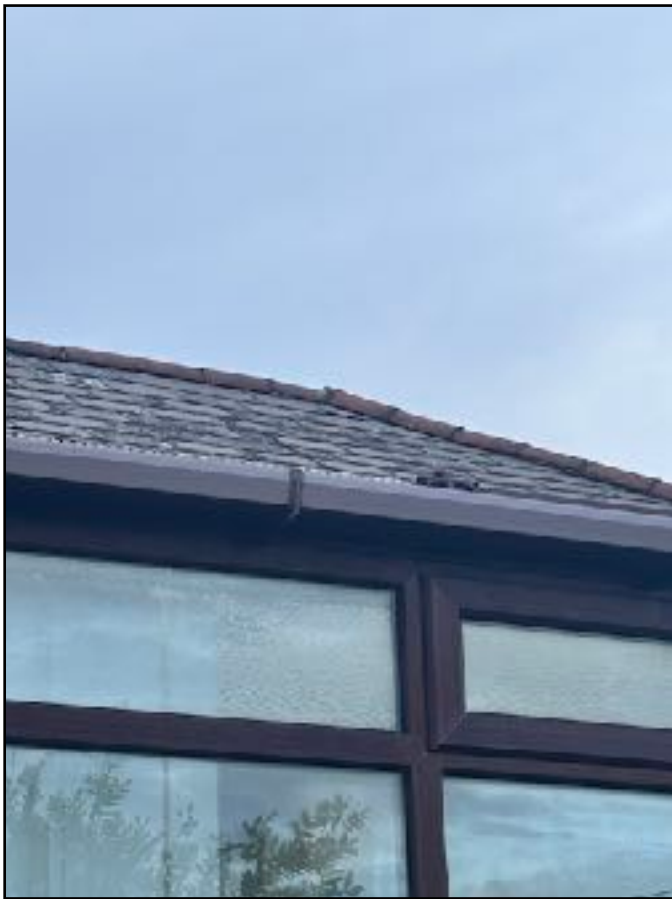
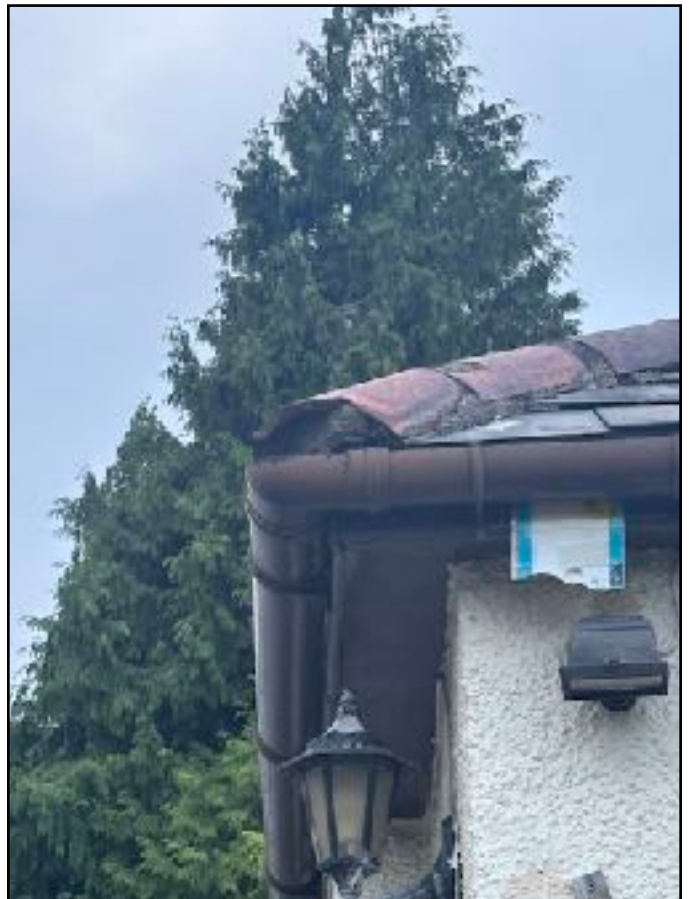
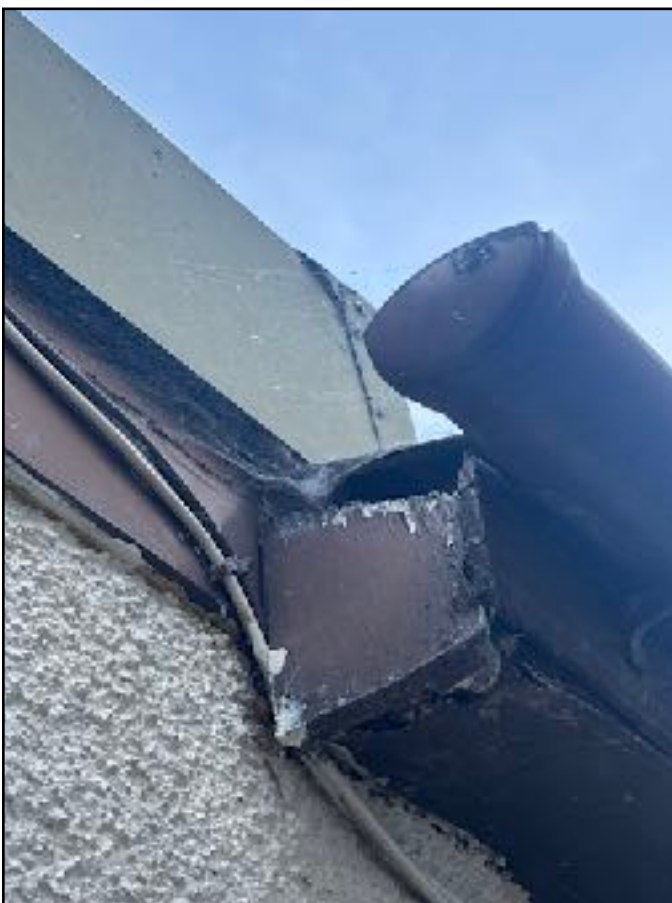
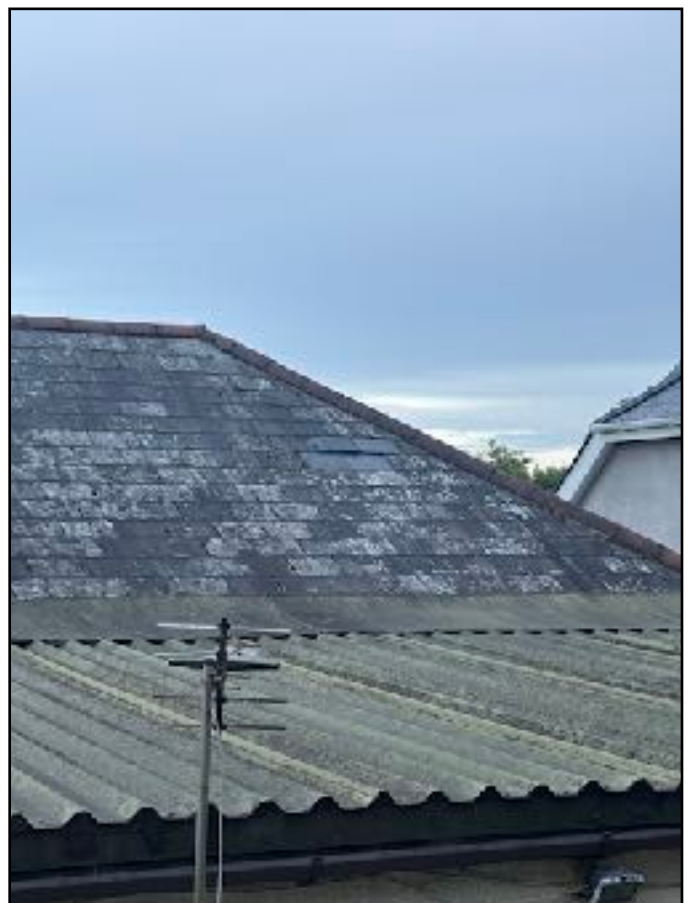
6.6 Examples of apertures allowing access to cavities in the building:

6.3 Due to the age and condition of the building, there were a small number of opportunities present for bats to access and use the building and those that were available were deemed as having moderate potential for roosting bats. There were a small number of raised slates and ridge tiles; areas of missing mortar; small holes in the soffits and an area of damaged soffit.

6.4 No droppings or evidence of bats were discovered on any external features.

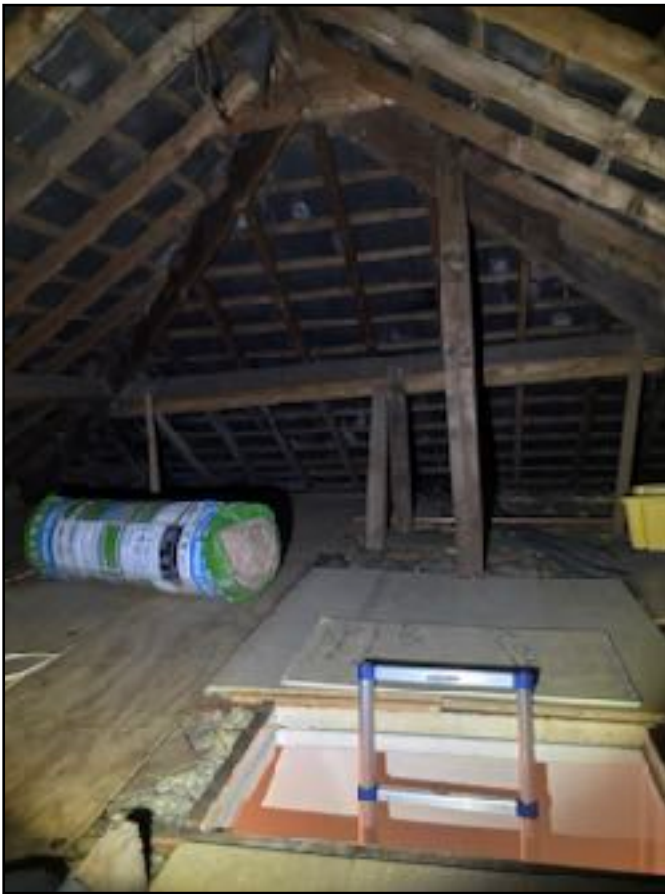
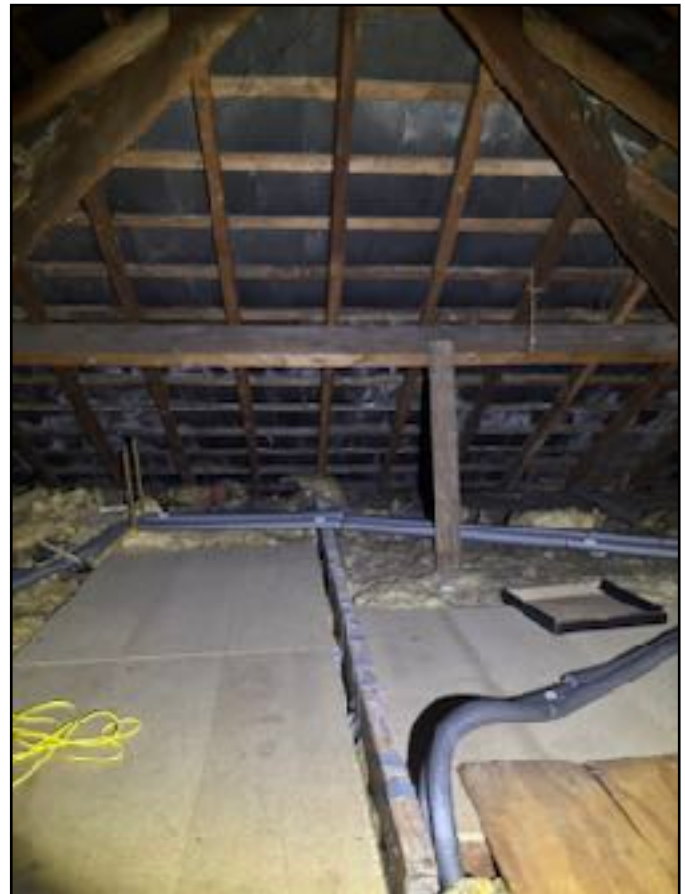
7.2 There was an accessible attic space within the property. The space was of a traditional cut design and unlined; the underside of the roofing slates could be visualised. The space was partially boarded out and there was insulation covering the majority of the floor. There were no areas of light ingress within the space.

7.3 **No droppings or evidence of bats were discovered on any internal features.**

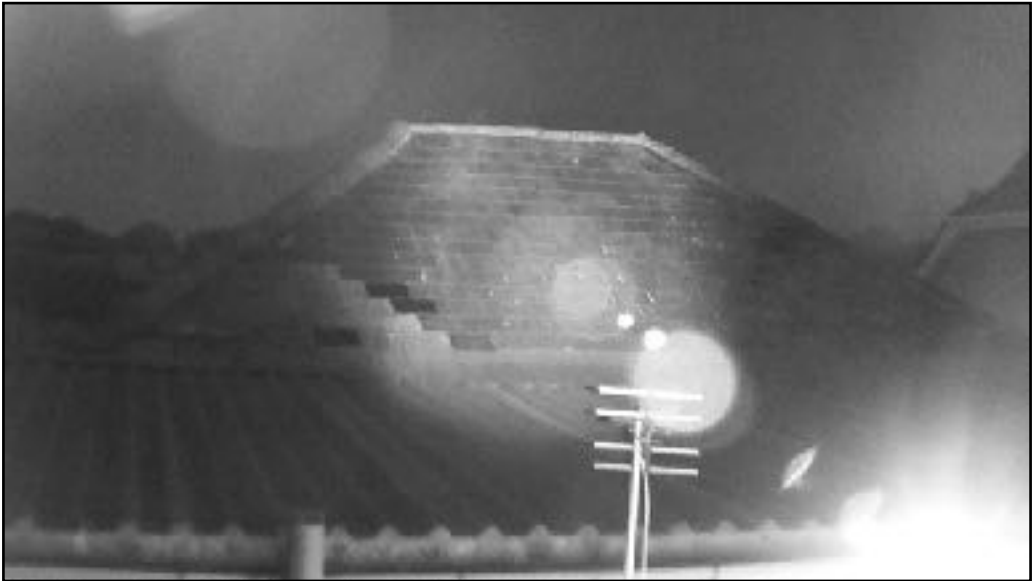
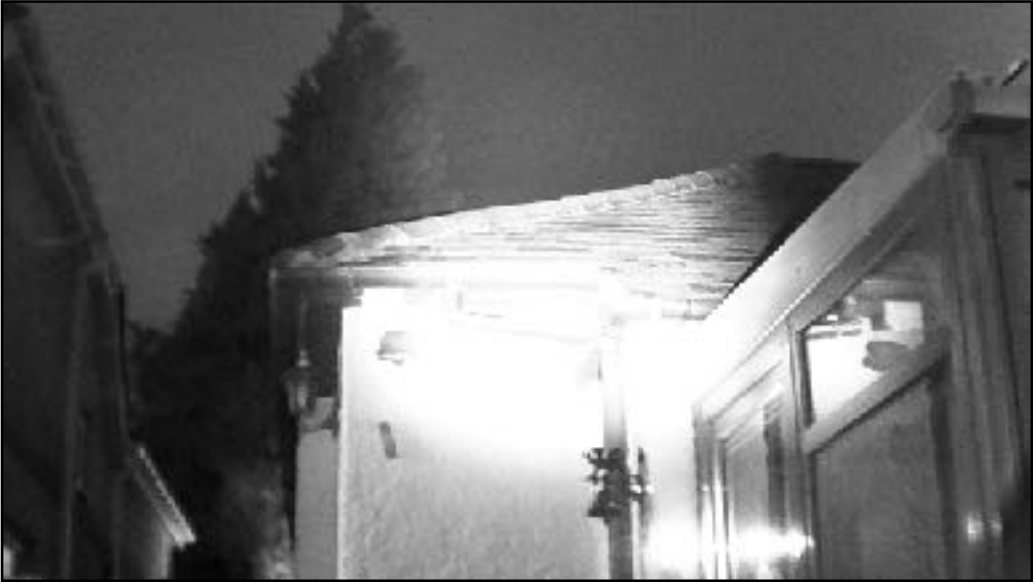
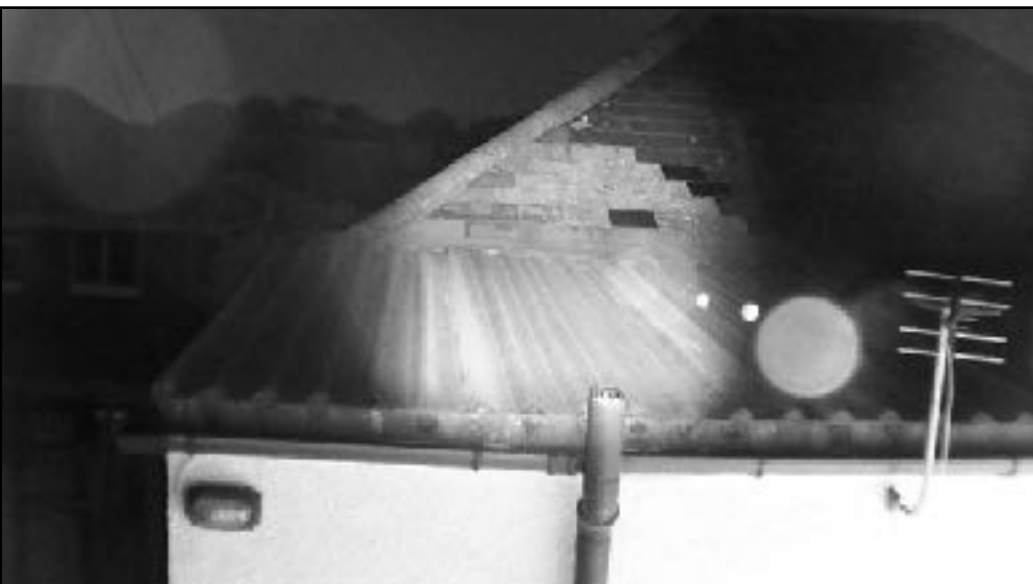
8.10 Examples of NVA Still Shots:

8.9 During the emergence surveys, a very low number of bat calls were recorded. A Noctule was detected but was not observed at the start of the first survey and a Common Pipistrelle was detected but was not observed towards the end of both of the surveys.

9.1 During the emergence surveys, no bats were observed emerging from the building.
