Bat Survey: 170-172 Commercial Road, Newport, NP20 2PL

Instructed by: AFA Architects & Planners

Author	Date	Version
Richard Watkins	October 2024	V2.0

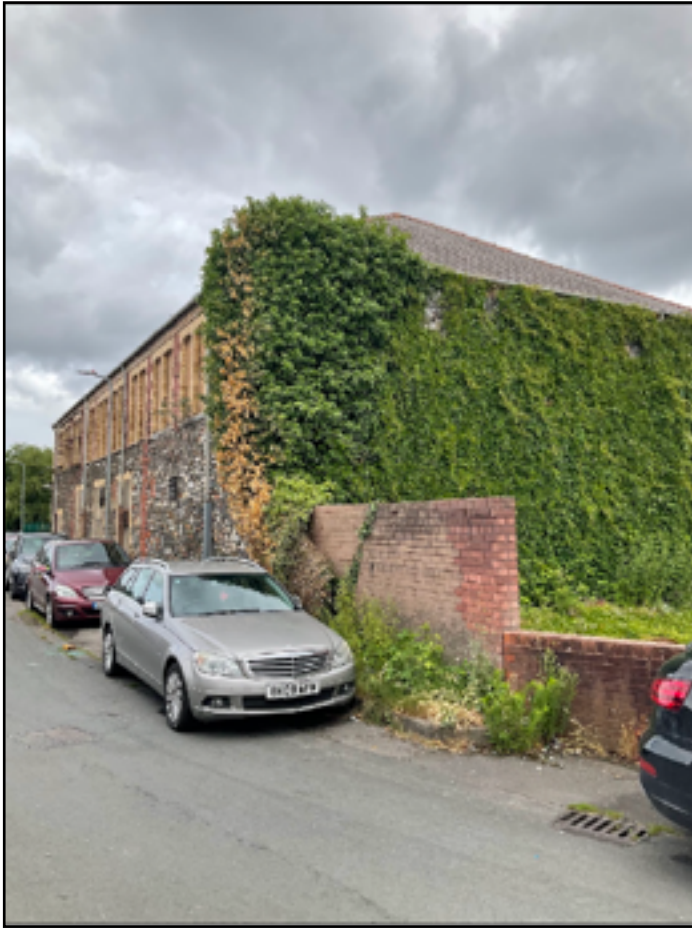
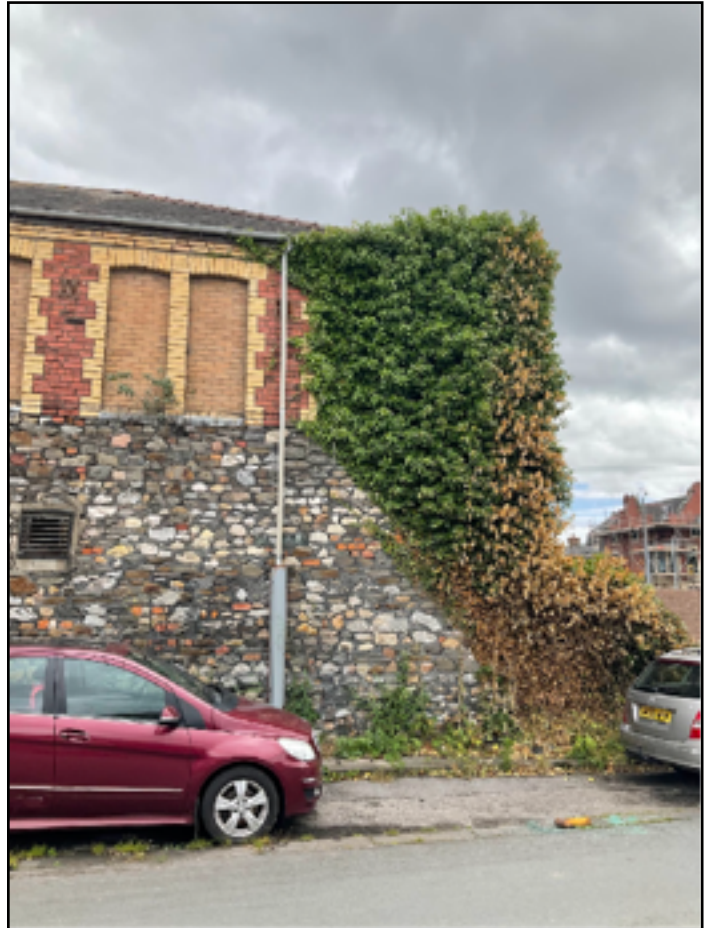
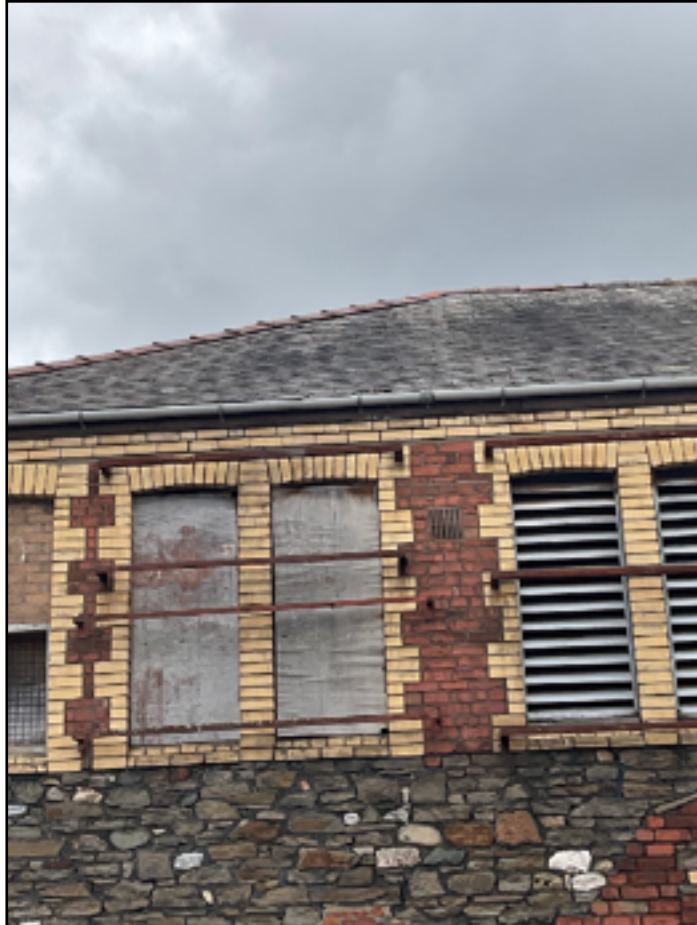
6.3 Due to the age and condition of the buildings, there were a small number of opportunities present for bats to access and use the buildings and those that were available were deemed as having moderate potential for roosting bats. On the two storey building there were raised and slipped slates; apertures between the timber fasciae and the walls; areas of missing mortar and areas of vegetation. On the former shop there were apertures between the concrete fasciae and the walls and apertures between the metal roofing sheets. Due to the presence of a flat roof, not all areas of the roof could be visualised. Therefore, following the survey guidelines, the building was classed as having moderate potential for roosting bats.

6.6 Examples of apertures allowing access to cavities in the buildings:

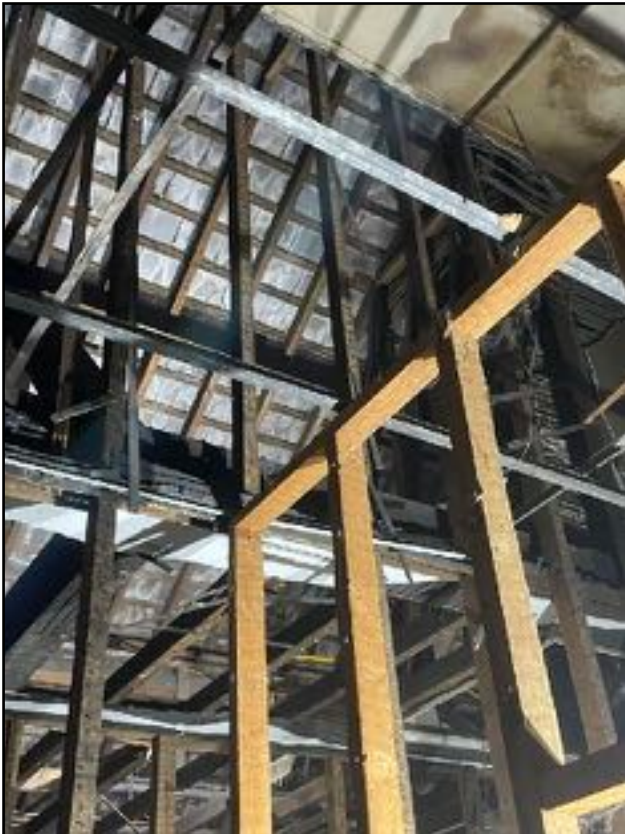
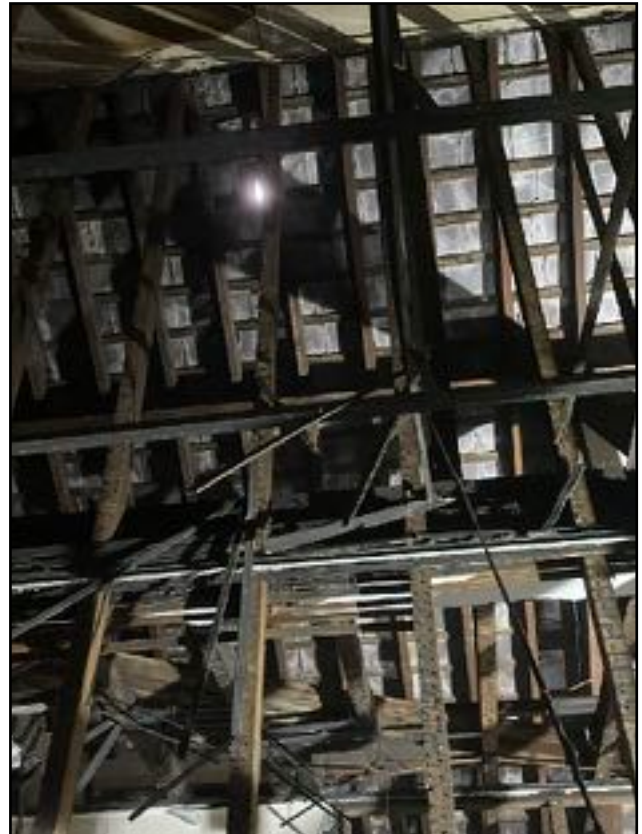
7.2 There were no enclosed attic spaces within the buildings. Ongoing works have commenced in the interior of the building and the ceilings have recently been taken down and the attic space above is now visible from the upper floors. The underside of the slates could be visualised and there was no lining present.

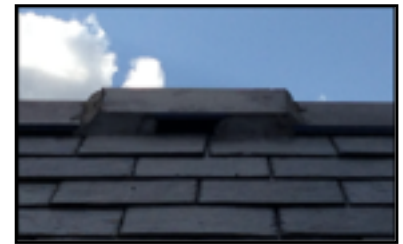
10.3 The raised ridge tiles will have two access apertures measuring 100mm long by 25mm high; one on the front elevation and one on the rear.

10.2 Permanent enhancements will comprise 3 raised ridge tiles and a self-contained roost area under the entire ridge line of the building.

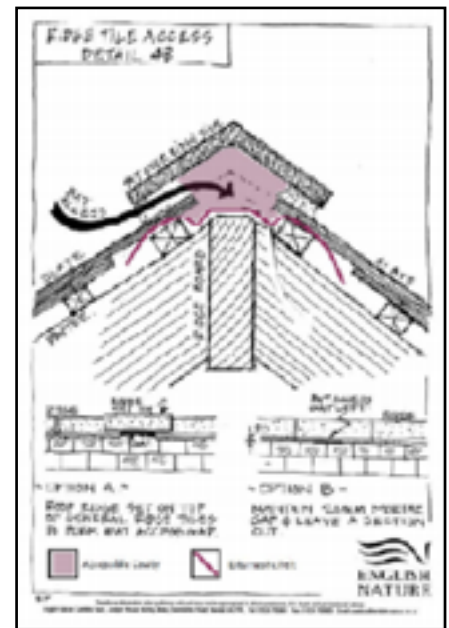
10.5 Bats will be restricted to the void in the underside of the ridge tile by using a continuous piece of 1F bitumen felt as a base liner. This will be fixed in location over the top rafters as per adjacent image.

10.6 Breathable membrane is dangerous for bats, therefore it is essential that the detail contained in the adjacent drawing is followed exactly and is to be fitted under direct ecological supervision by a suitably qualified ecologist.

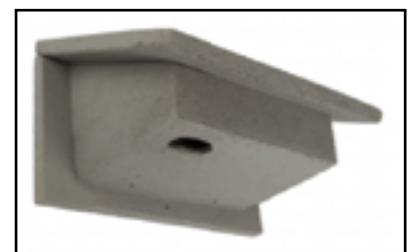
10.7 One Vivara Pro WoodStone Swift Nest Box will be surface mounted on the northern elevation of the building. **This will not be situated on a south facing elevation. Care must be taken not to obstruct the entrance hole.**

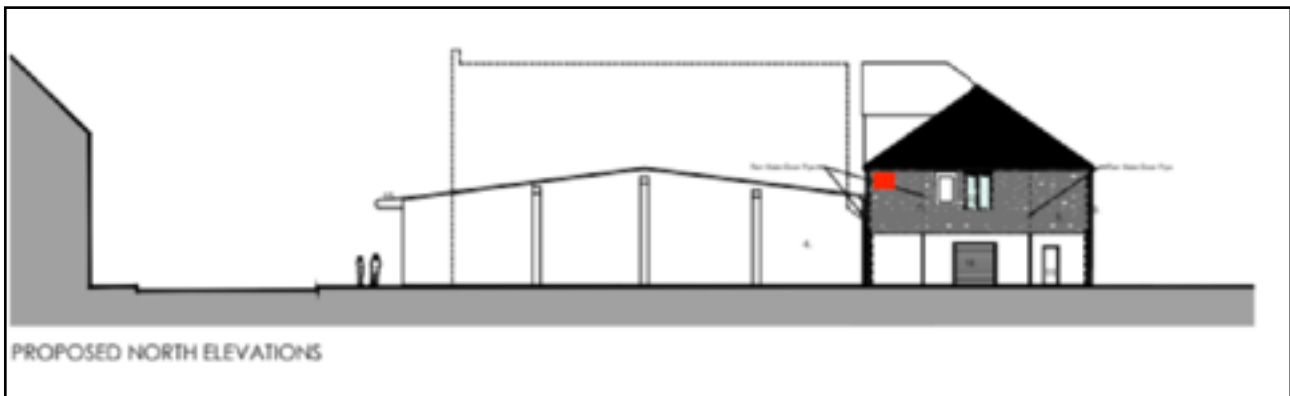
Northern Elevation

10.12 Recommended Locations of Bat and Bird Enhancements:

Location of the Raised Ridge Tiles

Location of Vivara Pro WoodStone Swift Nest Box
