Bat Scoping Survey: The West of England Tavern, 44 Mill Parade, Newport, NP20 2JS

Author	Date	Version
Richard Watkins	October 2023	V1.0

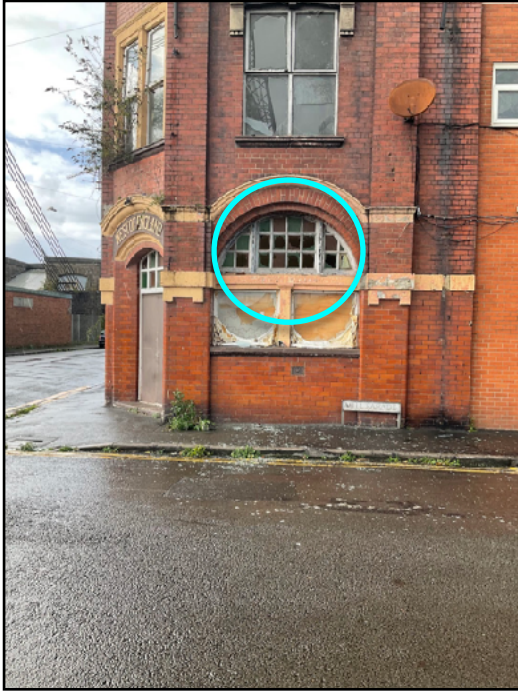
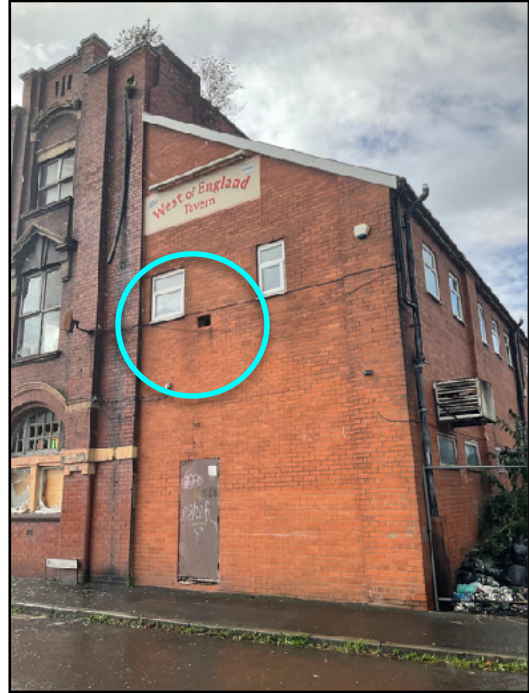
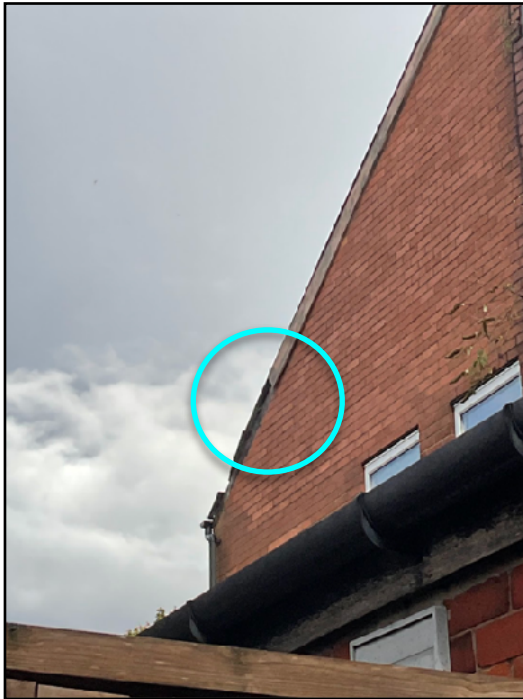
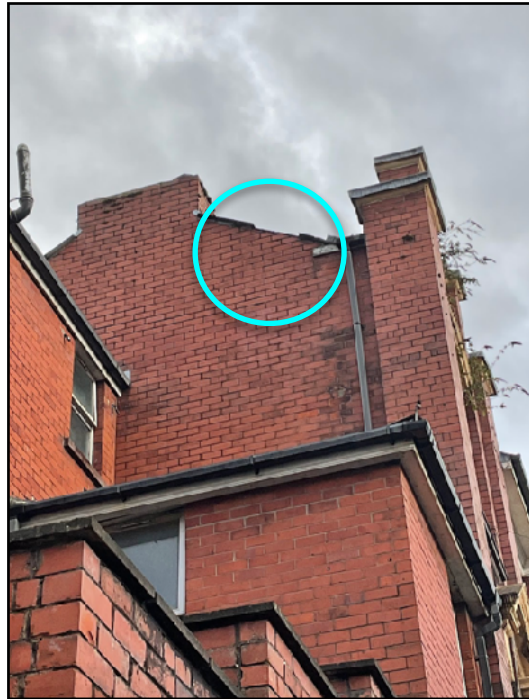
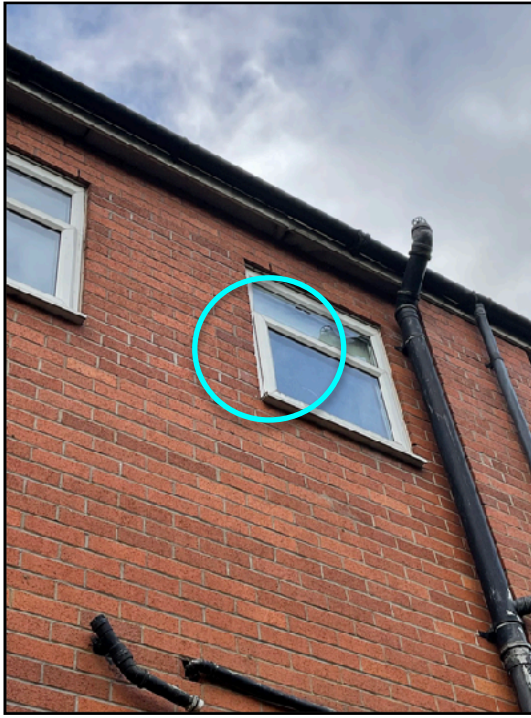
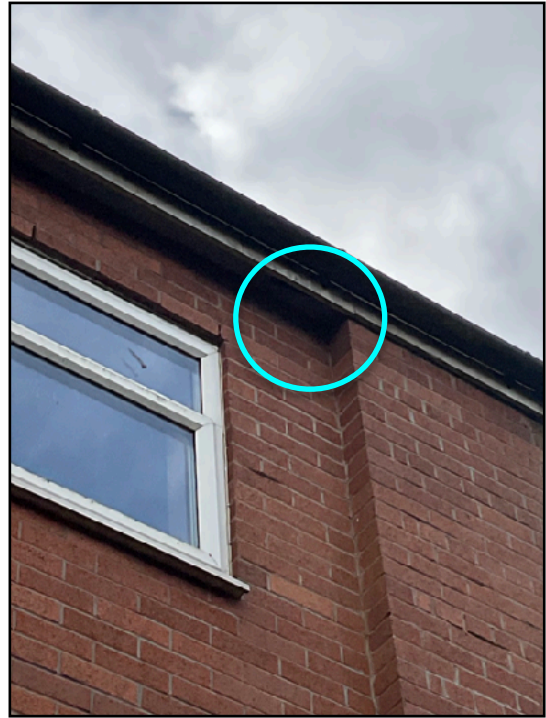
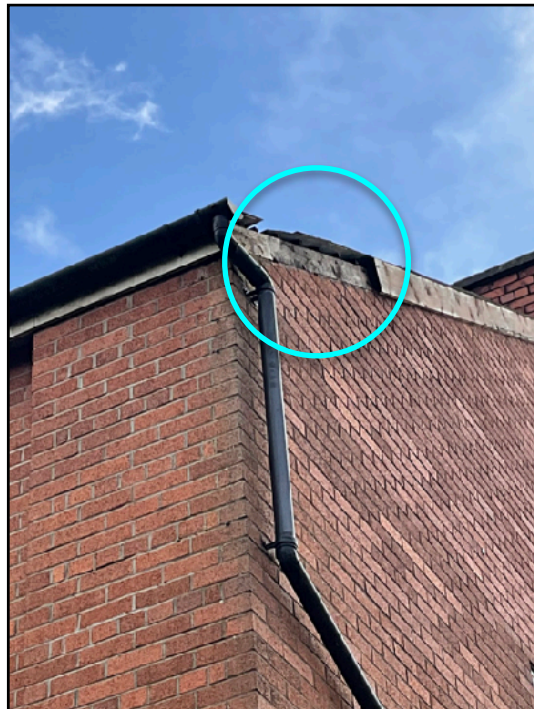
6.3 Due to the age and condition of the building, there were a number of opportunities present for bats to access and use the building and due to the height of the building, not all areas of the roof could be visualised. Therefore, following the survey guidelines, the building was classed as having moderate potential for roosting bats. There were apertures in the soffits; areas of missing fasciae; slipped and missing slates; broken and open windows and a recent aperture made in the brickwork.

6.6 Examples of apertures allowing access to cavities in the building:

8.10 The property does offer a number of opportunities for bats to access and use the building and those that were available were deemed as having moderate potential for roosting bats. Prior to the second phase of works commencing, at least two bat activity surveys are recommended to establish the presence or absence of bats within the building. The general shelf life of activity surveys is eighteen months. Updated survey work may be required after this time.

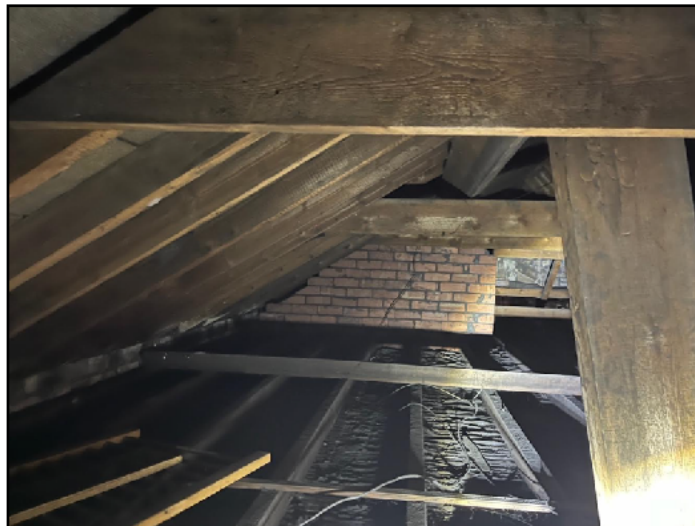
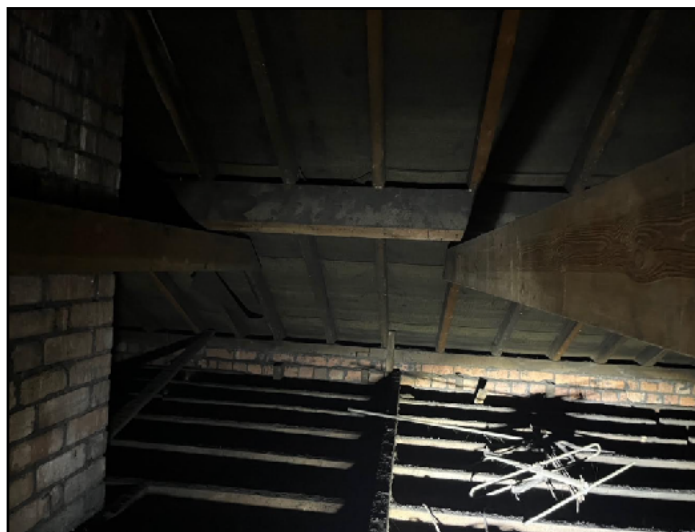
Main Attic Space

7.2 There were two accessible attic spaces within the property; one in the main building and one in the northern lean-to extension. There was also a cellar present within the property. Both of the attic spaces were lined and boarded out. There was an extensive amount of daylight emitted into the main attic space whereas there was no daylight emitted into the attic space in the extension. No direct access was possible for bats into the cellar.

7.3 No droppings or evidence of bats were discovered on any internal features.

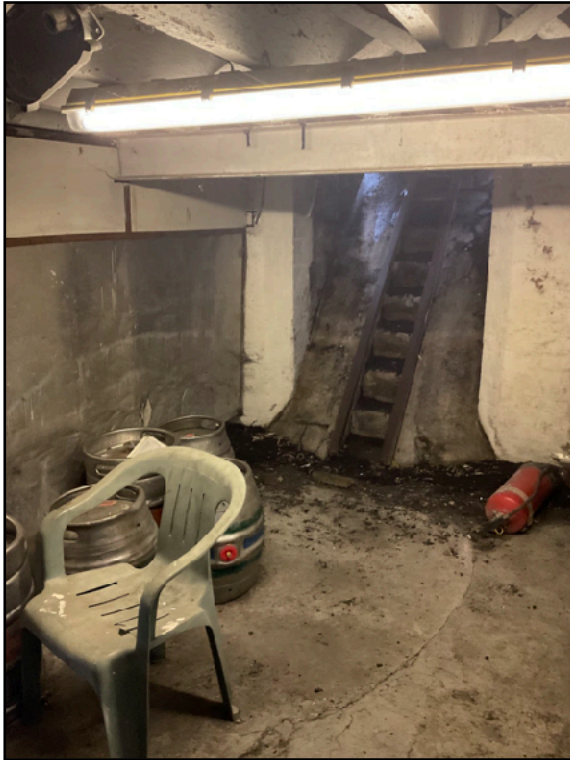
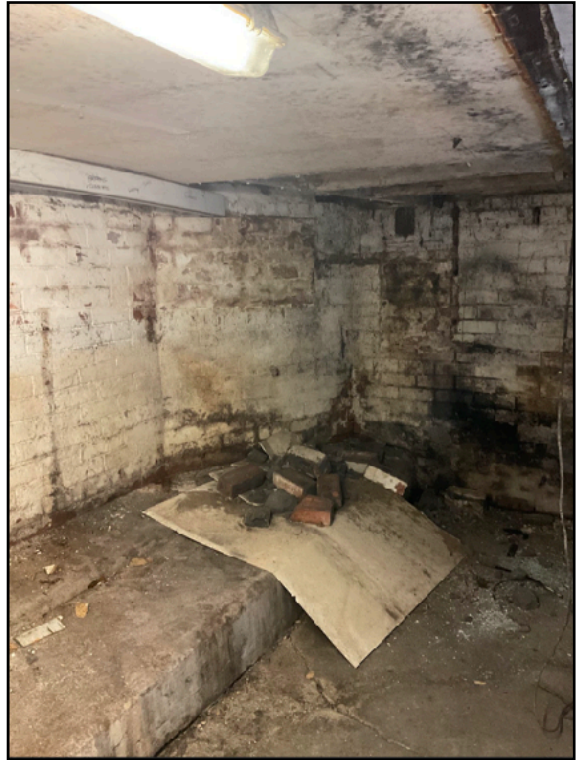
Cellar

8.7 The property does not offer any significant hibernation potential. There was no direct flight access for bats into the cellar. The external walls were also sound with no visible apertures for bats preventing access into the wall structure. When considering the limited bat access points into the building, the hibernation use of the building is considered to be very low.
