BS5837 2012 Tree Information – 584 Malpas Road

584 Malpas Road
Newport
NP20 6QA

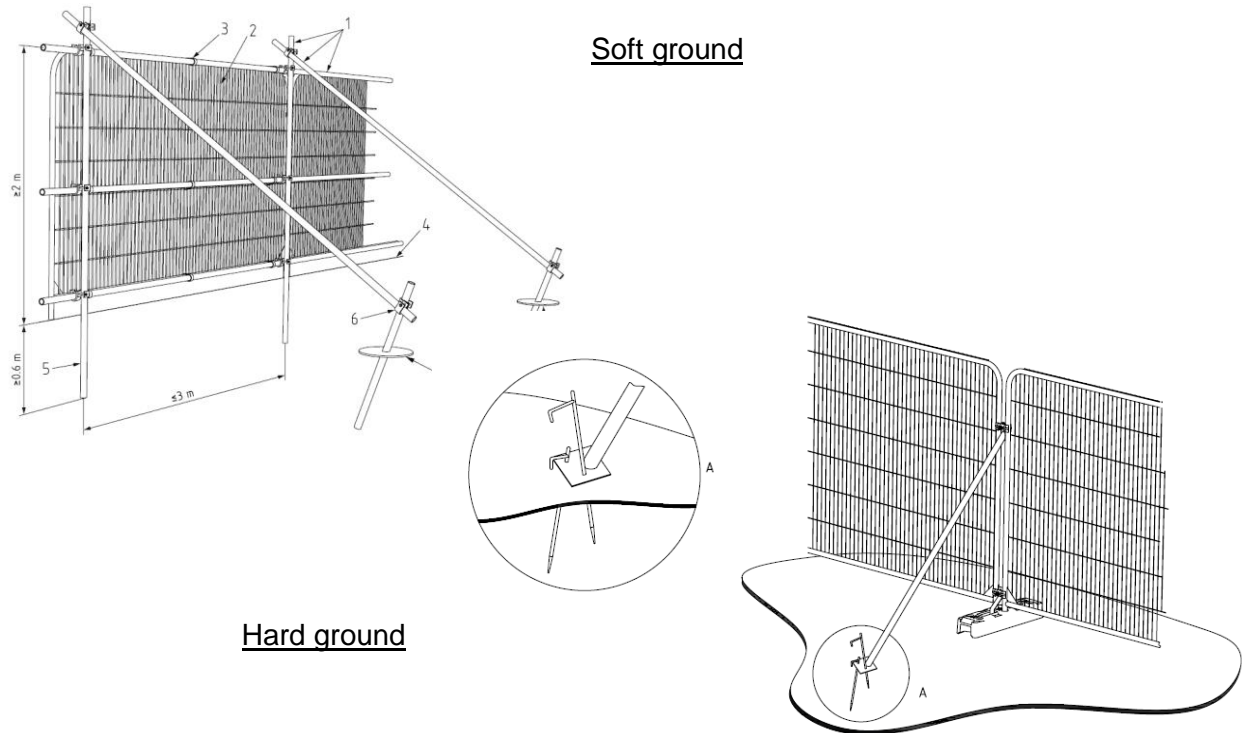
The BS document provides various diagrams on how to protect tree rooting areas. The fence needs to be erected prior to construction traffic site occupation and often with the arboriculturist present to ensure correct placing. Types for hard and soft ground surfaces are shown below.

The rooting area is calculated by using a stem measurement. For single stems trees the diameter if the stem is measured at 1.5m above ground level or point of even stem taper. This figure, in millimeters is then multiplied by twelve and this will then give the radial measurement from the stem to the edge of the rooting area. A circular area is created around the tree at the radial measurement. This is where the fencing should be located. Multi stemmed trees now require average stem size calculations based on 2-5 stems or 5+ stems. Contact the arboriculturist if in any doubt.

The design of RPA or CEZ fencing should be so that it cannot be moved during works. It must also be robust enough to withstand minor knocks and scrapes from plant equipment. The fence must be in place prior to site occupation by plant equipment and should be removed once the site has been vacated by construction traffic. Should there be a requirement to place pedestrian walkways across and RPA a suitable method of ground protection should be used. A geo textile layer, compressible material and then boards should suffice as a walkway. This specification will need to be agreed by the arboriculturist prior to installation. It should also be laid in front of the direction of travel during installation. All hedges and trees over 150mm diameter at 1.5m need root protection. If no RPA measurement is provided for a tree or hedge requiring root protection ensure the fence is set 2m from the outer edge of the tree/hedge drip line.

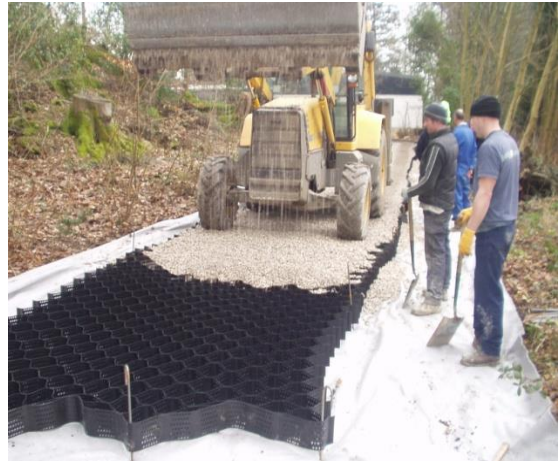
Expand the confinement systems 2.56m wide panels to the full 8.1m length. Pin the panels with staking pins to anchor open the cells and staple adjacent panels together to create a continuous mattress. Infill the cells with a no fines angular granular fill (typically 40-20mm) within each open cell. The use of cellular confinement reduces the bearing pressure on the subsoil by stabilizing aggregate surfaces against rutting under wheel loads. Comparisons between cellular confinement and traditional aggregate and geo grid-reinforced structures demonstrate a 50% reduction in construction thickness of the granular material.

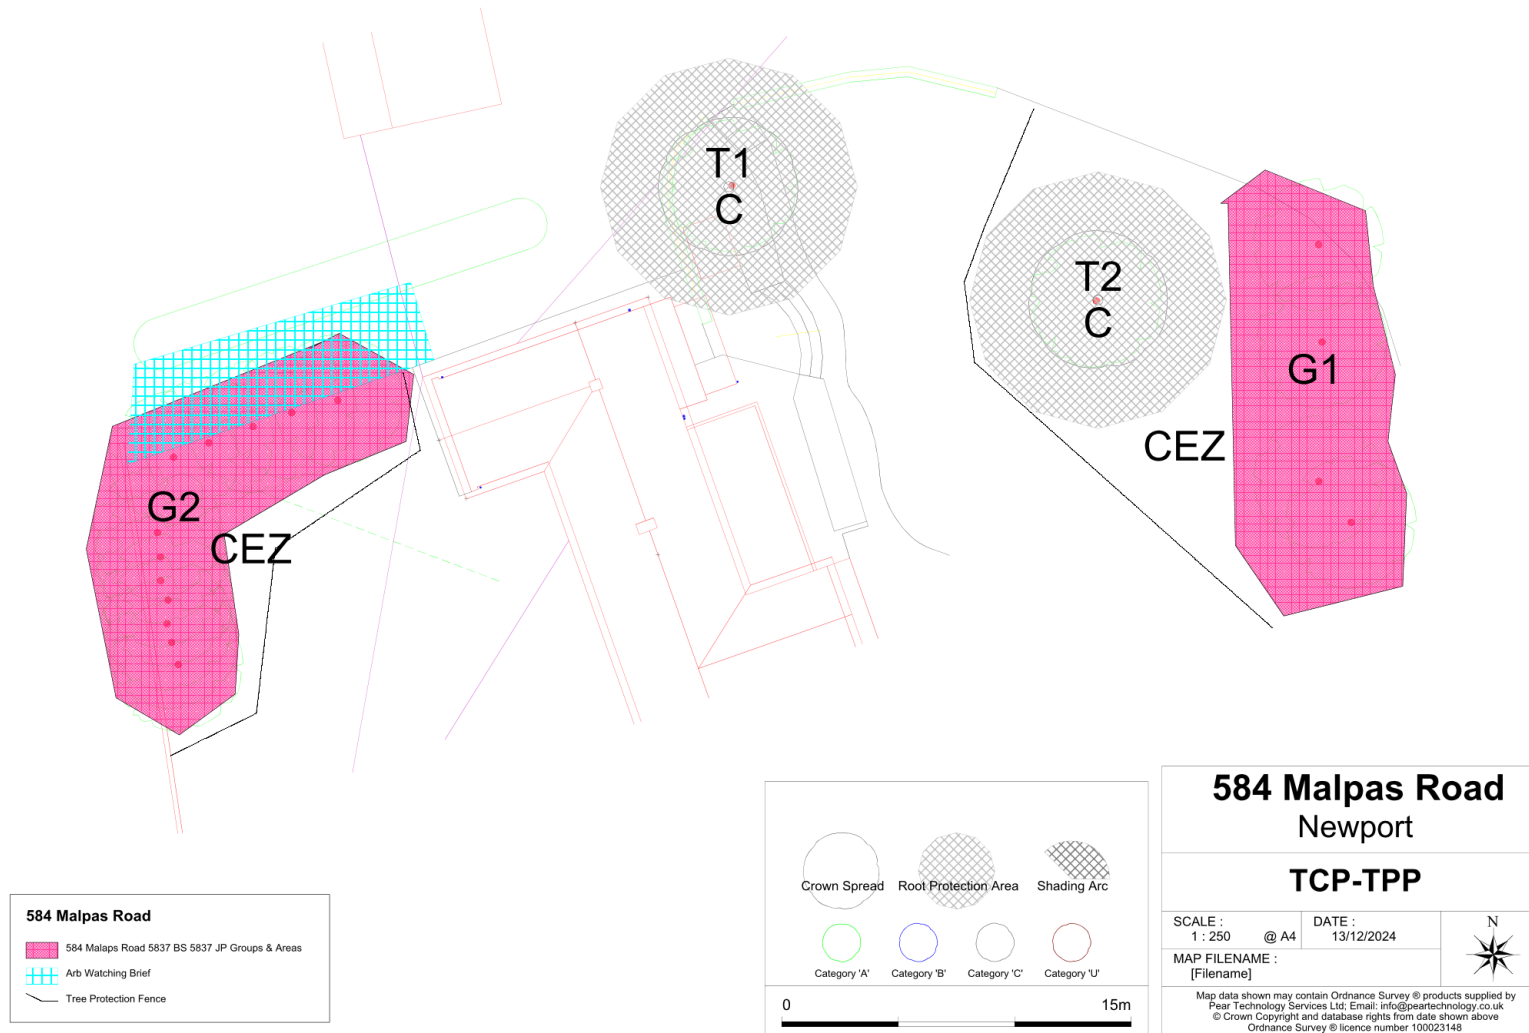
Site Plan (Screen grab – please see scale pdf plan)

Scale plans can be sent as PDF files if required. The plans are to indicate locations of trees, locations of main objects on site and the location of tree protection fencing. Stem diameters found in tree and tree group data tables should be used to mark out the location of root protection fencing on site.
