Bat Survey: Penyworld Farm Barn, Penhow, Caldicot, NP26 3AJ

Author	Date	Version
Richard Watkins	October, 2022	V2.0

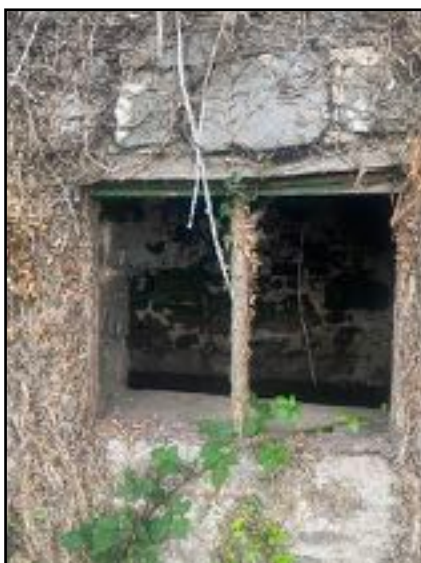
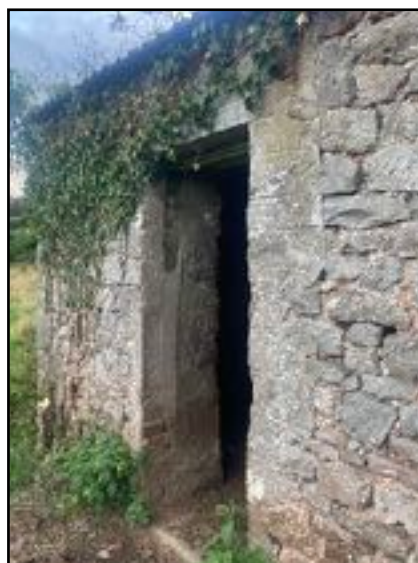
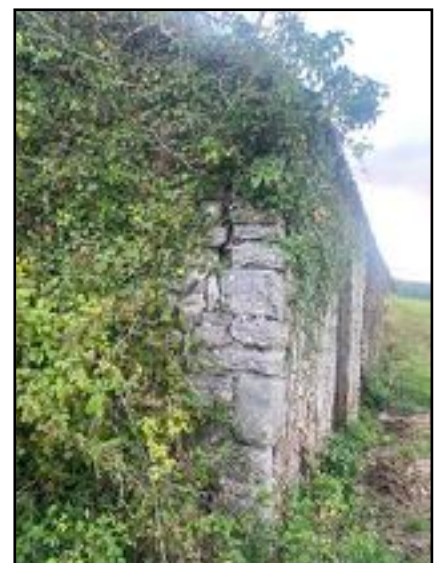
6.3 Due to the age and condition of the building, there were a number of opportunities present for bats to access and use the building and those that were available were deemed as having at least moderate to high potential for roosting bats. There were apertures in the stone walls; apertures between the walls and the roof; areas of overgrown vegetation and two open windows and doorways.

6.6 Examples of apertures allowing access to cavities in the building:

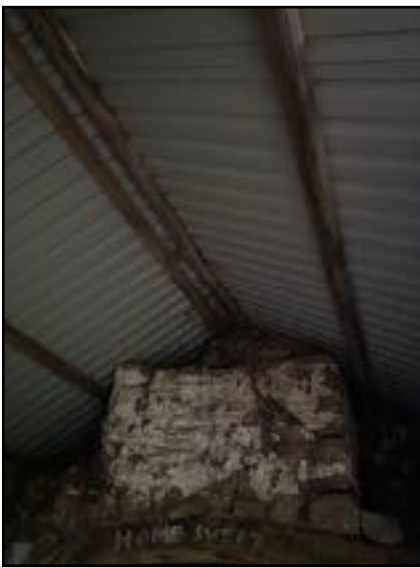
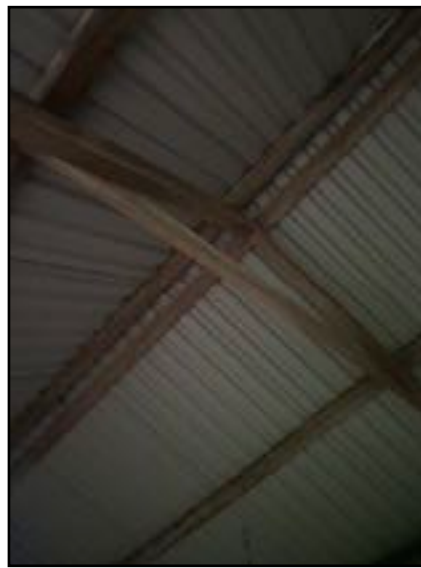
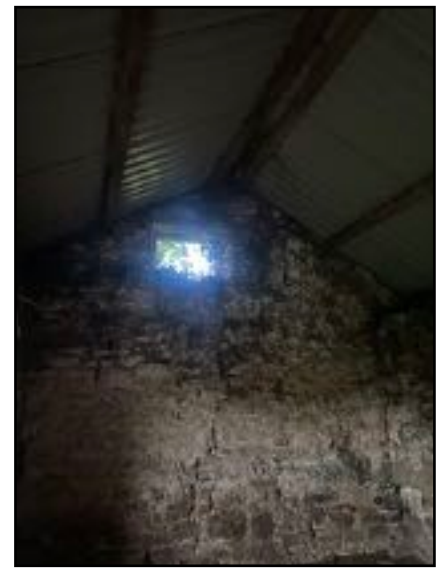
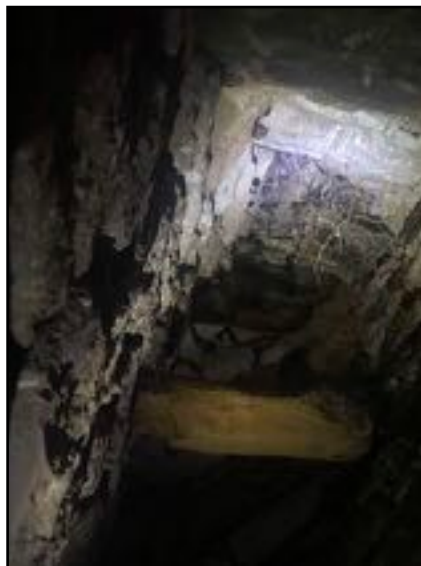
7.2 During the internal scoping survey, Lesser Horseshoe Bats (*Rhinolophus hipposideros*) bats were observed roosting in the chimney of the barn. 16 Lesser Horseshoe bats on the first survey and 3 Lesser Horseshoe bats on the second survey. The bats were observed roosting in the chimney.

7.3 The barn is single storey with a vaulted ceiling internally. The two open windows and doorways do let daylight into the barn, however, the chimney is closed off and creates a dark environment for bats to roost.

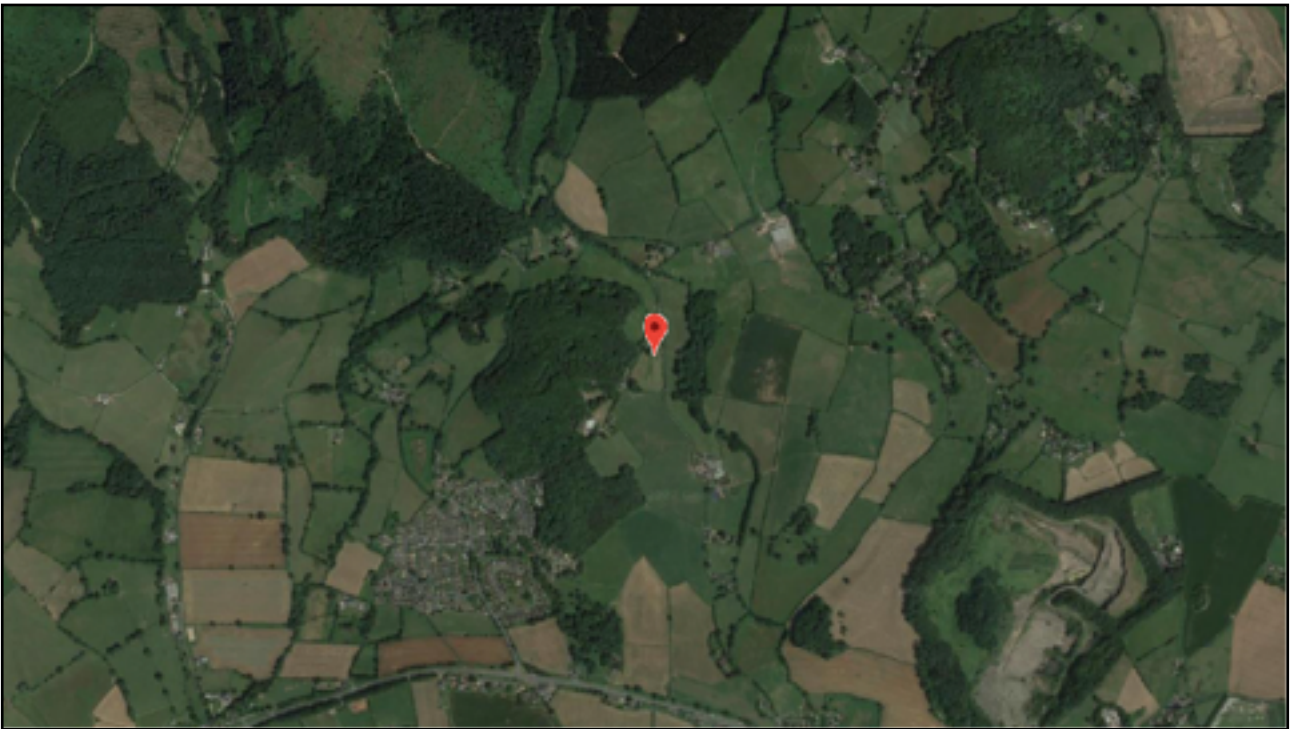
Aerial Site Photo

The site in its wider environment offering optimal ecological connectivity to the surrounding habitat.
