Bat Survey: Silver Birches, Market Road, Parc Seymour, NP26 3AE

Instructed by: Tony Phillips

Reported by: Ecological Services Ltd
10 Mount Pleasant, Llanelly Hill, Abergavenny, Monmouthshire, NP7 0NT

Author	Date	Version
Richard Watkins	June 2025	V1.0

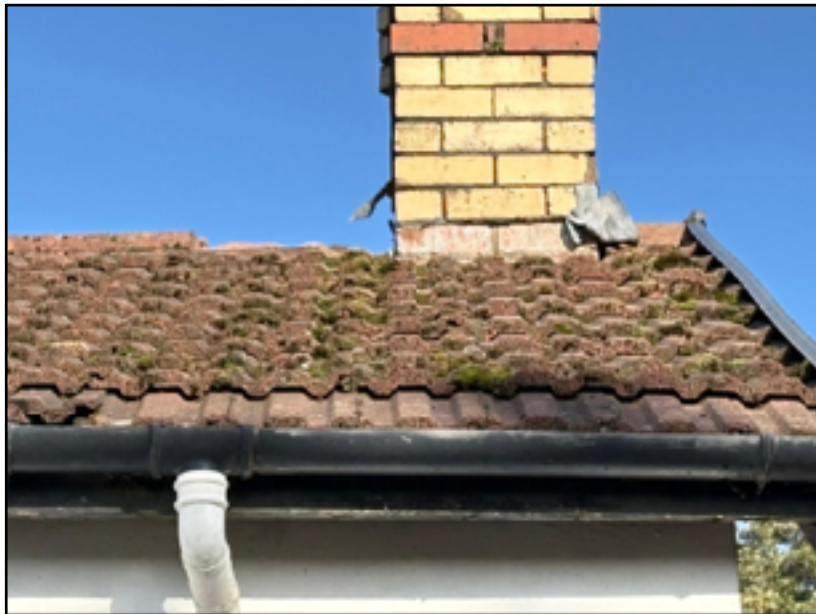
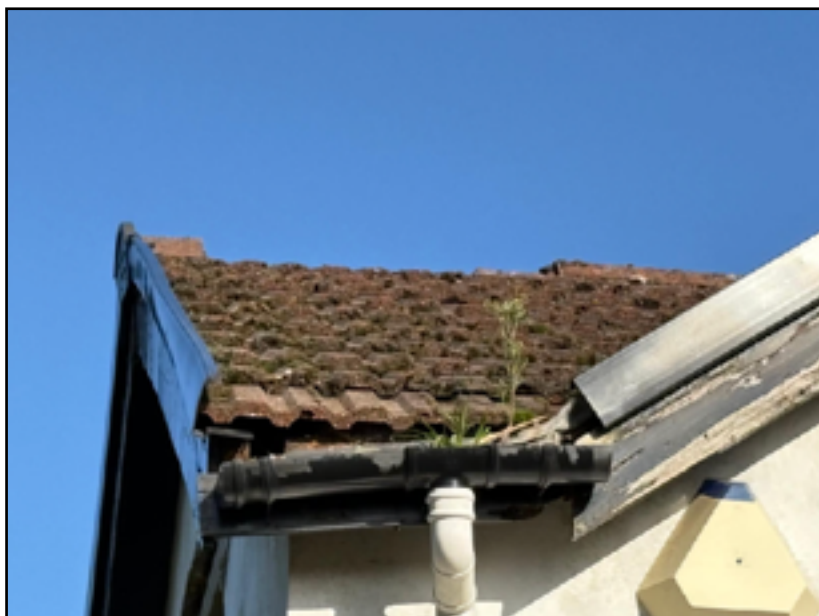
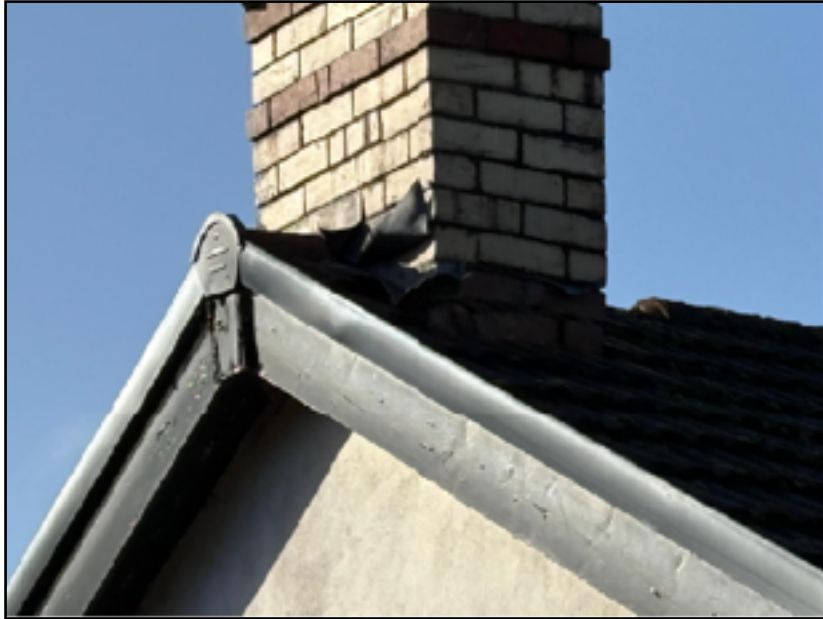
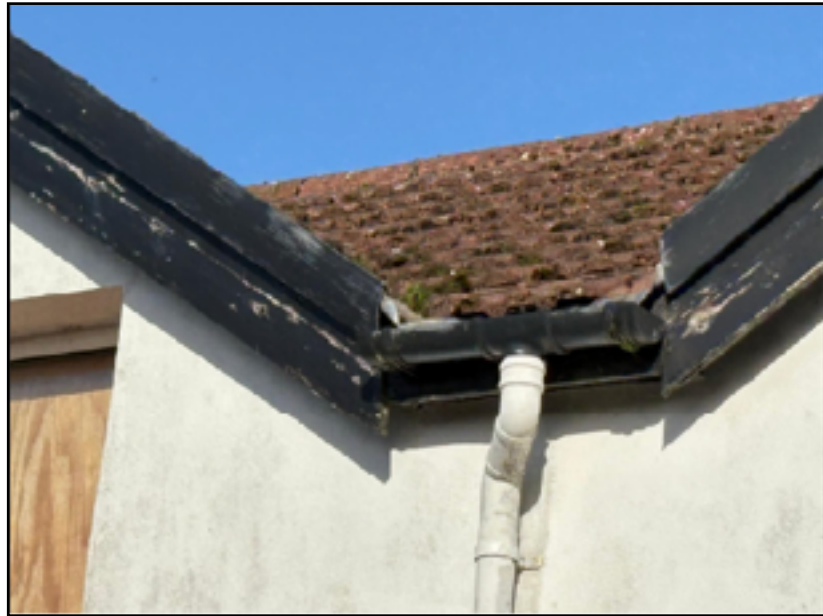
6.6 Examples of apertures allowing access to cavities in the building:

6.3 Due to the age and condition of the building, there were a number of opportunities present for bats to access and use the building and those that were available were deemed as having moderate to high potential for roosting bats. There were raised and missing ridge tiles; areas of raised flashing around the chimney; a number of raised roofing tiles; apertures underneath the plastic verge protectors and apertures underneath areas of fascia.

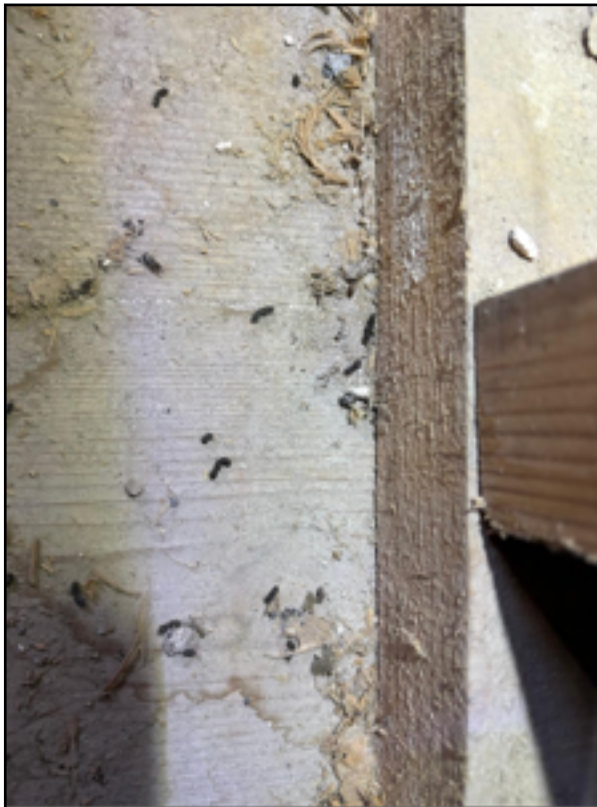
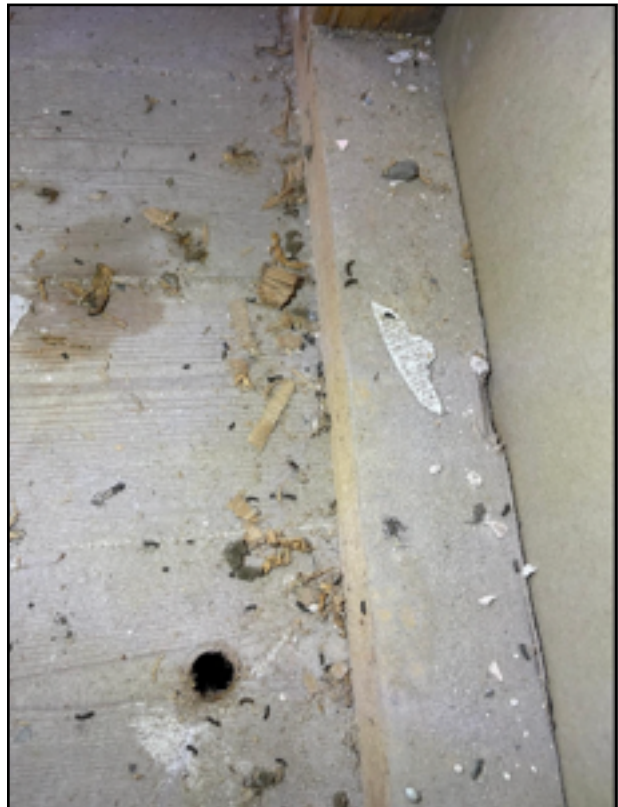
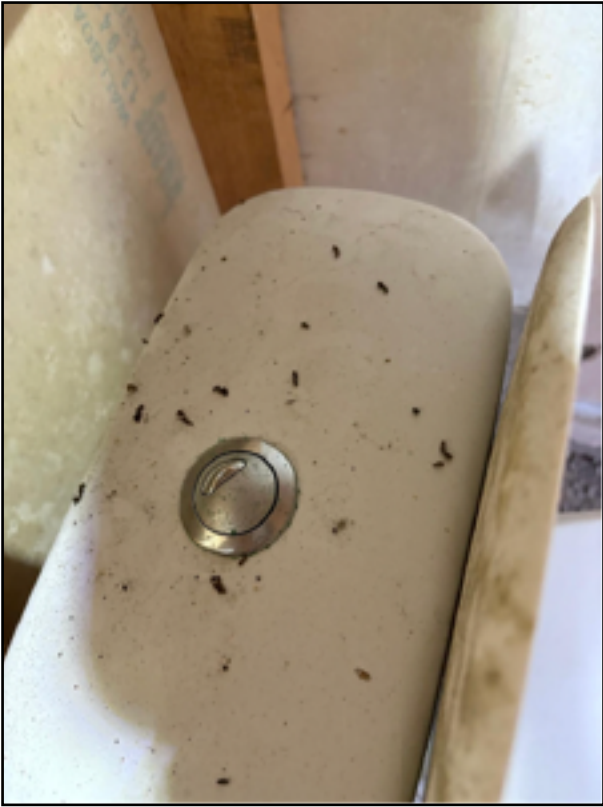
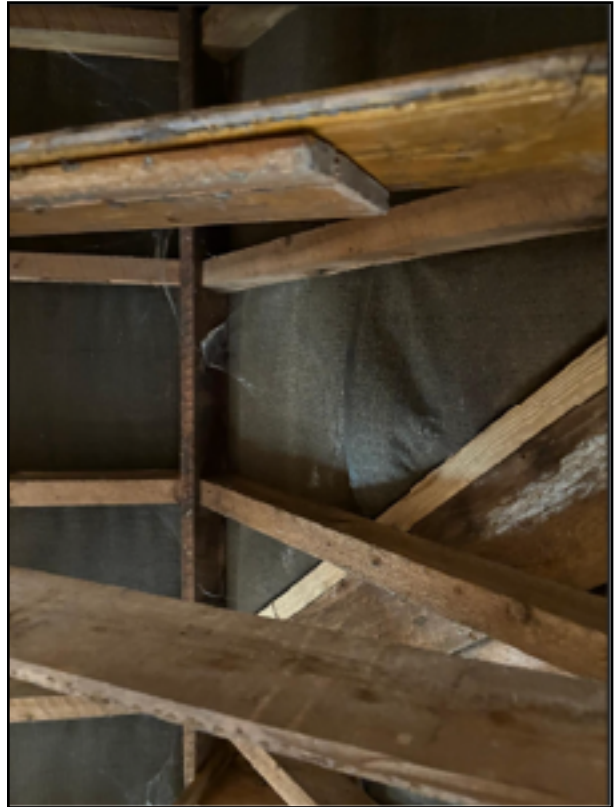
7.2 The majority of the upper storey ceilings had been removed and therefore the attic space above was visible from the upper storey of the property. The space was lined and of a trussed design.

7.3 There were a number of bat droppings indicative of a Pipistrelle Species (*Pipistrellus sp.*) of bat within the attic space and the upper storey of the property.

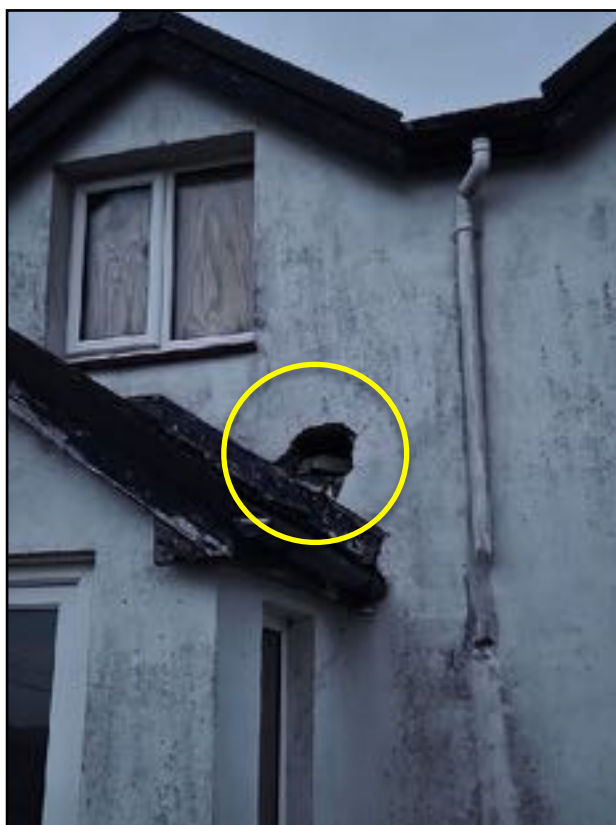
2 Soprano Pipistrelles (*Pipistrellus pygmaeus*) were observed emerging from a hole in the wall to the southern elevation of the building.

9.11 As the building is proposed to be fully renovated, the confirmed bat roosting location will be destroyed. Therefore a European Protected Species Licence, issued by Natural Resources Wales will be legally required to destroy the roosts.

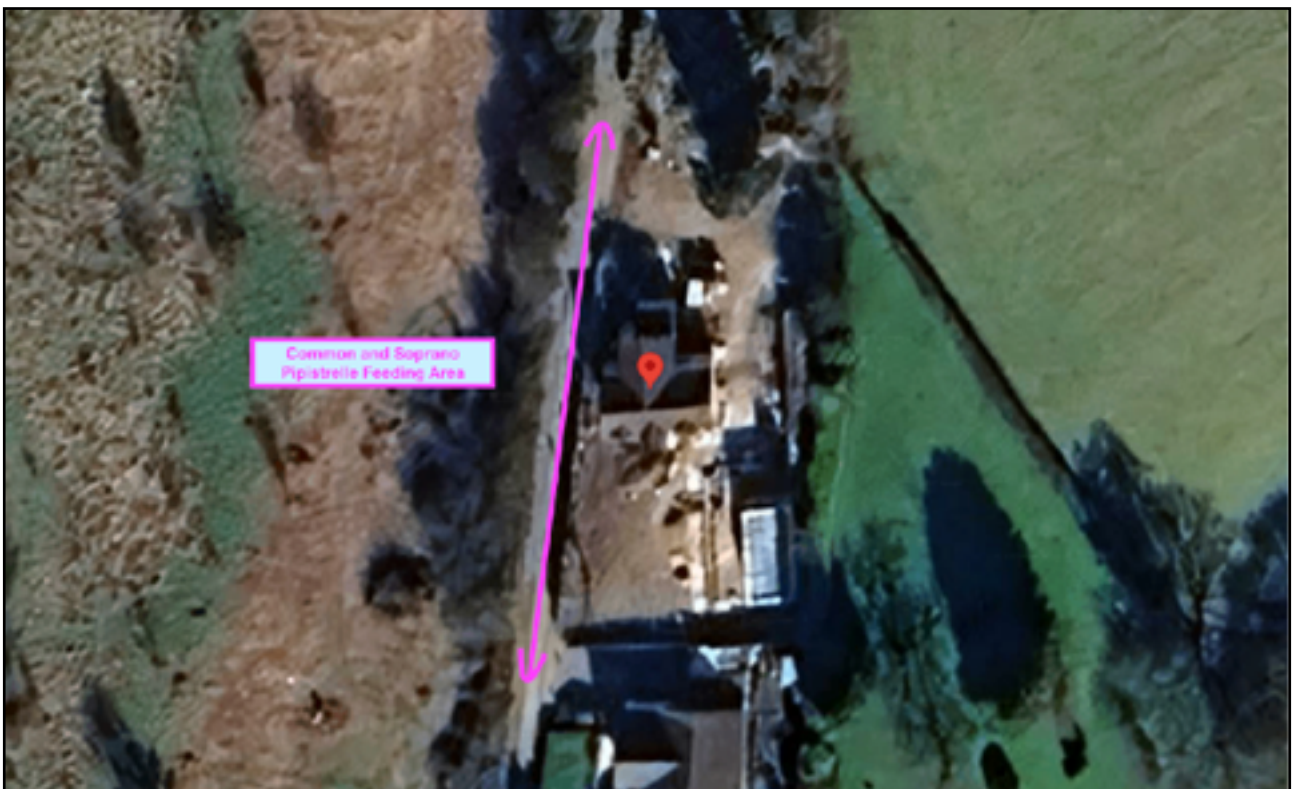
8.9 During the first emergence survey, a low number of bat calls were recorded. A small number of Common and Soprano Pipistrelles were observed feeding along the road to the immediate west of the property and a Noctule was detected but was not observed.

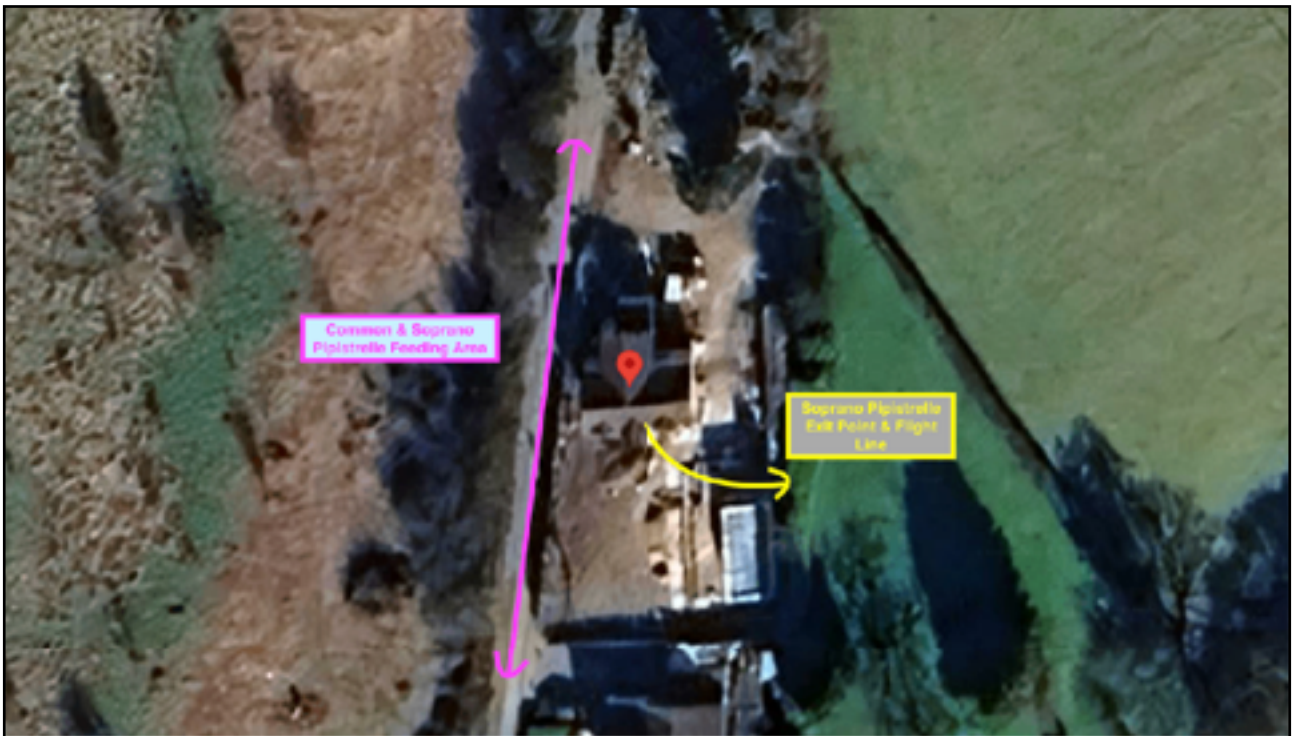
8.10 During the second emergence survey, a low number of bat calls were recorded. 2 bats were observed emerging from the building and a small number of Common and Soprano Pipistrelles were observed feeding along the road to the immediate west of the property.

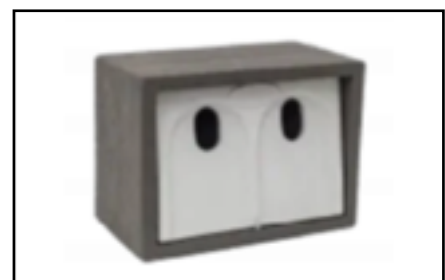
10.7 Two Vivara Pro WoodStone House Sparrow Nest Boxes will be built into the block work on the eastern elevation of the building. **These will not be situated on a south facing elevation. Care must be taken not to obstruct the entrance holes.**

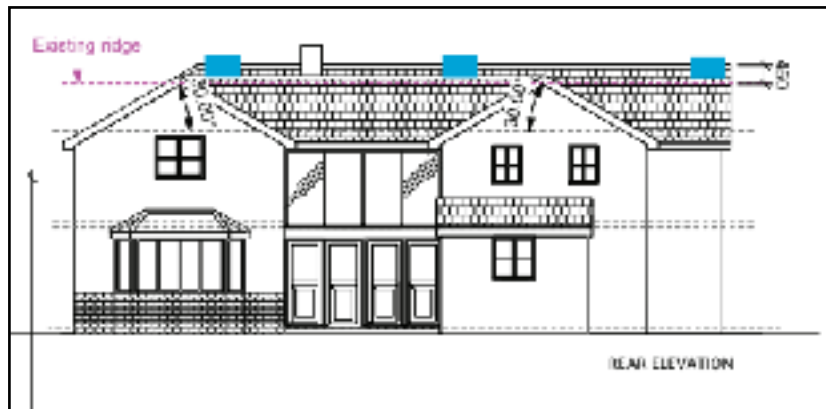
10.12 Recommended Locations of Bat and Bird Mitigation:

Location of Vivara Pro WoodStone House Sparrow Nest Box

Location of the Raised Ridge Tiles
