Bat Survey: Garden Cottage, Pentre-Poeth Road, Rhiwderin, Newport, NP10
8RT

Instructed by: David Williams Homes Ltd

Reported by: Ecological Services Ltd
10 Mount Pleasant, Llanelly Hill, Abergavenny, Monmouthshire, NP7 0NT

Author	Date	Version
Richard Watkins	June 2024	V1.0

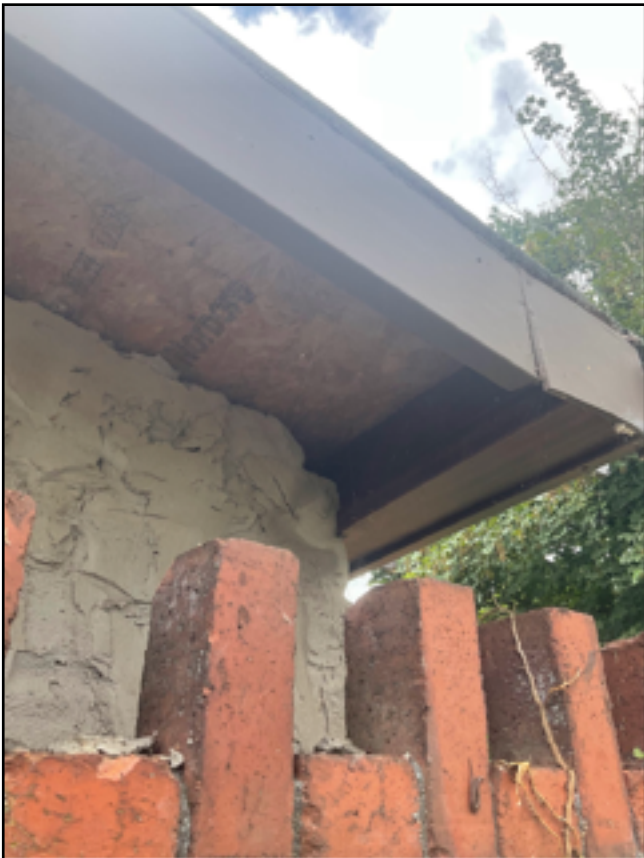
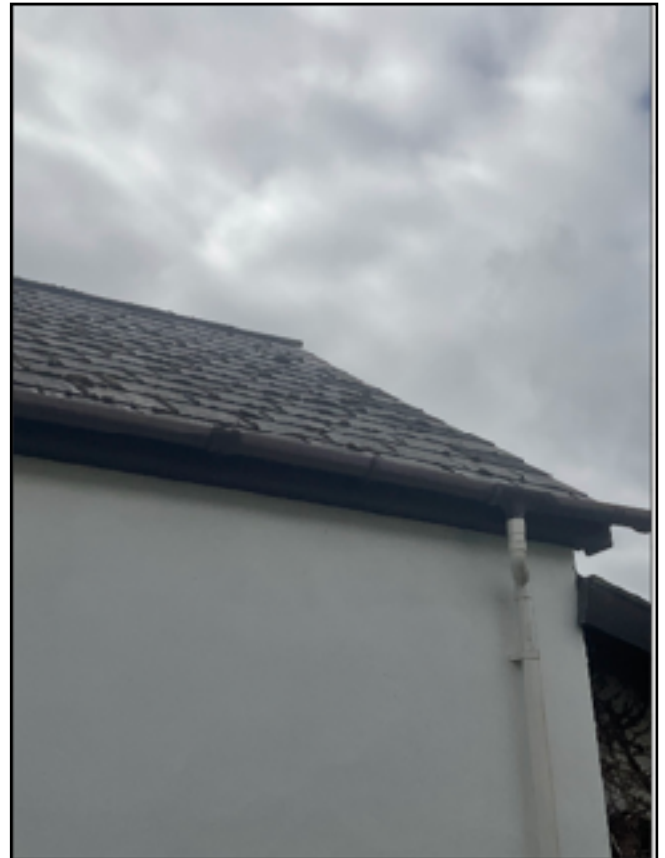
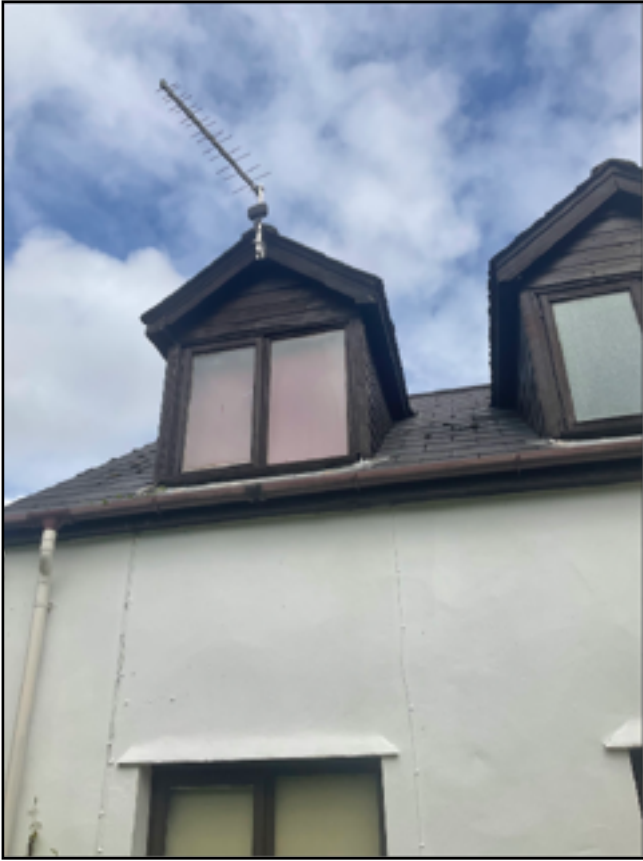
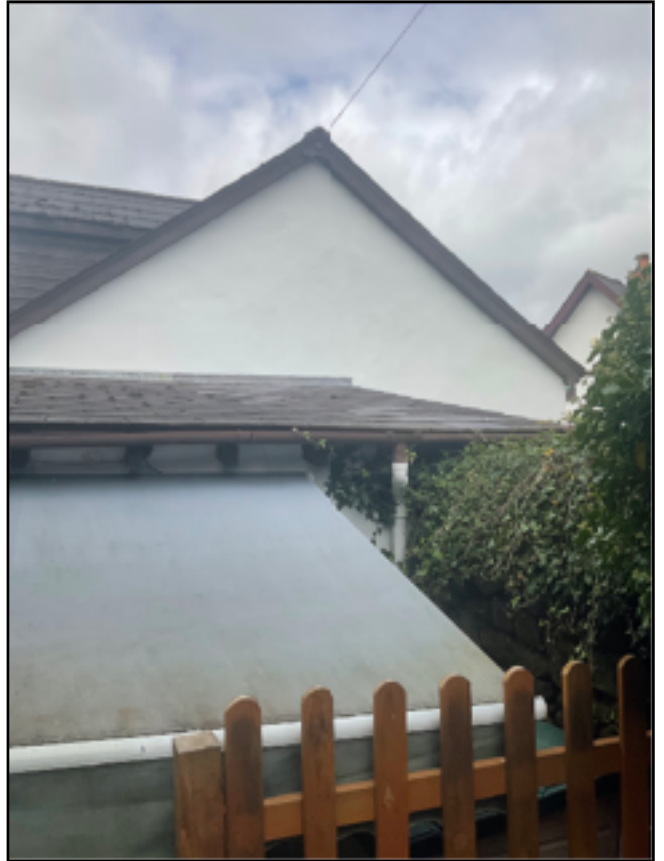
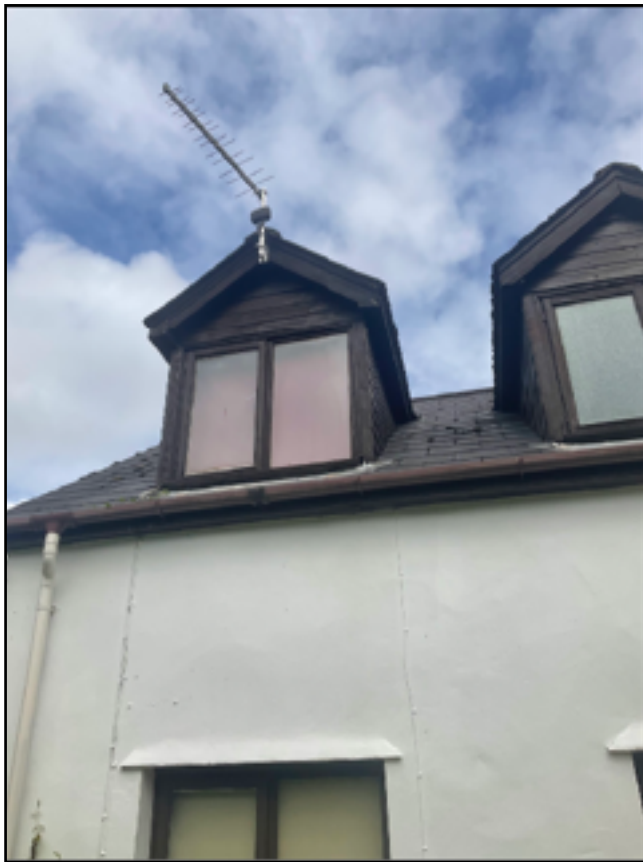
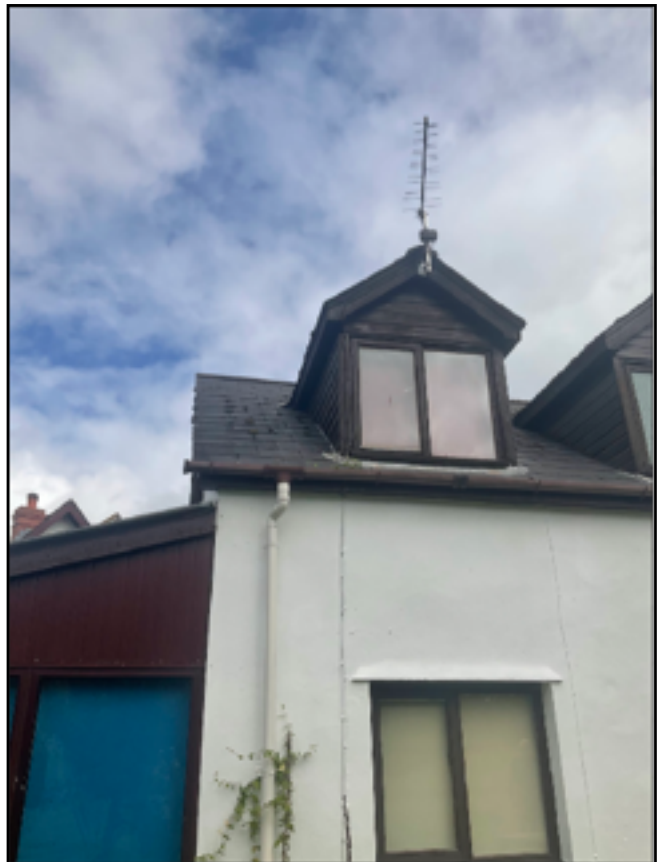
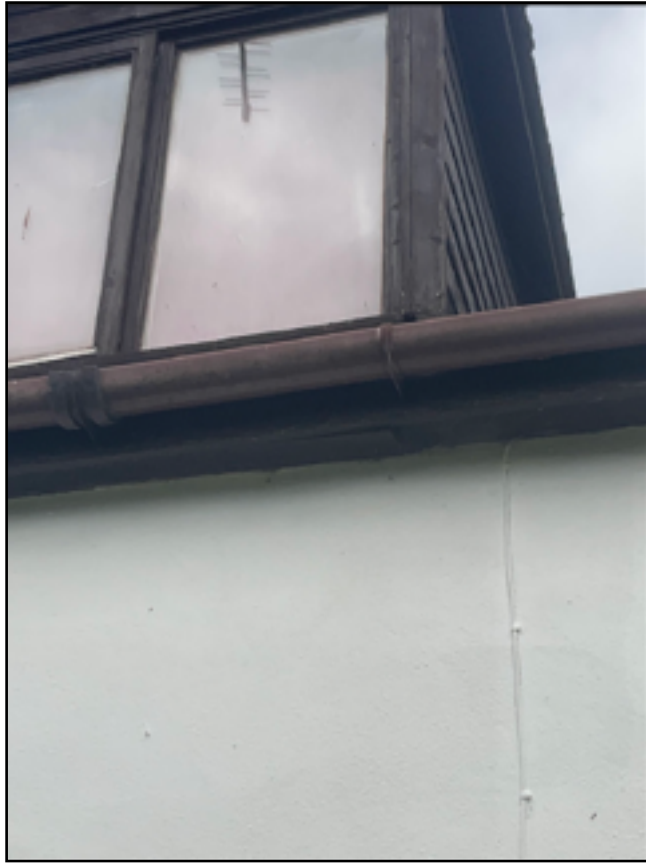
6.6 Examples of apertures allowing access to cavities in the building:

6.3 Due to the age and condition of the building, there were a small number of opportunities present for bats to access and use the building and those that were available were deemed as having moderate potential for roosting bats. There were small apertures in areas of the timber fasciae; apertures around the corners of both of the dormer windows; slightly raised slates and ridge tiles on the lean-to extension to the eastern gable end; an aperture at the apex on the eastern gable end and a slightly raised end ridge tile.

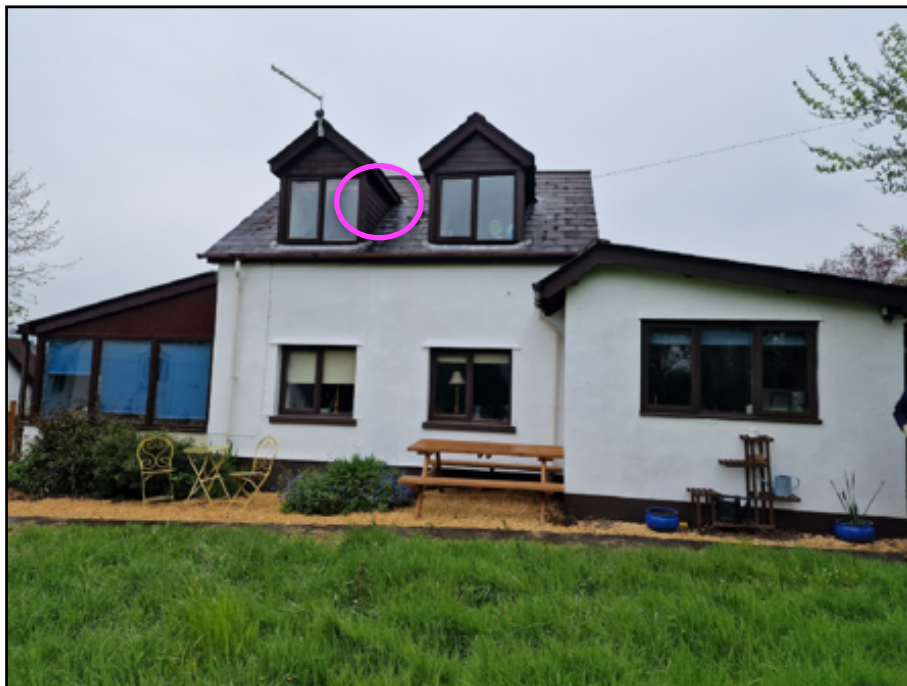
8.3 First Emergence Survey on 23rd August 2023

4 Common Pipistrelles (*Pipistrellus pipistrellus*) were observed emerging from the corner of one of the dormer windows to the southern elevation of the building.

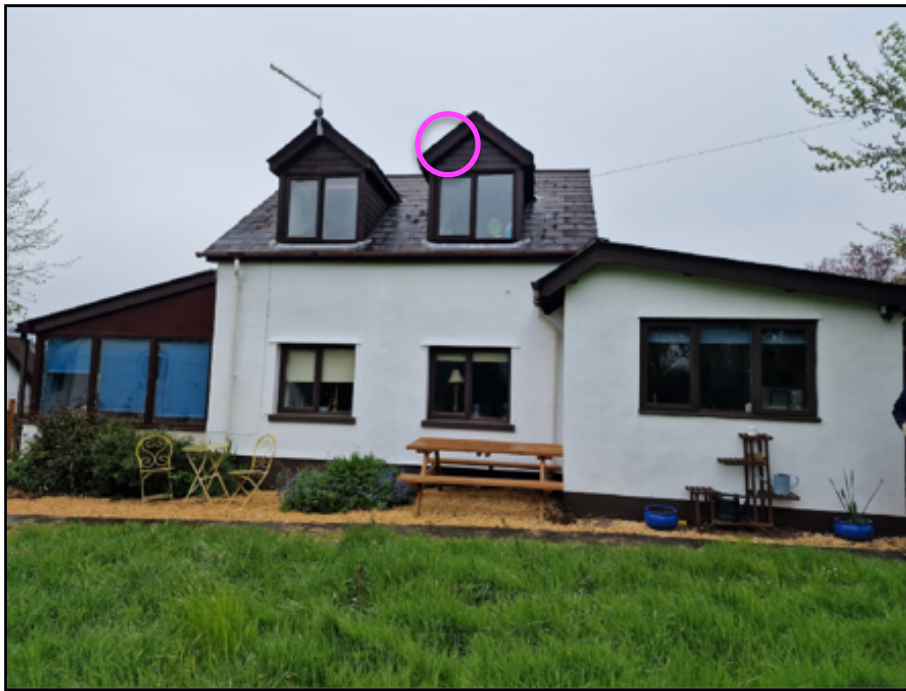
8.4 Second Emergence Survey on 18th June 2024

1 Common Pipistrelle was observed emerging from one of the dormer windows to the southern elevation of the building.

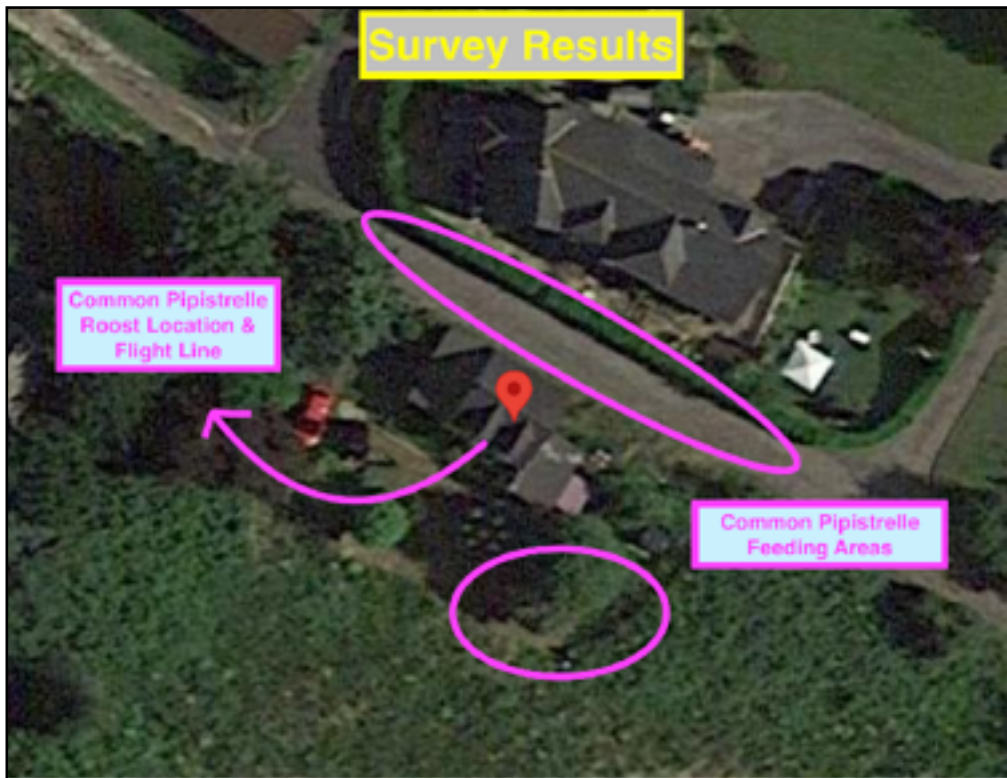
8.9 During the first emergence survey, a low number of bat calls were recorded. 4 Common Pipistrelles were observed emerging from the building; a small number of Common Pipistrelles were observed foraging around the property and a Noctule was detected but was not observed.

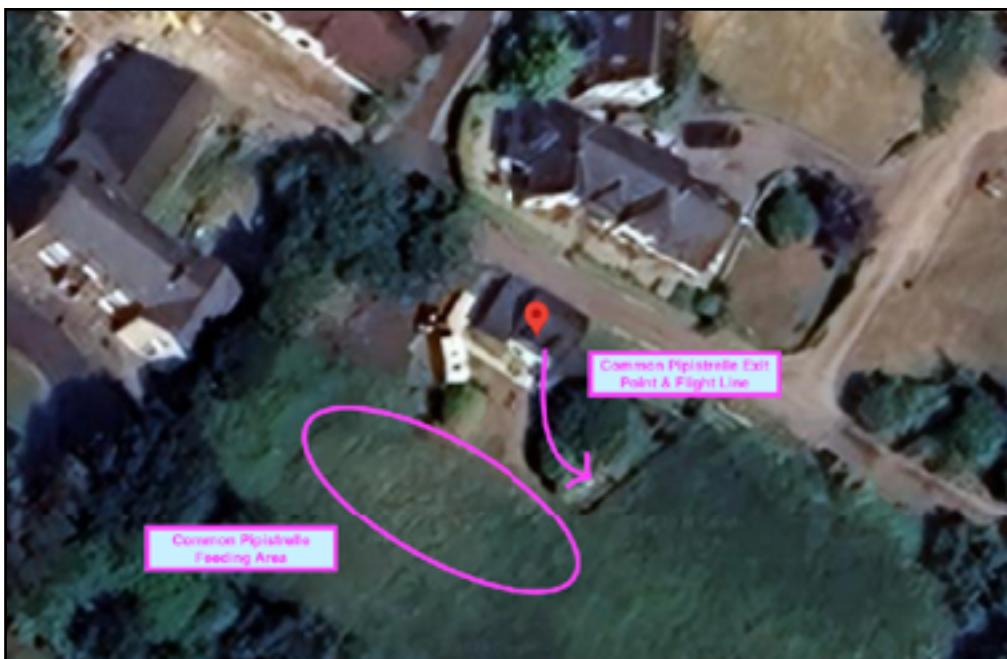
8.10 During the second emergence survey, a very low number of bat calls were recorded. 1 Common Pipistrelle was observed emerging from the building and a small number of Common Pipistrelles were observed foraging around the property.

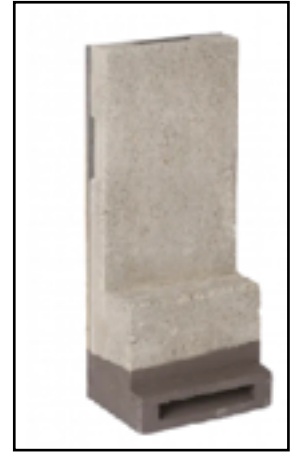
10.7 It is further proposed that new roosting for bats be created by building one Vivara Pro WoodStone Bat Box into the block work on the western elevation of the new build.

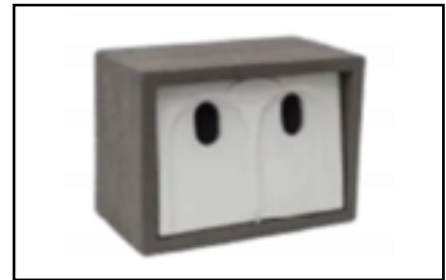
10.9 Two Vivara Pro WoodStone House Sparrow Nest Boxes will be built into the block work of the new build (one on the eastern elevation and one on the western elevation). **These will not be situated on a south facing elevation. Care must be taken not to obstruct the entrance holes.**
