**PRELIMINARY INTERIM
EARTHWORKS REPORT**
Herbert Road
Newport

Report No. 12032/ER1

REPORT TITLE : **Geotechnical and Geo-environmental Report: Proposed Residential Development, Land off Herbert Road, Newport**

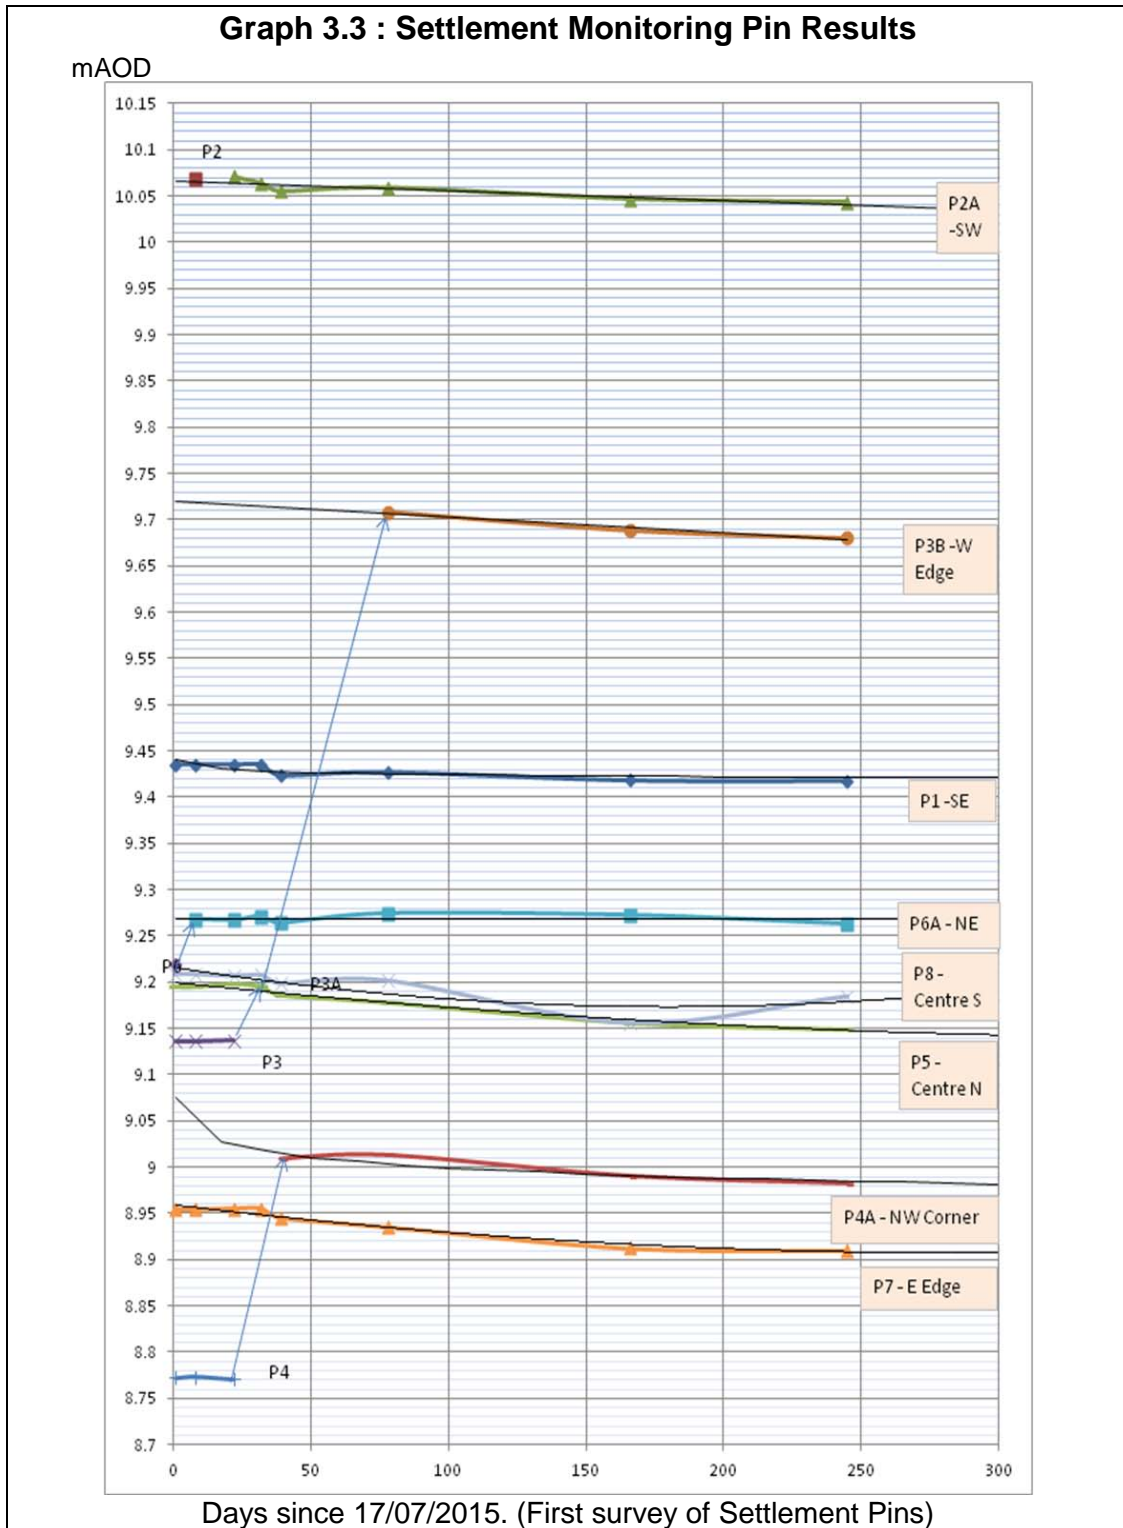
The graph below shows all of the surveyed monitoring pins on an arithmetic time scale. When a monitoring pin was damaged or destroyed an effort was made to replace the pin. When a monitoring pin was damaged / destroyed it was given a sequential alphabetical designation.

During earthworks half of the monitoring points were lost or damaged resulting in the loss of data comparable to baseline conditions. Monitoring Pins 2, 3, 4 and 6 were lost. Monitoring Pins 1, 5, 7 and 8 remain intact.

Round 1, 17/7/15. Initial Survey (P2 damaged - not surveyed)
 Round 2, 24/7/15. Initial Survey of P2 and P6A
 Round 3, 7/8/15, Initial Survey of P2A
 Round 4, 17/8/15, Initial Survey of P3A and survey of damaged P2A
 Round 5, 24/8/15, Initial Survey (P3A damaged - not surveyed)
 Round 6, 2/10/15 Initial Survey of P3A

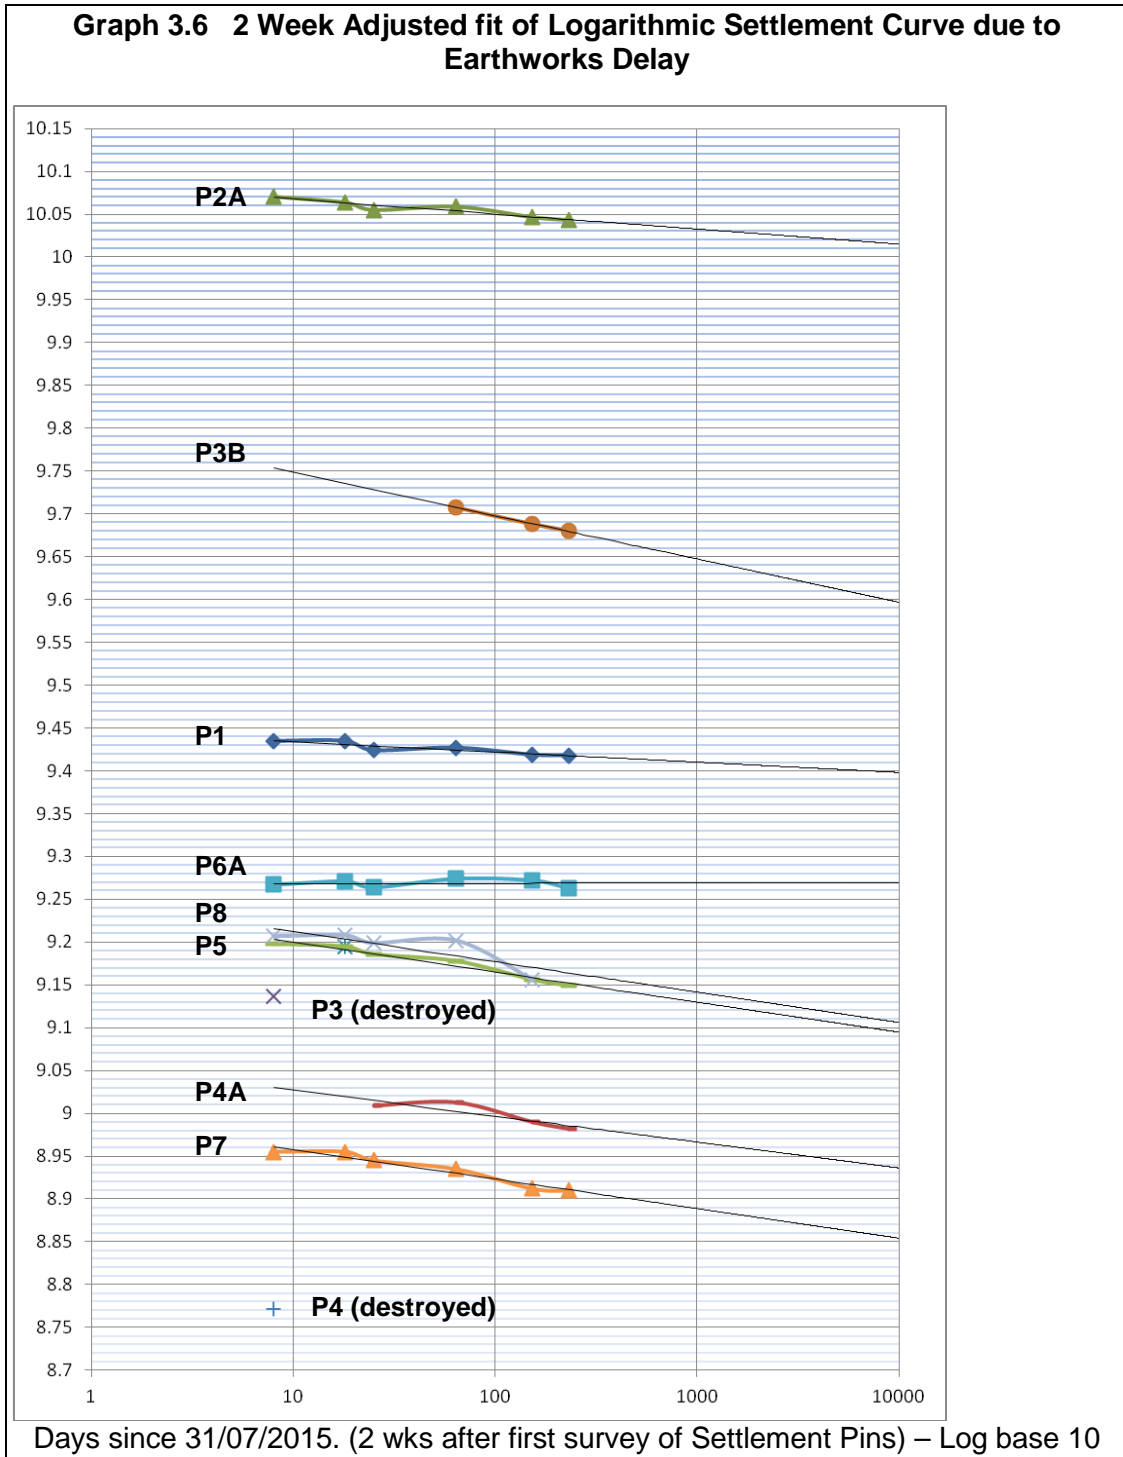
Data for Monitoring Pins 5, 7 and 8 do not appear to fit a logarithmic settlement curve as no settlement was observed within the first two weeks. This suggests that the start date may be out. Therefore Graph 3.6 shows settlement on a logarithmic scale starting on 31/7/2015, two weeks after the commencement of the earthworks. Settlement at Monitoring Pins 5 and 7 appear to be a closer fit as a result.

Data for Monitoring Pins 5, 7 and 8 do not appear to fit a logarithmic settlement curve suggesting that the start date may be out. No settlement was observed within the first two weeks. This could be a result of the earthworks taking longer than anticipated and the placement of fill in these areas being delayed. It has therefore been considered to discount the first two weeks of placement of the settlement pins since the correlation with a logarithmic settlement curve is closer.
