# Landscape and Visual Appraisal

**Retrospective Planning Application to Caerphilly  
County Borough Council For a Single Lake**

**Cefn Mably Farm Park, Cefn Mably, Cardiff, CF3 6LP**

**Date: 22 April 2025**

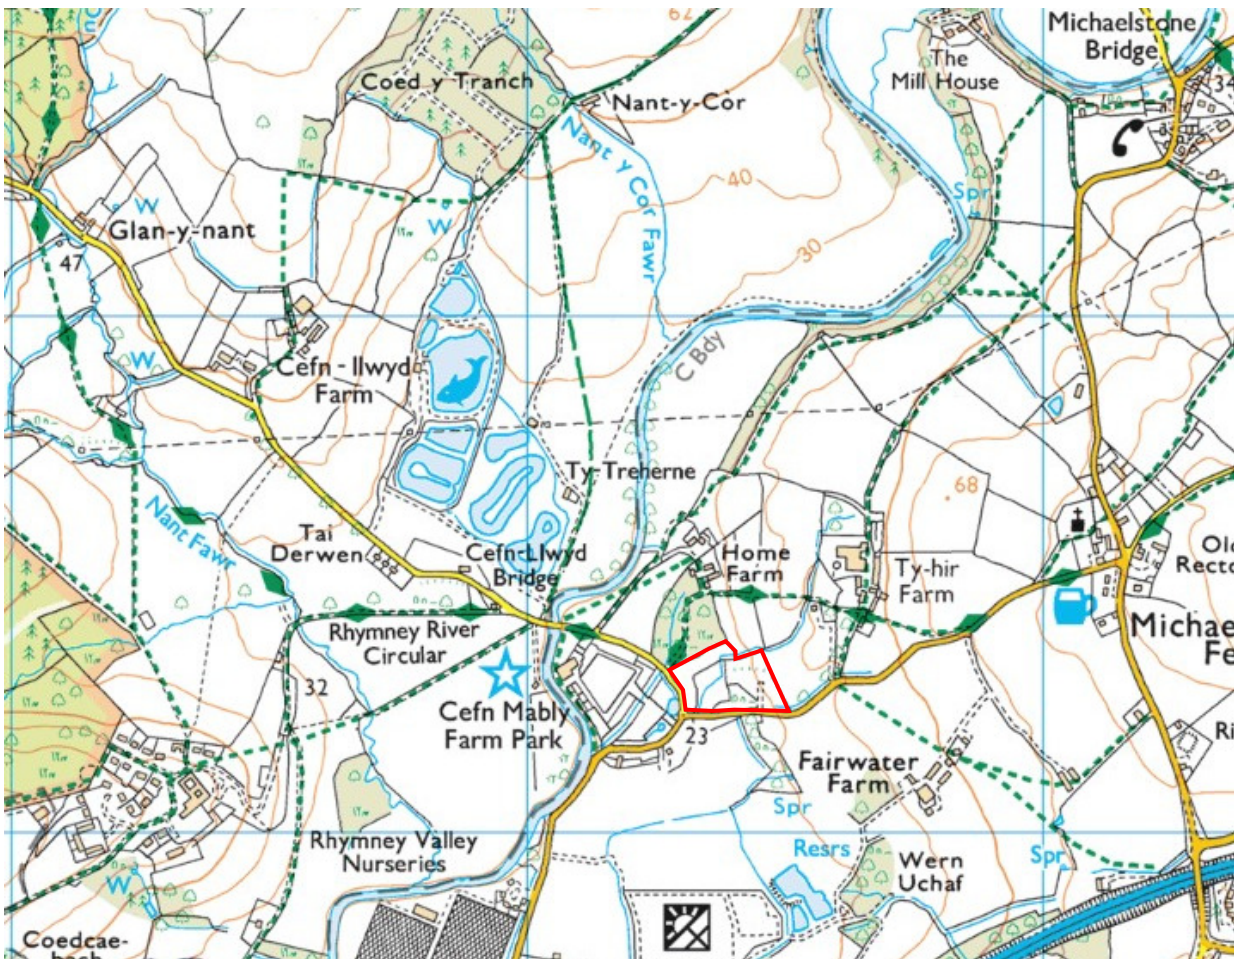
Figure 1: Location Plan and Development Site

The local topography and woodland blocks provide considerable screening of the development site from view point locations to the north and west. The small village of Michaelston-y-Fedw is located on the local high ground to the east of the development site but is screened from the developments site by local topography and local trees and hedgerow.

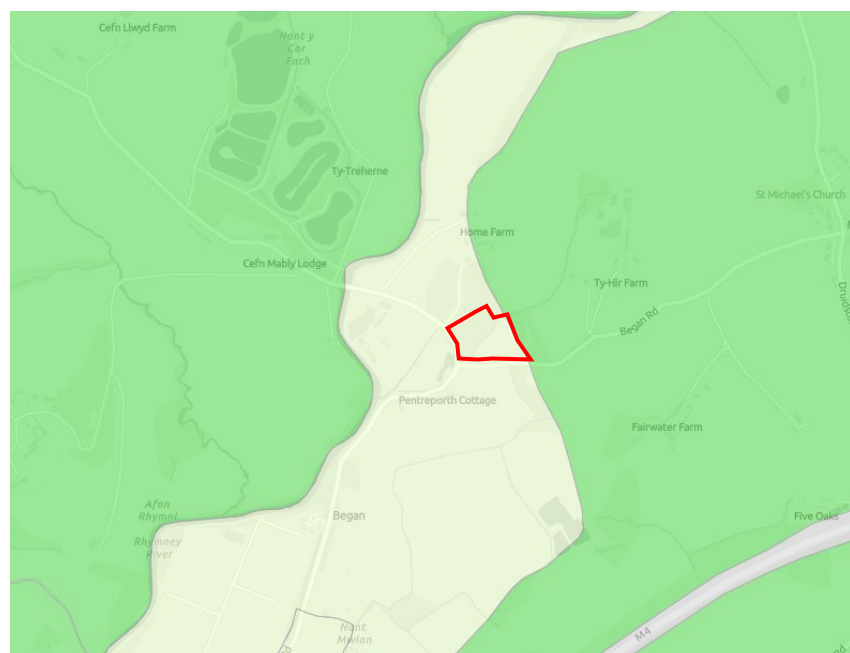
Figure 2: **Rhydney Valley NWPRTVS003** (Visual and Sensory)

Therefore, the **Rhymney Valley NWPRTVS003** has a **Medium Sensitivity** to the lake development.

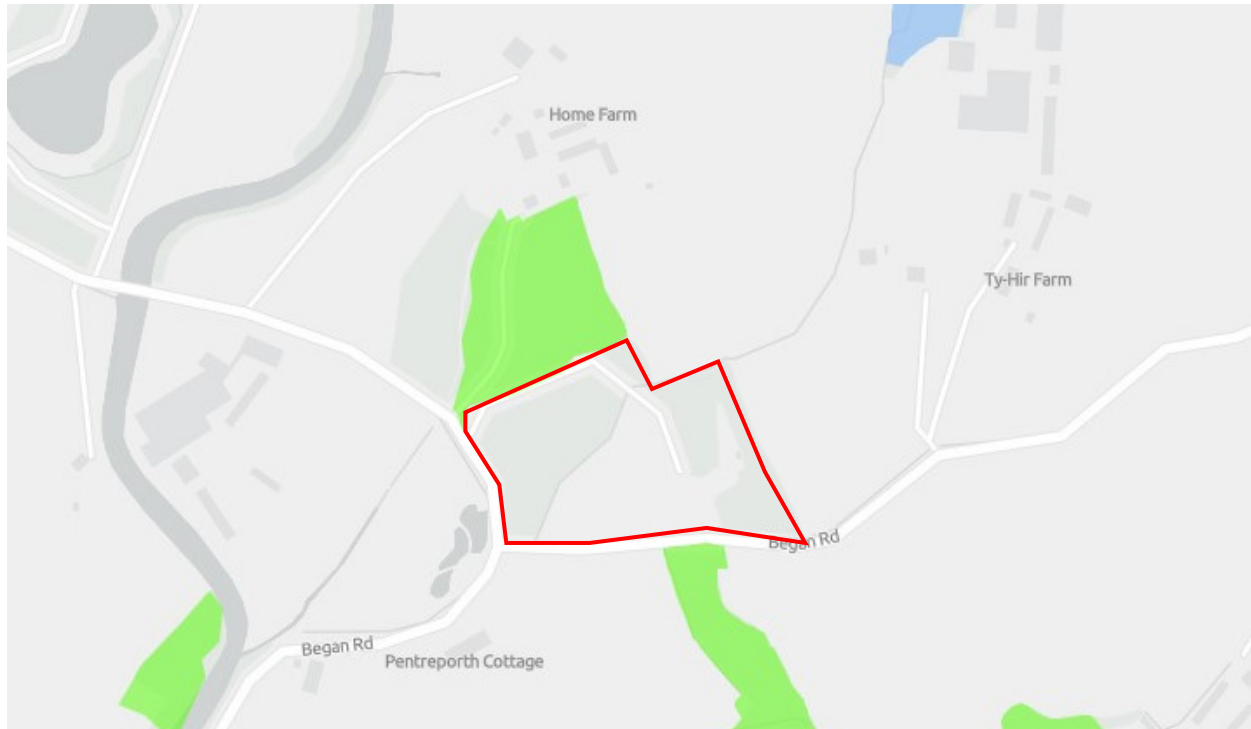
There are several blocks of Ancient Semi-Natural Woodland that are located to the north and the south of the developments site and along the Rhymney River corridor to the north-west. These woodland blocks would not be directly impacted by the lake development and provide considerable screening of the development site from the higher ground locations to the north and west.

Figure 3: Ancient and Semi-Ancient Woodland

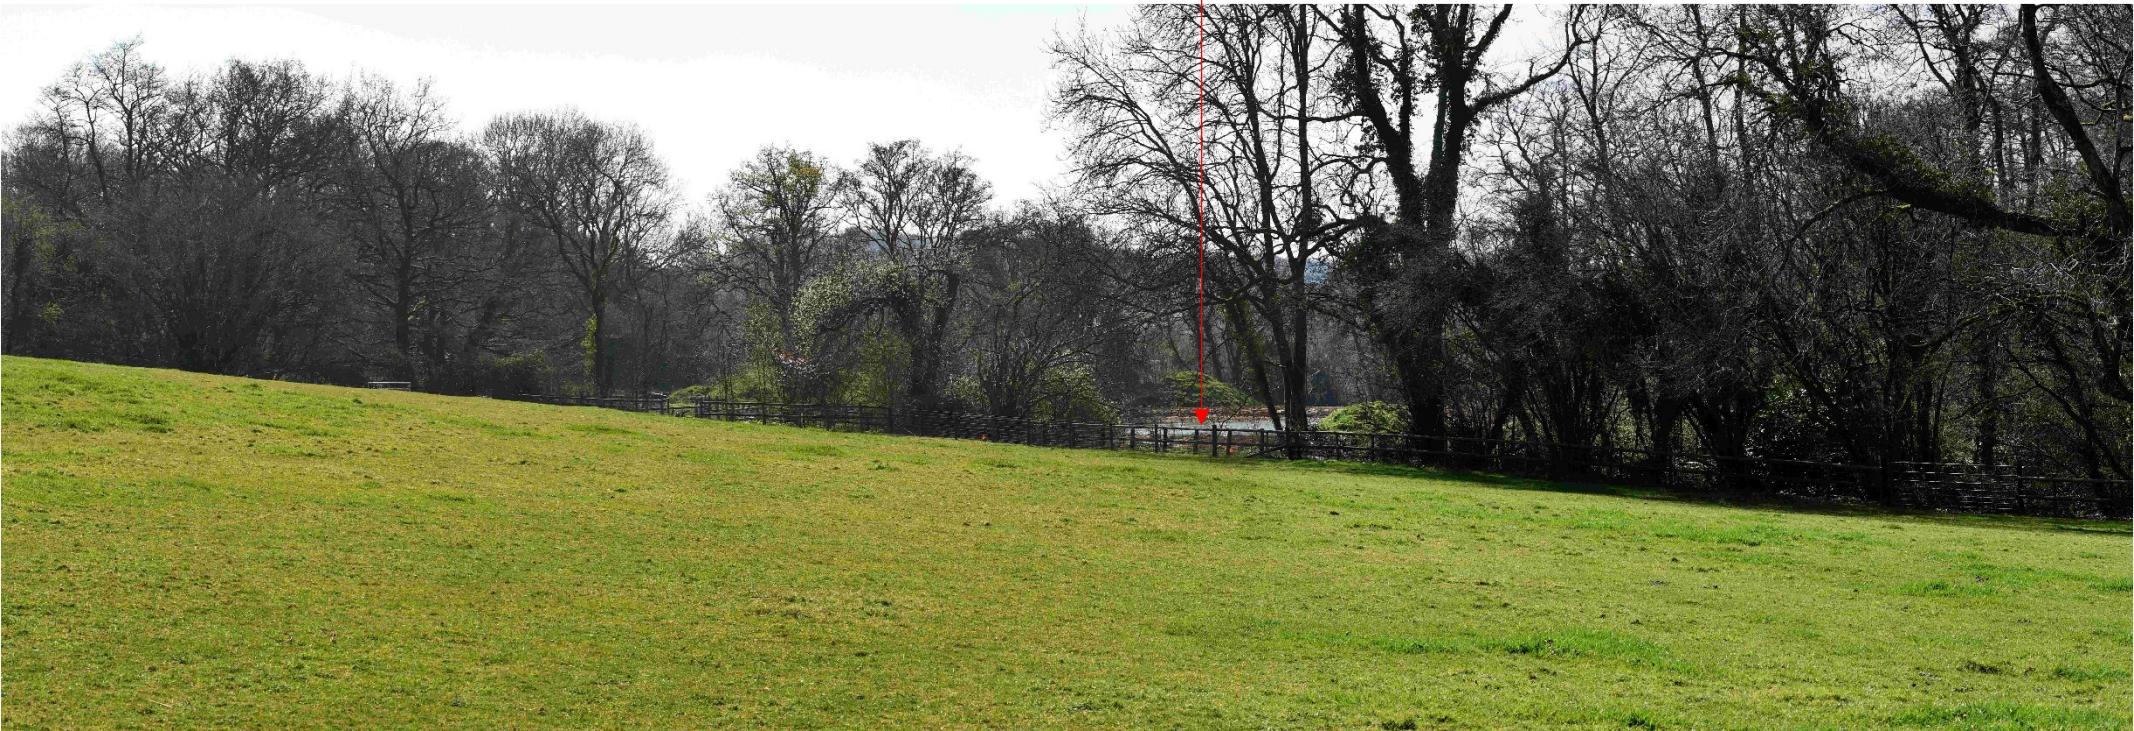
**Viewpoint 1: Rhymney Circular Footpath, near Home Farm, Looking South.**

Lake Within Development Site With Newly Planted Trees

This photograph is taken from the footway and is a good example of the view by local hikers as they walk along a short section within this sloped field.

The existing boundary hedgerow to this development site, as seen in this photograph, already contributes to the reducing views toward the lake and adjacent earth bunds.

New tree and hedgerow planting would contribute to reducing the view of the lake and earth bunds.

| Landscape Sensitivity to Change: | Medium, | Magnitude of Change: | NEGLIGIBLE, | Significance of Effect (Residual): | NEUTRAL. |
| Visual Sensitivity to Change (Footpath): | High, | Magnitude of Change: | Negligible, | Significance of Effect (Residual): | NEUTRAL. |

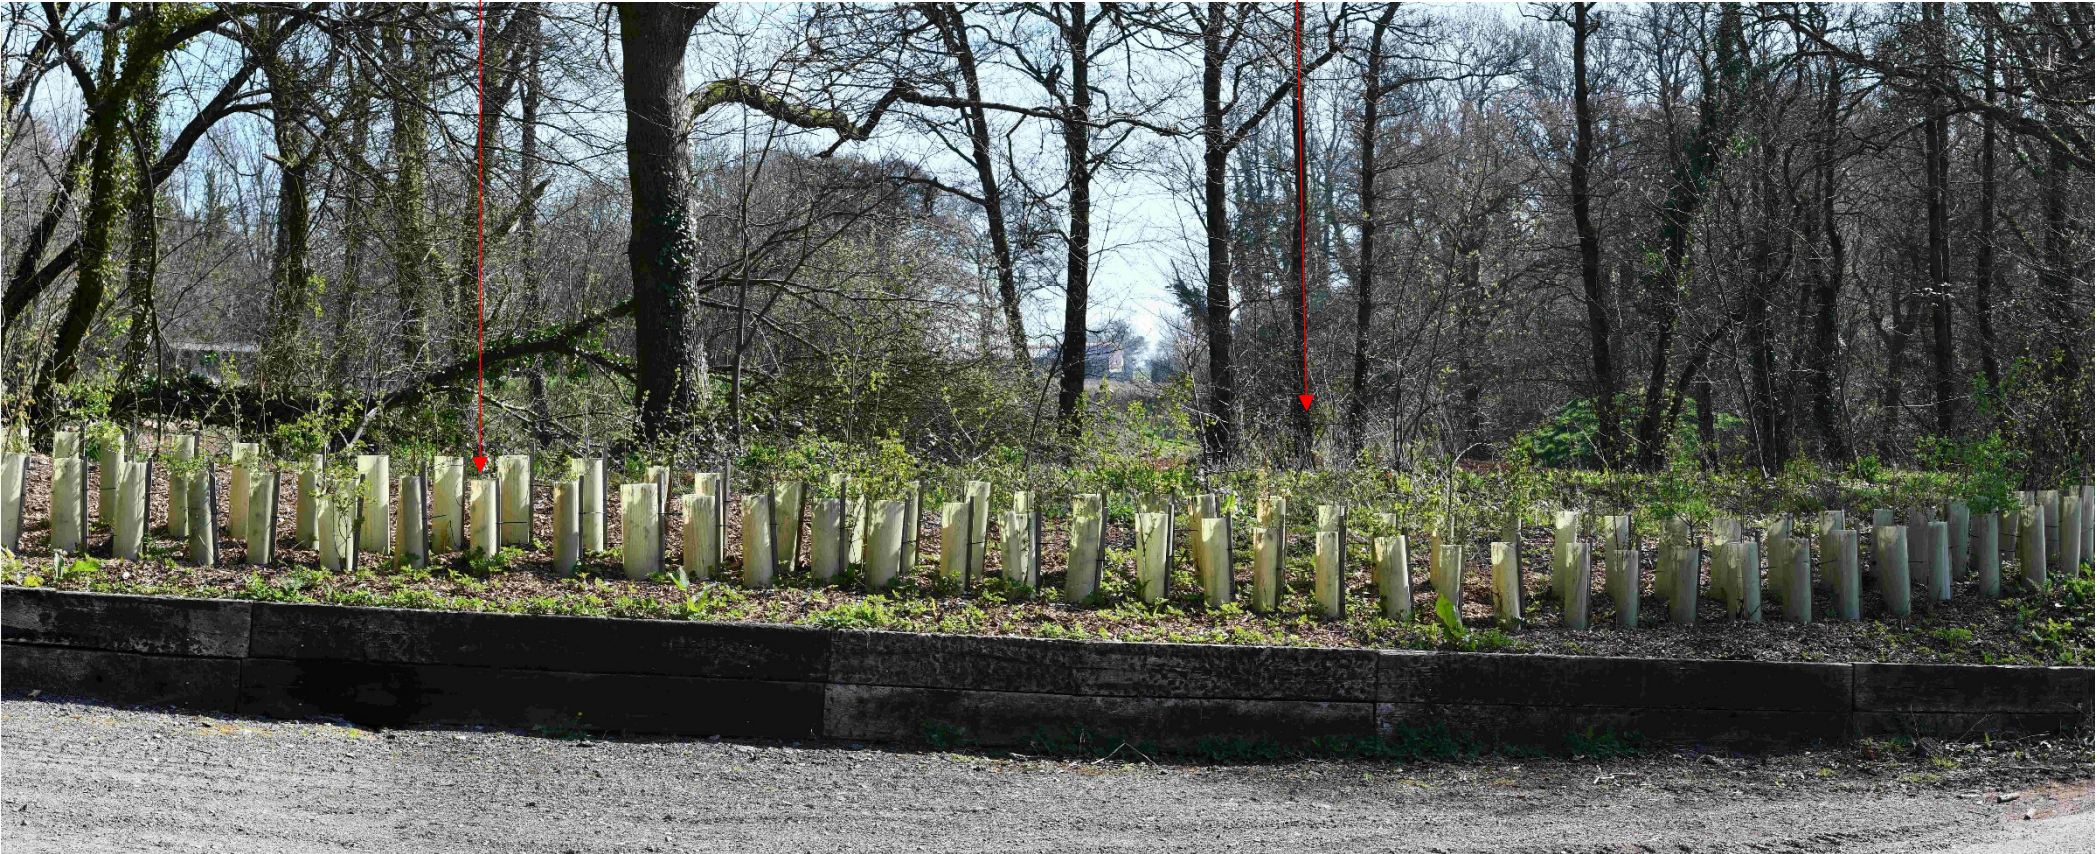
Viewpoint 2: Cefn Mably Road, Looking East.

Newly Planted Tree and Hedge Along Cefn Mably Road  
and Entrance into Development Site.

Approximate Direction of Lake

This photograph is taken at the Cefn Mably Road junction and the private access track into the development site.

From Cefn Mably Road there are no views of the development site due to adjacent tall trees and mature, dense hedgerow.

A new boundary of trees and hedgerow has been planted, as seen in the photograph, and would, in time, return a native hedgerow along this section of Cefn Mably Road.

| Landscape Sensitivity to Change: | Medium, | Magnitude of Change: | NEGLIGIBLE, | Significance of Effect (Residual): | NEUTRAL. |
| Visual Sensitivity to Change: | Low, | Magnitude of Change: | NONE, | Significance of Effect (Residual): | NO CHANGE. |

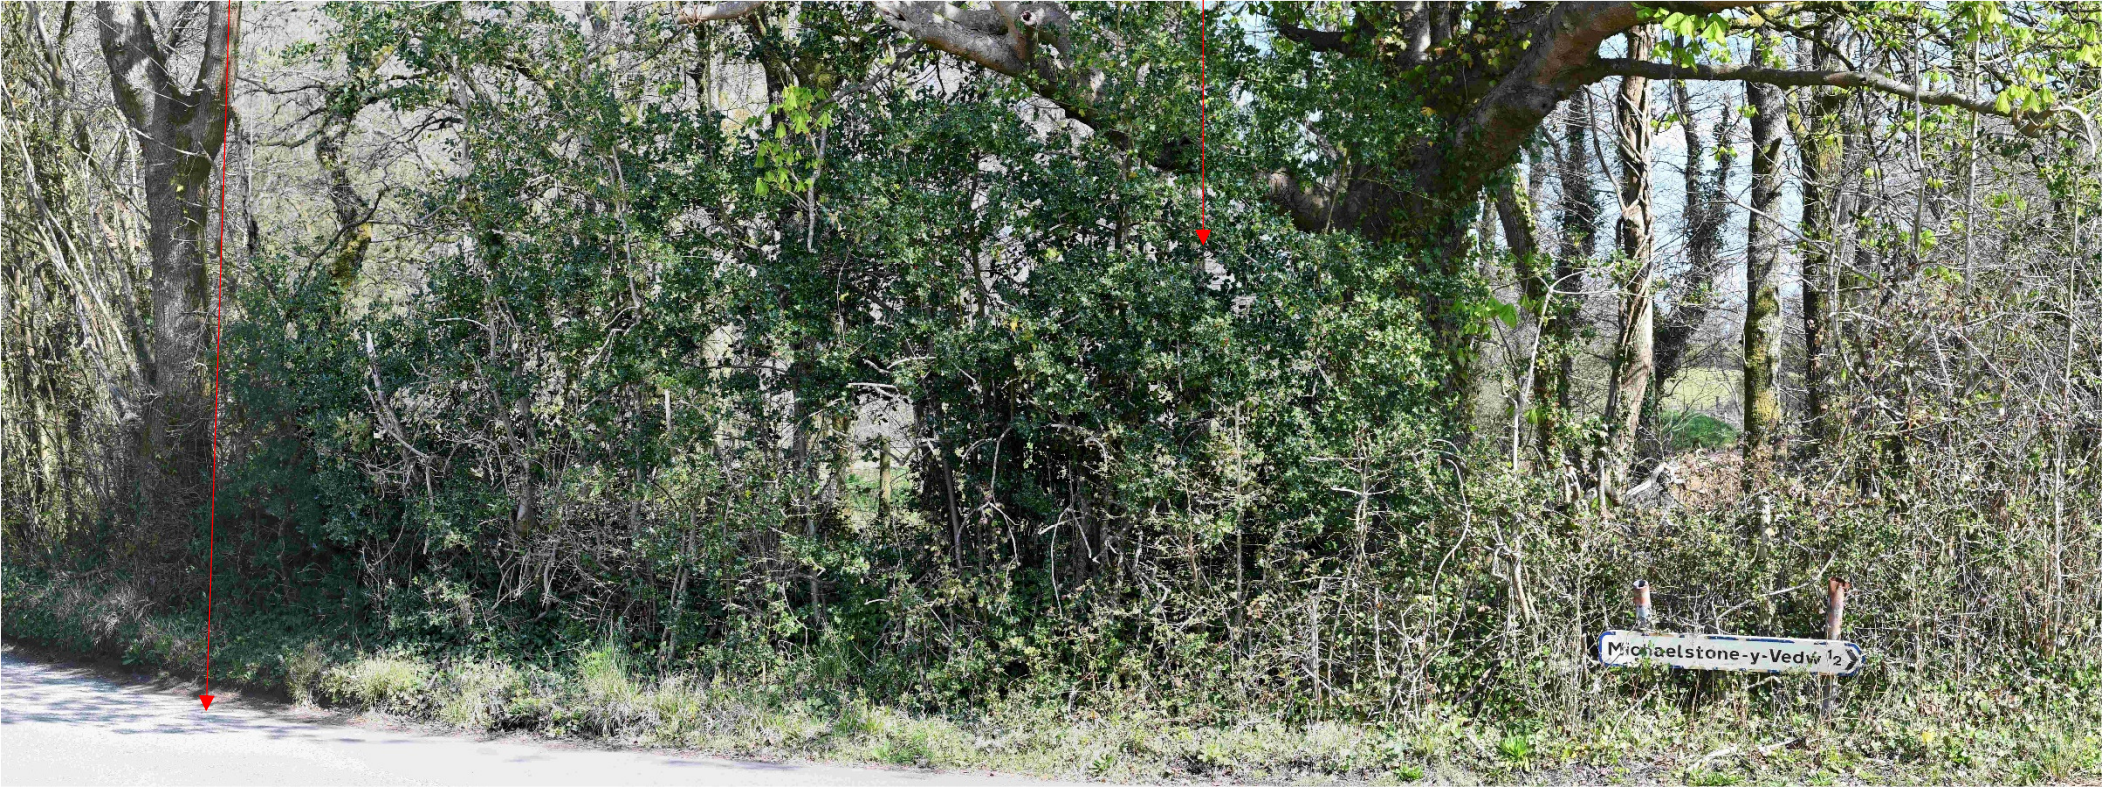
Viewpoint 3: Junction of Cefn Mably Road and Bagan Road, Looking East.

NO VIEW

This photograph is taken from the junction of the adjacent Cefn Mably Road / Bagan Road and the existing dense hedgerow and trees provide screening into the development site.

It is intended that as part of the ongoing management that the boundary trees and hedgerow would be maintained as seen in the photograph and would continue to screen the lake within the development site.

| Landscape Sensitivity to Change: | Medium, | Magnitude of Change: | NEGLIGIBLE, | Significance of Effect (Residual): | NEUTRAL. |
| Visual Sensitivity to Change: | Medium, | Magnitude of Change: | NEGLIGIBLE, | Significance of Effect (Residual): | NO CHANGE. |

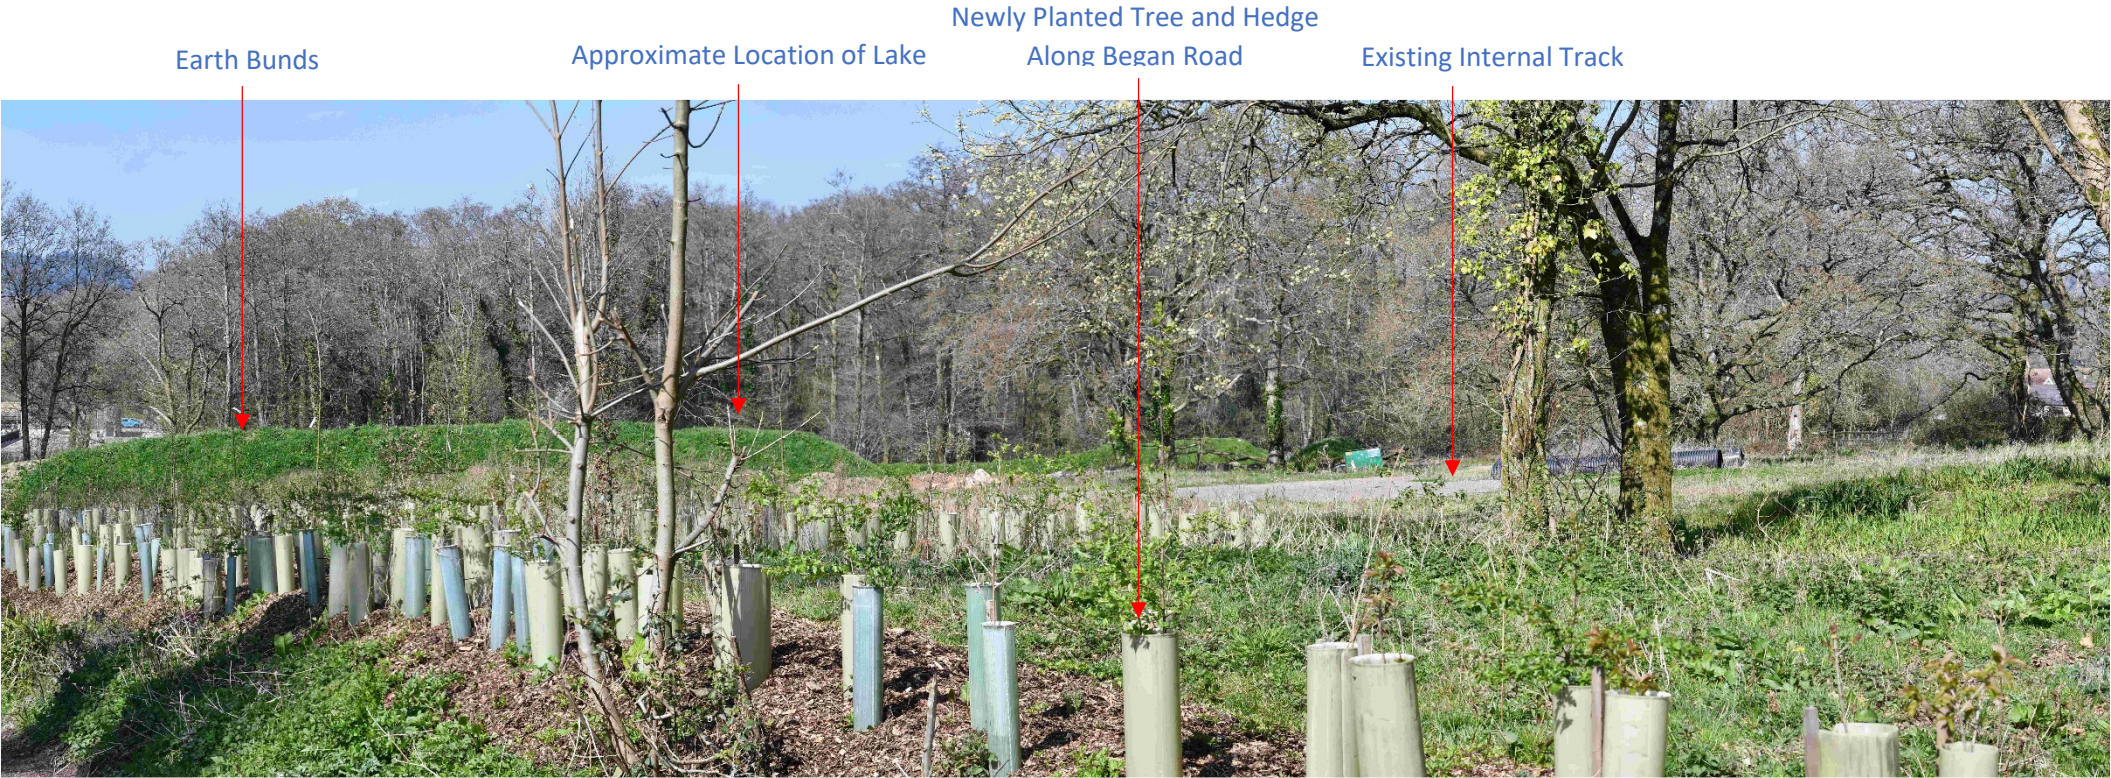
Viewpoint 4: Began Road, Looking North.

This photograph is taken from the adjacent Began Road along the southern boundary of the development site. There is no view of the lake but there is an oblique, partial and transient view of the earth bunds within the development site.

A new boundary of trees and hedgerow has been planted, as seen in the photograph, and would, in time, return a native hedgerow along this section of Began Road as well as reduce the impact of the earth bunds.

| Landscape Sensitivity to Change: | Medium, | Magnitude of Change: | NEGLIGIBLE, | Significance of Effect (Residual): | NEUTRAL. |
| Visual Sensitivity to Change (Roadway): | Low, | Magnitude of Change: | NEGLIGIBLE, | Significance of Effect (Residual): | NEUTRAL. |

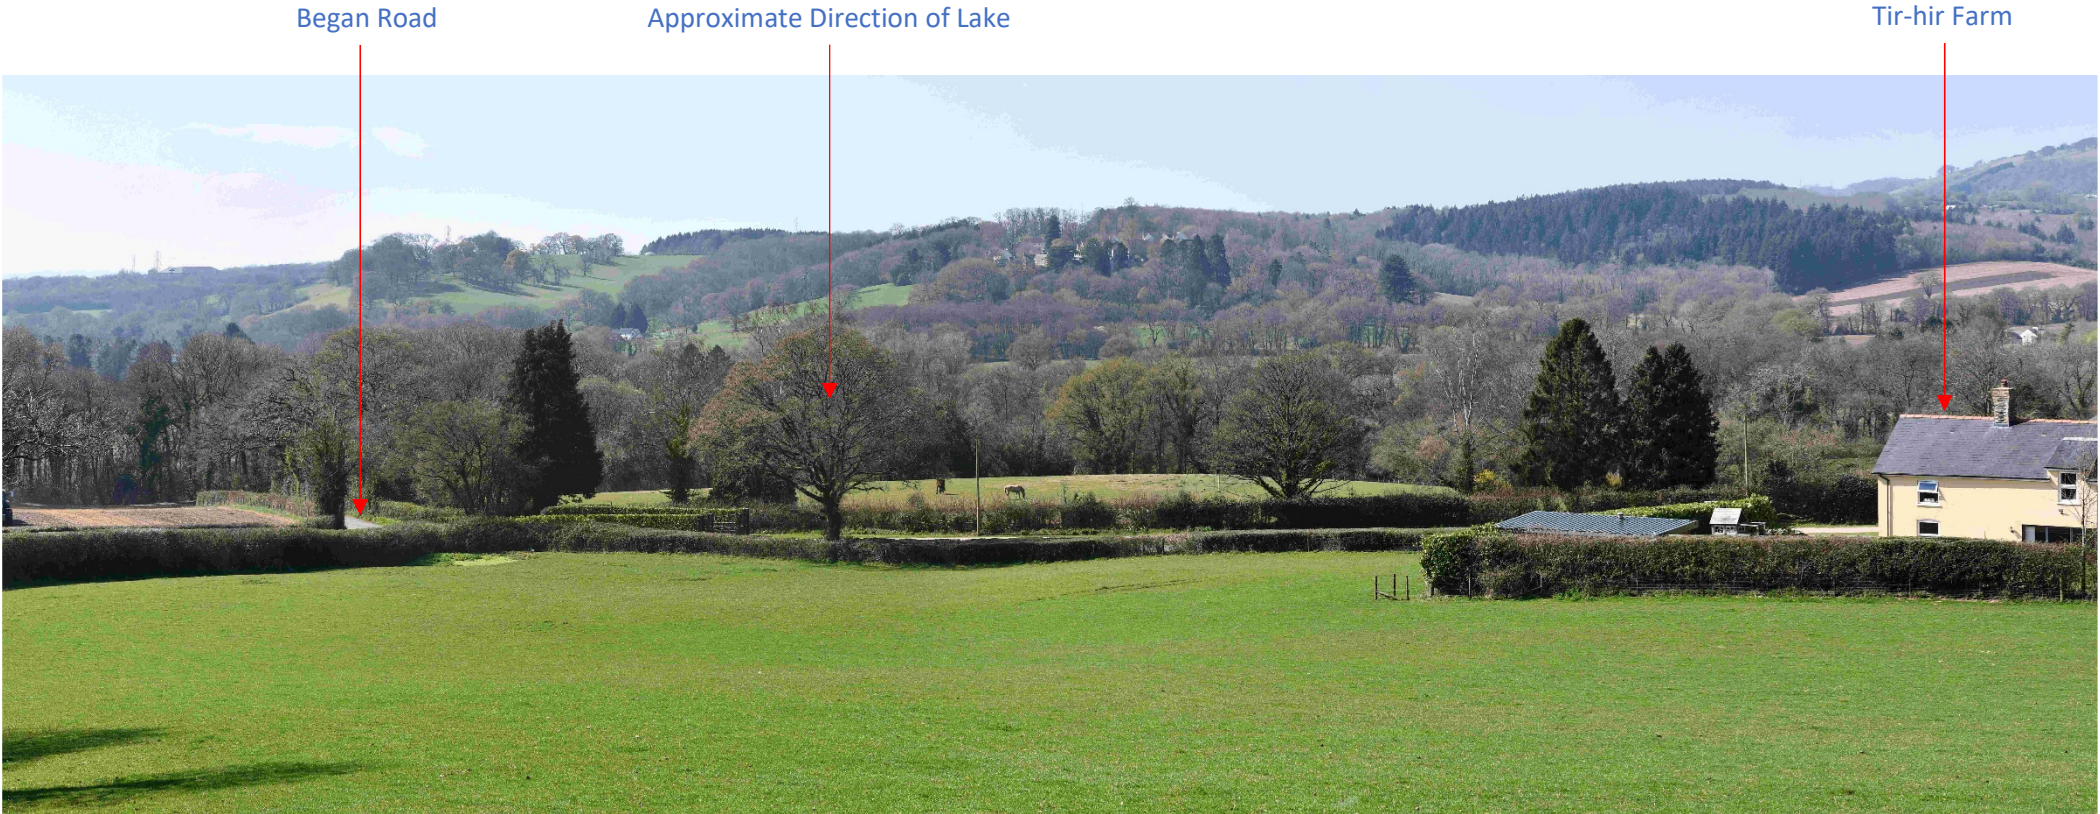
Viewpoint 5: Footpath near Ty-hir Farm, Looking West.

NO VIEW

This photograph is taken from the footpath, located (approx. 800m) to the east of the development site and there are no views of the development site due to existing mature and tall hedgerows and the local undulating topography.

It is intended that as part of the ongoing management that the boundary trees and hedgerow would be maintained, as seen in the photograph, and would continue to screen the lake within the development site.

| Landscape Sensitivity to Change: | Medium, | Magnitude of Change: | NEGLIGIBLE, | Significance of Effect (Residual): | NEUTRAL. |
| Visual Sensitivity to Change (Footpath): | Medium, | Magnitude of Change: | NONE, | Significance of Effect (Residual): | NO CHANGE |

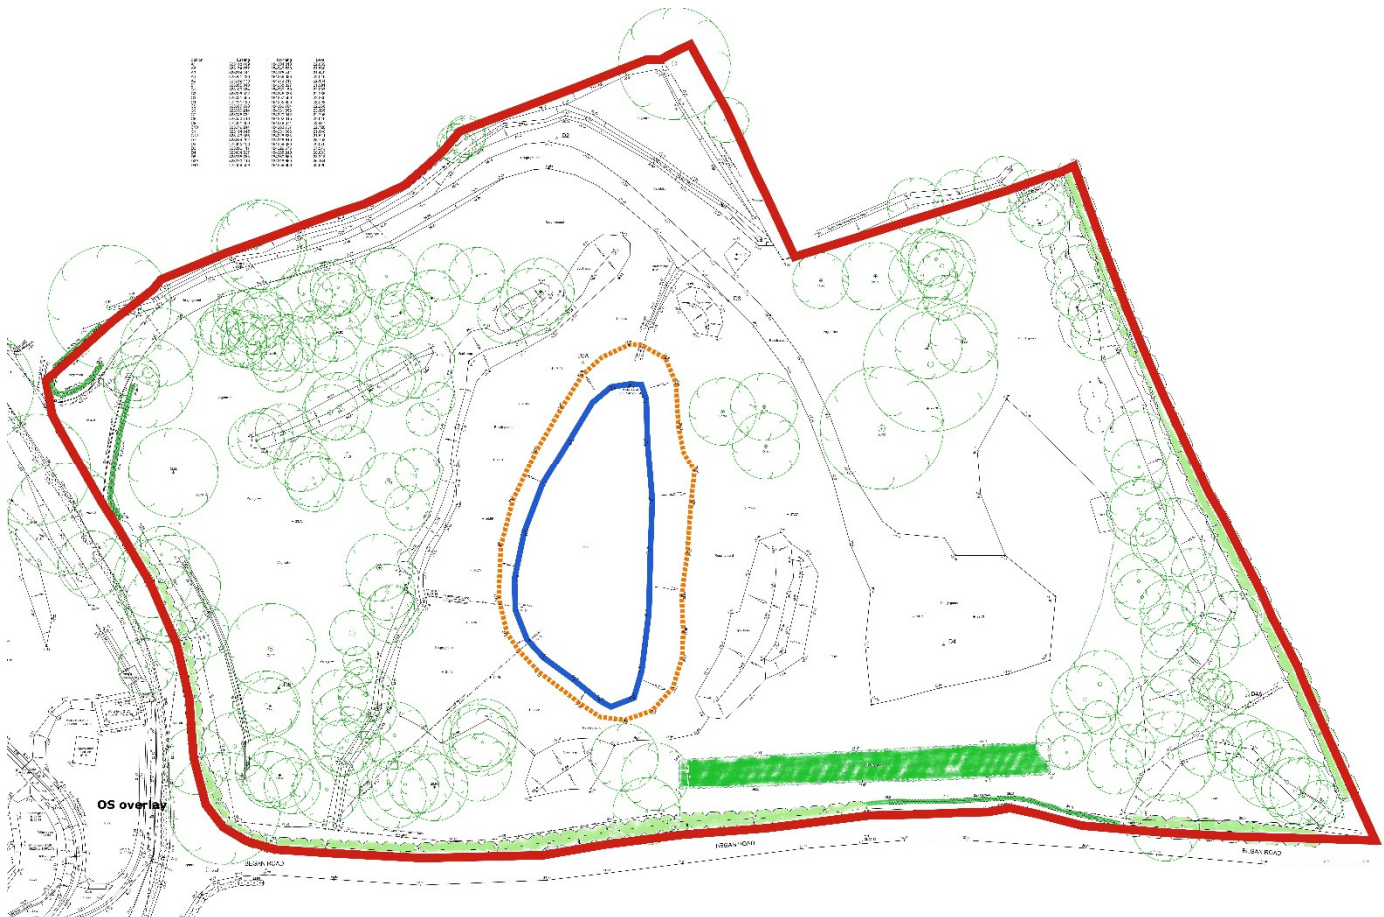
Figure 7: Landscape Plan - Existing and Proposed Hedgerow Planting

Significant lengths of hedgerow have already been planted along Cefn Mably Road and Began Road as well as 'secondary' tree belts and numerous individual trees (6-8cm girth) which would all contribute to reducing the visual impact of the lake and associated earth bunds (approx. 2 metres tall).

There have been planted significant lengths of hedgerow along Cefn Mably Road and Began Road as well as 'secondary' tree belts and numerous individual trees (6-8cm girth) along the southern boundary. All of which would contribute to reducing the visual impact of the lake and associated earth bunds (approx. 2 metres tall).
