NEWPORT SILO BASE

GEO-ENVIRONMENTAL APPRAISAL

SEPTEMBER 2024

| Document Control Form | |
|---|---|
| REPORT REFERENCE | GRO-23226-5338 |

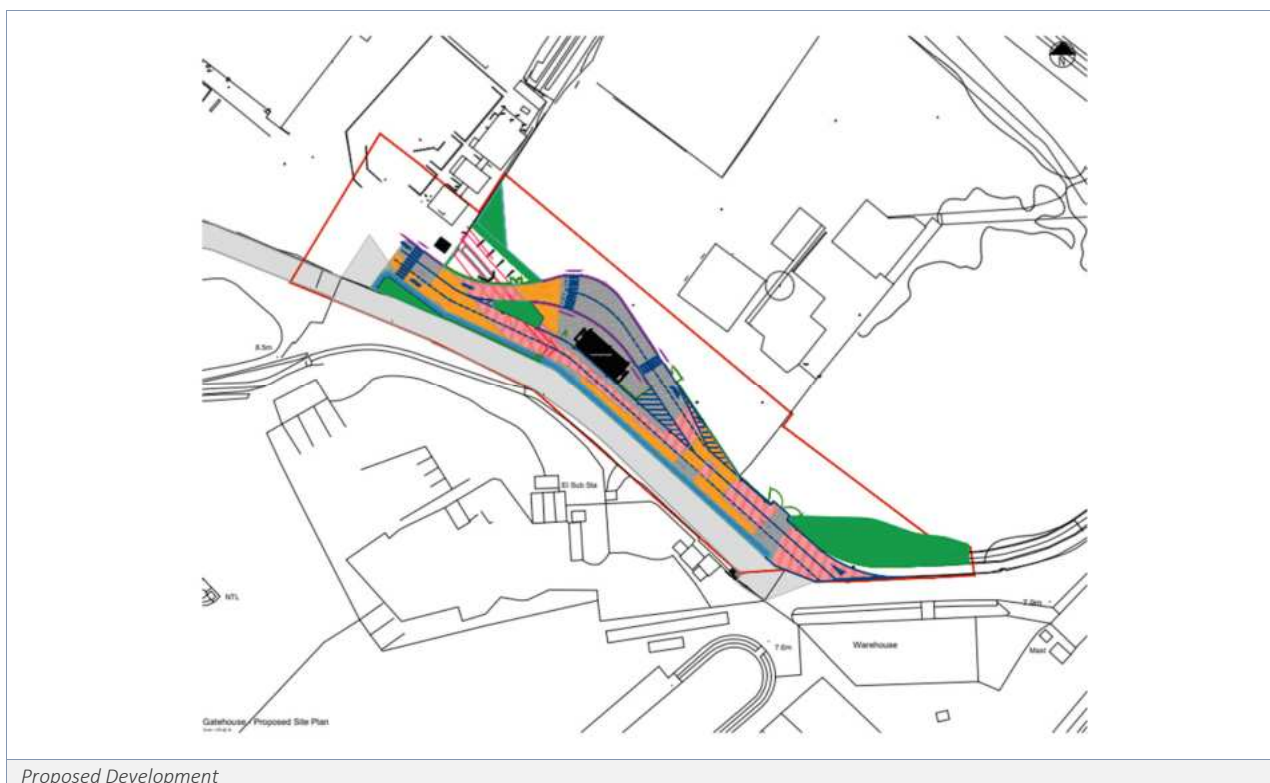
The proposed development is commercial end use comprising a new access road and site entrance to the site.

Some areas of the existing roadway are to be retained and some are to be grubbed up and replaced with new roadways in line with Couch consulting plan 221681-AHR-GH-XX-DR-A-SK-010.

The access road at the site is to be retained and replaced in accordance with Couch Consulting plan 221681-AHR-GH-XX-DR-A-SK-010 as shown below, hatchings on the plan denote the varying areas of the new access road to be constructed.

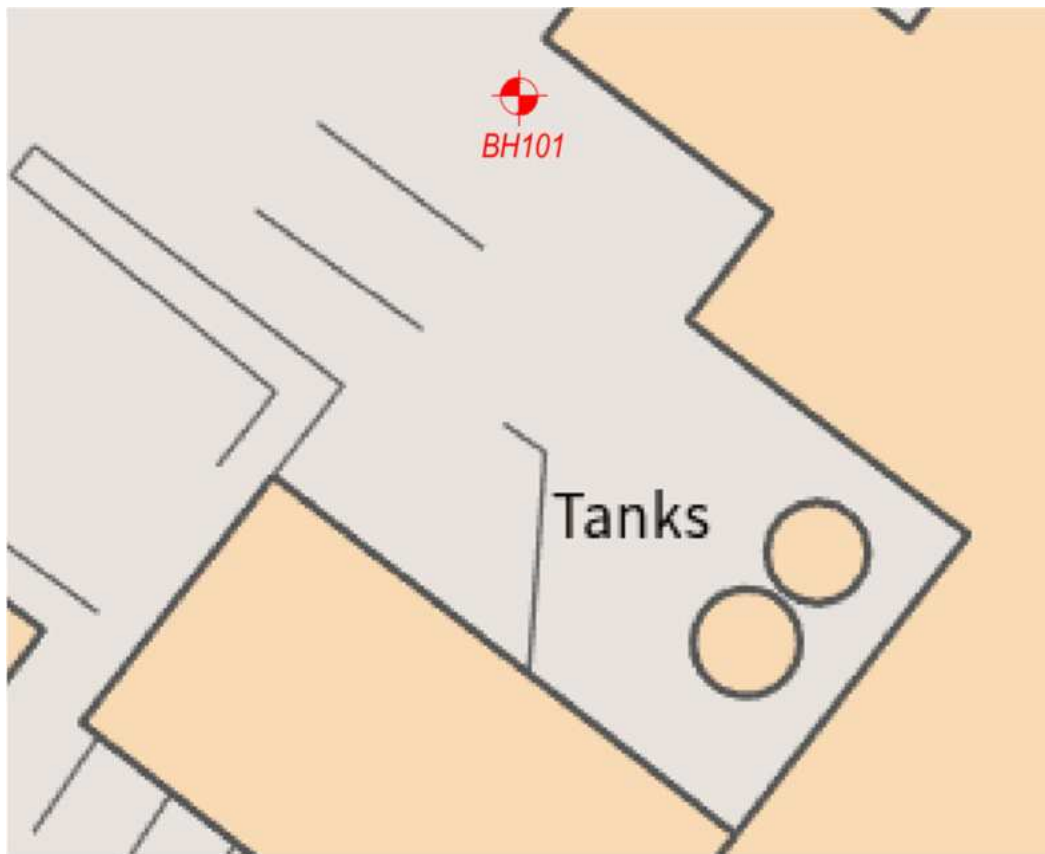
Previous Exploratory Hole Location Plan

- 1 No. cable percussive borehole (BH101) was drilled to a depth of 15.0m bgl using a Dando 2000
- Rotary follow was advanced from 15.0m to a final depth of 19.5m bgl

Soft grey silty organic Clay was encountered from a depth of 1.8m bgl to a depth of 12.7m bgl.

Bedrock consisting of red brown/green grey Mudstone was encountered from 12.7m bgl to a final depth of 19.5m bgl.

Groundwater seepages were encountered at 0.9m bgl and 10.95m bgl within the borehole.

Clinker and ash were present within the Made Ground from 0.5m to 1.8m bgl. Olfactory evidence of contamination was noted in the form of a hydrocarbon odour within the same Made Ground strata. Strong organic odour was also noted within the natural silty Clay.

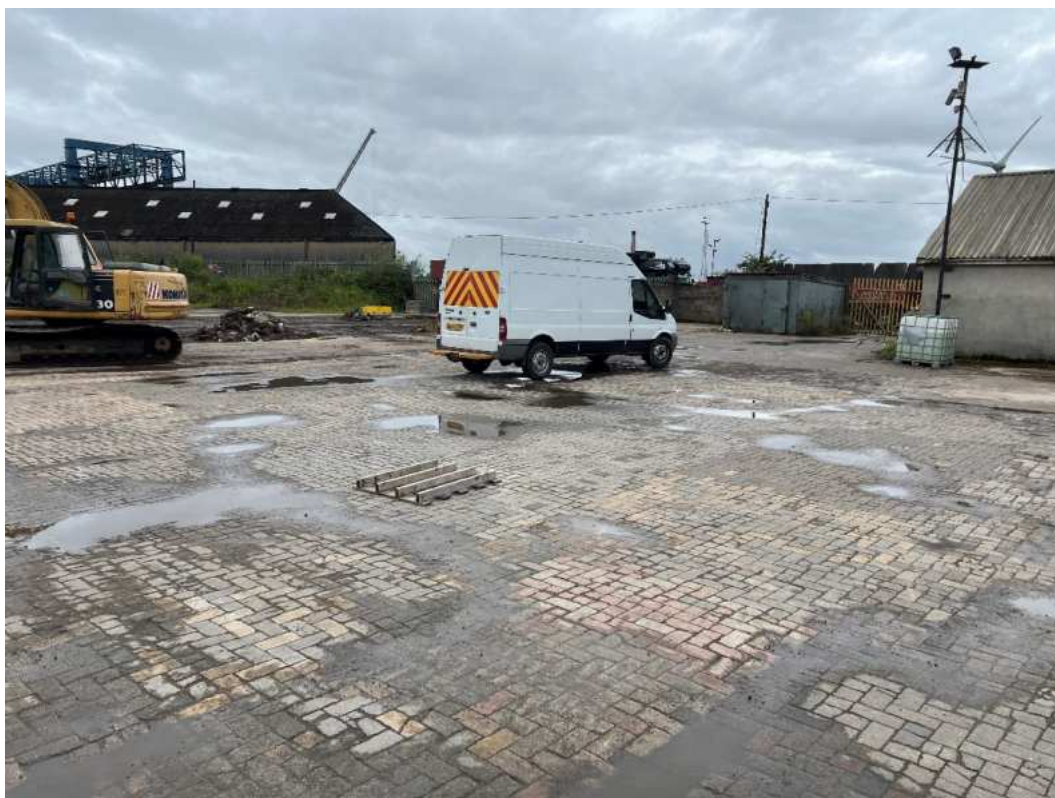
Photograph 1 – South area of site.

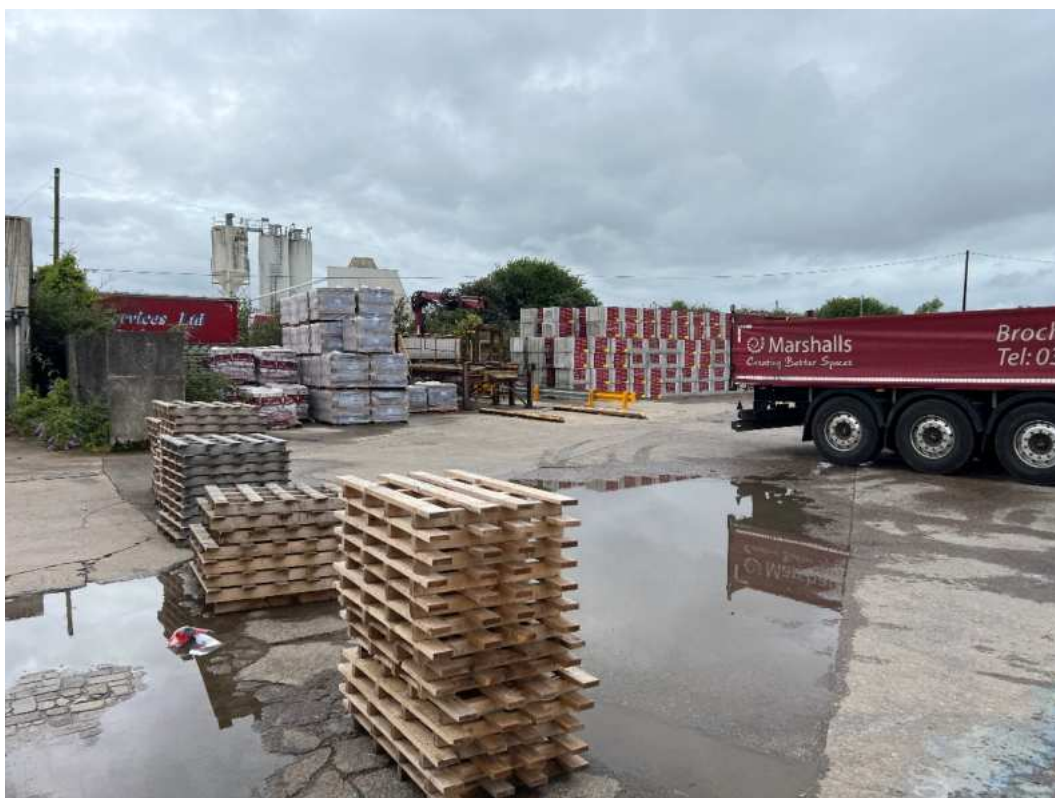
Photograph 2 – Hardstanding surfacing of site.

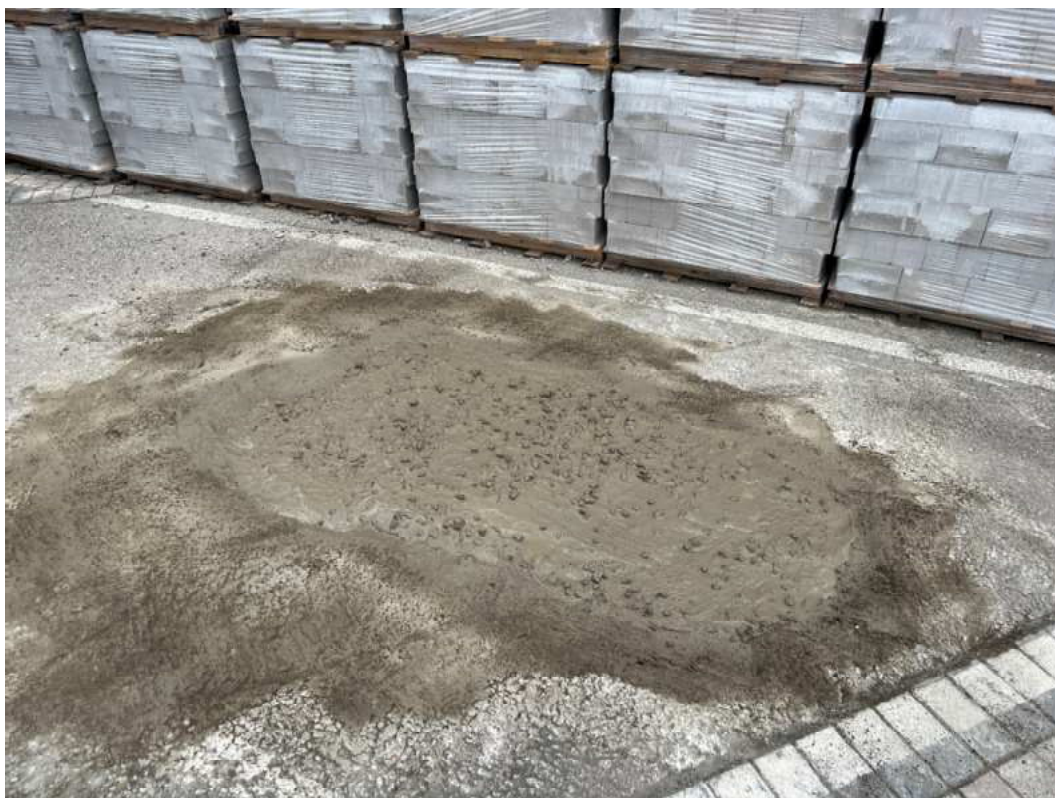
*Photograph 3 – Reinstatement of trial pit.*

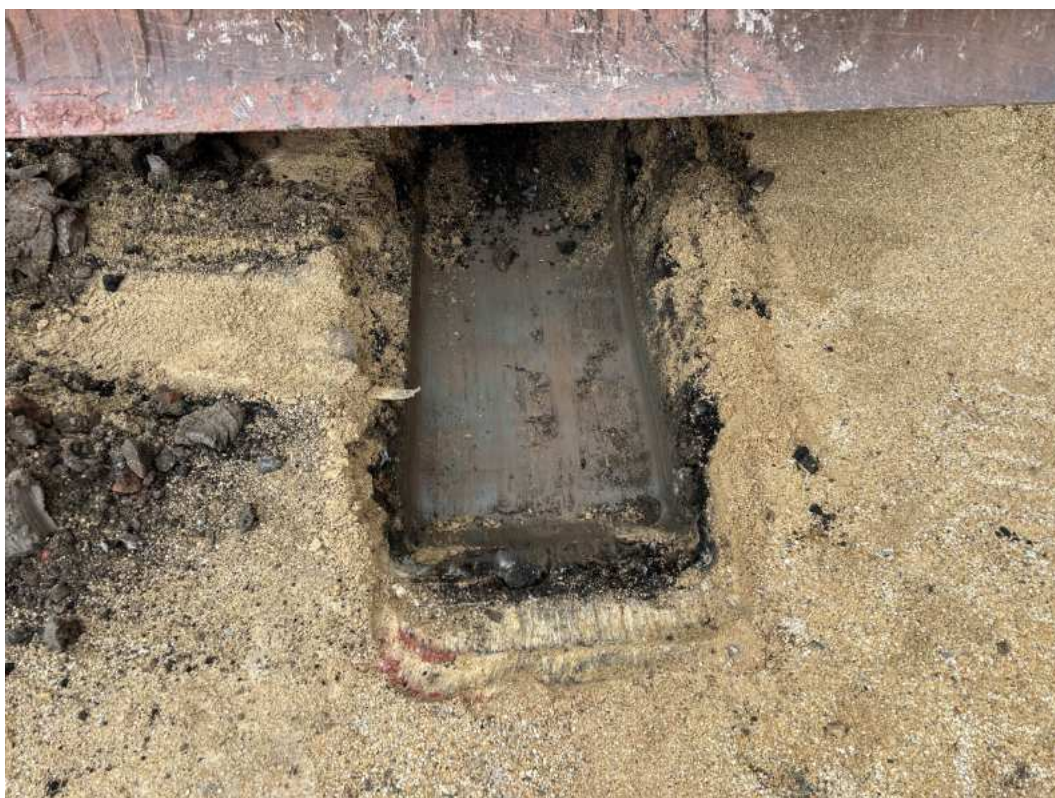
*Photograph 4 - Prior to plate load test.*

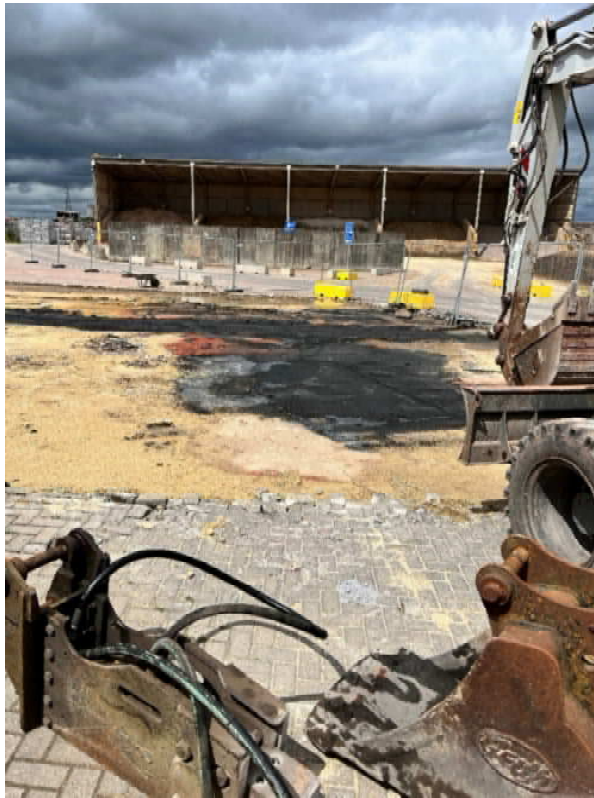
At the time of the investigation the site was predominantly surfaced by concrete. In the far south and north hard surfacing had been broken out exposing the subbase prior to the Ground Investigation.

*Photograph 5 – Northern area broken out prior to ground investigation.*

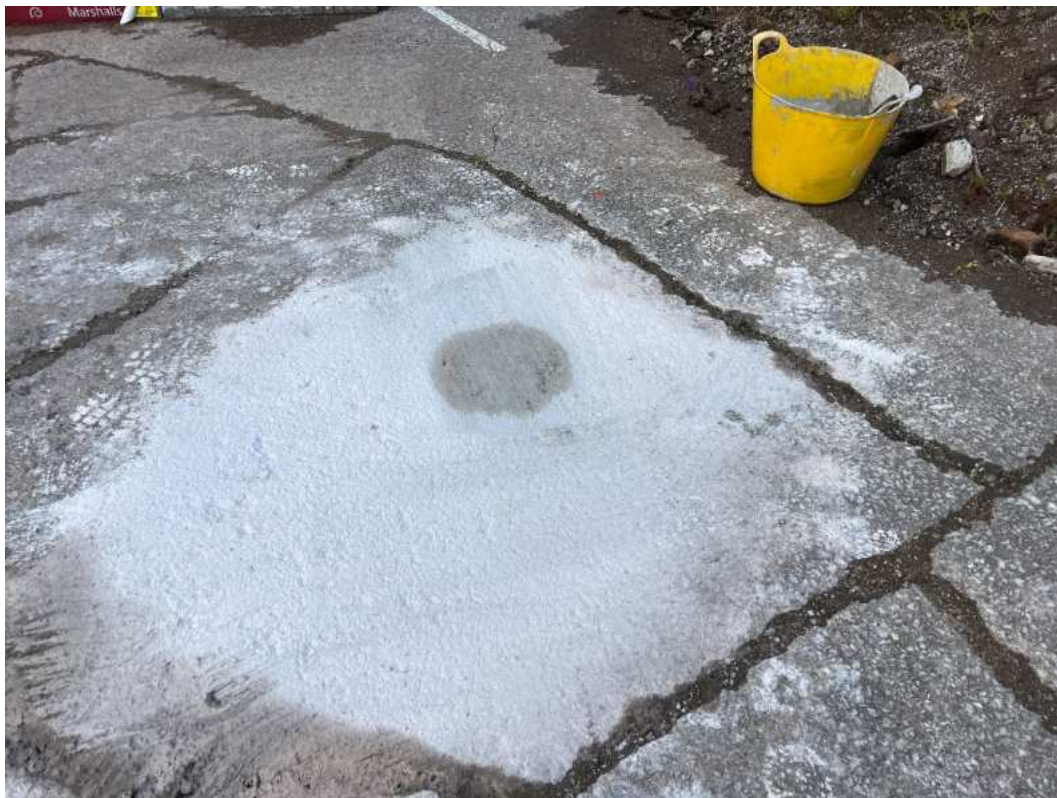
*Photograph 6 – Borehole reinstatement.*
