# Tregwilym Lodge Nursing Home - Preliminary Roost Assessment

Prepared for  
RFP Architects Ltd

Date  
2026

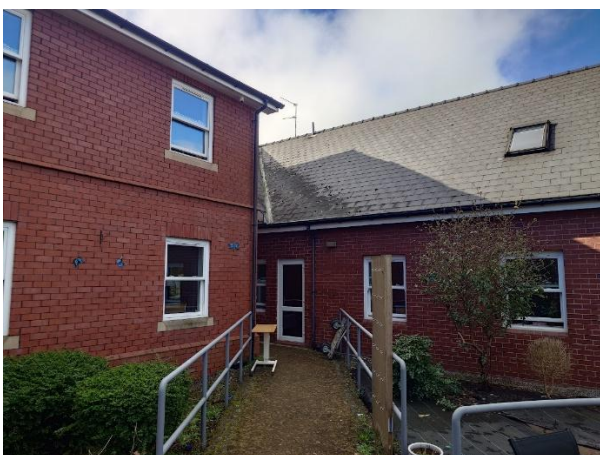
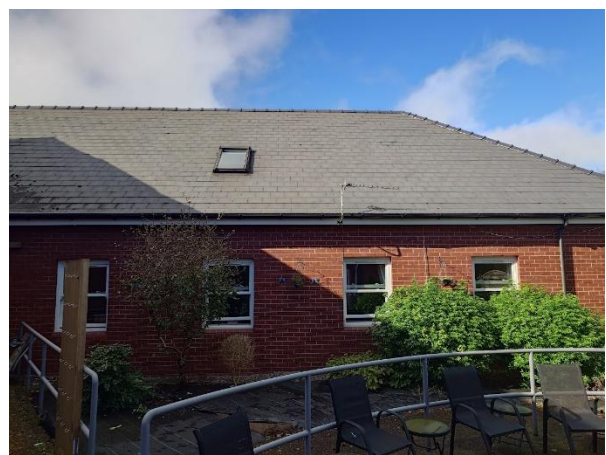
Figure 4-1: Roof that will be impacted during works

The building roof consists of a single pitched tiled structure. There are rooms within the roof structure with no loft space available. The section of roof that will be impacted by the works is arranged in a U-shape around a small courtyard.

The roof is relatively new and all tiles are in good condition and closely fitting offering no potential for roosting bats. The ridge tiles at the top of the roof are also in good condition and closely fitted. A single tile was observed to be loose, however, this was on the opposite side of the building.

During the site survey, no significant features were recorded present on the exterior of the surveyed building which were deemed to have the potential to provide suitability for use by roosting bats. No field sign evidence suggesting the use of the site by bat was recorded at the time of the survey. It is deemed that the building in its current state has negligible potential for roosting bats with no obvious habitat features on the roof to be impacted likely to be used by roosting bats; however, a small element of uncertainty remains as bats can use small and apparently unsuitable features on occasion (such as the underside of the skylight)

The roof space in the area of the works is deemed to have negligible potential for roosting bats with the rest of the building also providing only 1-2 features small that could be suitable for bats on occasion. As such it is recommended that the works can go ahead without the need for further surveys, however, should features become apparent or a bat discovered during the stripping of the roof, all works should stop and a suitably experienced bat ecologist should be consulted.

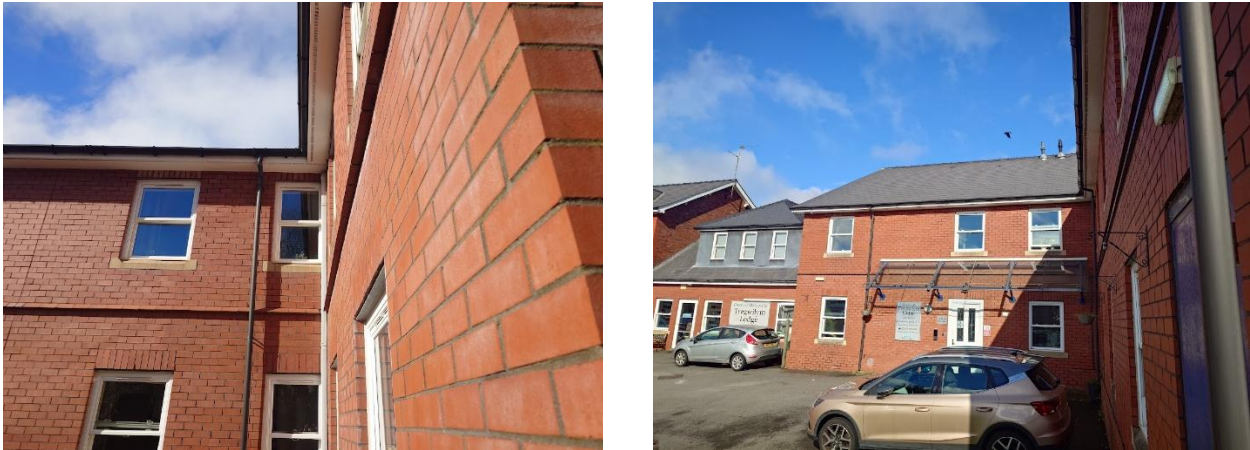
Figure 4-2: Steel ducting running the length of the building.

The roof overhands the main building by approximately 30cm, and is covered with steel ducting. This is in good condition and is regularly maintained. No gaps were recorded that could be utilised by bats.
