## Tier 2 Geotechnical and Geoenvironmental Assessment

Site: Newport Solar Farm

**REPORT TITLE** : **Geoenvironmental and Geotechnical Report:  
Proposed Commercial Development, Solar  
Farm in Newport**

**REPORT REFERENCE** : **GGR-08062026-TF-26-137-CA-03**

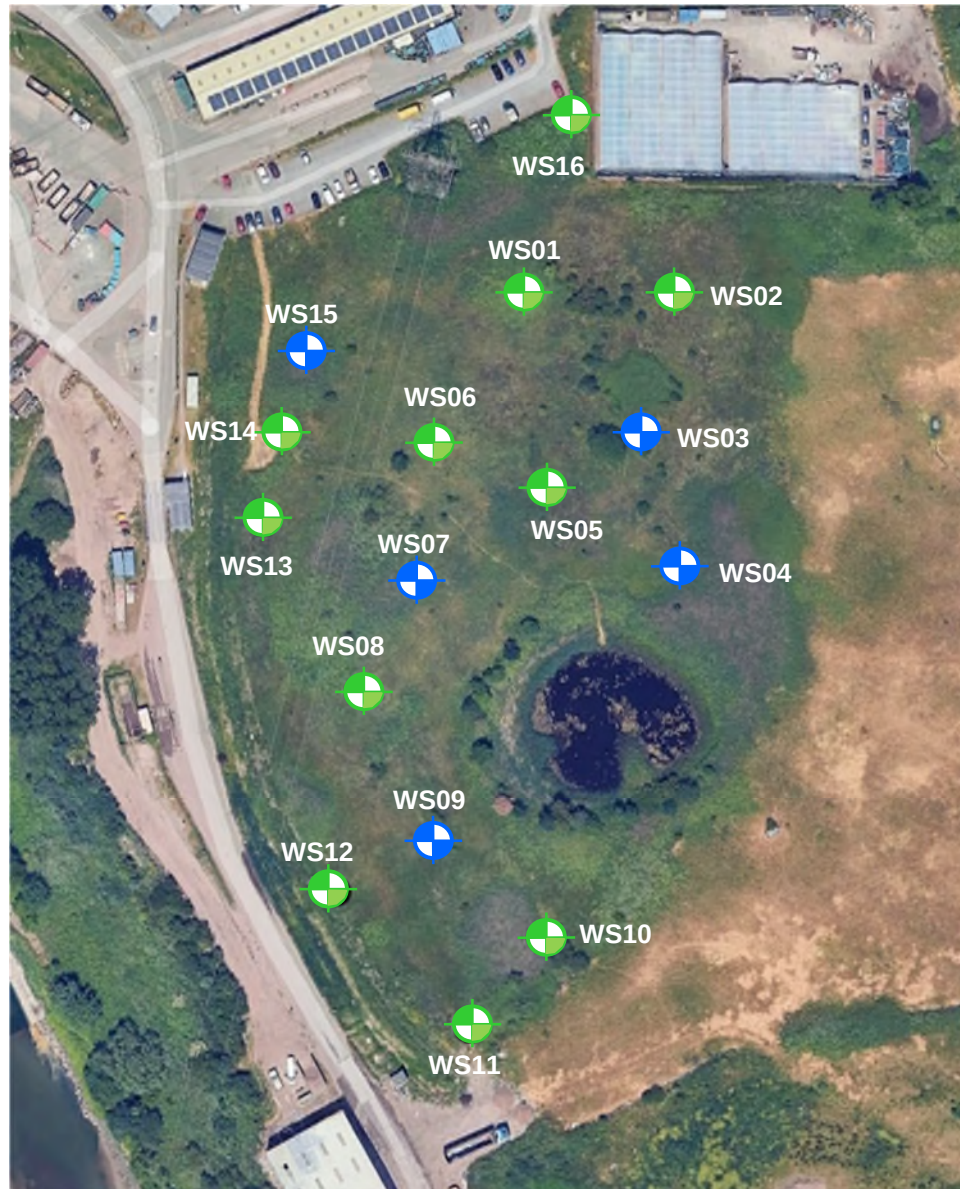
**Site Name:** Solar Farm, Newport  
**Project Number:** TF-26-137-CA  
**Drawing Title:** Borehole Layout  
**Drawing Number:** 01  
**Scale:** Not to scale

The boreholes referenced WS01 to WS16, were formed using a Terrier 2000 rig. Dynamic sampling techniques were employed from surface to produce a continuous disturbed sample.
