**Earthworks  
Validation Report**  
Proposed Residential Development  
Herbert Road  
Newport

Phases 2 - 4

**REPORT TITLE** : **Earthworks Validation Report:  
Herbert Road, Newport, Phases 2 - 4**

**JOB NUMBER** : **12032/VR1-V3**

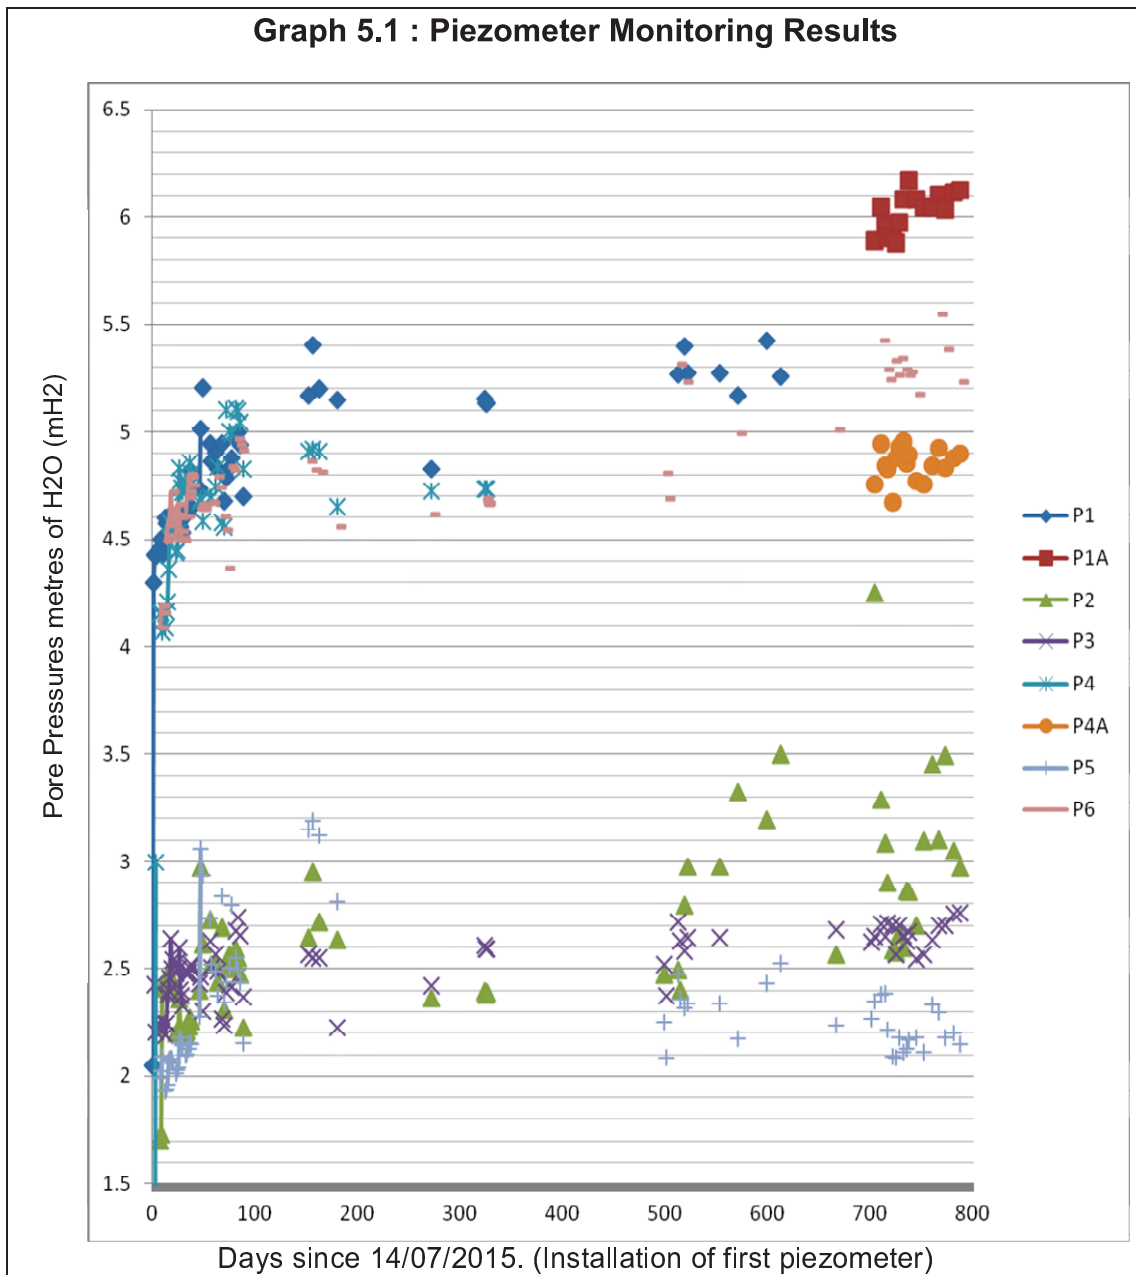
During full time supervision the increasing pore water pressures observed from the piezometers appeared to correlate with the placement of fill. As evidenced by jumps in pore water pressure over the day. Peak pore water pressure dissipated initially quickly but the rate of dissipation reduced resulting in jumps of pore water pressure.

Pore water pressure was monitored daily during the period of full time supervision and significant activity on site. Full time supervision was between 14/7/2015 through to 20/8/2015. Monitoring continued beyond this point on a less frequent basis, typically once or twice a week, to reflect reduced site activity.

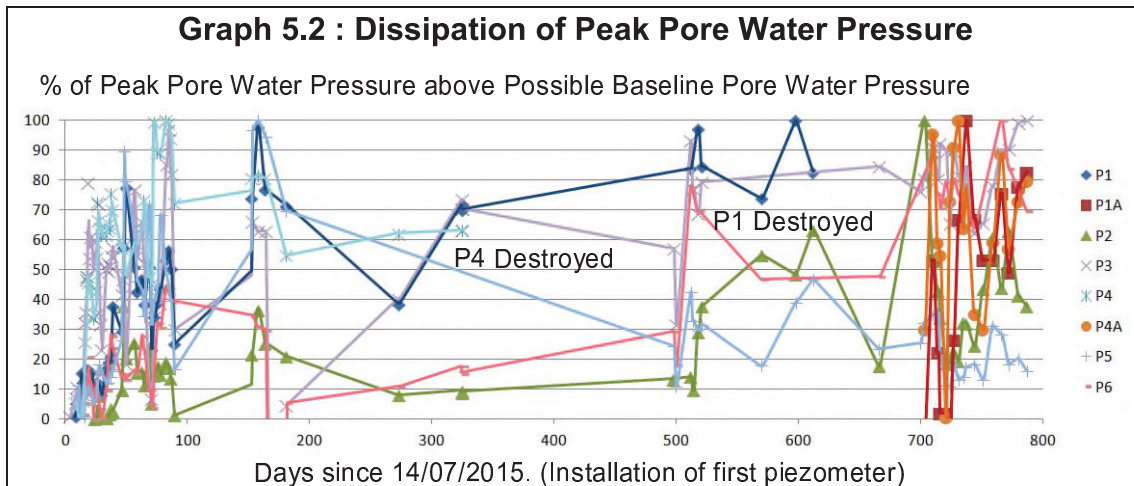
During settlement pore water pressure dissipates as water is squeezed out of consolidating material. The graph below shows the generation of peak pore water pressure generated by the placement of fill typically between 3 and 5 months after the commencement of the earthworks.

Pore water pressure has been observed to be dissipating, evidence of consolidation and settlement. However the monitoring of pore water pressure dissipation has been disrupted by filling events.

Pore water pressure dissipation of a single filling event should produce a single curve. However multiple filling events are likely to explain for the peaks and troughs of pore water dissipation suggesting that following the initial placement of the assessed stockpile further material has been placed on site.

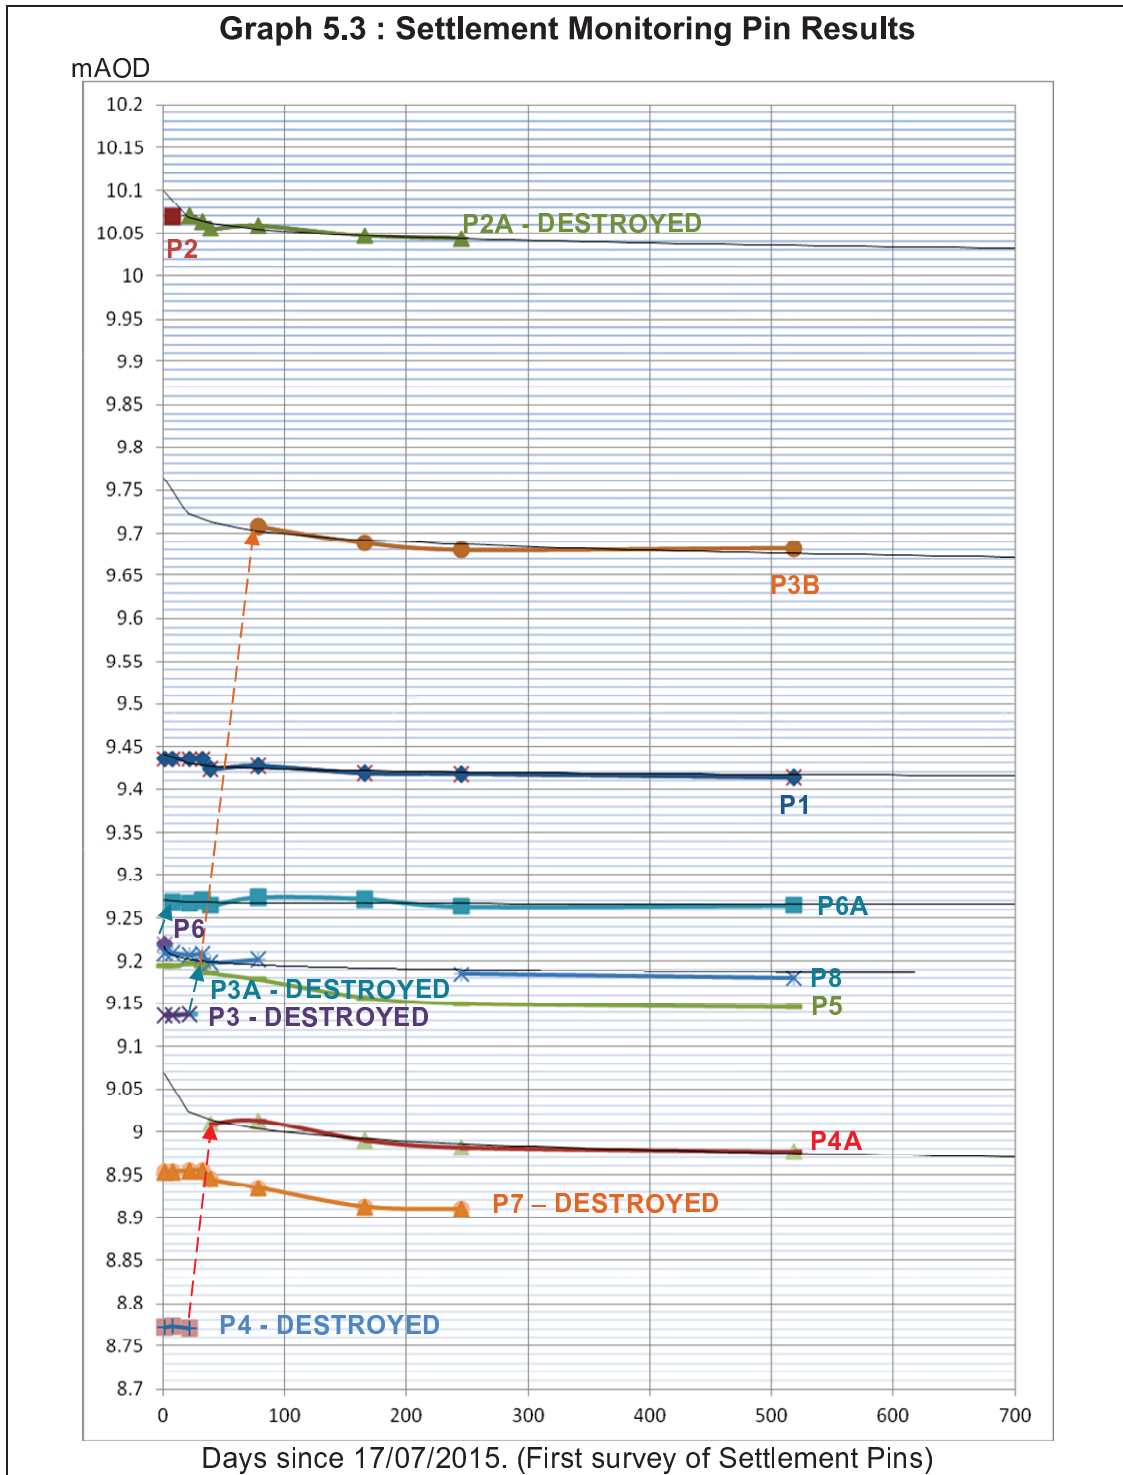
The graph below shows all of the surveyed original monitoring pins on an arithmetic time scale. When a monitoring pin was damaged or destroyed an effort was made to replace the pin. When a monitoring pin was damaged / destroyed it was given a sequential alphabetical designation.

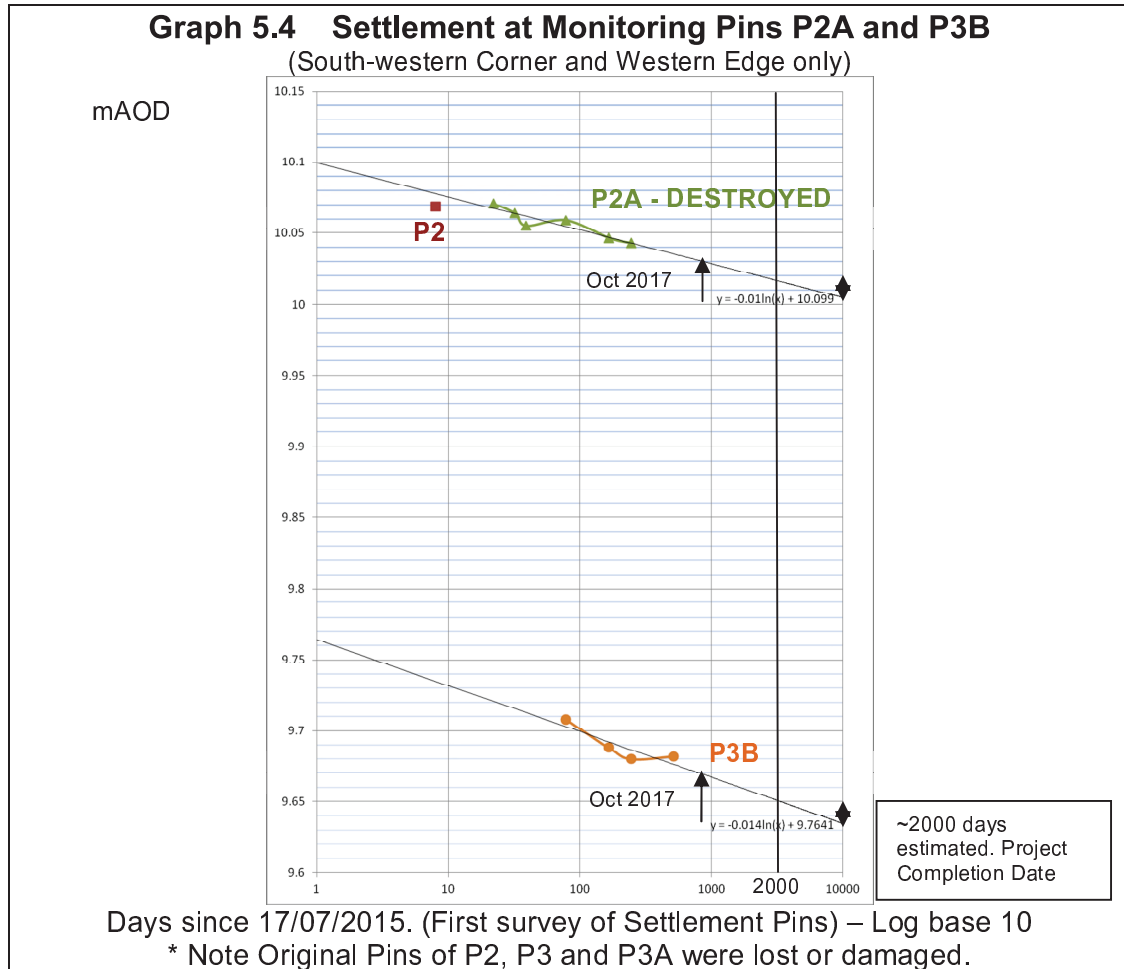
In principle secondary settlement is infinite with settlement rates dropping on a logarithmic scale. However in practice the increase in settlement after  $10^4$  days (~30years) appears to be generally “complete”.

Unfortunately baseline conditions for Monitoring Pin 2 (located within the south-western corner of the site) were lost as the pin was destroyed following the placement of fill. Monitoring Pin 2A however recorded ~28mm of settlement over 223 days. Whilst the initial readings may be lost and the monitoring point has been destroyed it may be possible to conjecture future settlement from the data obtained.

Unfortunately baseline conditions for Monitoring Pin 3 (located on the western edge of the site) were following the placement of fill. Monitoring Pin 3A was similarly lost. It is considered that any attempt to assess future settlement from Monitoring Pin 3B would be open to too much error and inaccuracy to predict. 28mm settlement was measured over 440days. Future settlement at this location may be slightly greater than at Monitoring Pin 2A but still less than 50mm or ~20mm after project completion.

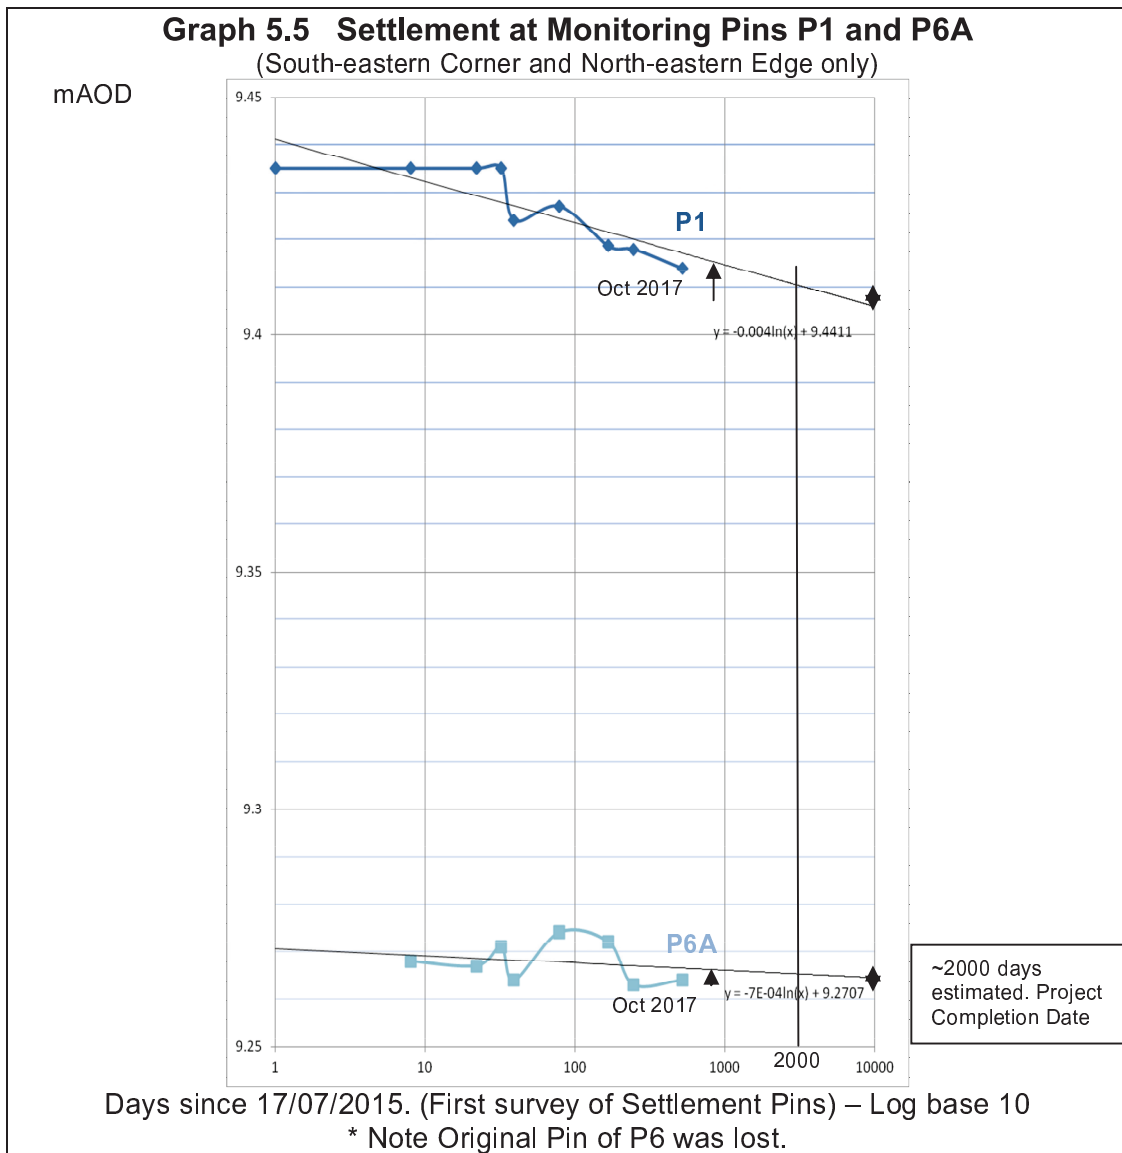
Data for Monitoring Pin 1 (located near the South-eastern Corner of the site) is complete and to date indicates settlement of ~21mm over 517 days. Conjecturing future settlement from the data obtained indicates that levels may settle to 9.405mAOD after 10<sup>4</sup> days (~30years or 2045). With the last survey indicating levels of 9.414m a further 0.010m (10mm) should be anticipated under the current surcharge by 2045 or ~5mm after project completion.

Unfortunately baseline conditions for Monitoring Pin 6 (located within the North-eastern corner of the site) were lost as the pin was destroyed. Monitoring Pin 6A has however recorded ~5mm of settlement over 510 days. Whilst the initial readings may be lost it may be possible to conjecture future settlement from the data obtained.

Following the current trend of settlement the above graph indicates at that levels may have settled at 9.27mAOD after 10<sup>4</sup> days (~30years or 2045). With the survey indicating fluctuating levels of 9.263m no further settlement is anticipated under the current surcharge by 2045.

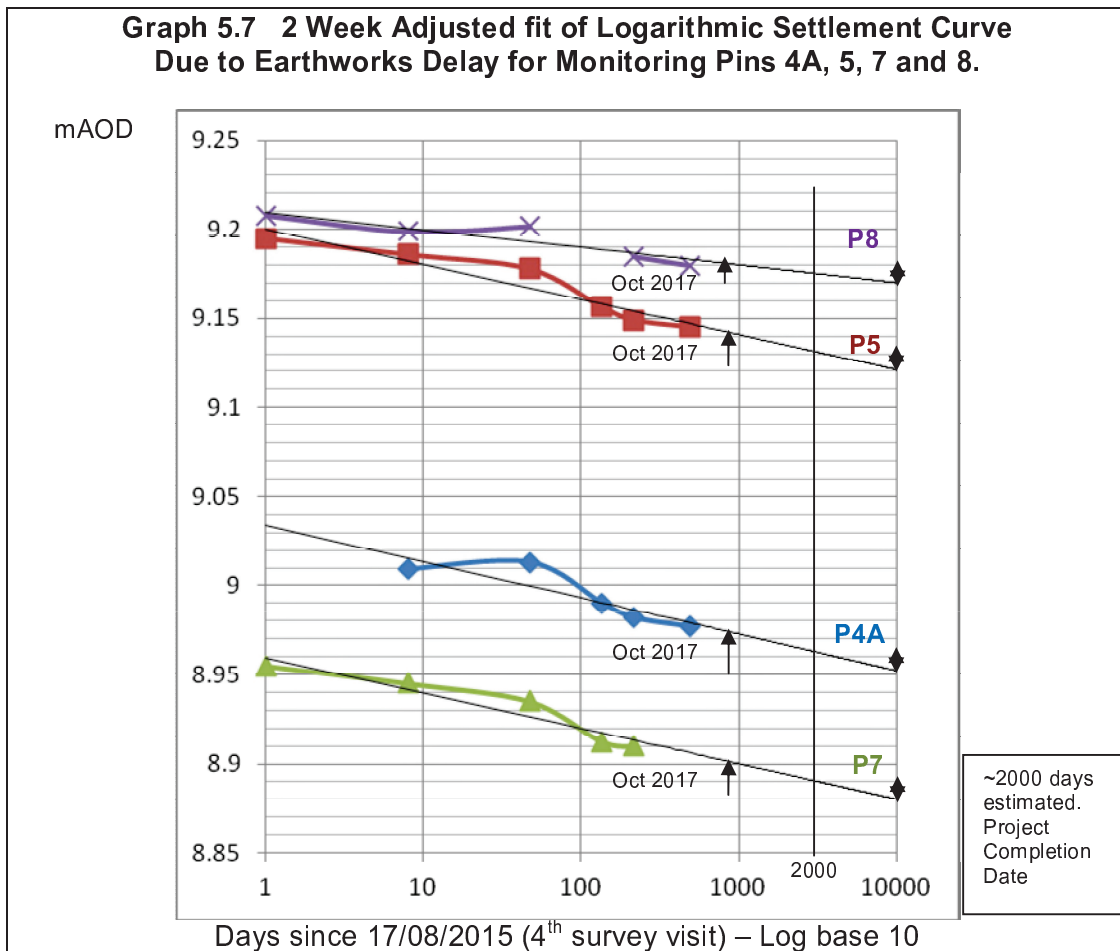
### Monitoring Pin 4A

Unfortunately baseline conditions for Monitoring Pin 4 (located within the North-western corner of the site) were lost as the pin was destroyed. Monitoring Pin 4 recorded 1mm of settlement within ~20 days. It is considered that any attempt to assess future settlement at Monitoring Pin 4A would be open to too much error and inaccuracy to predict.

It is noted that following the current trend of settlement the graph indicates at that levels may settle to 8.950mAOD after  $10^4$  days (~30years or 2045). With the most recent survey indicating levels of 8.978mAOD a further ~30mm settlement is anticipated under the current surcharge by 2045 or ~20mm after project completion.
