Settlement Report
Proposed Residential Development
Herbert Road
Newport

Prepared for: Engie

August 2018

Report No. 12032/SR

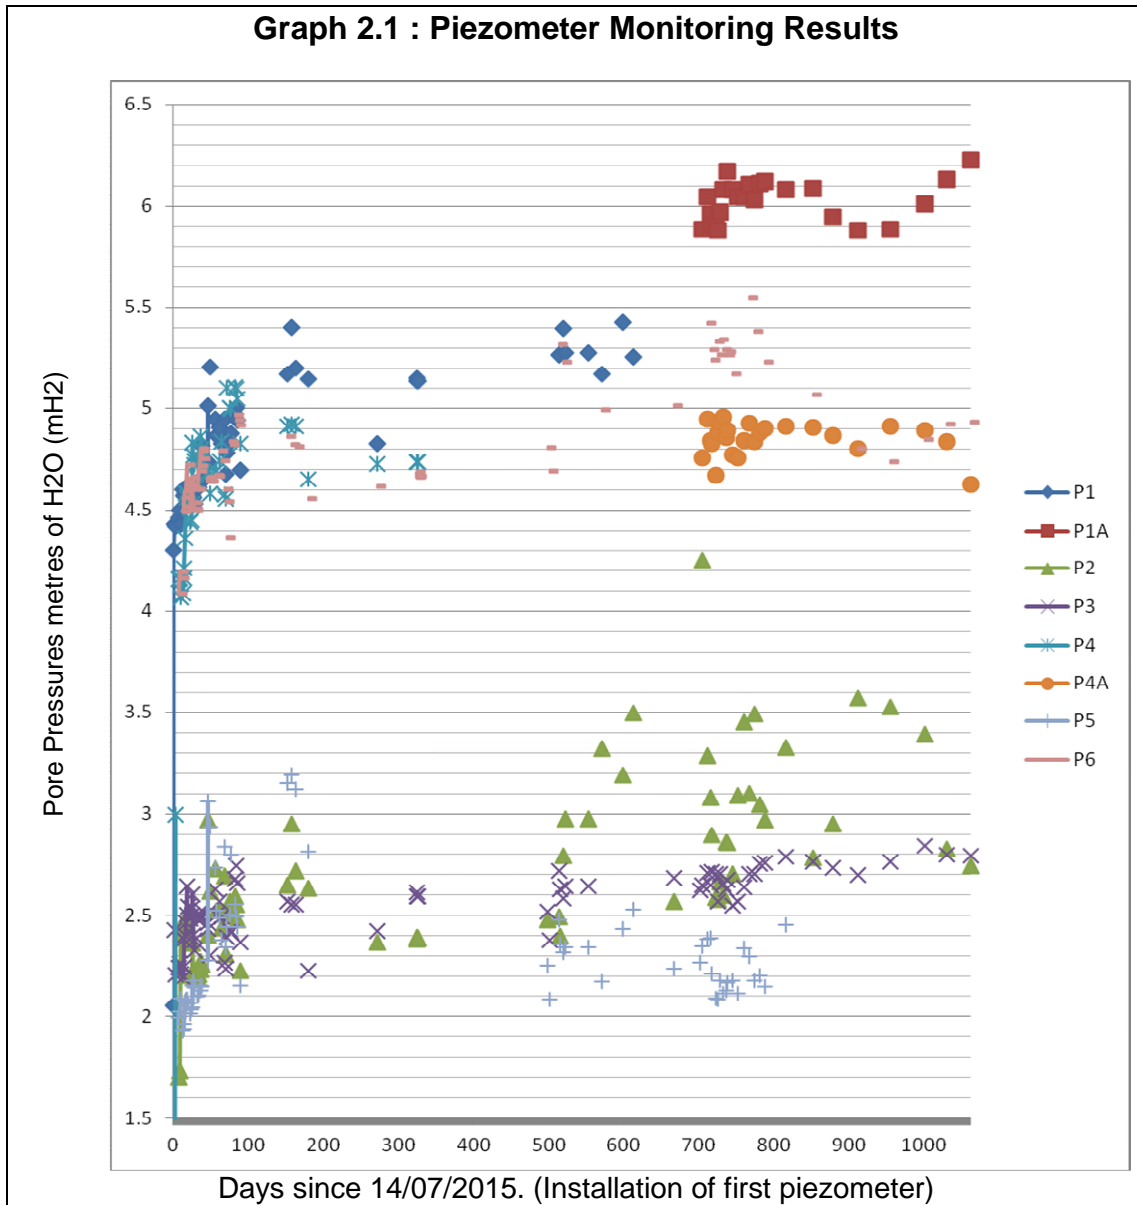
Pore water pressure was monitored daily during the period of full time supervision and significant activity on site. Full time supervision was between 14/7/2015 through to 20/8/2015. Monitoring continued beyond this point on a less frequent basis, to reflect reduced site activity.

During full time supervision the increasing pore water pressures observed from the piezometers appeared to correlate with the placement of fill. As evidenced by jumps in pore water pressure over the day. Peak pore water pressure dissipated initially quickly but the rate of dissipation reduced resulting in jumps of pore water pressure.

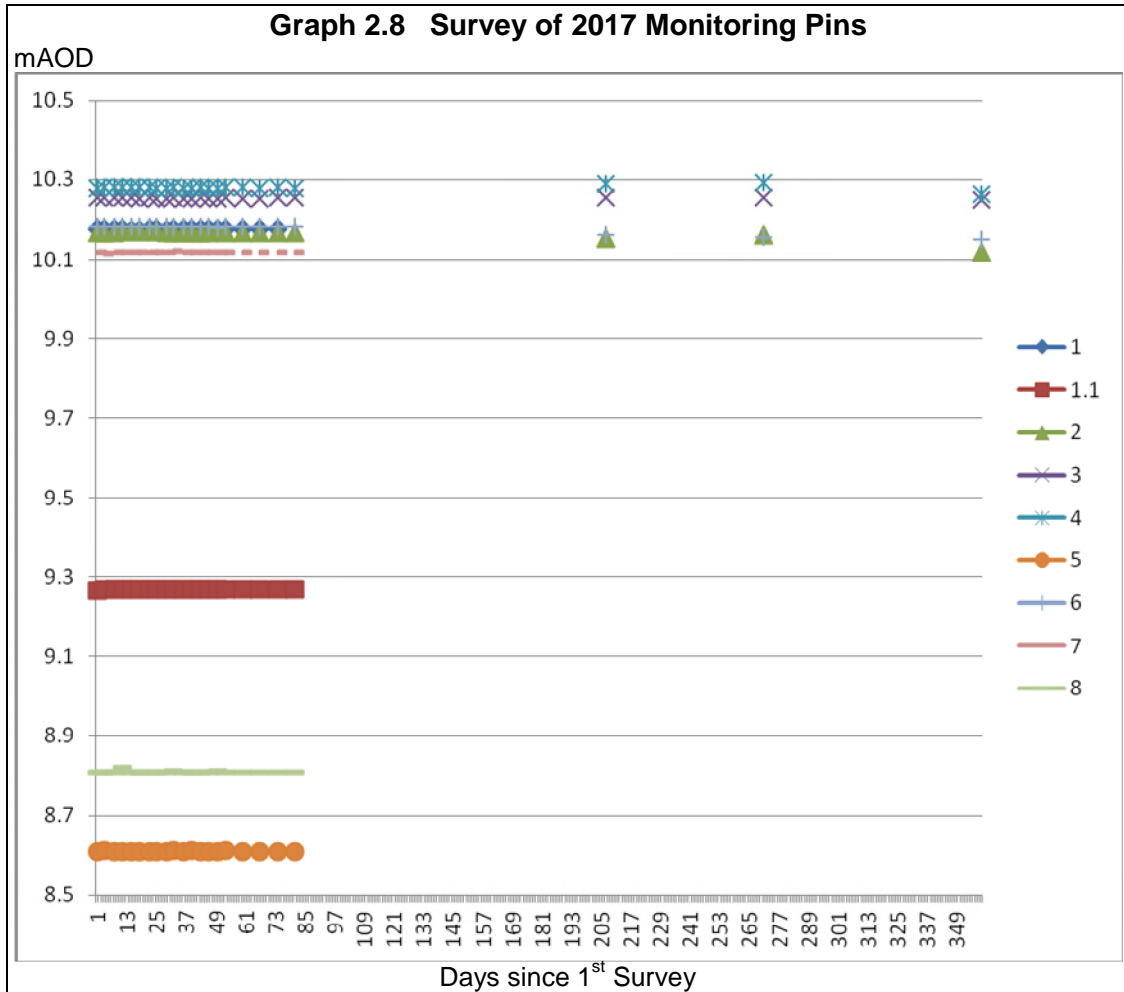
A series of new settlement monitoring pins were installed 6th June 2017 to replace the original series which were unserviceable for future phases of earthworks. ~1 year has passed, however this does not appear to have been a long enough period of time to demonstrate further settlement.

Not a single pin had dropped by 1mm in the first 80 days. This was to be expected as the rate of settlement is anticipated to be slow and less than 1% of the predicted settlement by 2045. See **Graph 3.8**.

Settlement pins were monitored less frequently during the past 80 days. Settlement Pin 1 was lost to construction of the haul road and Settlement Pin 5 was lost to construct the reen. Settlement Pins 7 and 8 were accidentally lost / destroyed at this time.
