# Ringland, Newport

## Phase 2 Ground Investigation

Curtins Ref: 066799-CUR-00-XX-RP-GE-002-V01

Issue Date: 16 March 2020

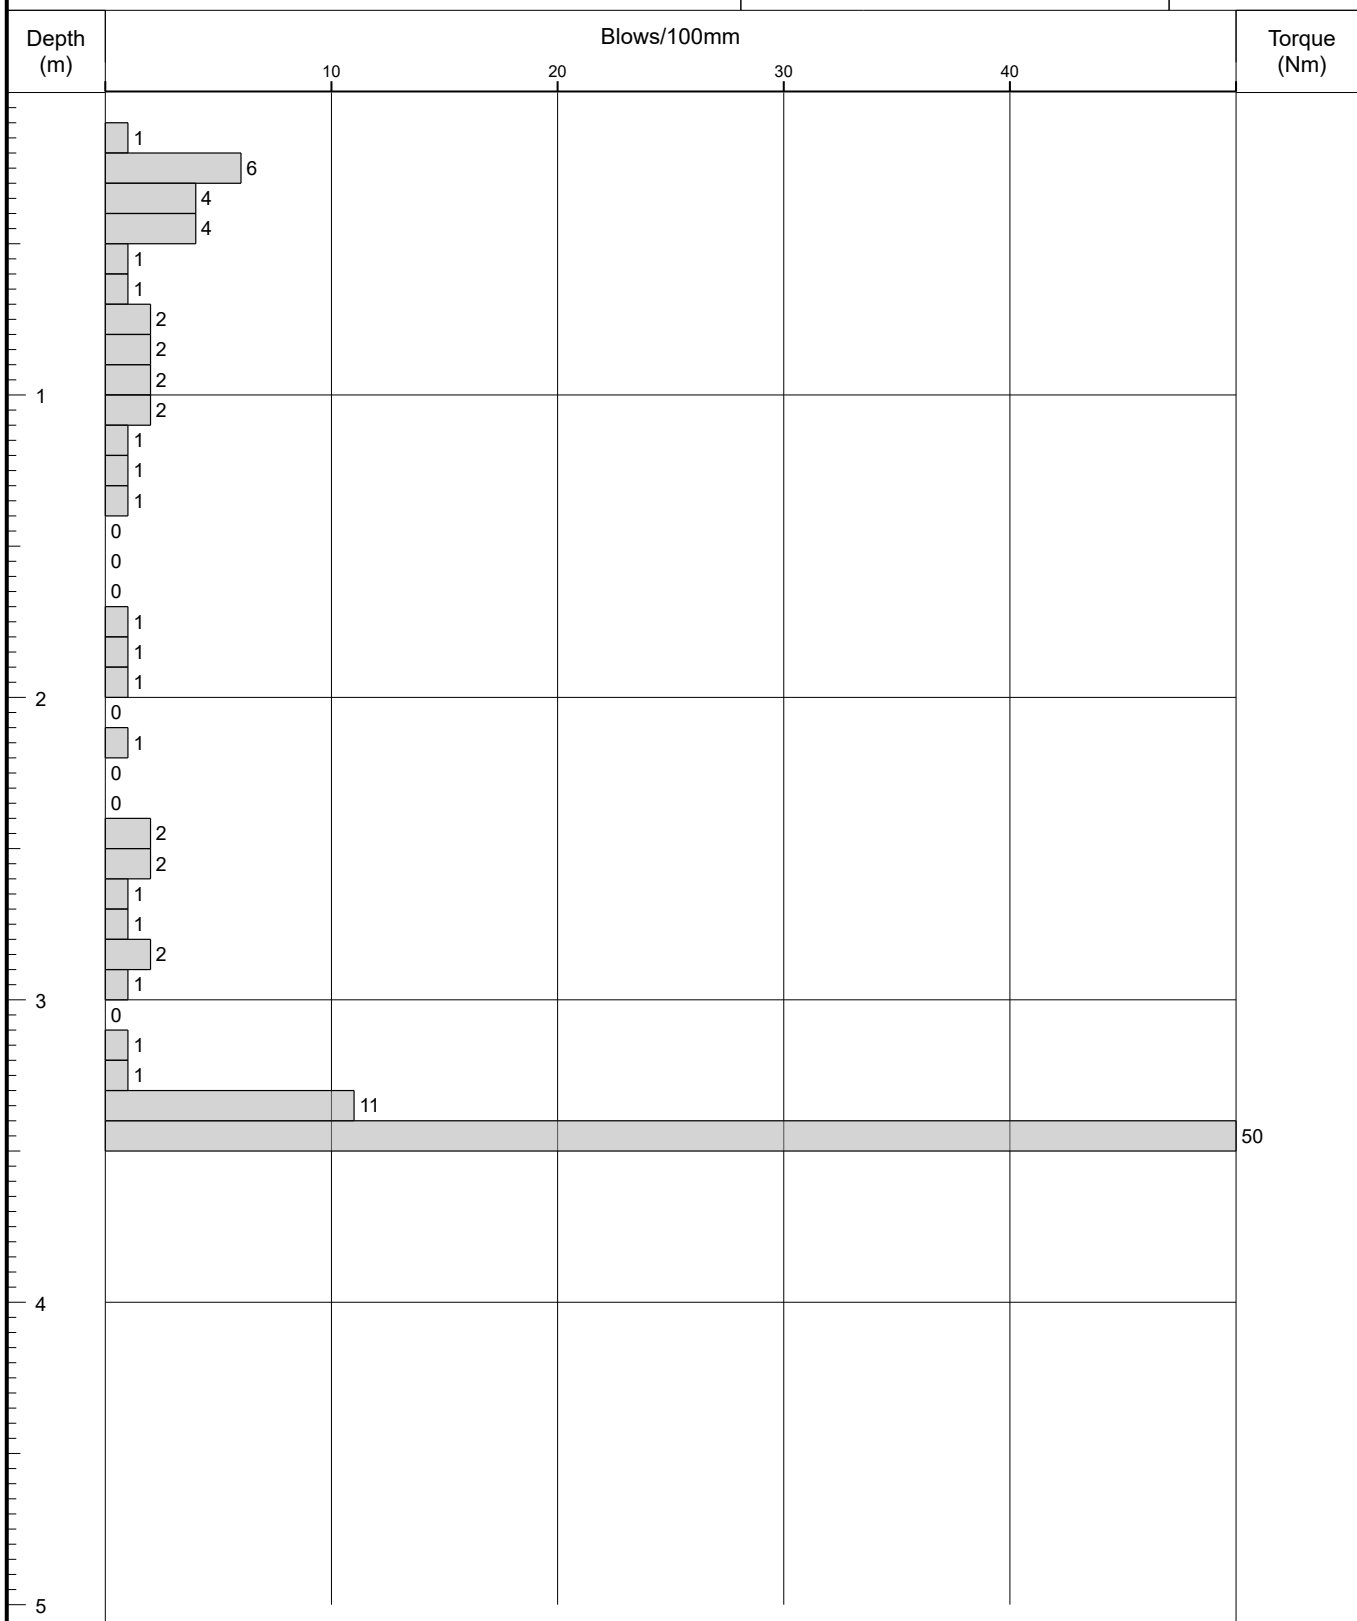
Located 0.75m off the wall

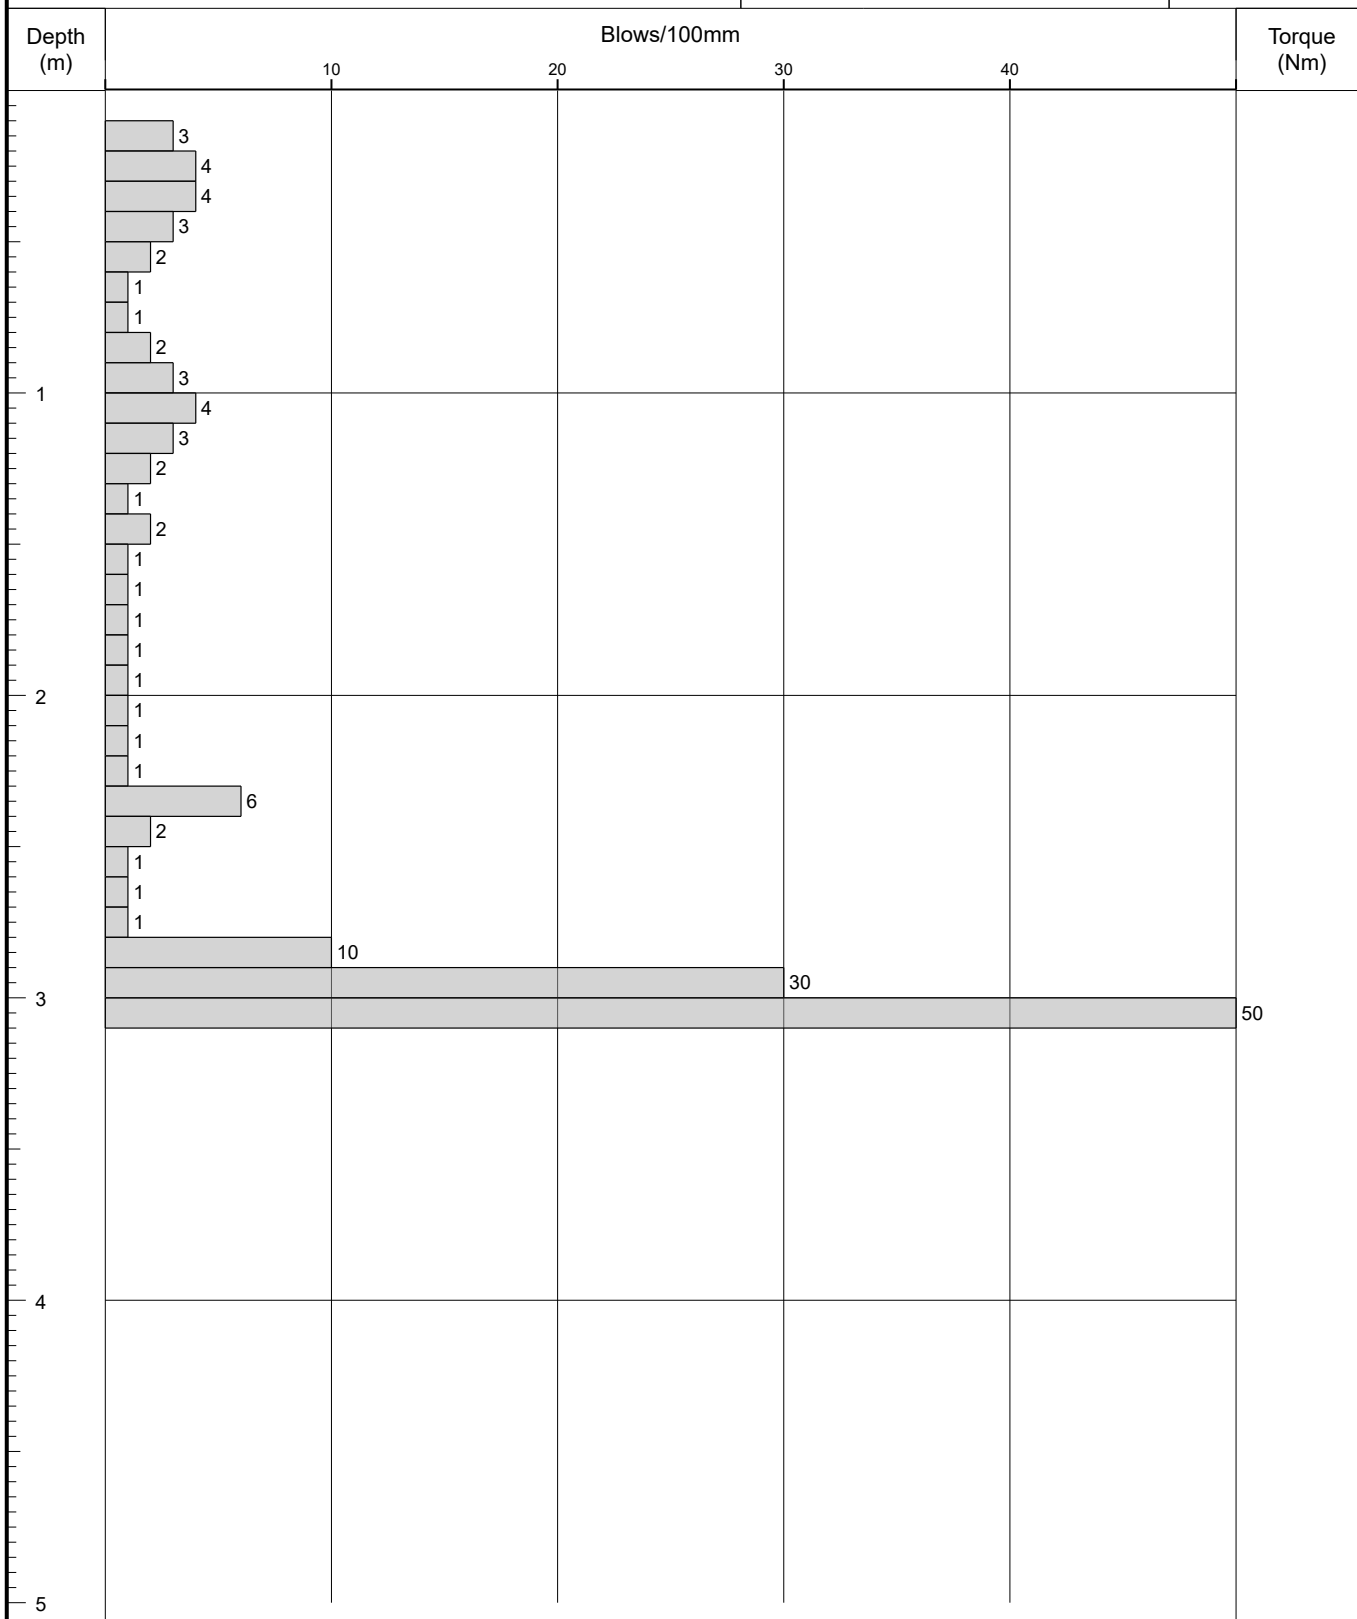
Located 1.50m off the wall

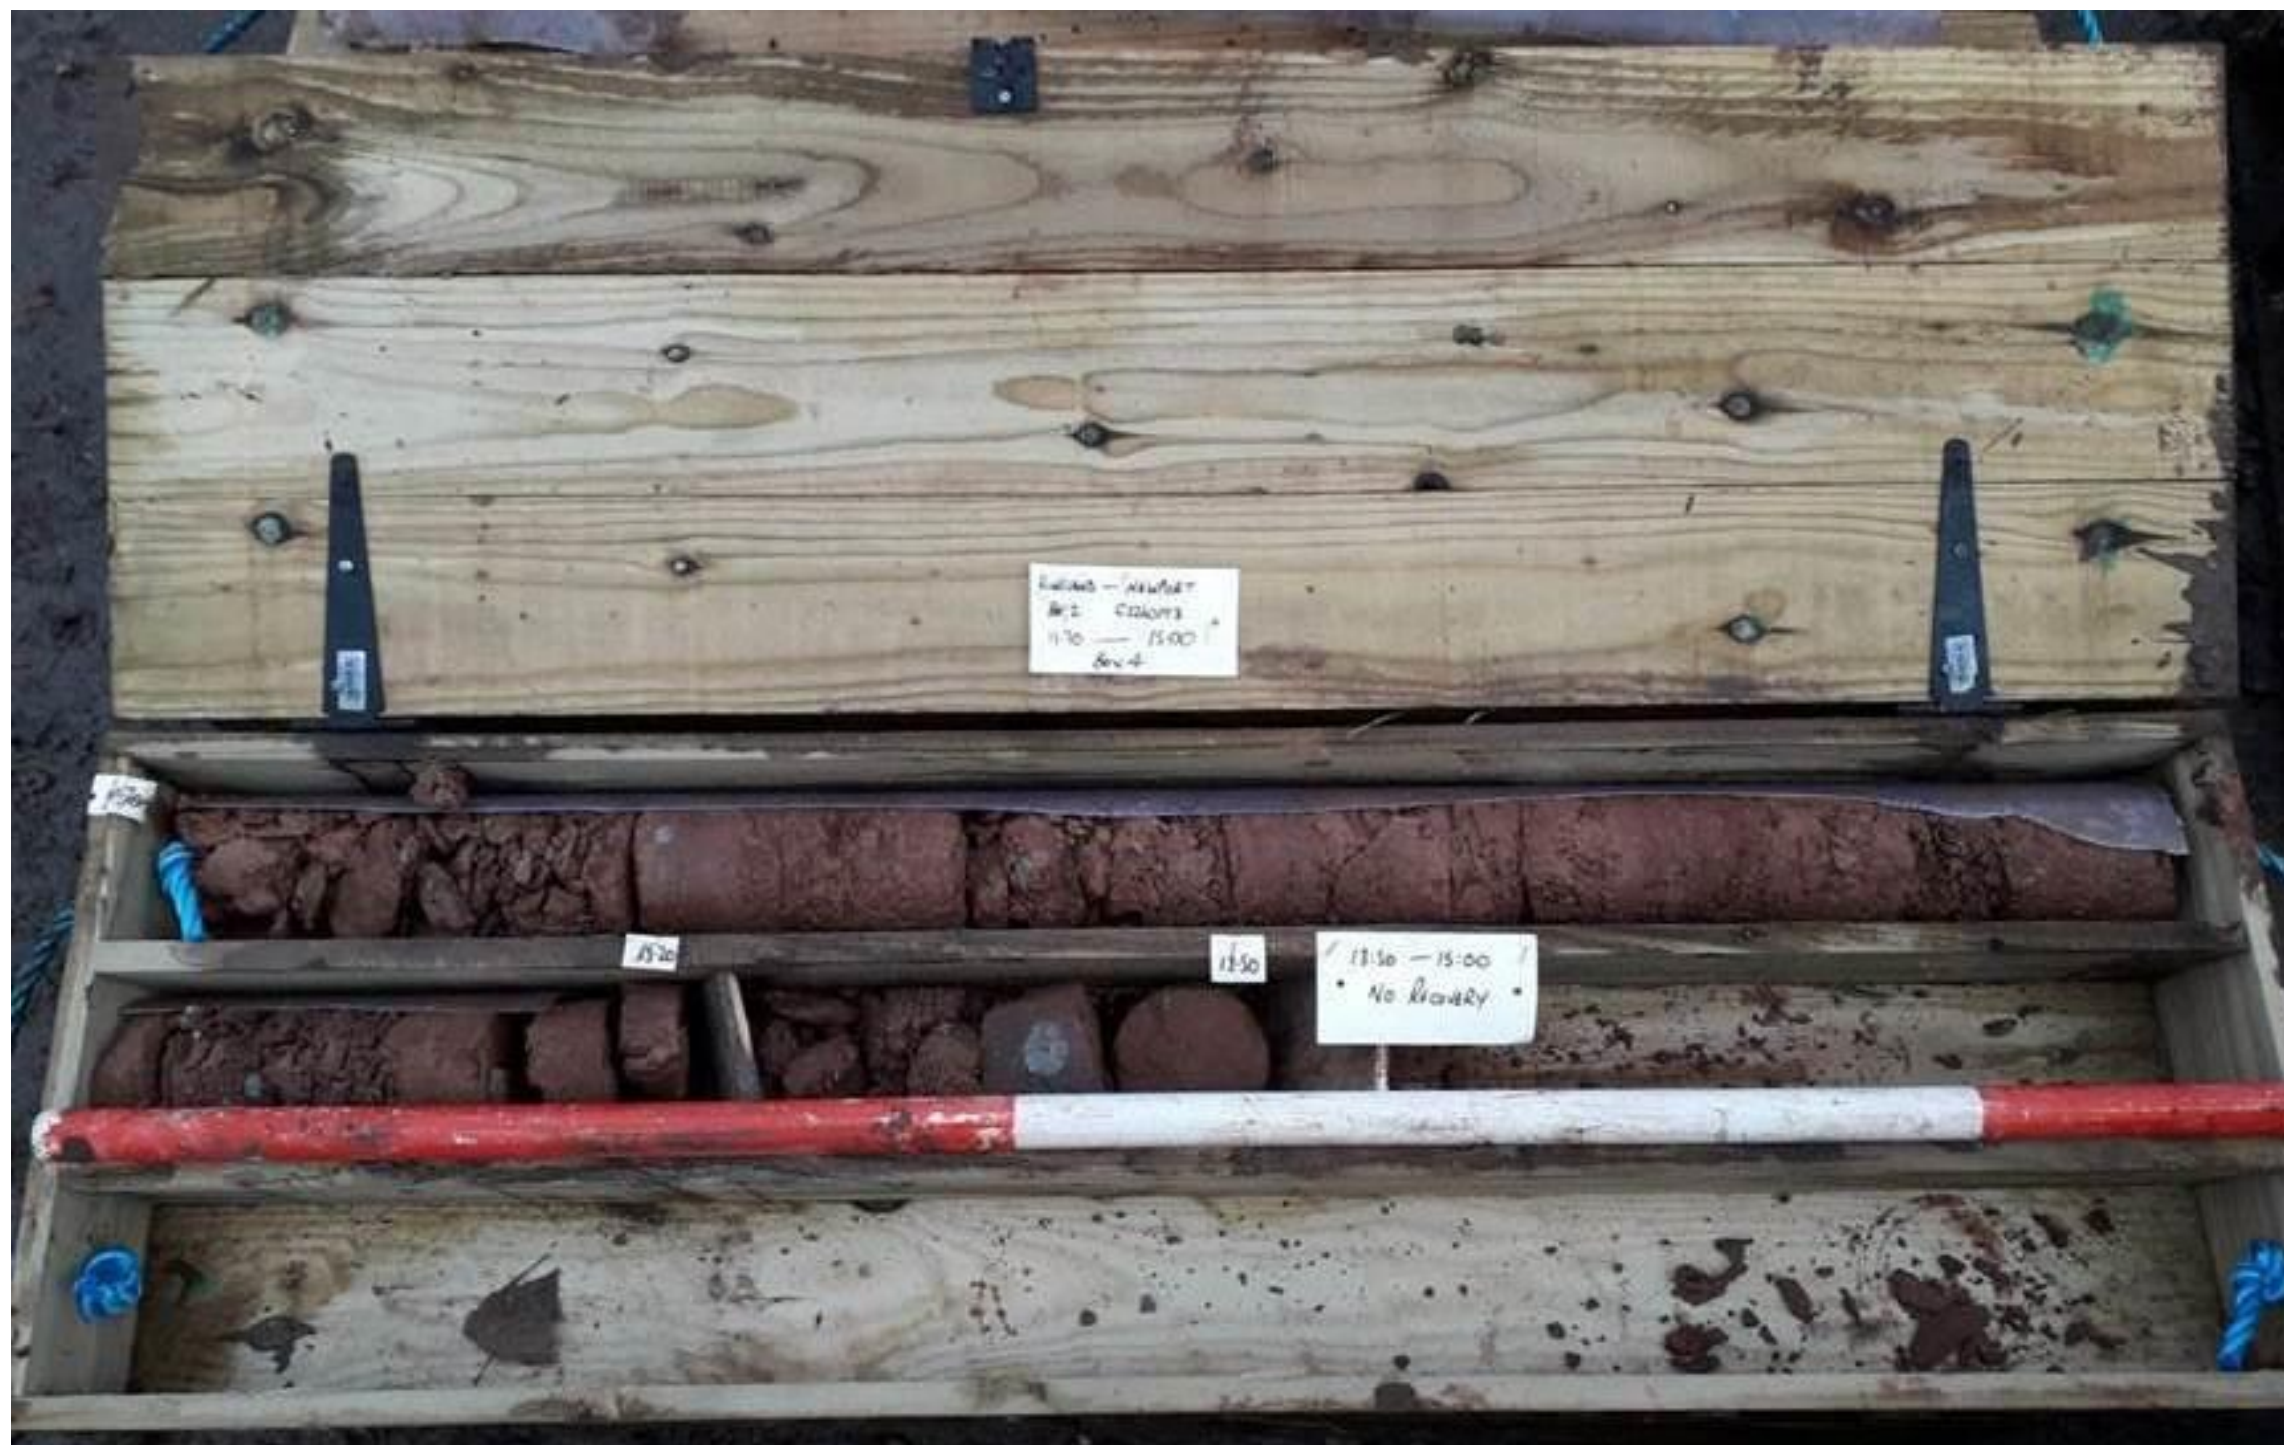
| | | Figure: A2.39 | |

| Date Drawn:<br>14-02-2020 | Scale: NTS | Title: BH02 Core Photographs | |

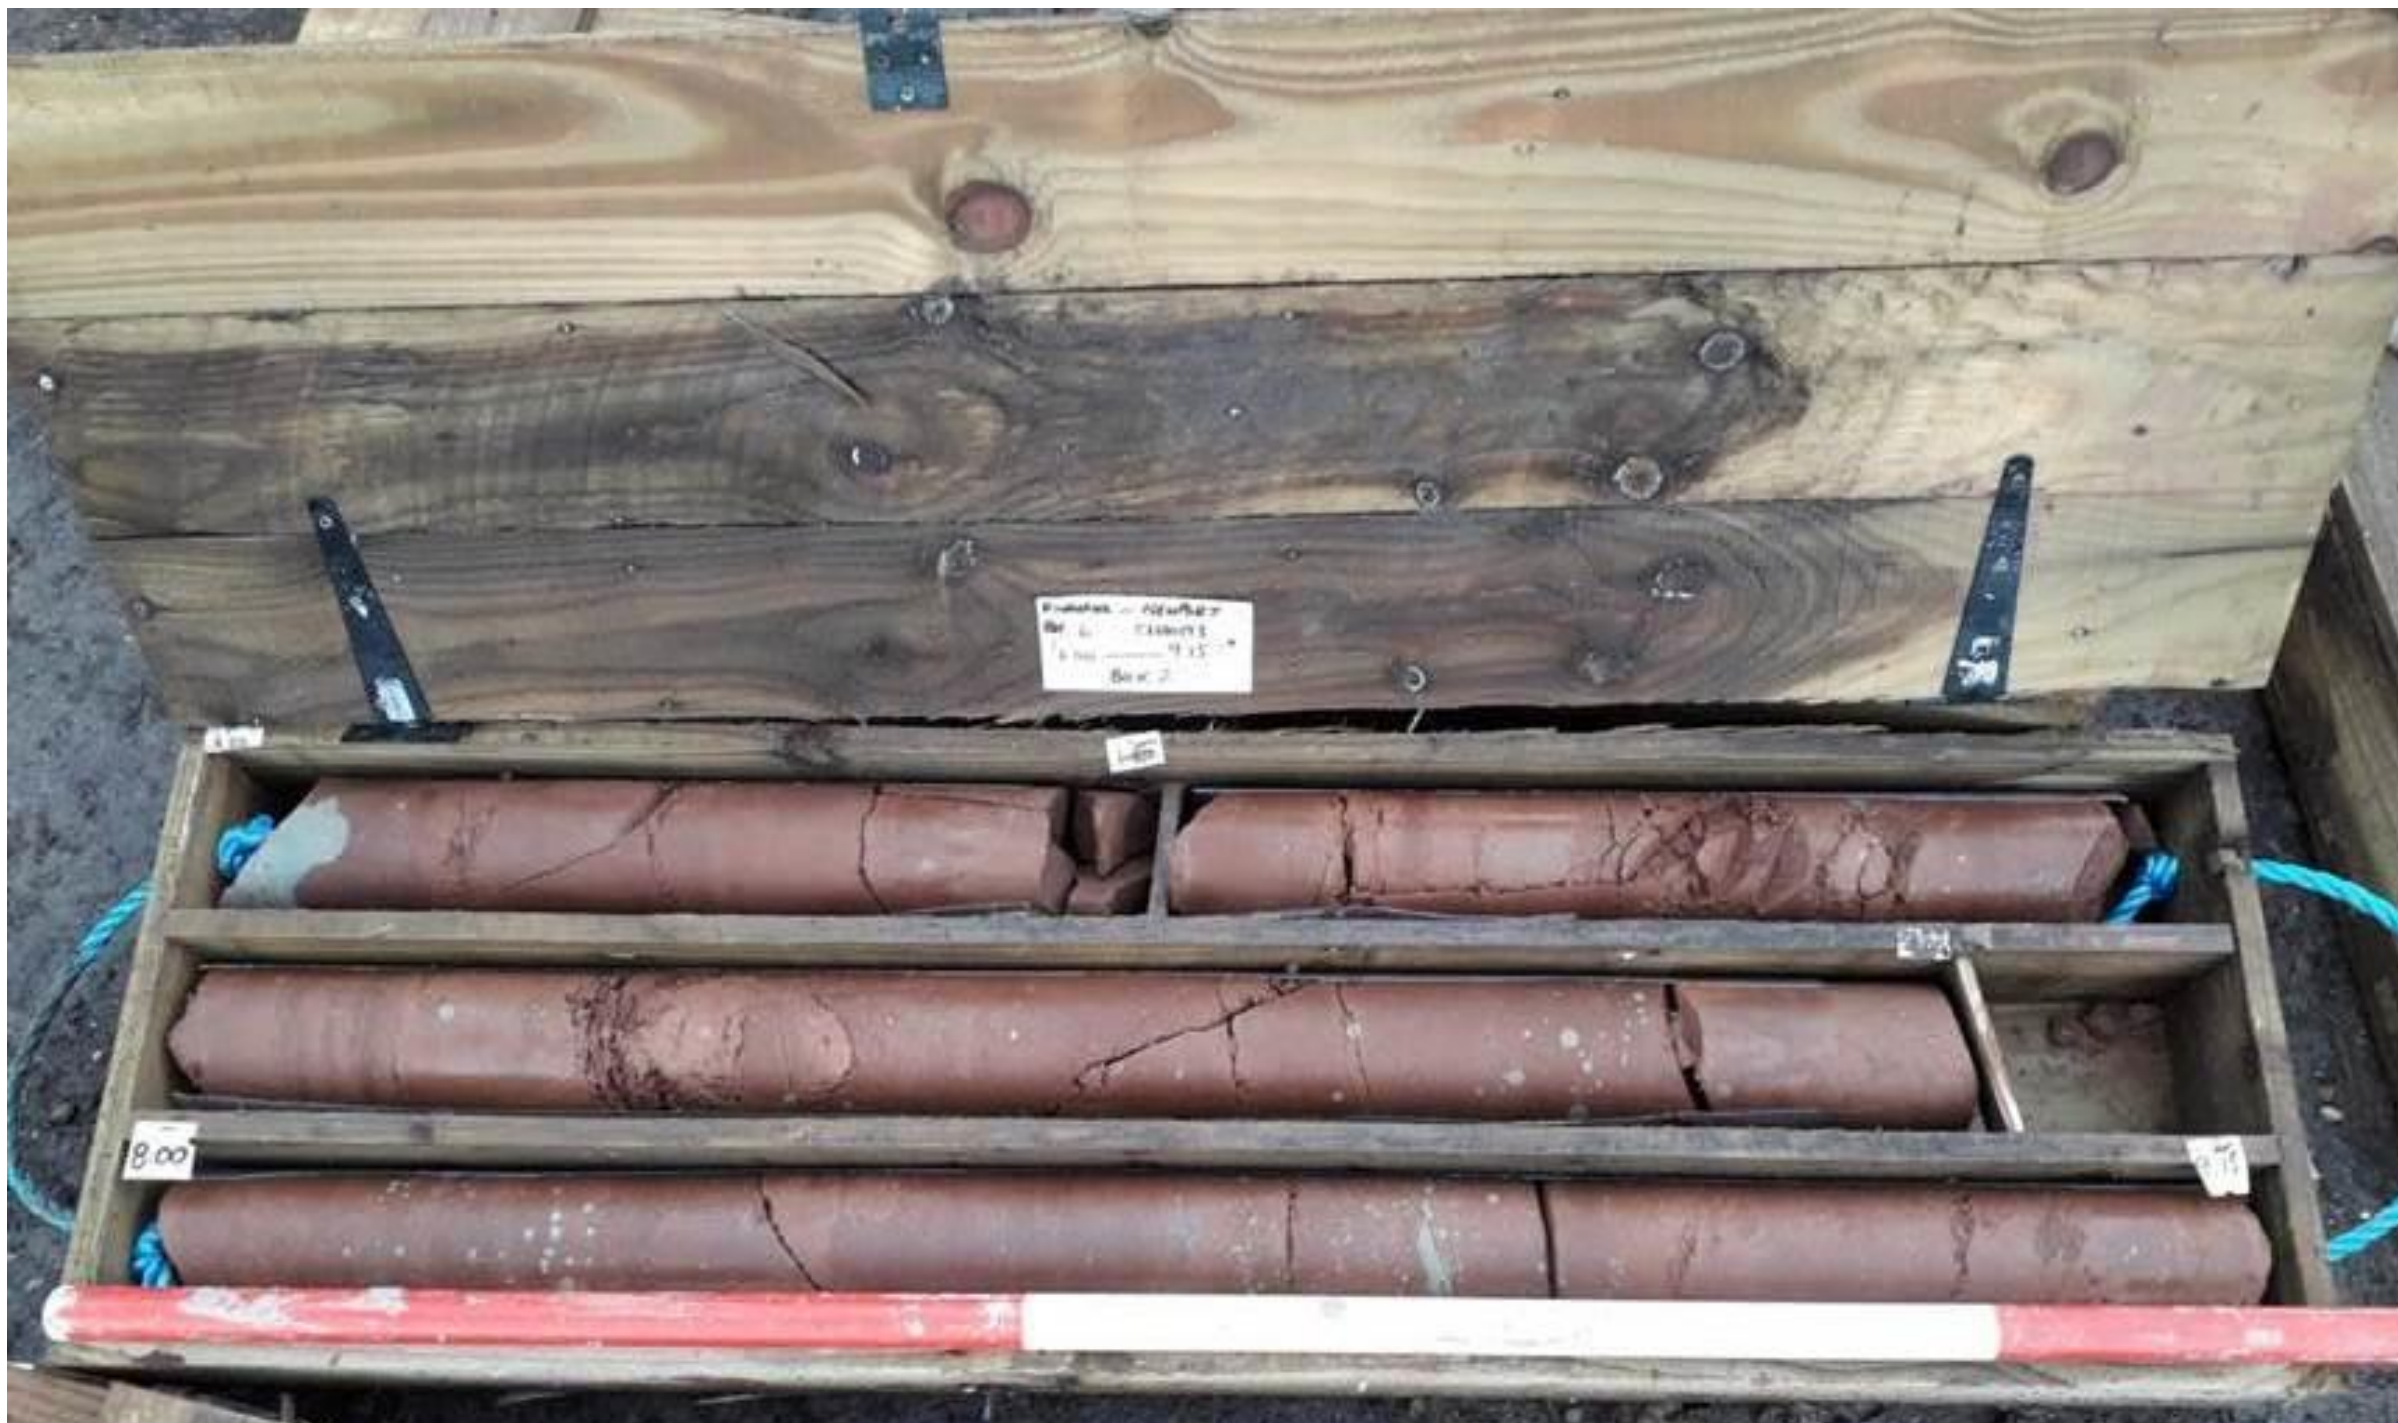
| | | Figure: A2.45 | |

| Date Drawn:<br>14-02-2020 | Scale: NTS | Title: BH06 Core Photographs | |

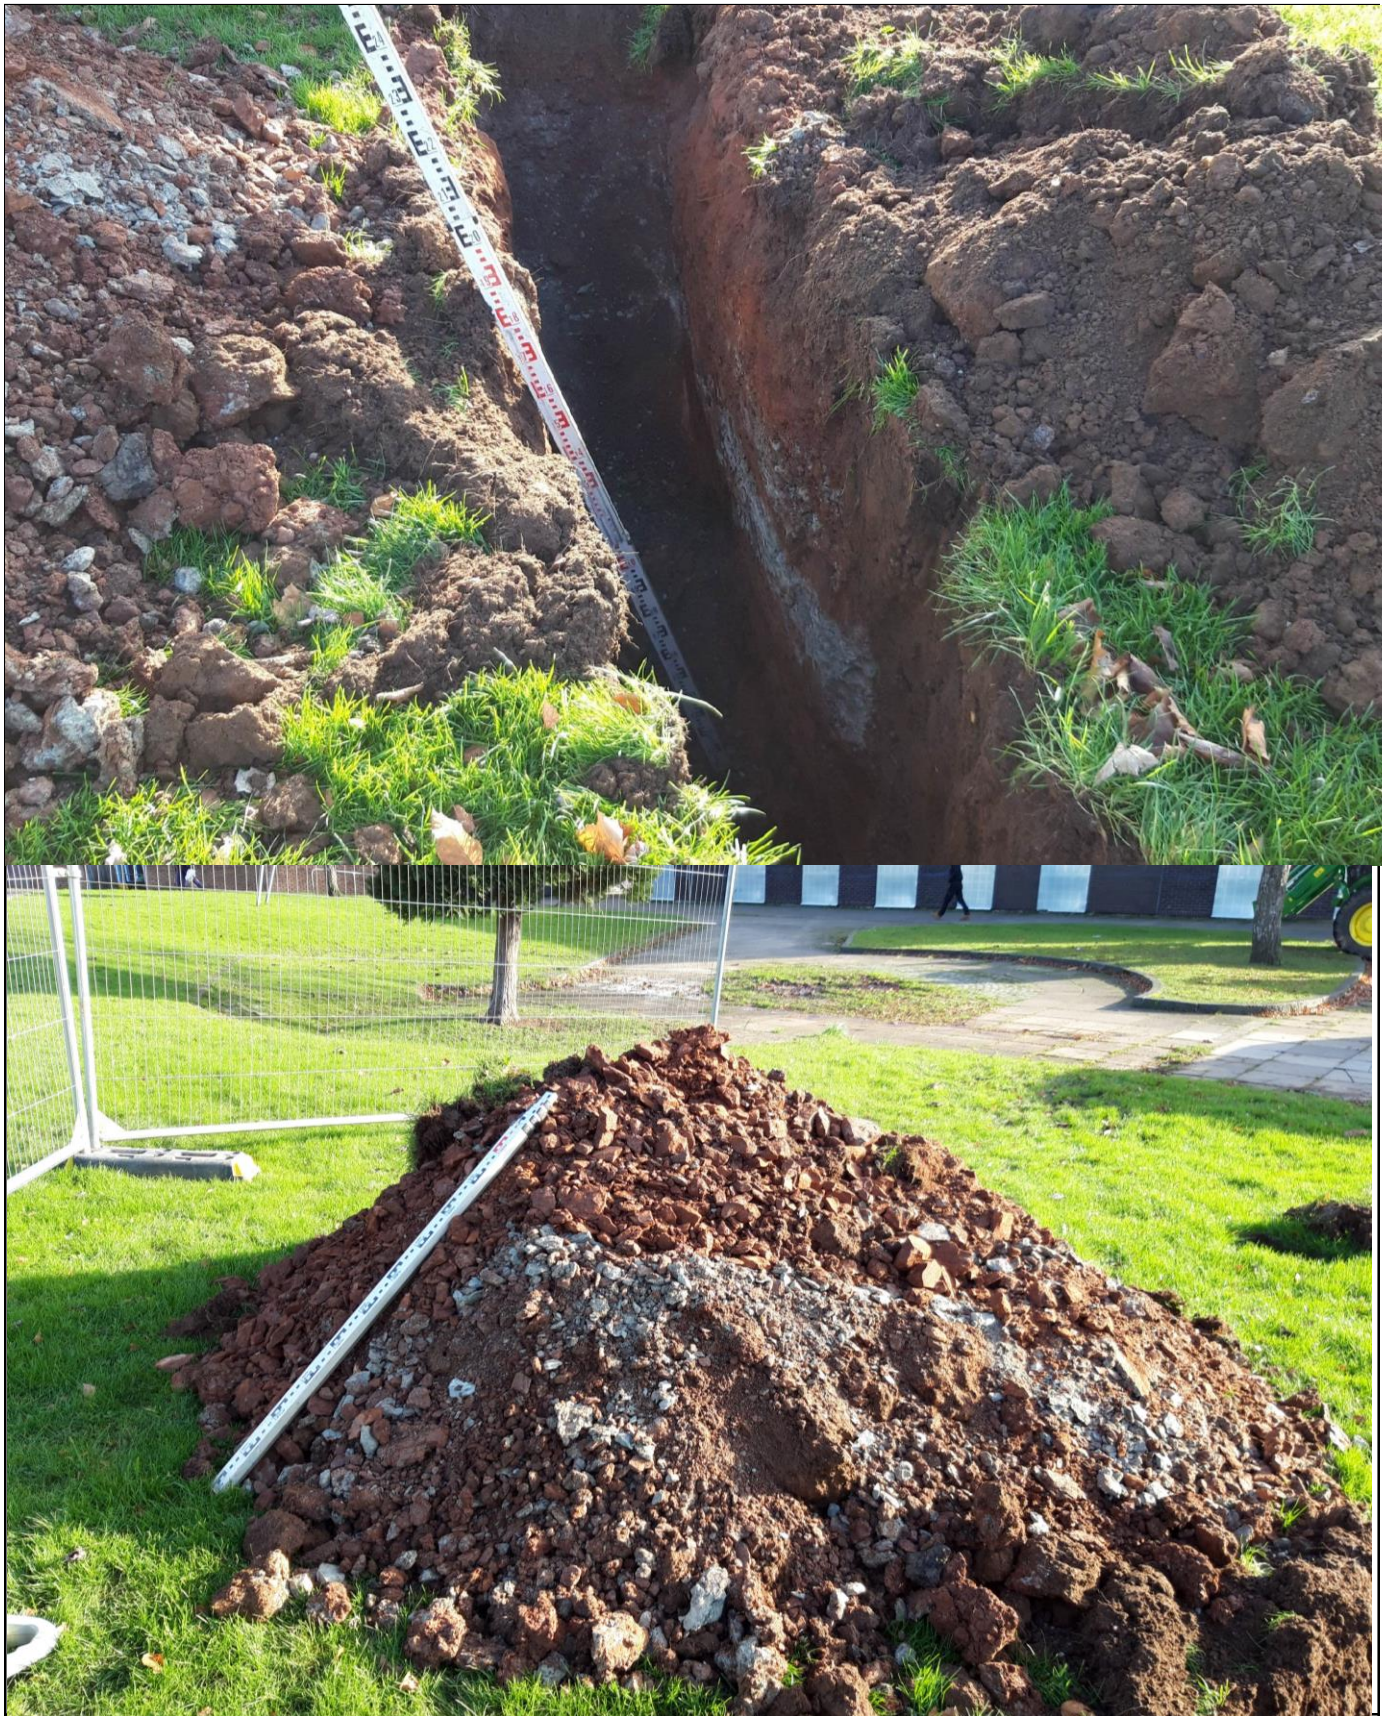
| | | Fig A2.54 | |

| Date Drawn:<br>23-02-2020 | Scale: NTS | Title: Exploratory Hole Photographs SA01 | |

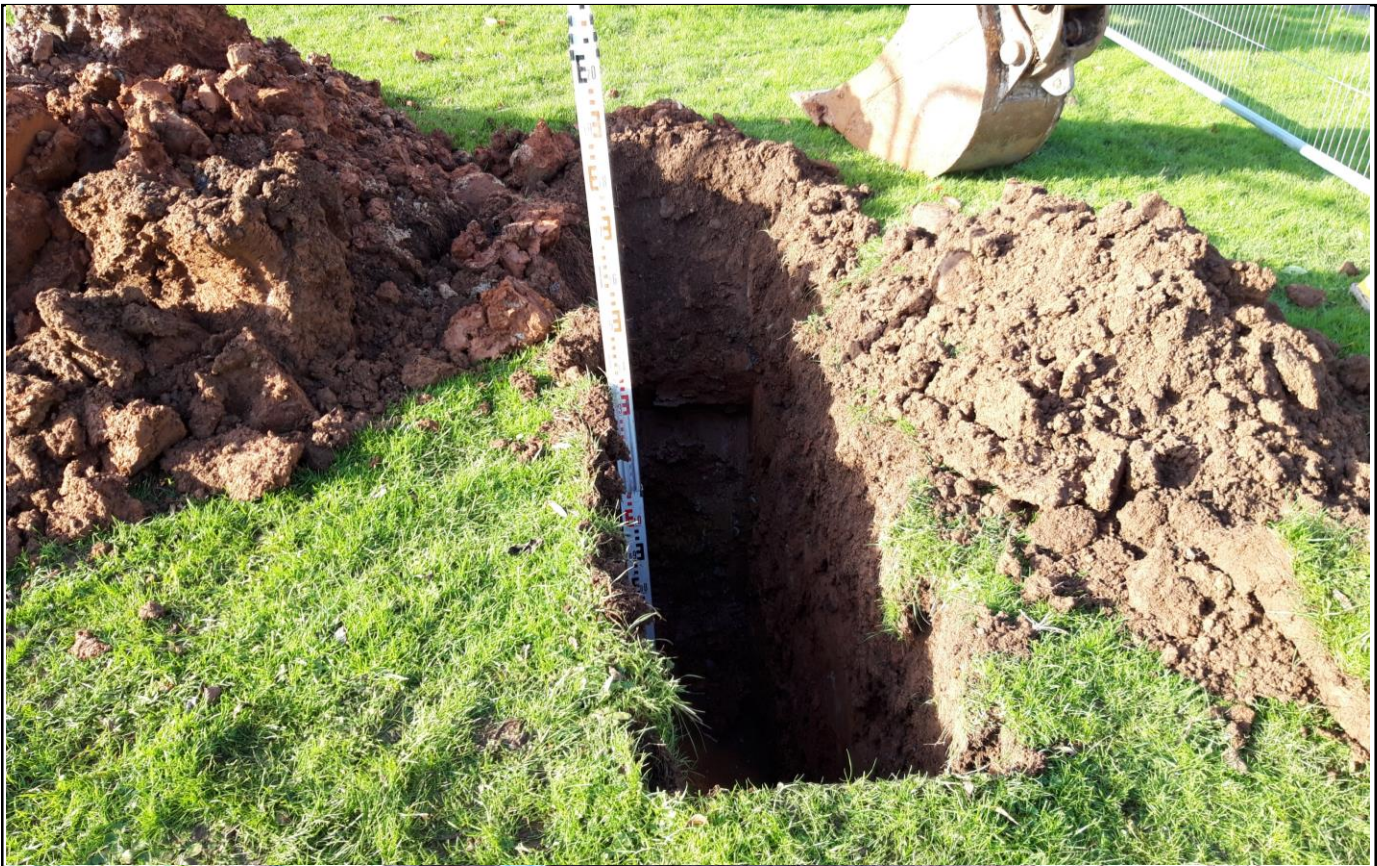
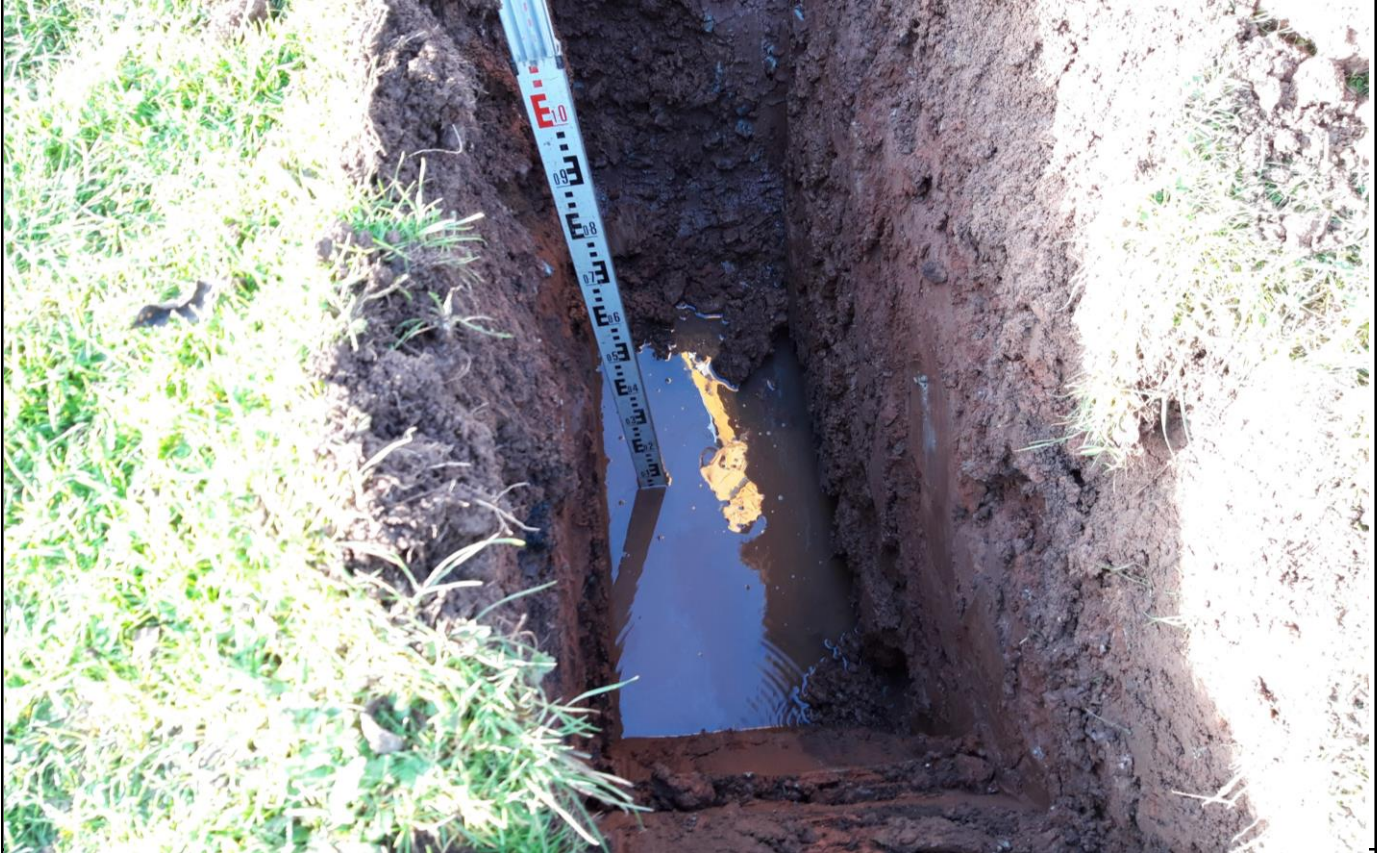
| | | Fig A2.55 | |

| Date Drawn:<br>23-02-2020 | Scale: NTS | Title: Exploratory Hole Photographs SA04 | |

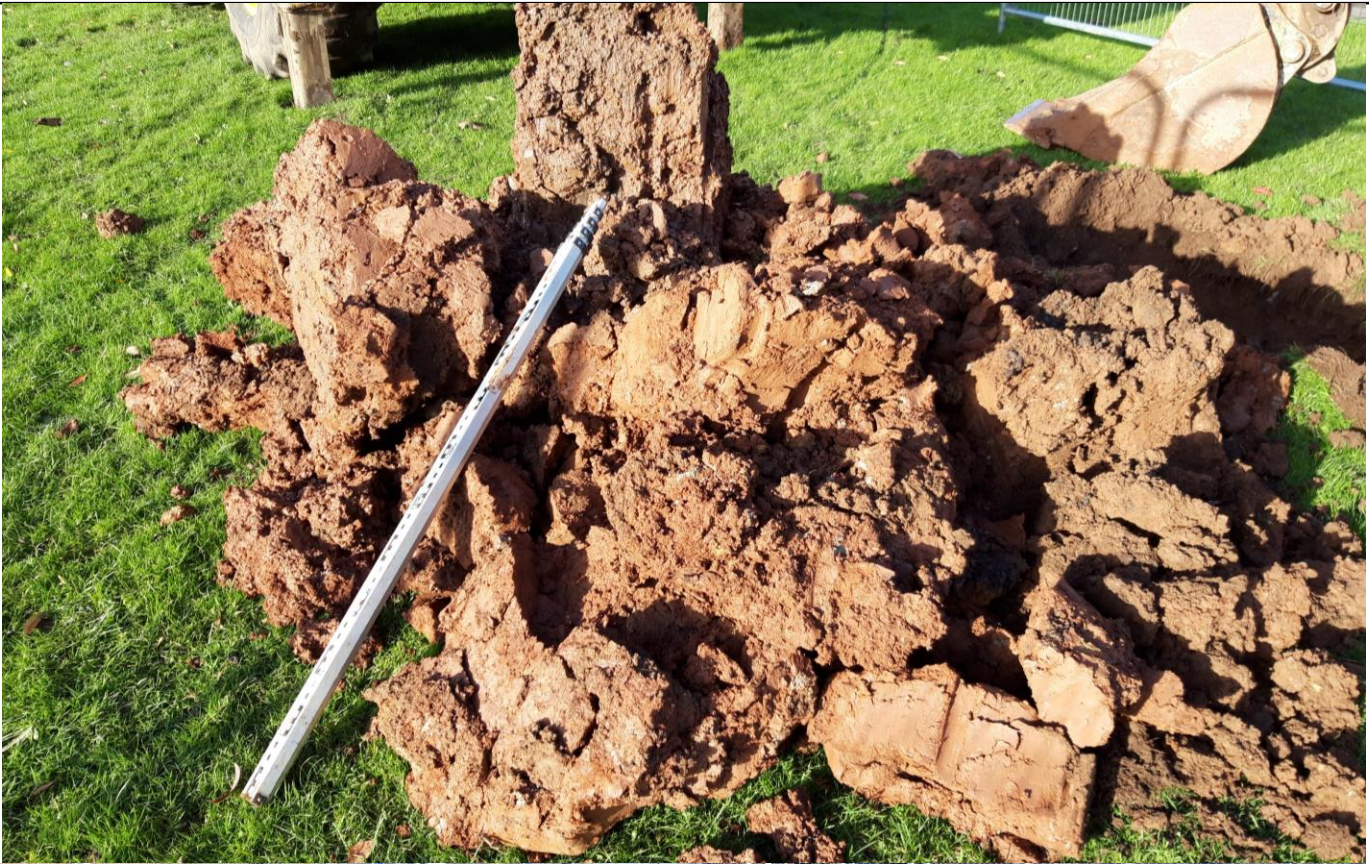
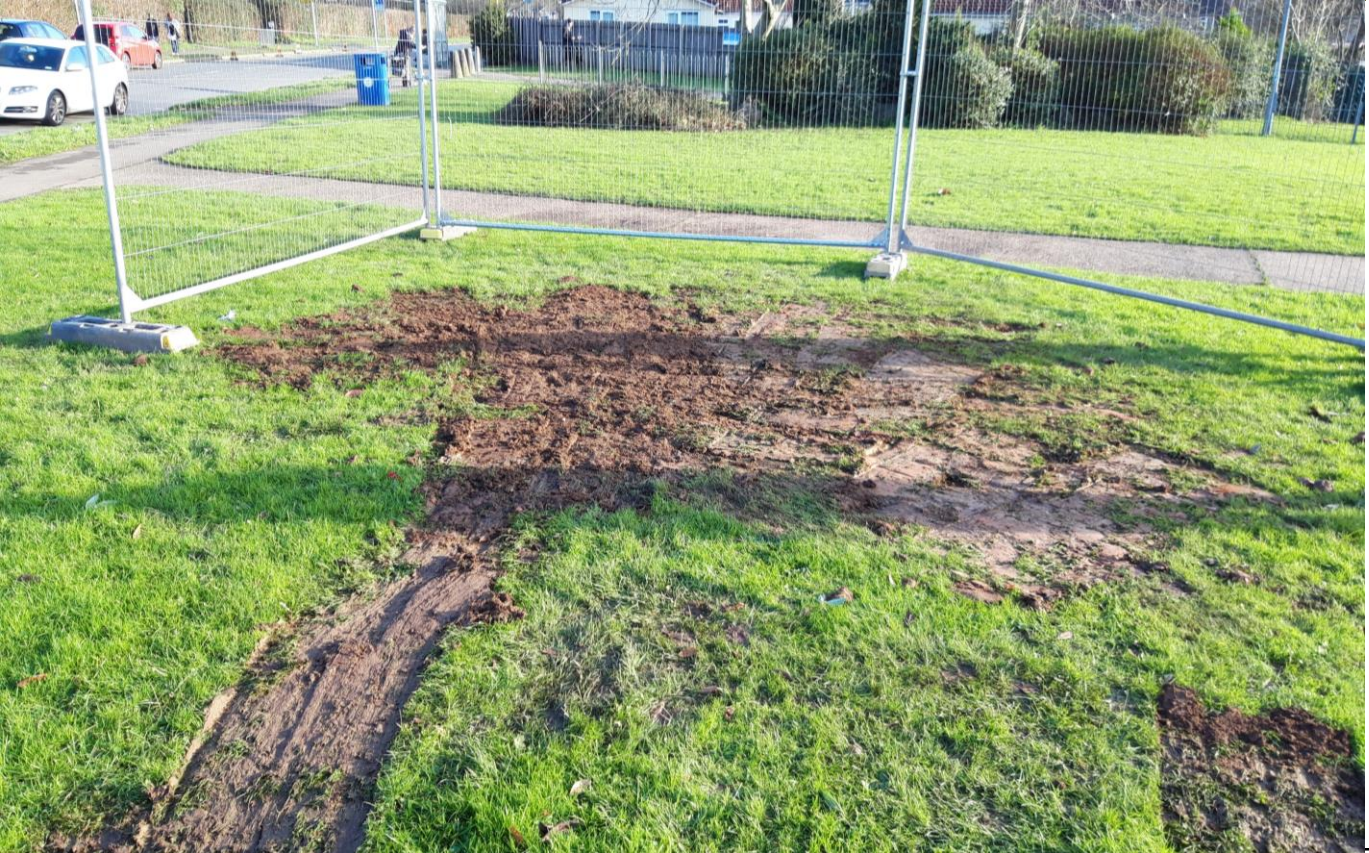
| | | Fig A2.56 | |

| Date Drawn:<br>23-02-2020 | Scale: NTS | Title: Exploratory Hole Photographs SA04 | |

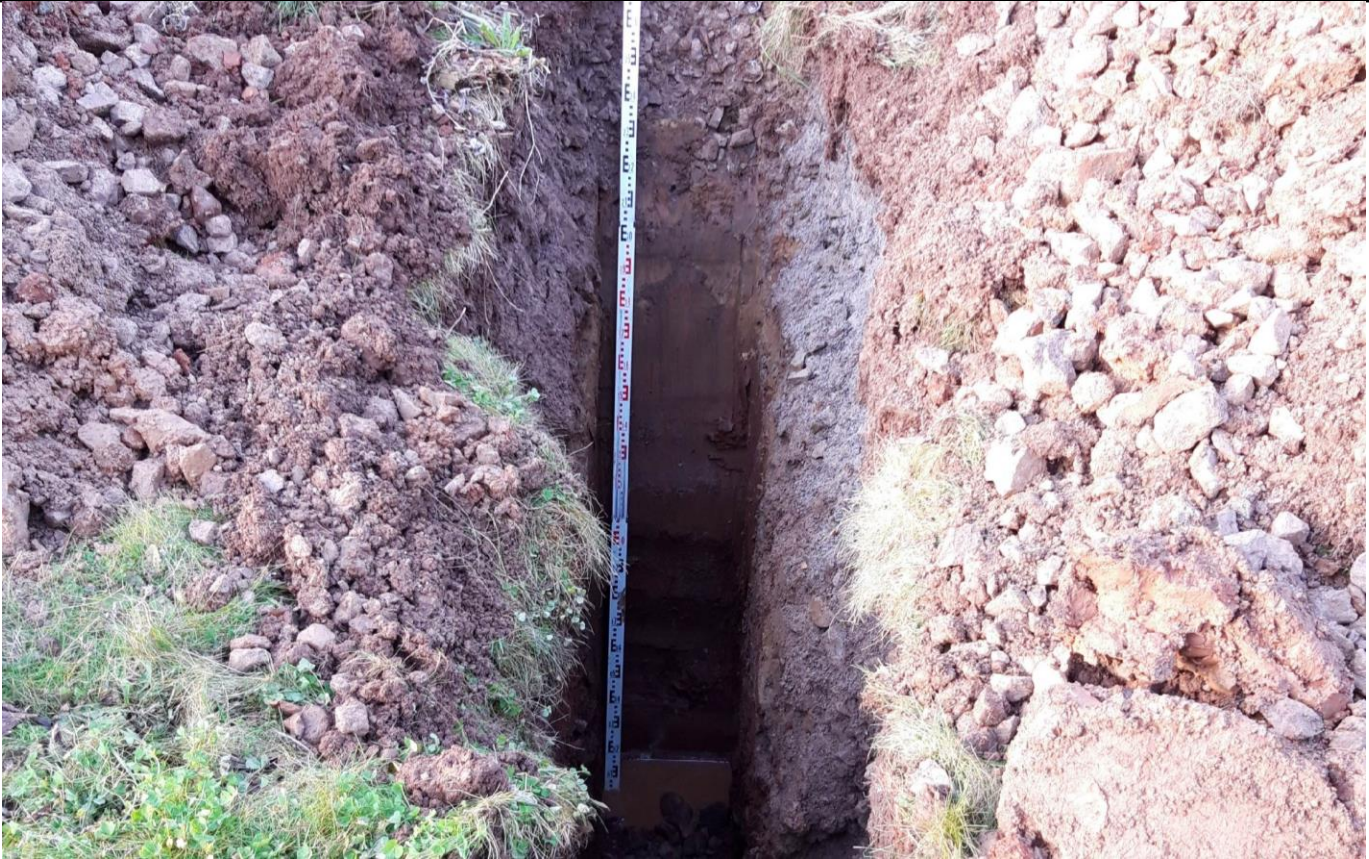
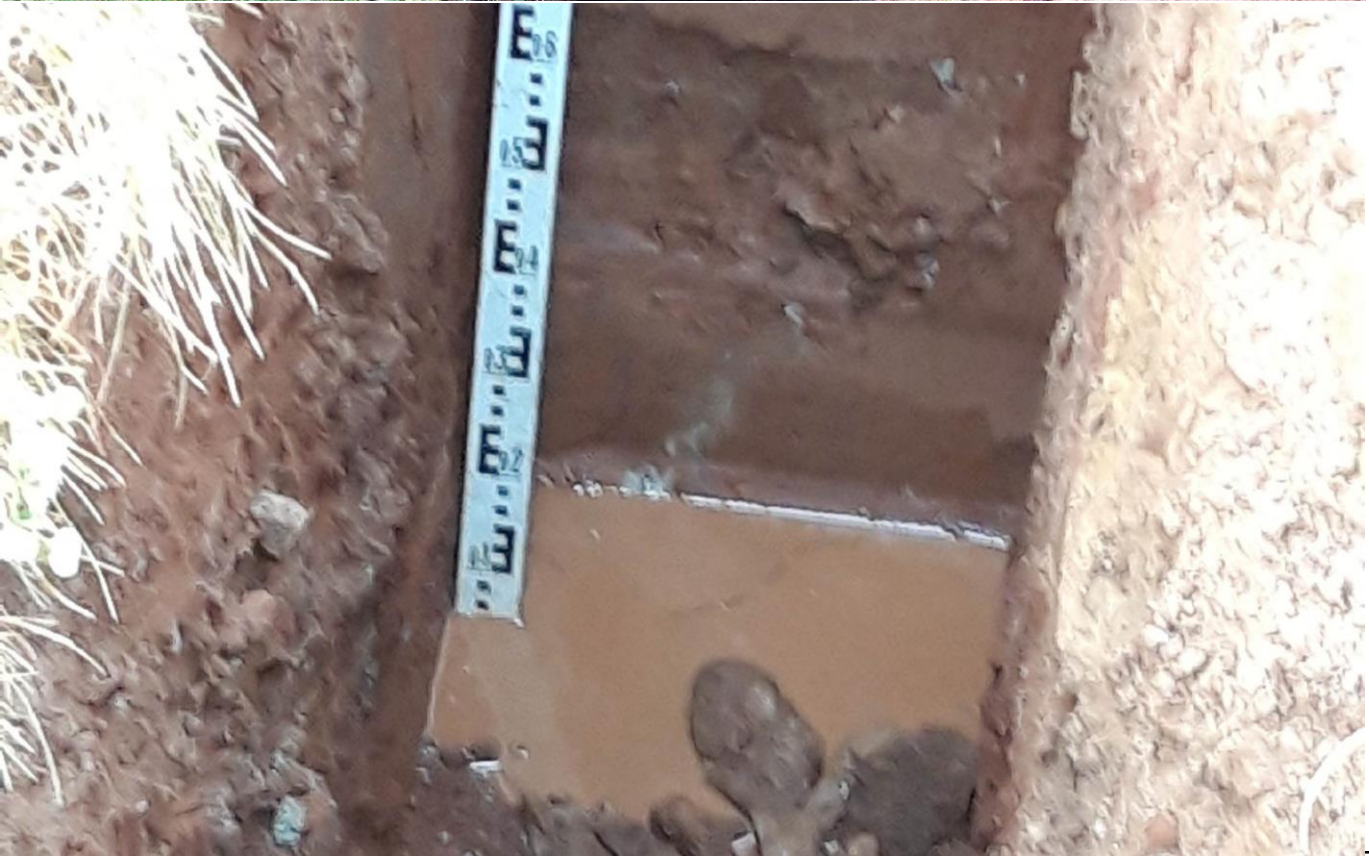
| | | Fig A2.57 | |

| Date Drawn:<br>23-02-2020 | Scale: NTS | Title: Exploratory Hole Photographs TP05 | |

However, made ground was encountered at depths up to 1.50m in WS05 & TP05 and to 2.30m and 2.20m respectively in TP03 & TP04. The deeper made ground appeared to be located in the landscaped area in the north of the site which was formerly occupied by a residential block demolished around 2016 and accordingly the made ground in this location appeared to consist of demolition material and could be infilled basements or foundations.

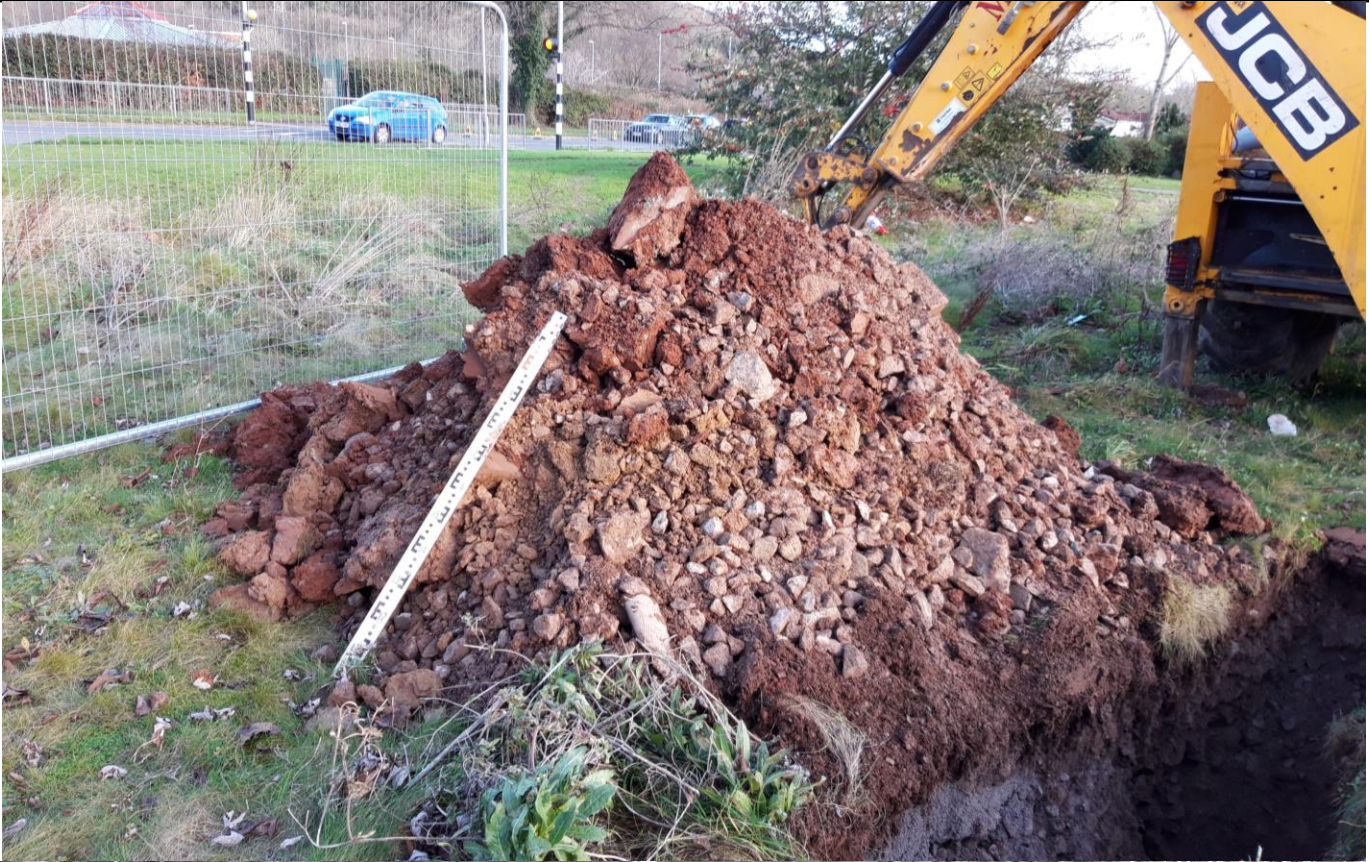
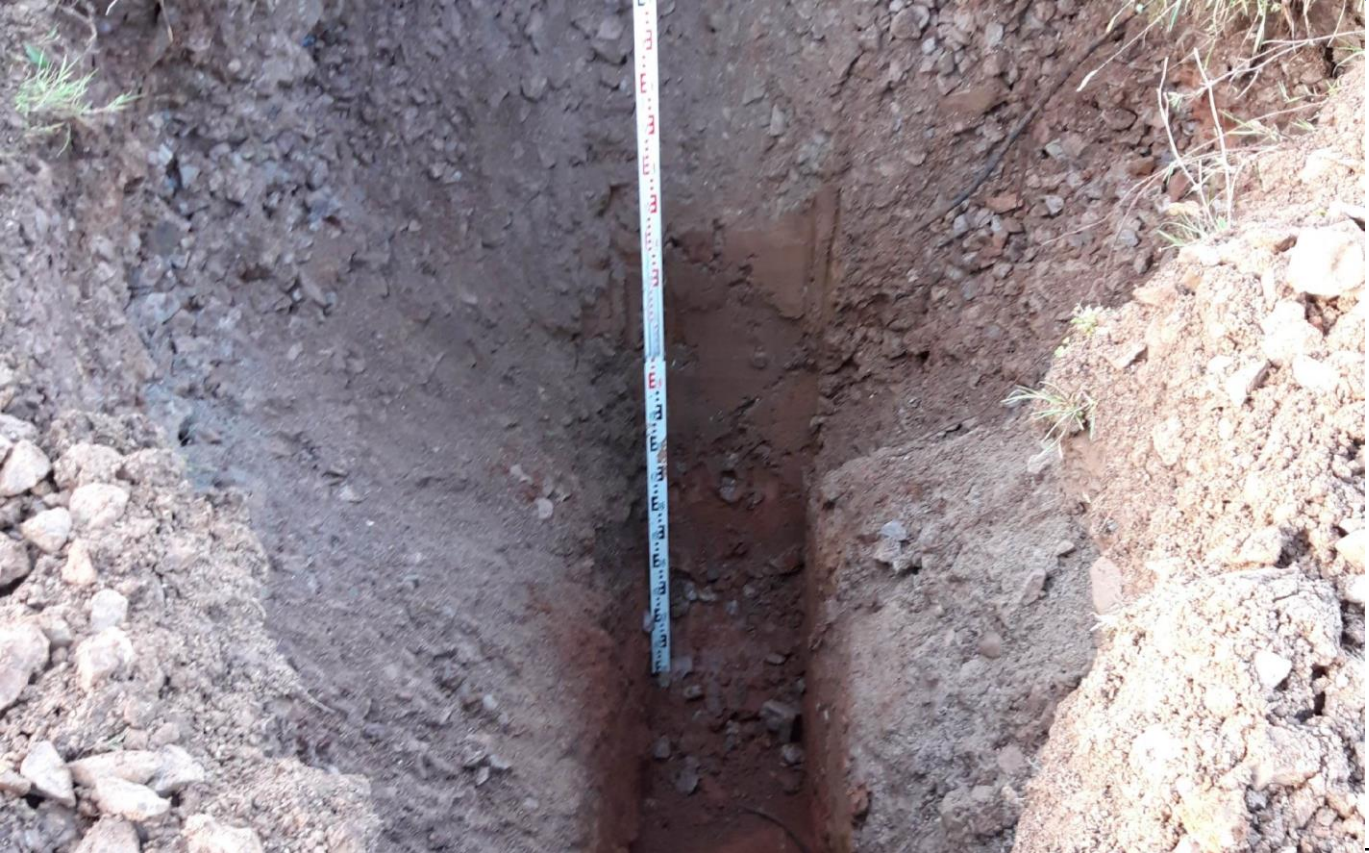
| | | Fig A2.58 | |

| Date Drawn:<br>23-02-2020 | Scale: NTS | Title: Exploratory Hole Photographs TP05 & TP04 | |
