# Ringland, Newport

## Phase 2 Ground Investigation

Curtins Ref: 066799-CUR-00-XX-RP-GE-002-V01

Issue Date: 16 March 2020

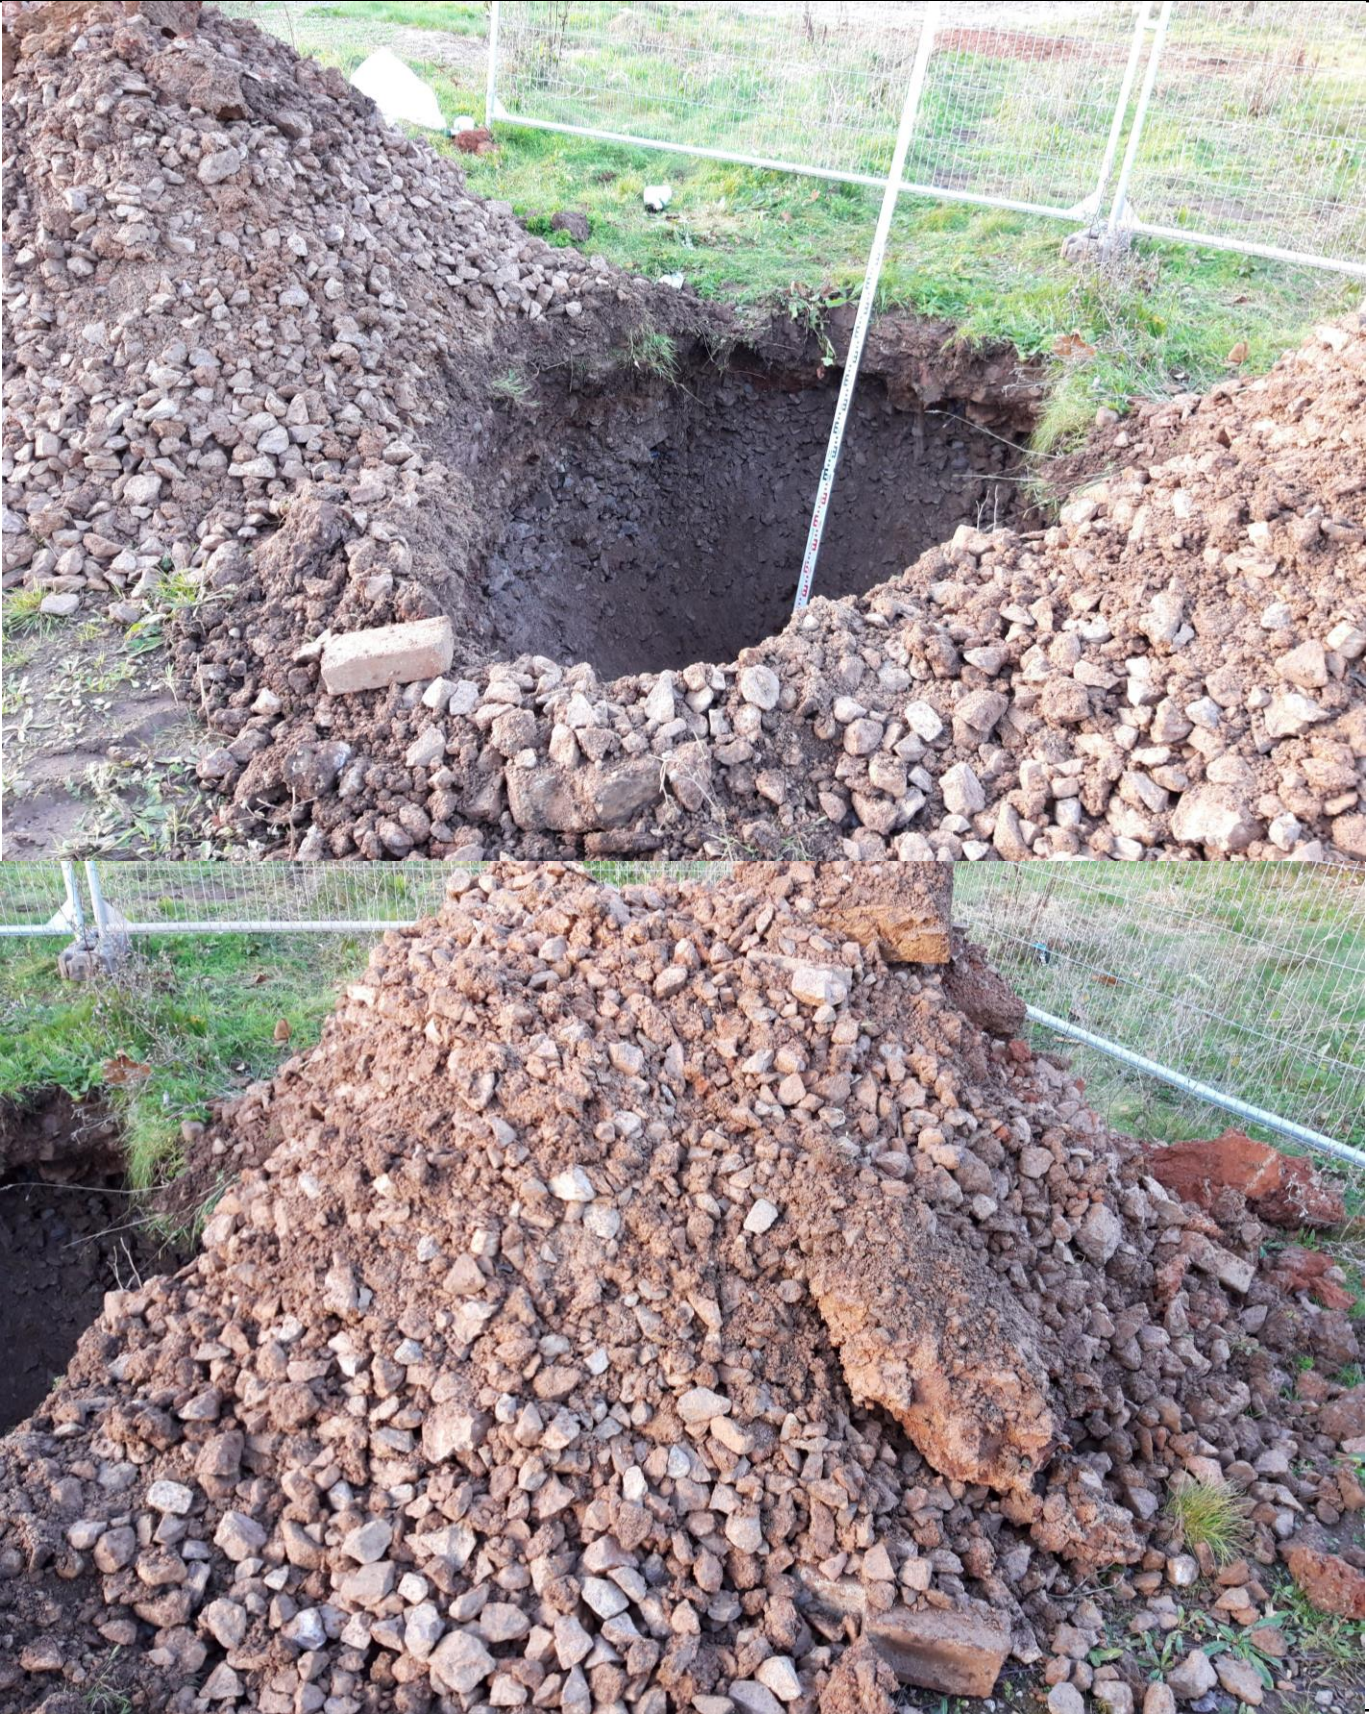
| | | Fig A2.59 | |

| Date Drawn:<br>23-02-2020 | Scale: NTS | Title: Exploratory Hole Photographs TP04 | |

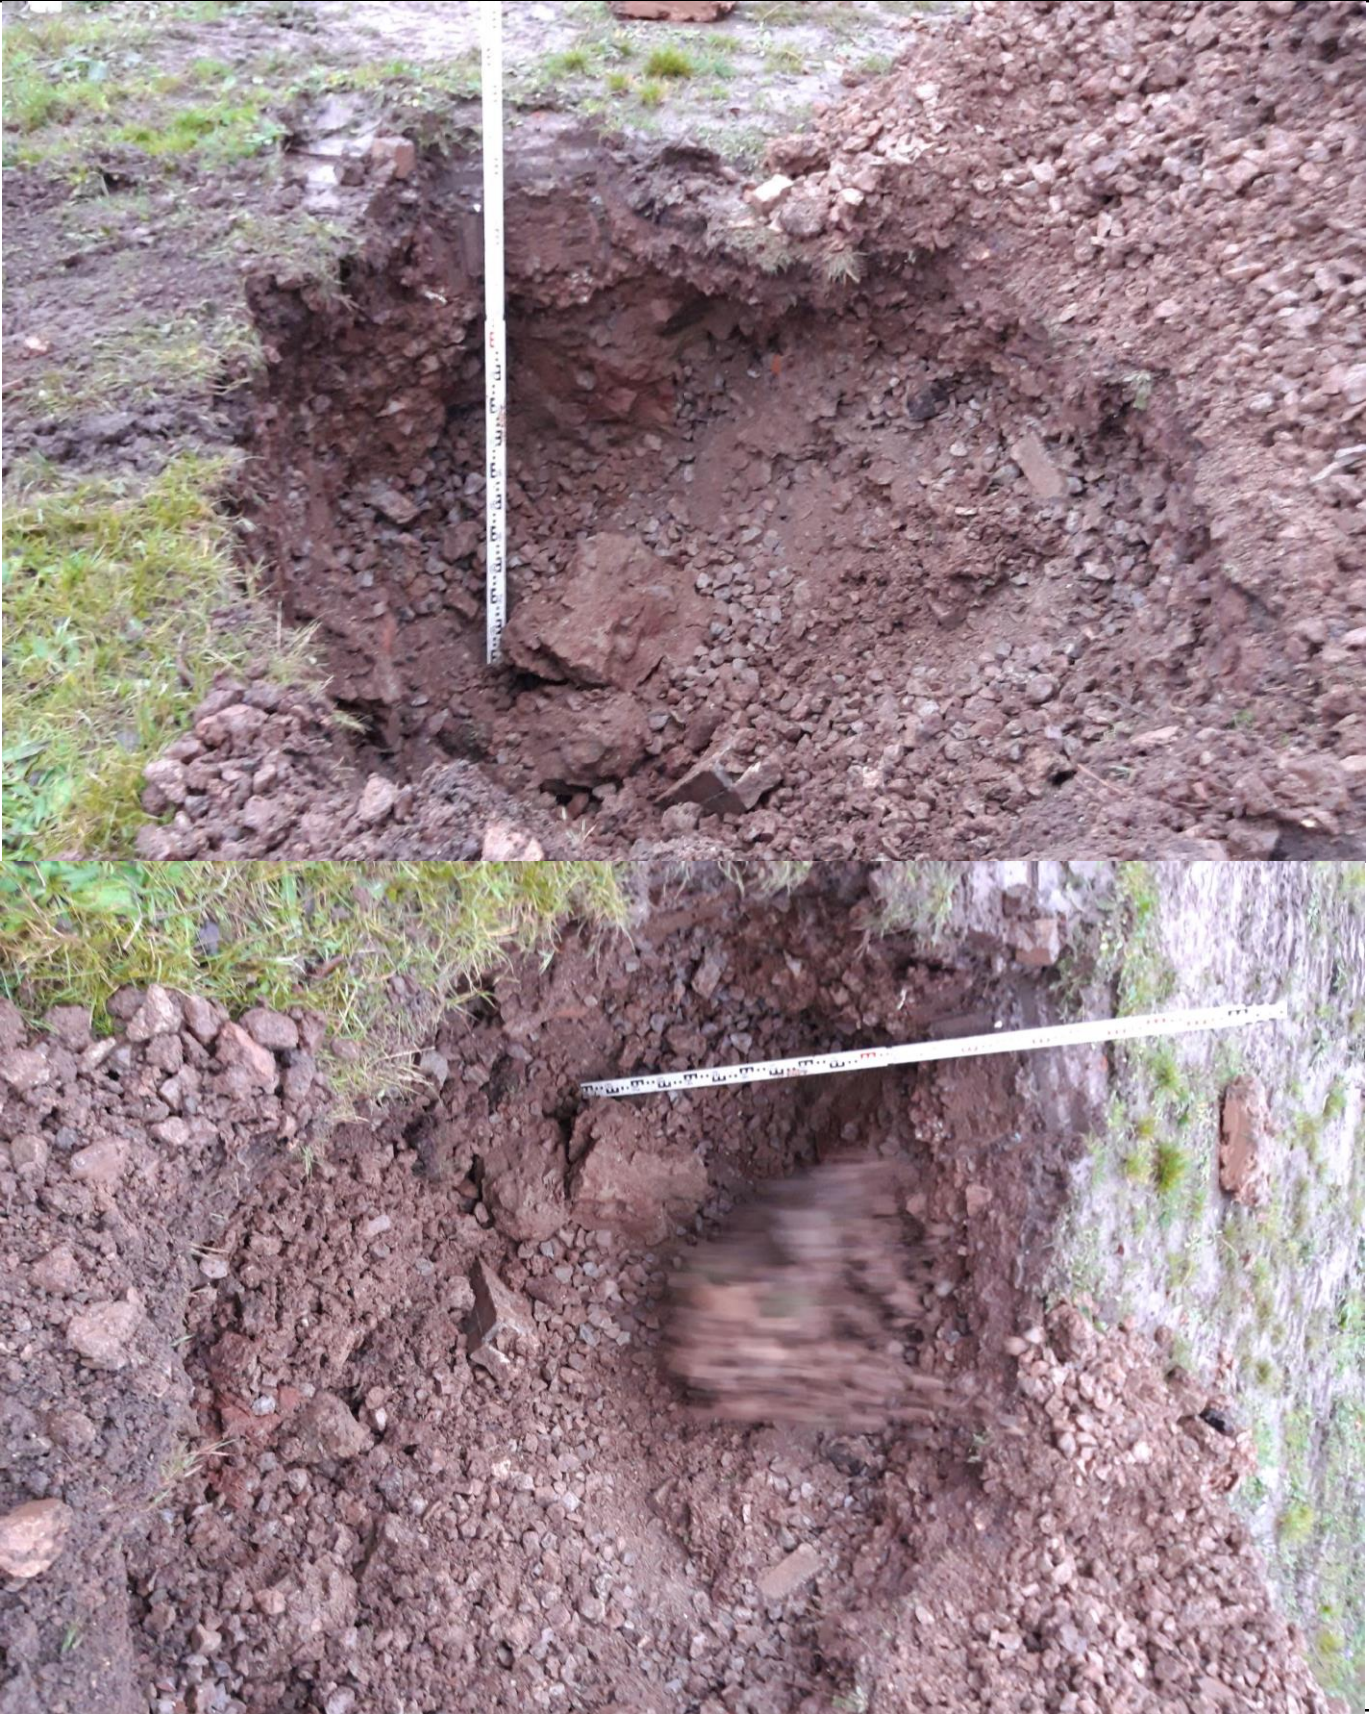
| Date Drawn:<br>23-02-2020 | Scale: NTS | Title: Exploratory Hole Photographs TP03 | |

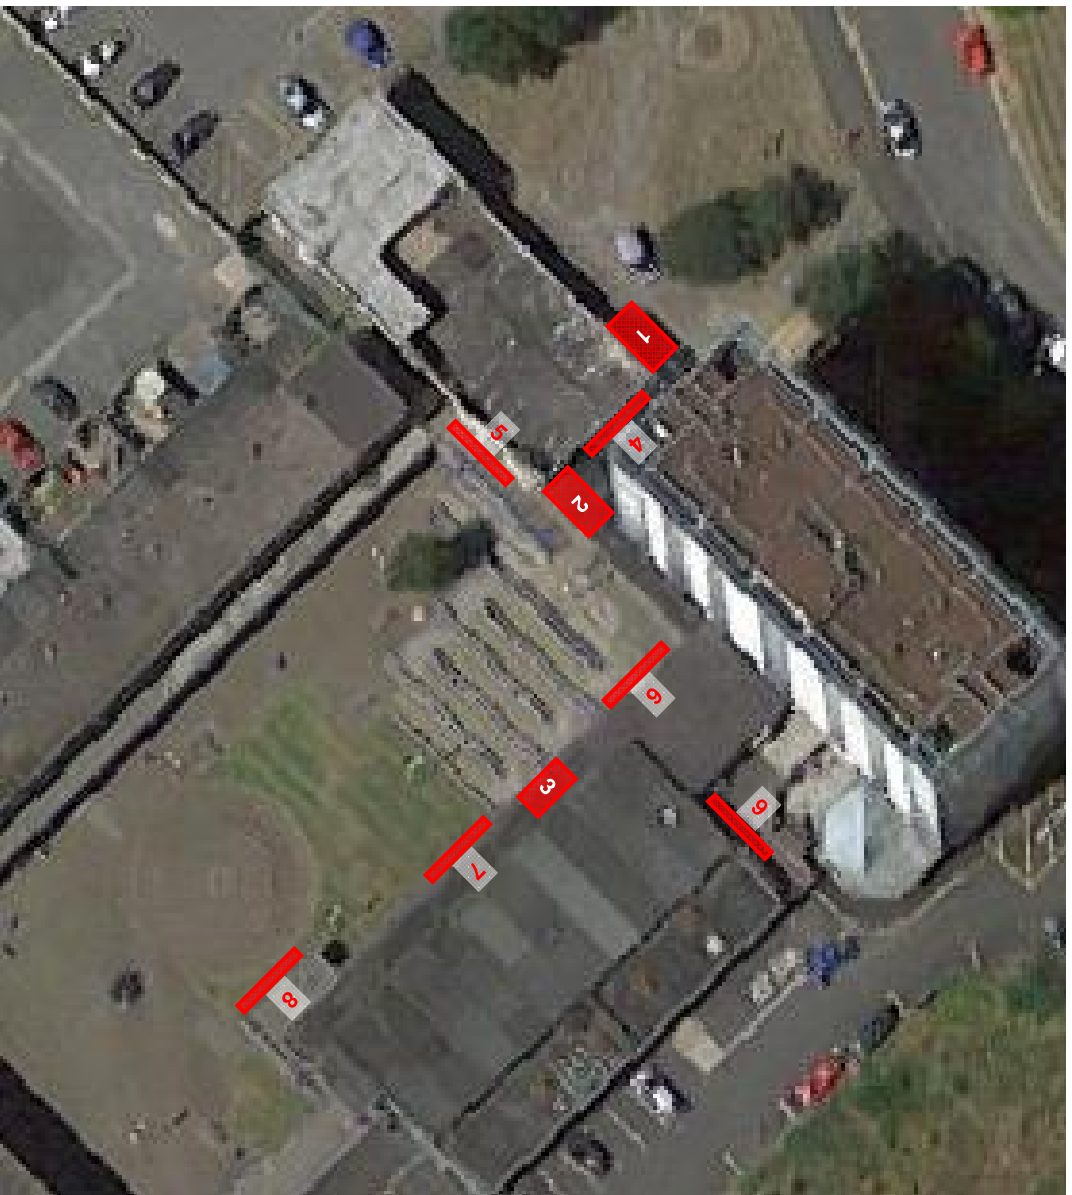
1. Remove paving slabs and undertake drilling to retained soil to probe at the base of the retaining wall to establish top of concrete level to retaining wall heel. Probing to continue at regular intervals away from building perimeter 0.75m, 1.5m, 2.25m, 3m etc. to establish lateral extent of retaining wall heel.

2. Lift paving slabs to walkway areas and undertake hand dug trial pit to establish detail to head of retaining wall and presence of concrete slab or otherwise to underside of paving.

- Remove paving slabs and undertake dynamic probe drilling to retained soil to contact base of the retaining wall to establish top of concrete level to retaining wall heel. Probing to continue at regular intervals away from building perimeter to establish lateral extent of retaining wall heel.
- Lift paving slabs and undertake trial pits to establish foundation extents as well as detail to head of retaining wall and presence of concrete slab or otherwise to underside of paving.

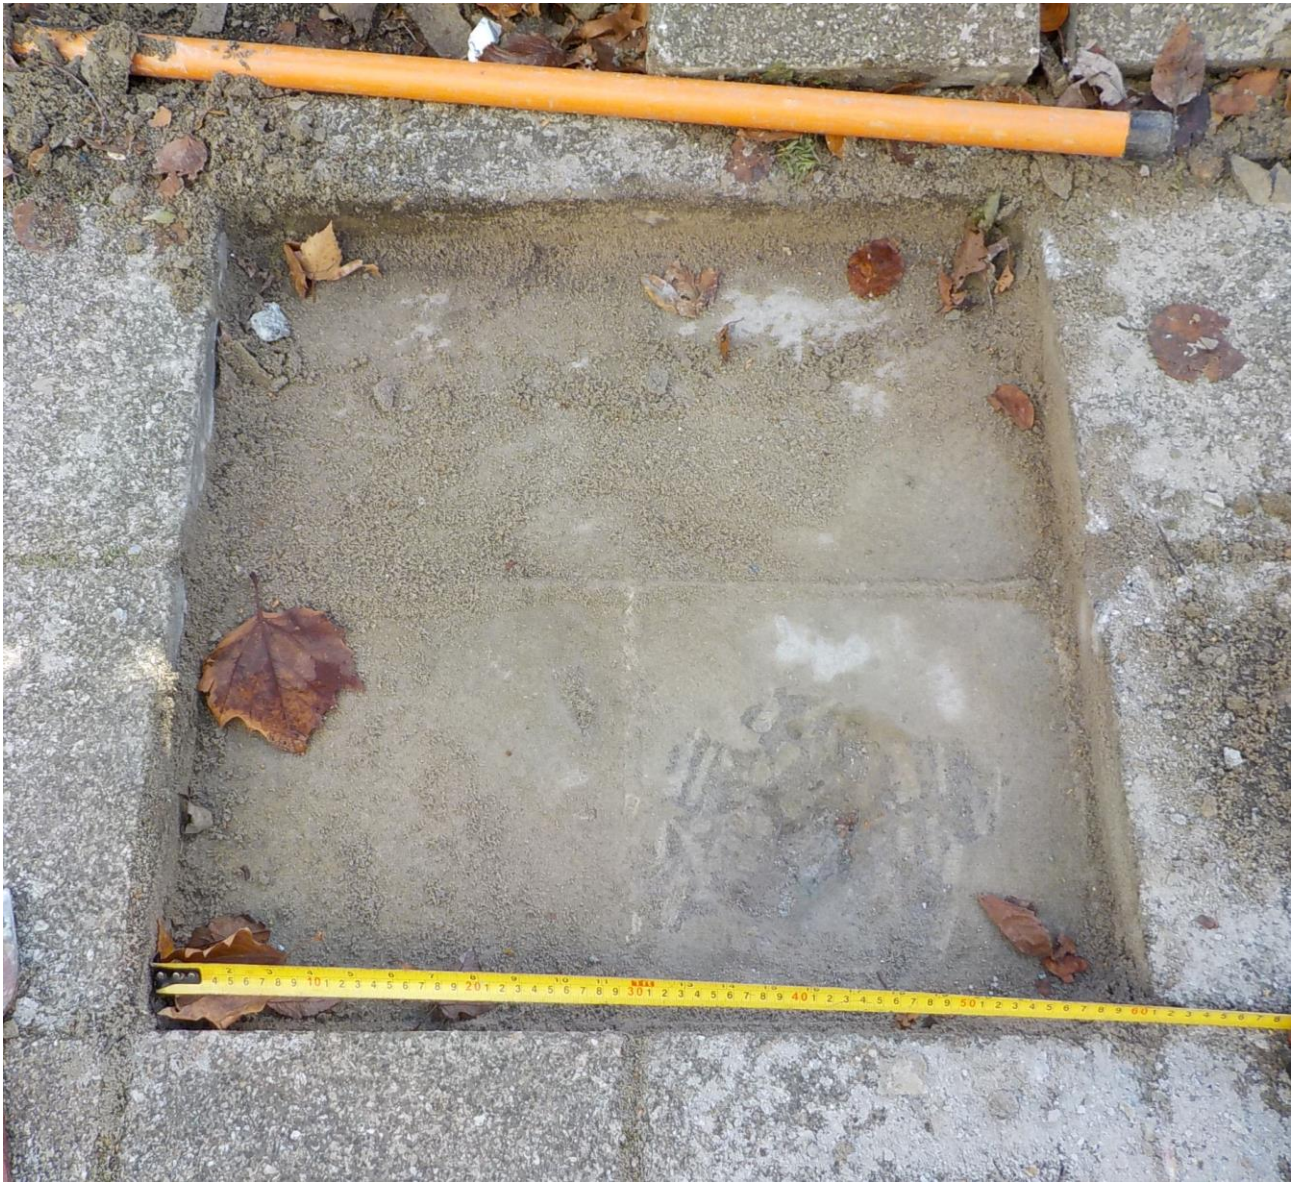
| | | Fig A2.62 | |

| Date Drawn:<br>23-02-2020 | Scale: NTS | Title: Opening Up Works Location 2 | |

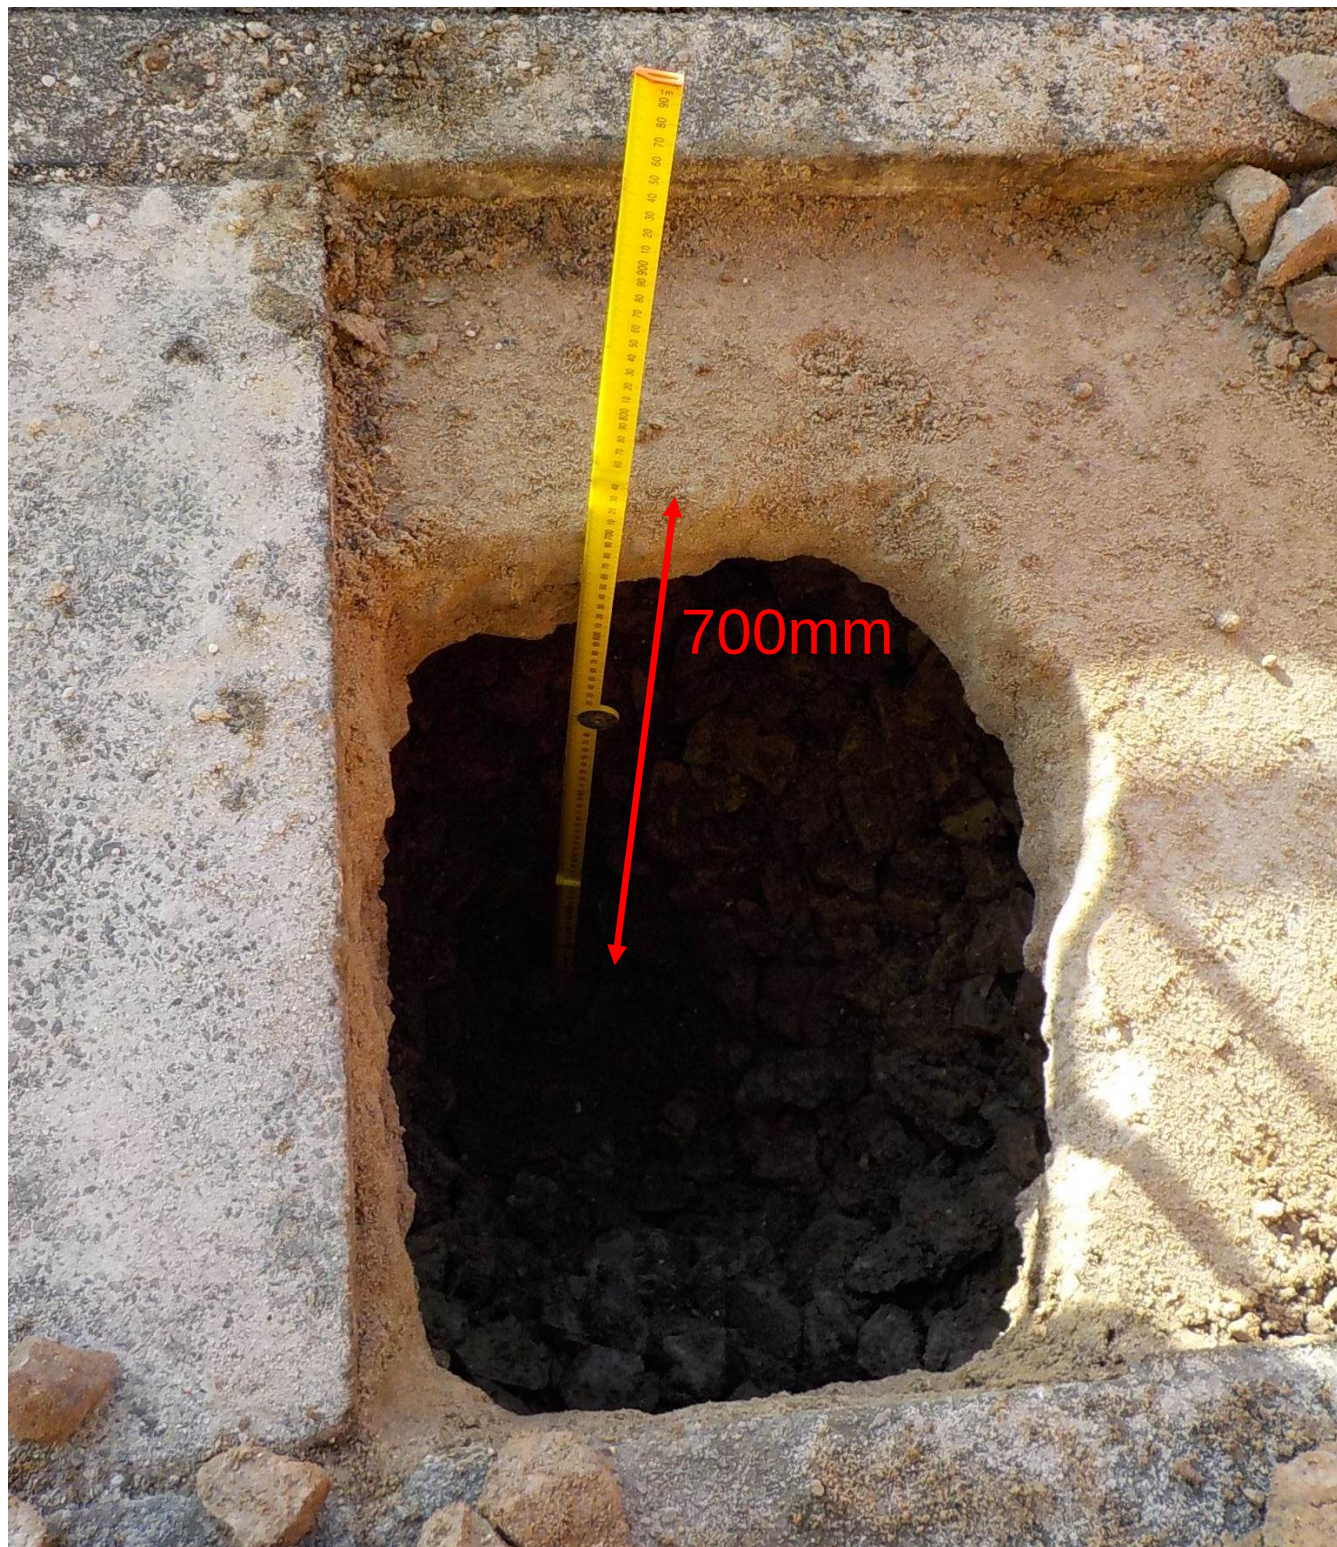
| | | Fig A2.63 | |

| Date Drawn:<br>23-02-2020 | Scale: NTS | Title: Opening Up Works Location 3 | |

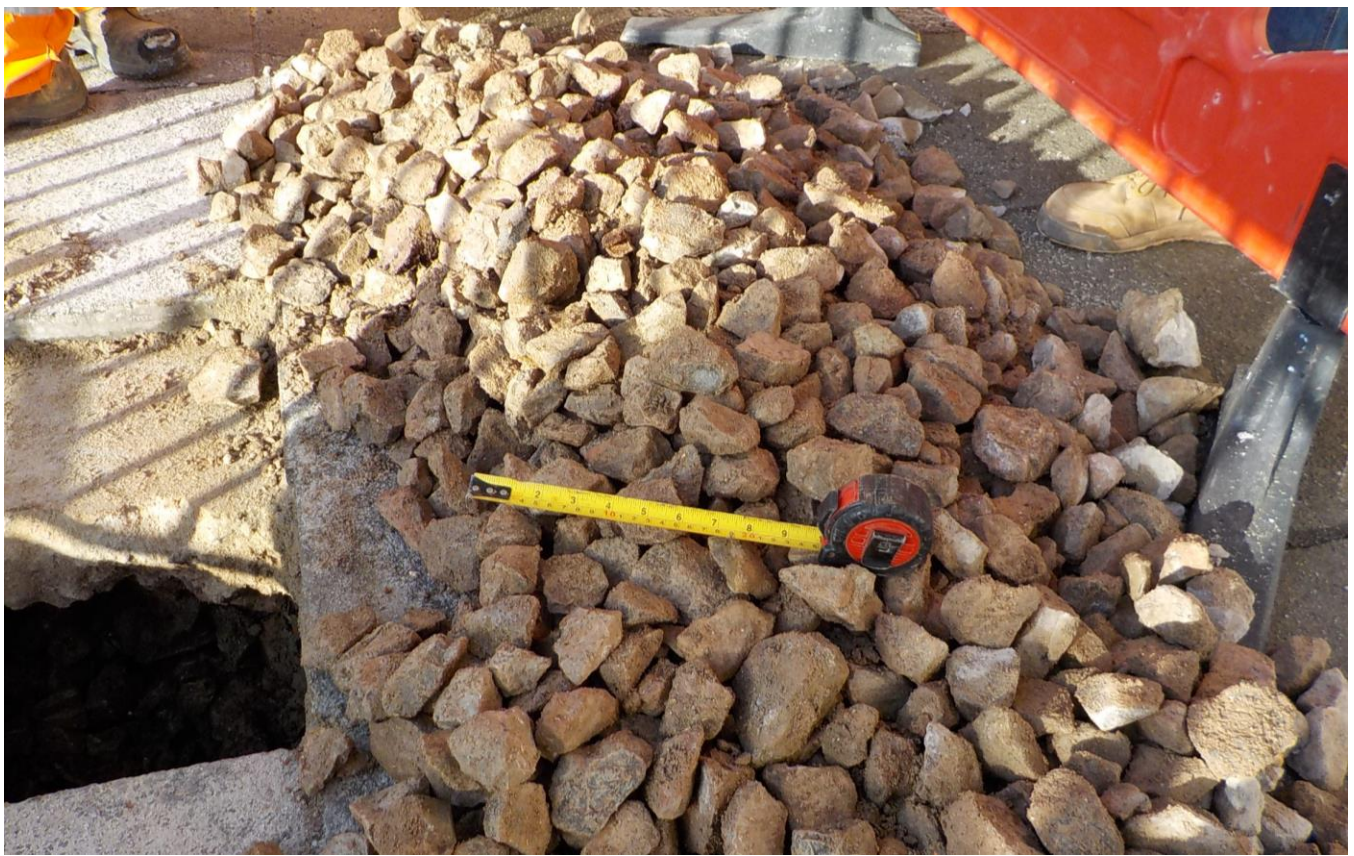
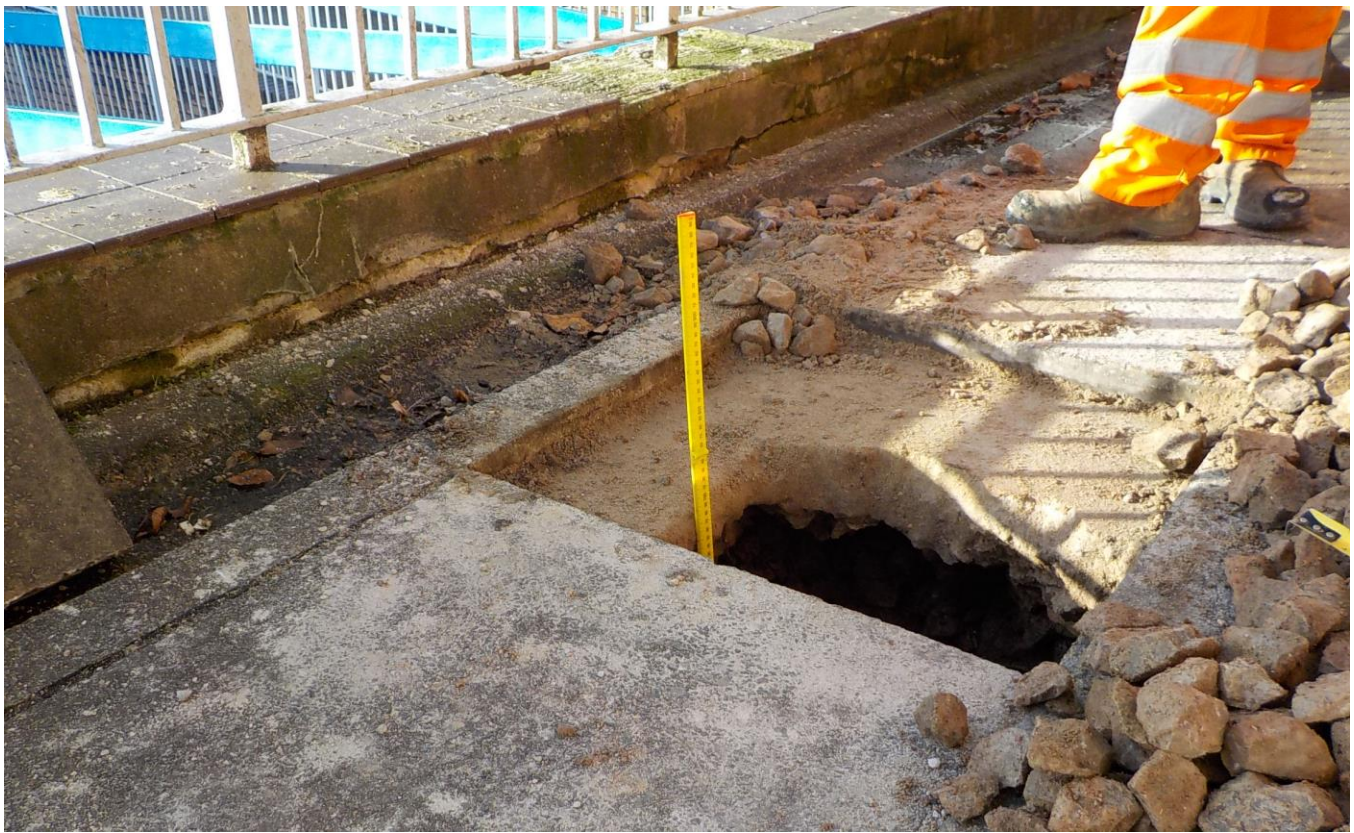
| | | Fig A2.64 | |

| Date Drawn:<br>23-02-2020 | Scale: NTS | Title: Opening Up Works Location 3 | |

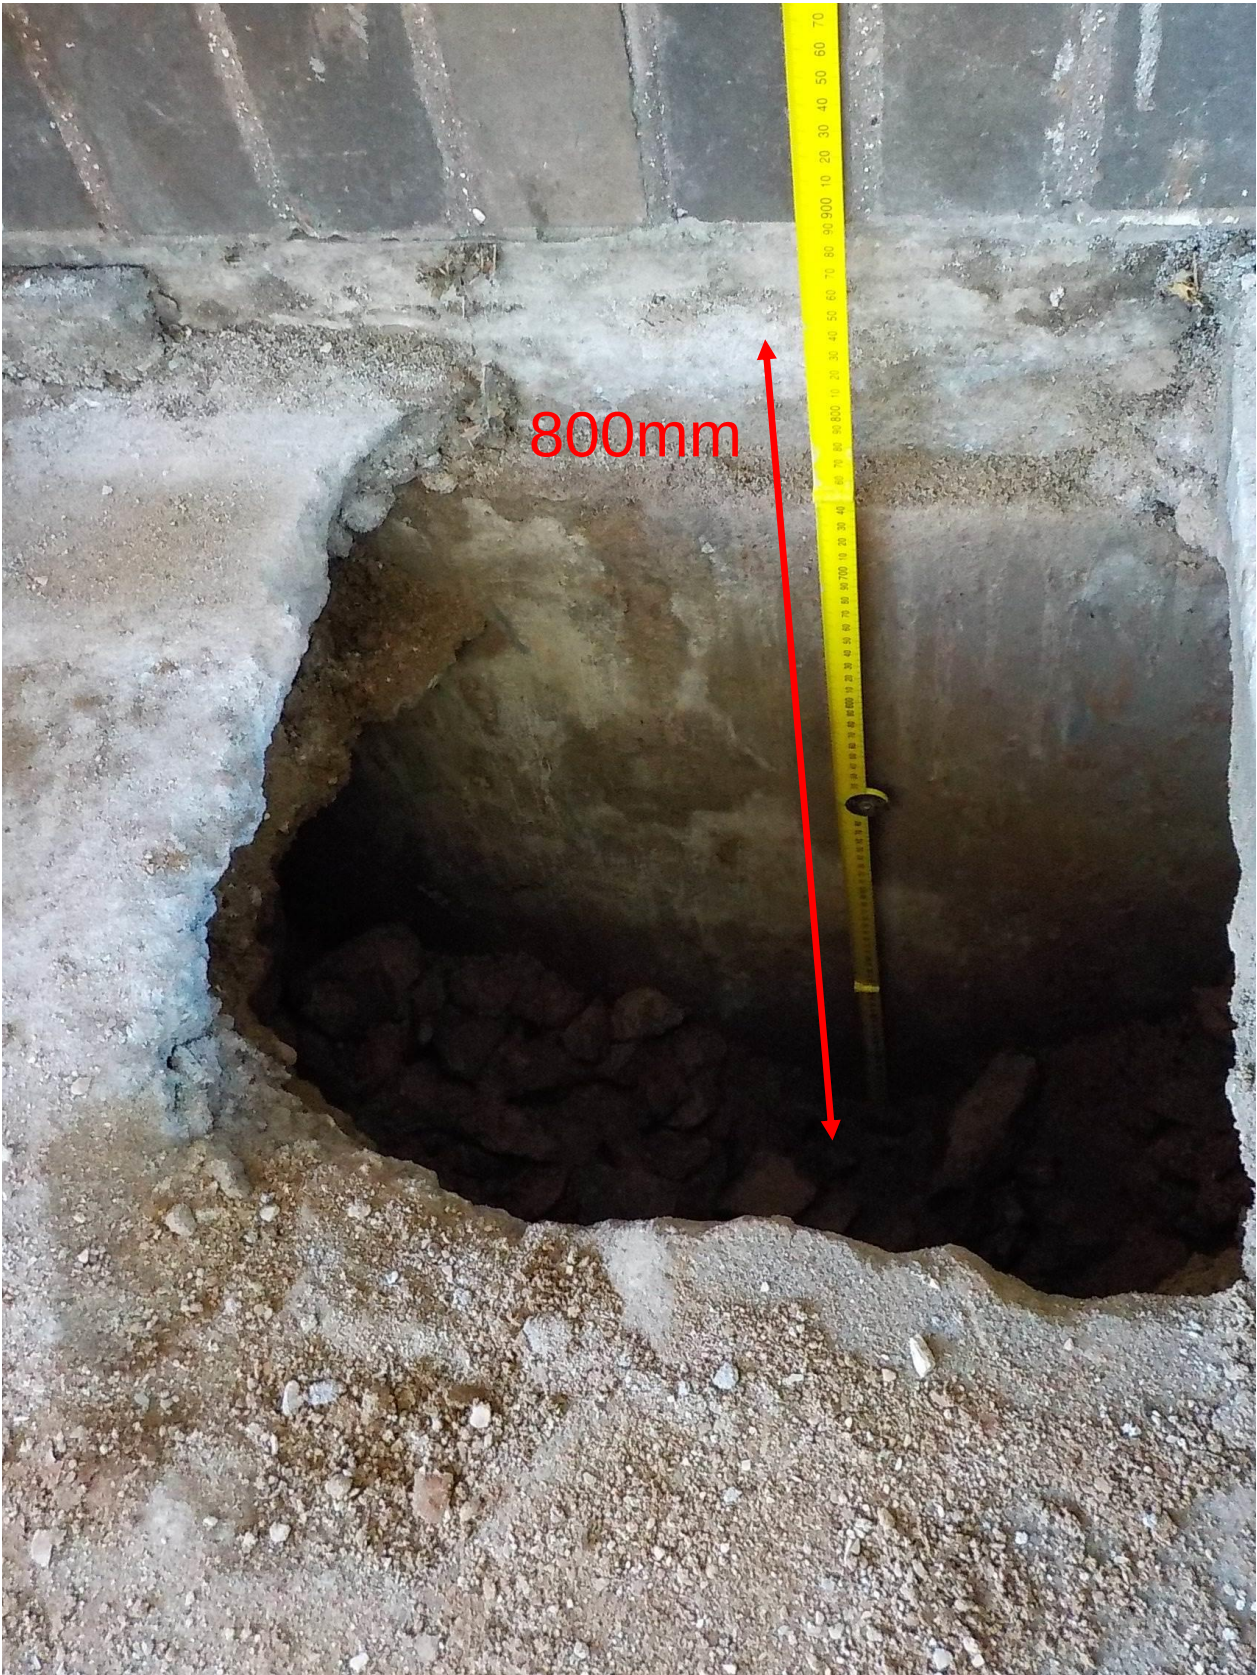
| Date Drawn:<br>23-02-2020 | Scale: NTS | Title: Opening Up Works Location 4 | |

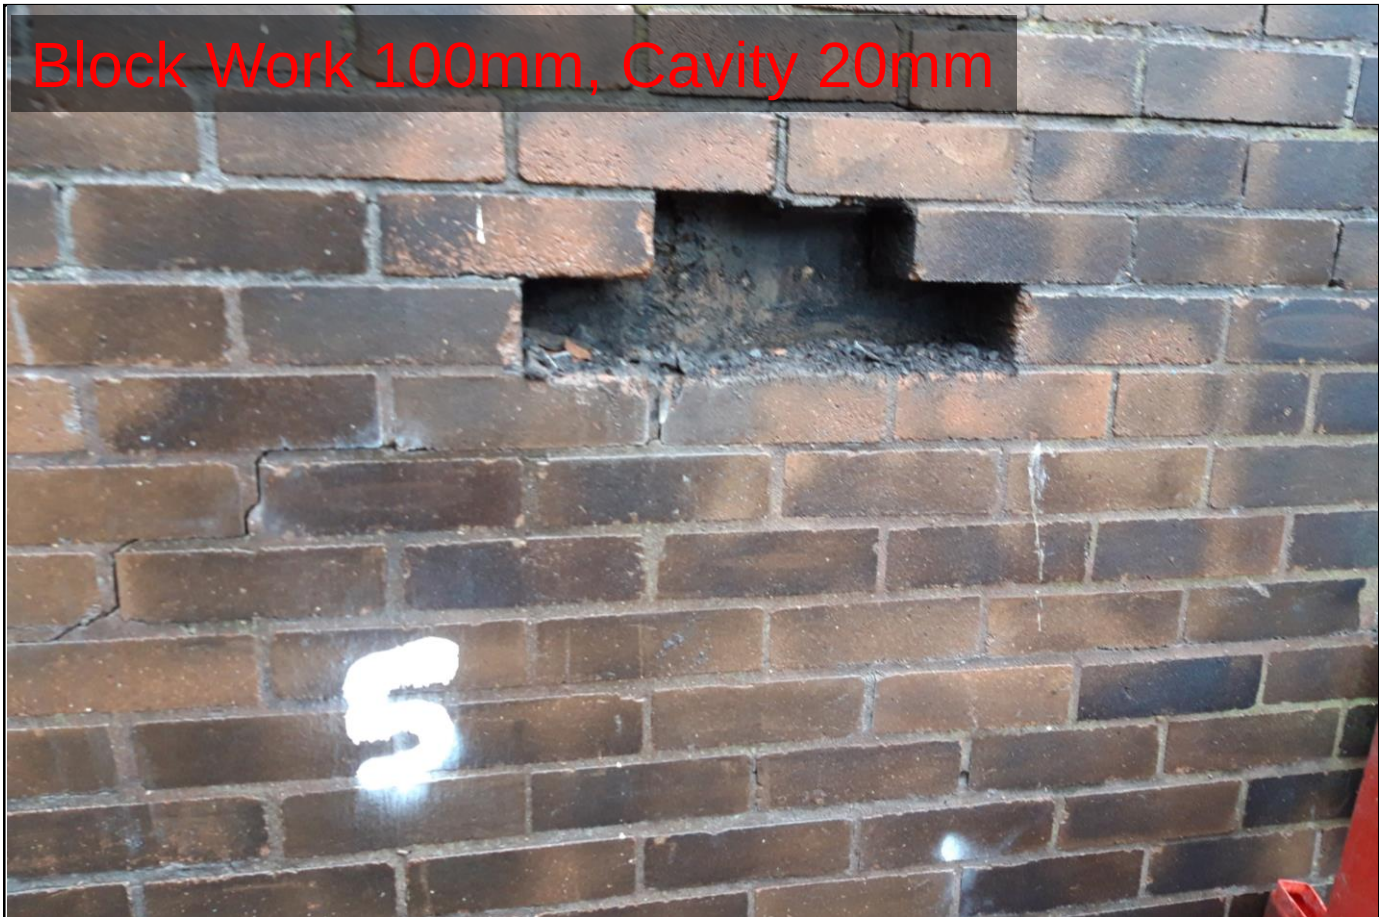
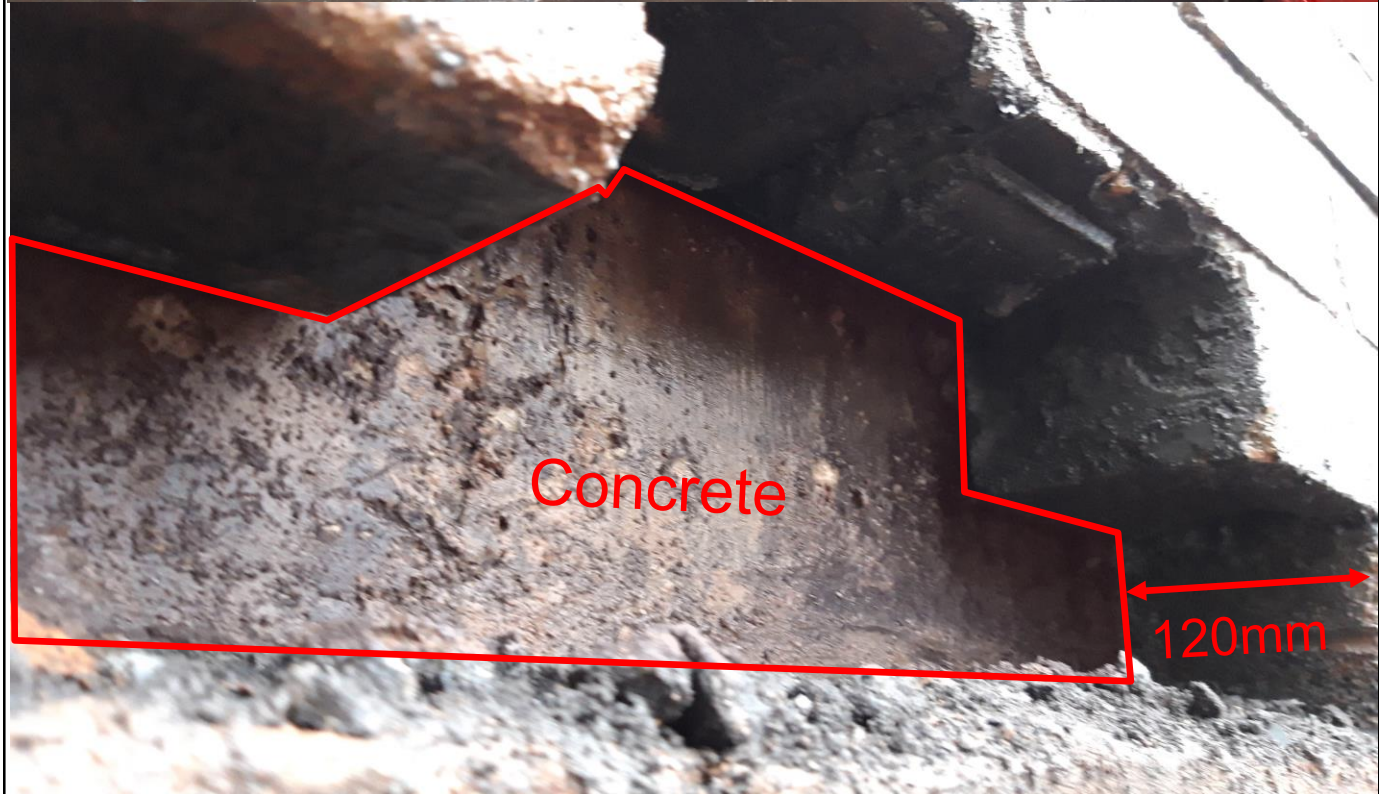
Block Work 100mm, Cavity 20mm

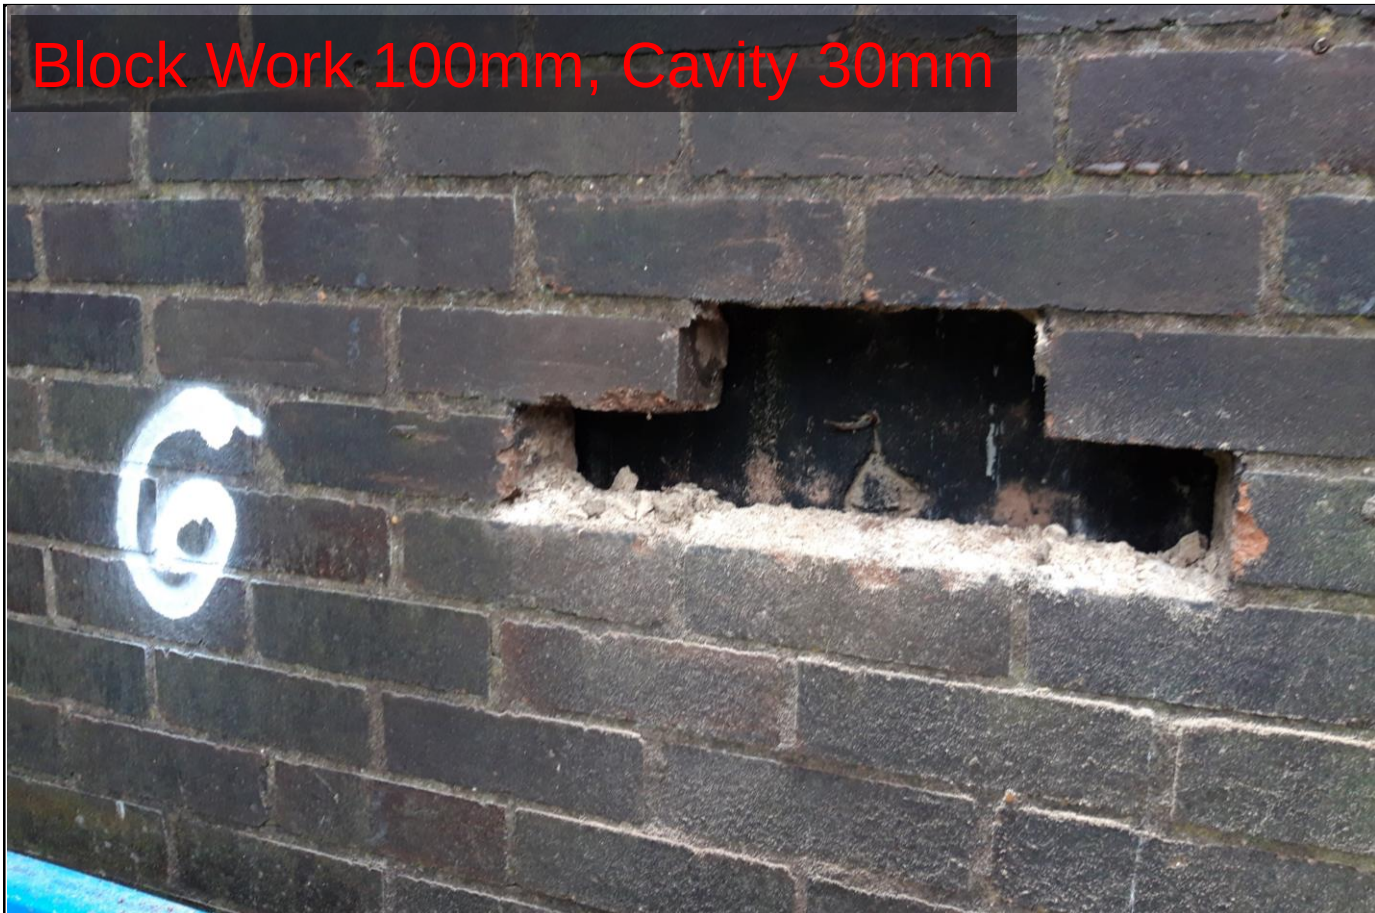
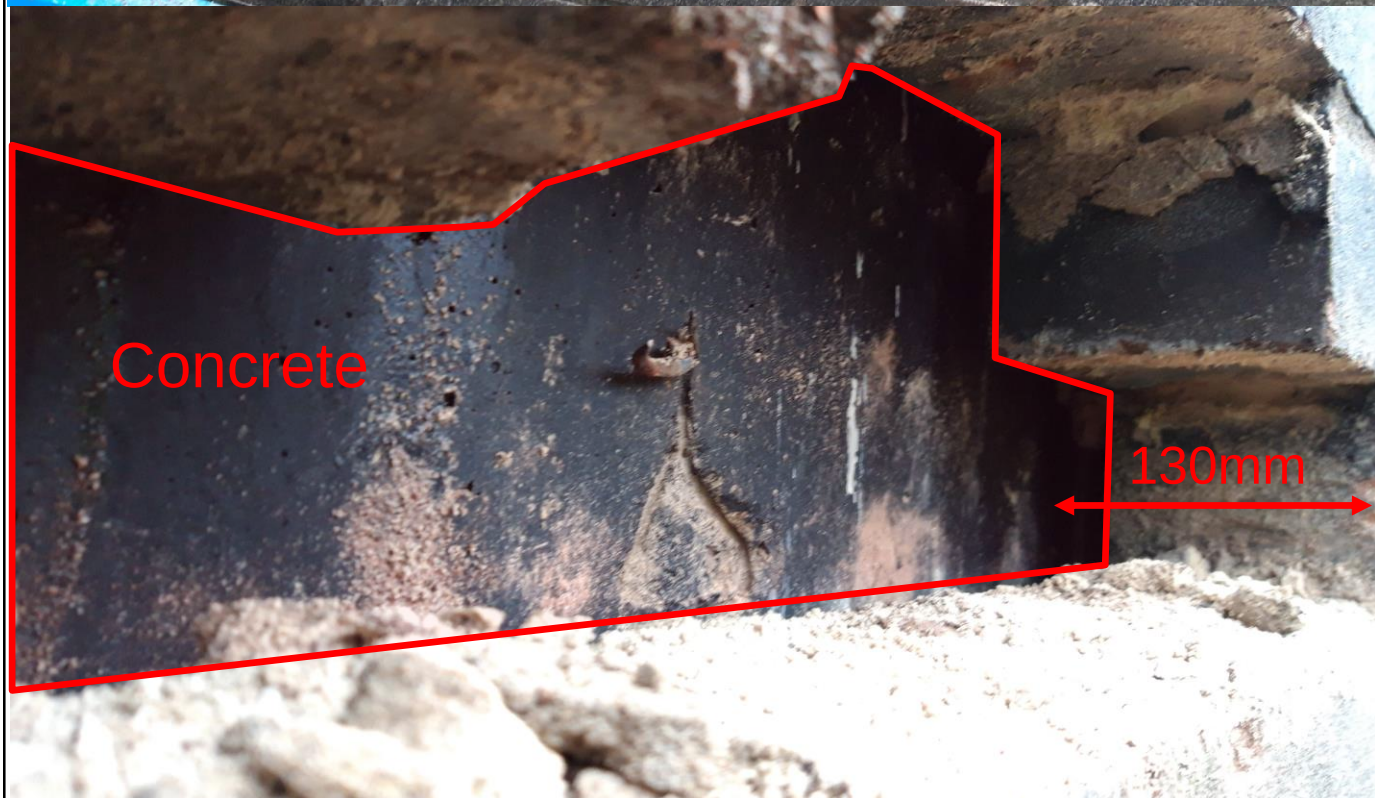
Block Work 100mm, Cavity 30mm

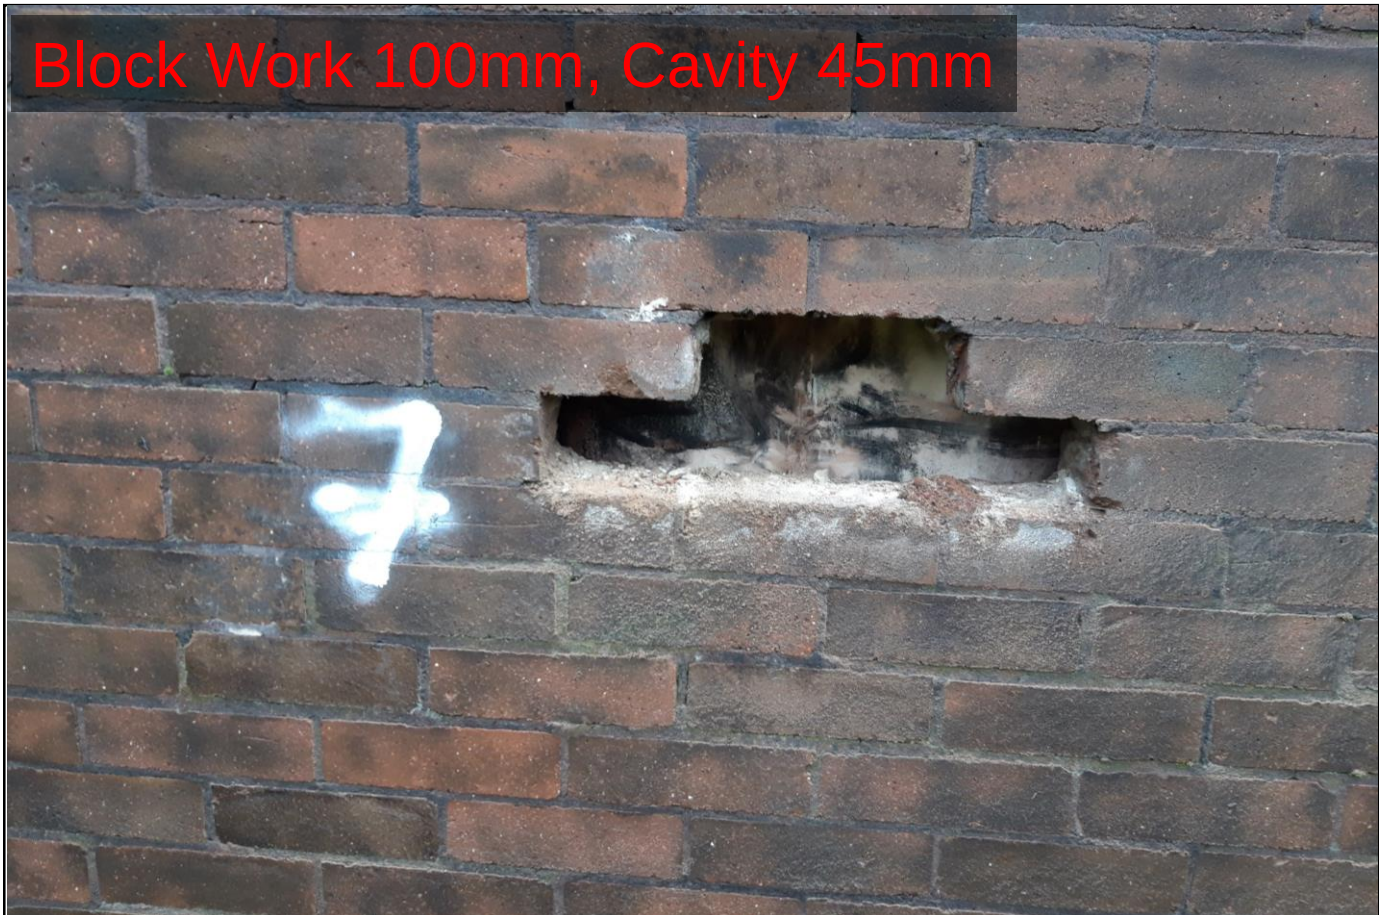
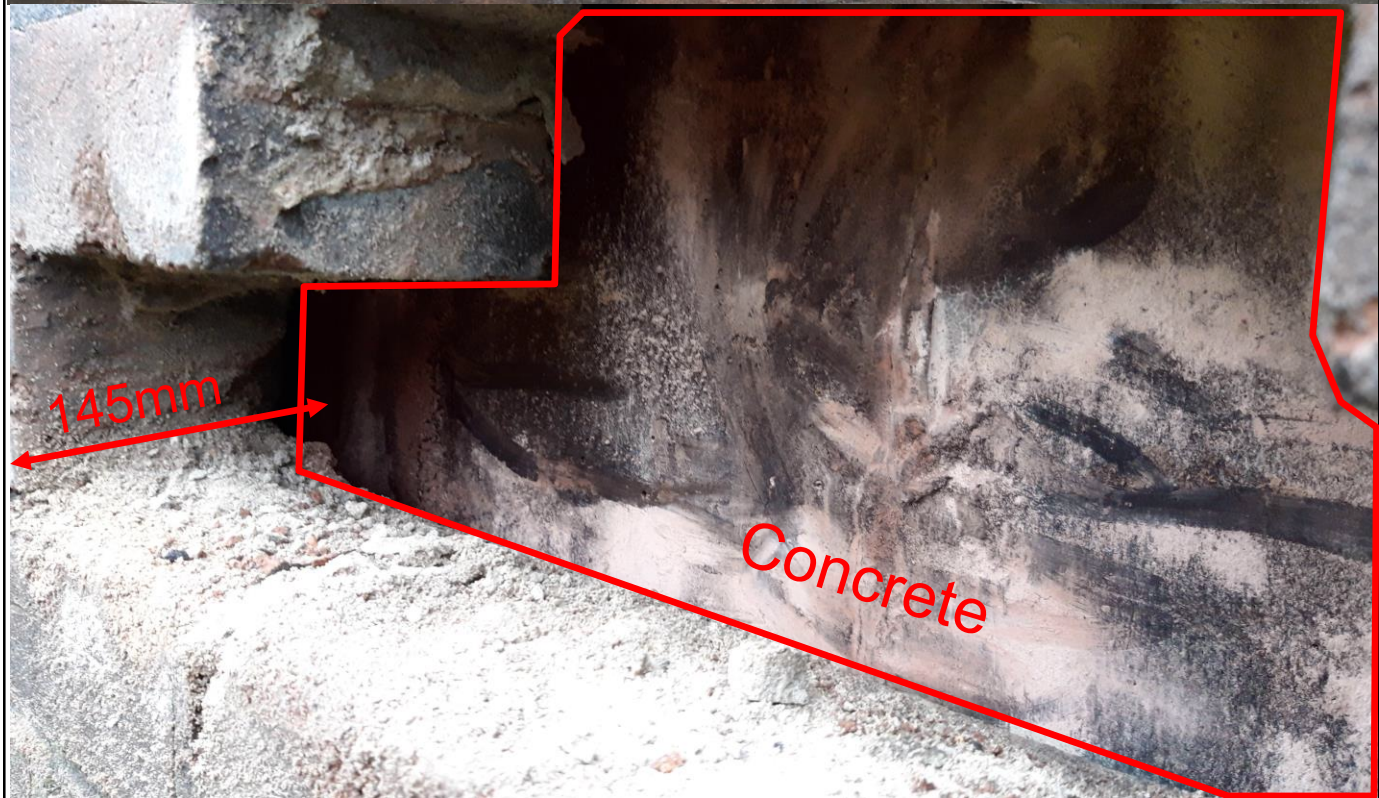
# Block Work 100mm, Cavity 45mm
