# Ringland, Newport

## Phase 2 Ground Investigation

Curtins Ref: 066799-CUR-00-XX-RP-GE-002-V01

Issue Date: 16 March 2020

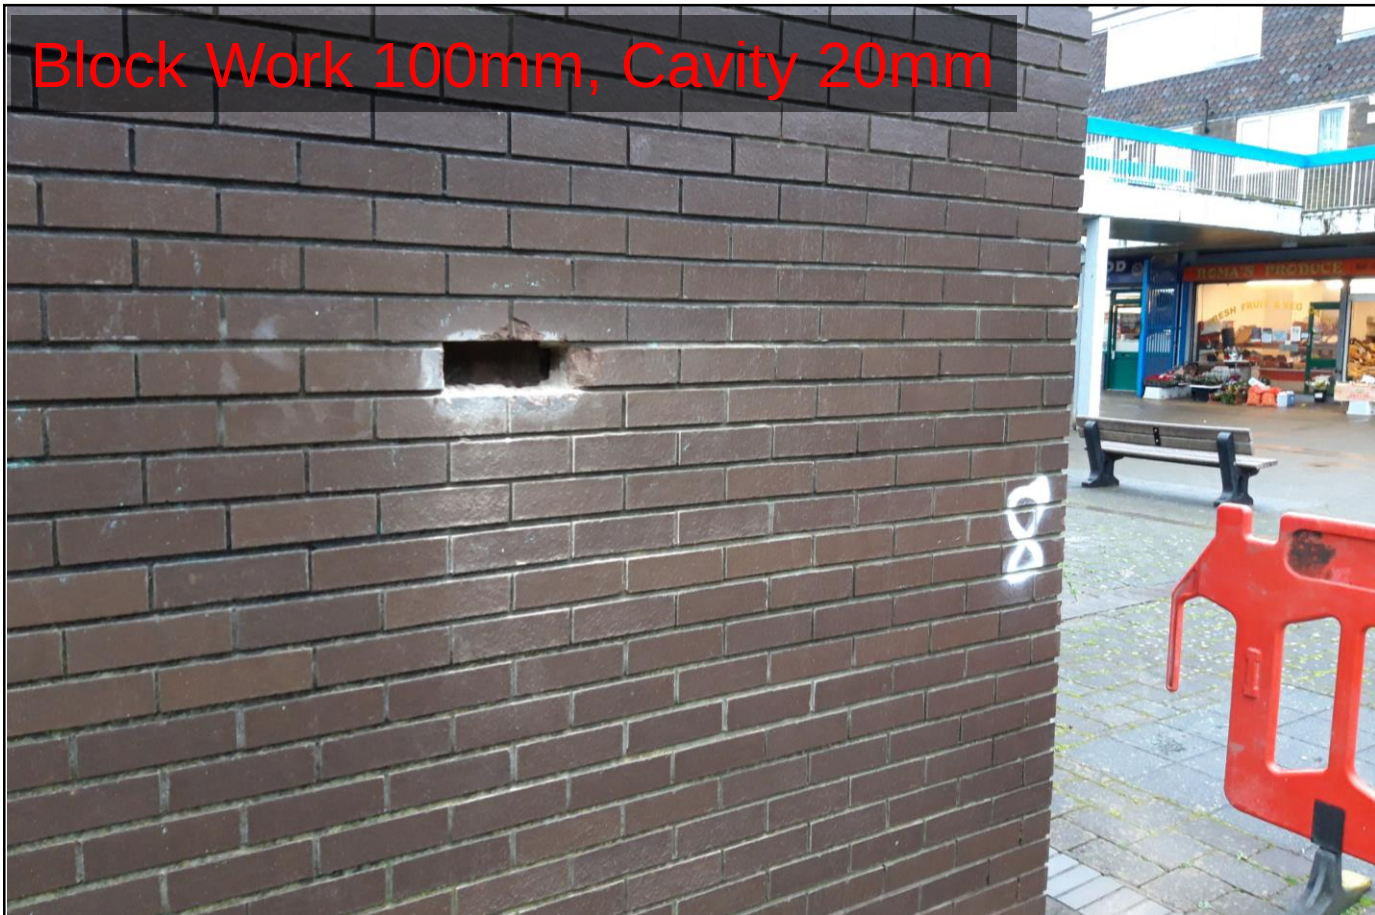
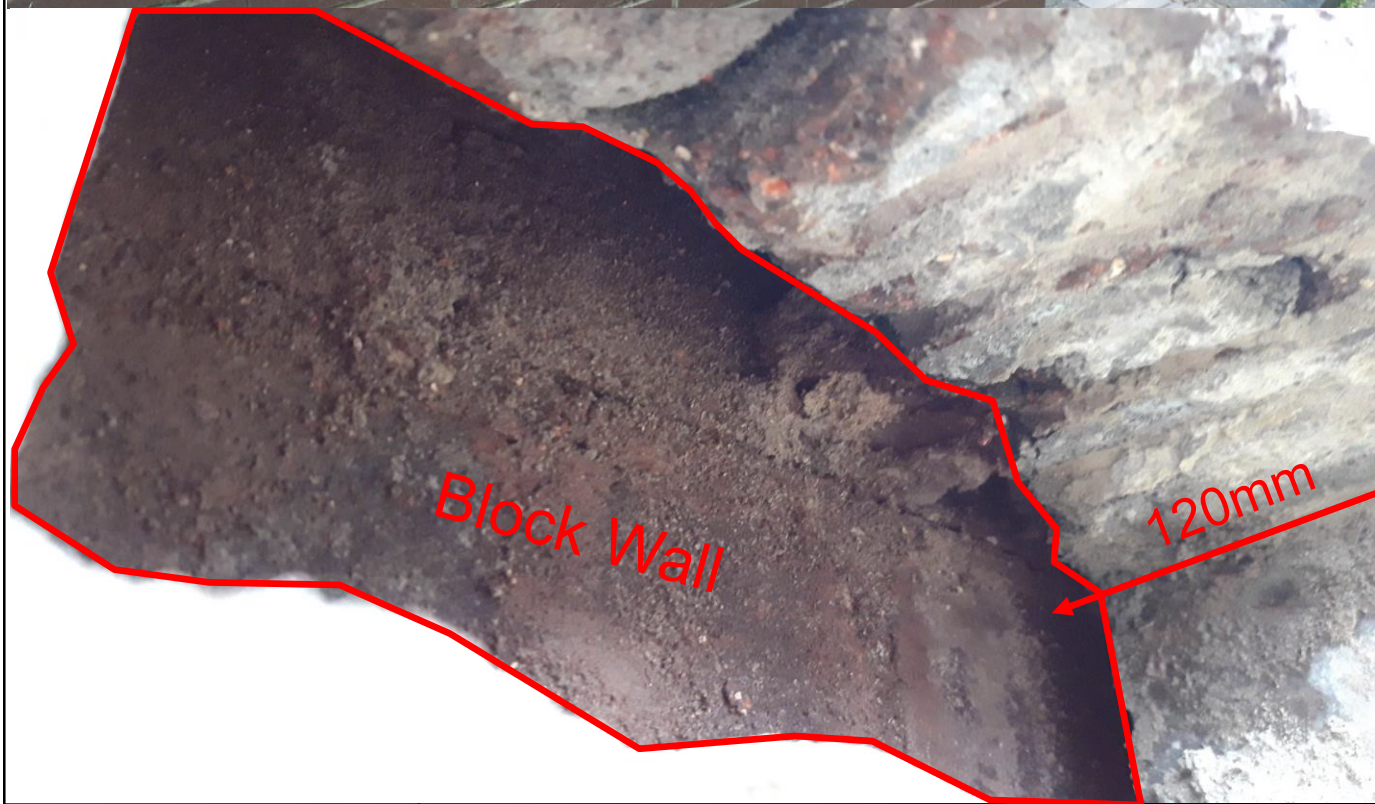
Block Work 100mm, Cavity 20mm

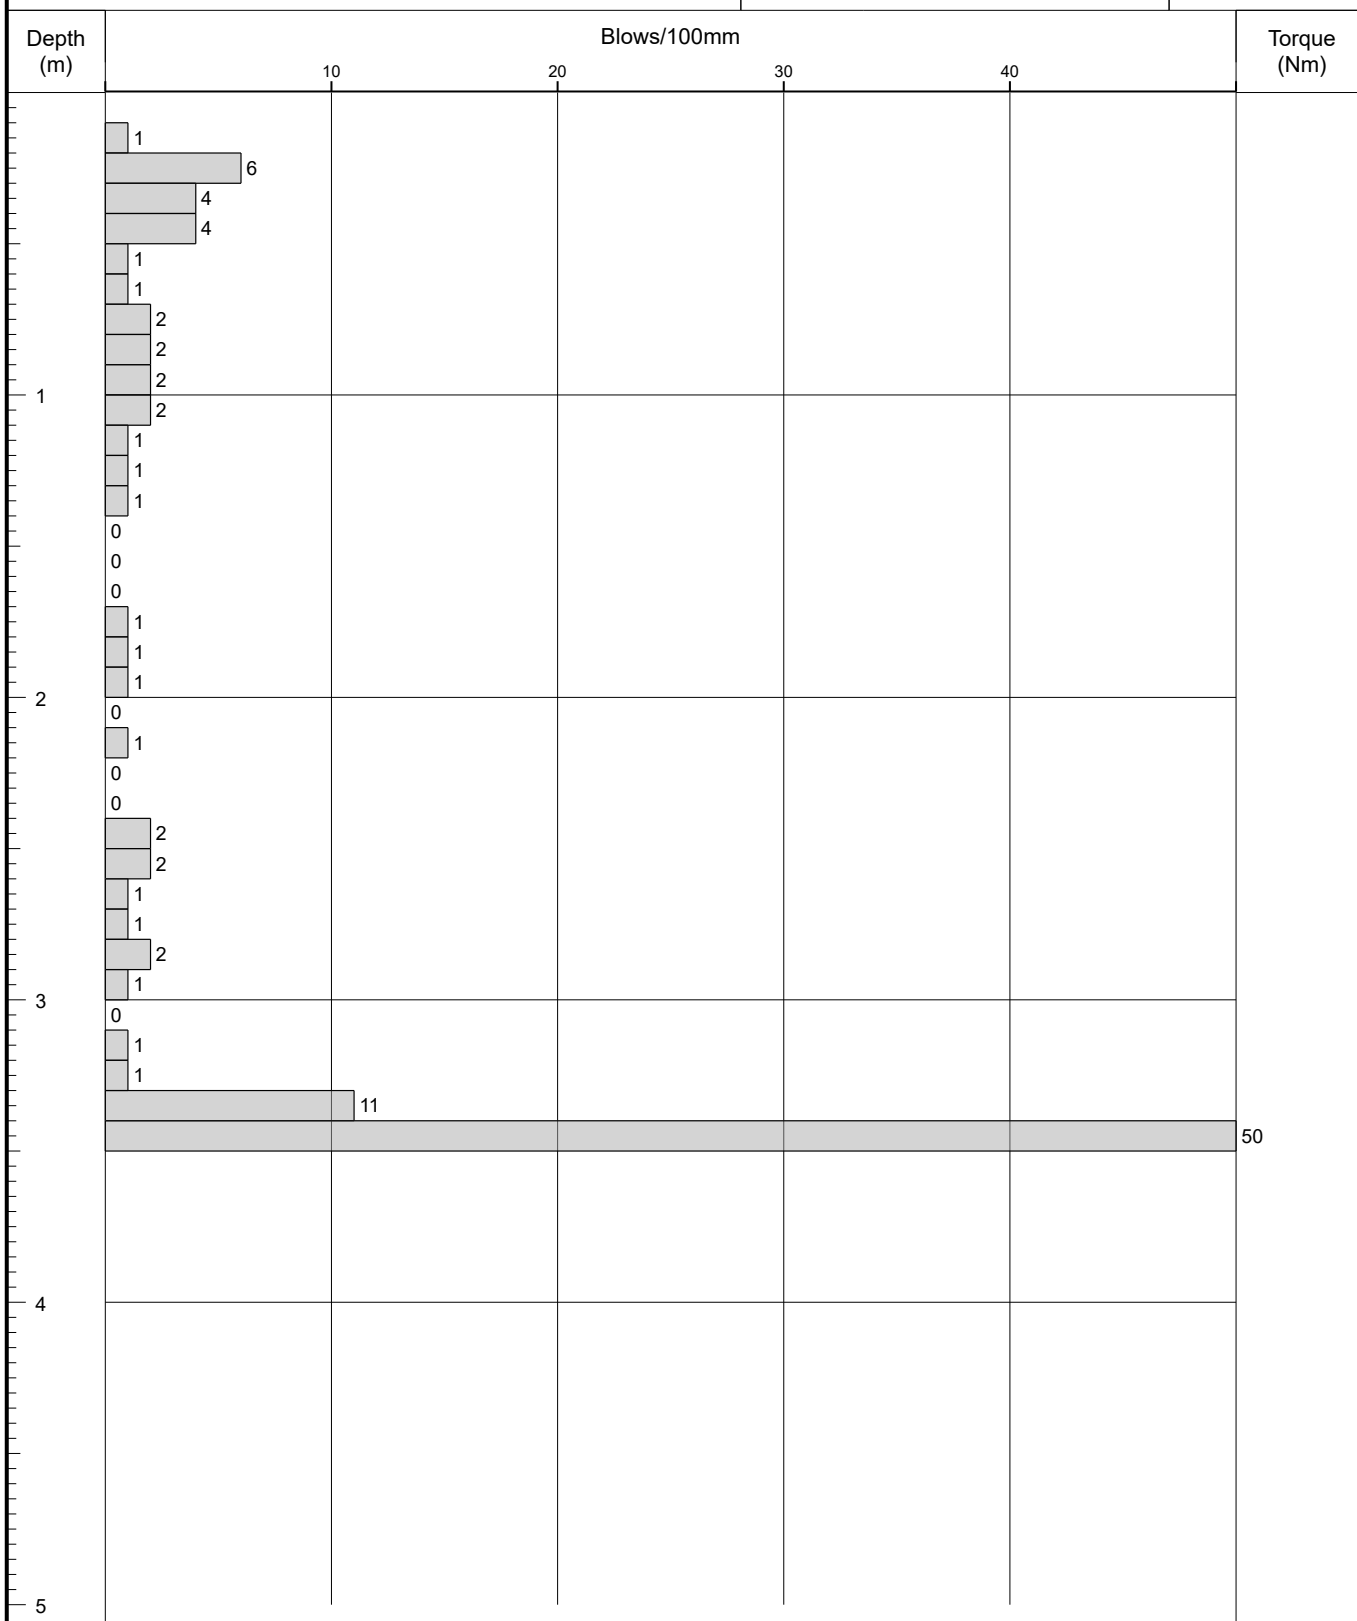
Located 0.75m off the wall

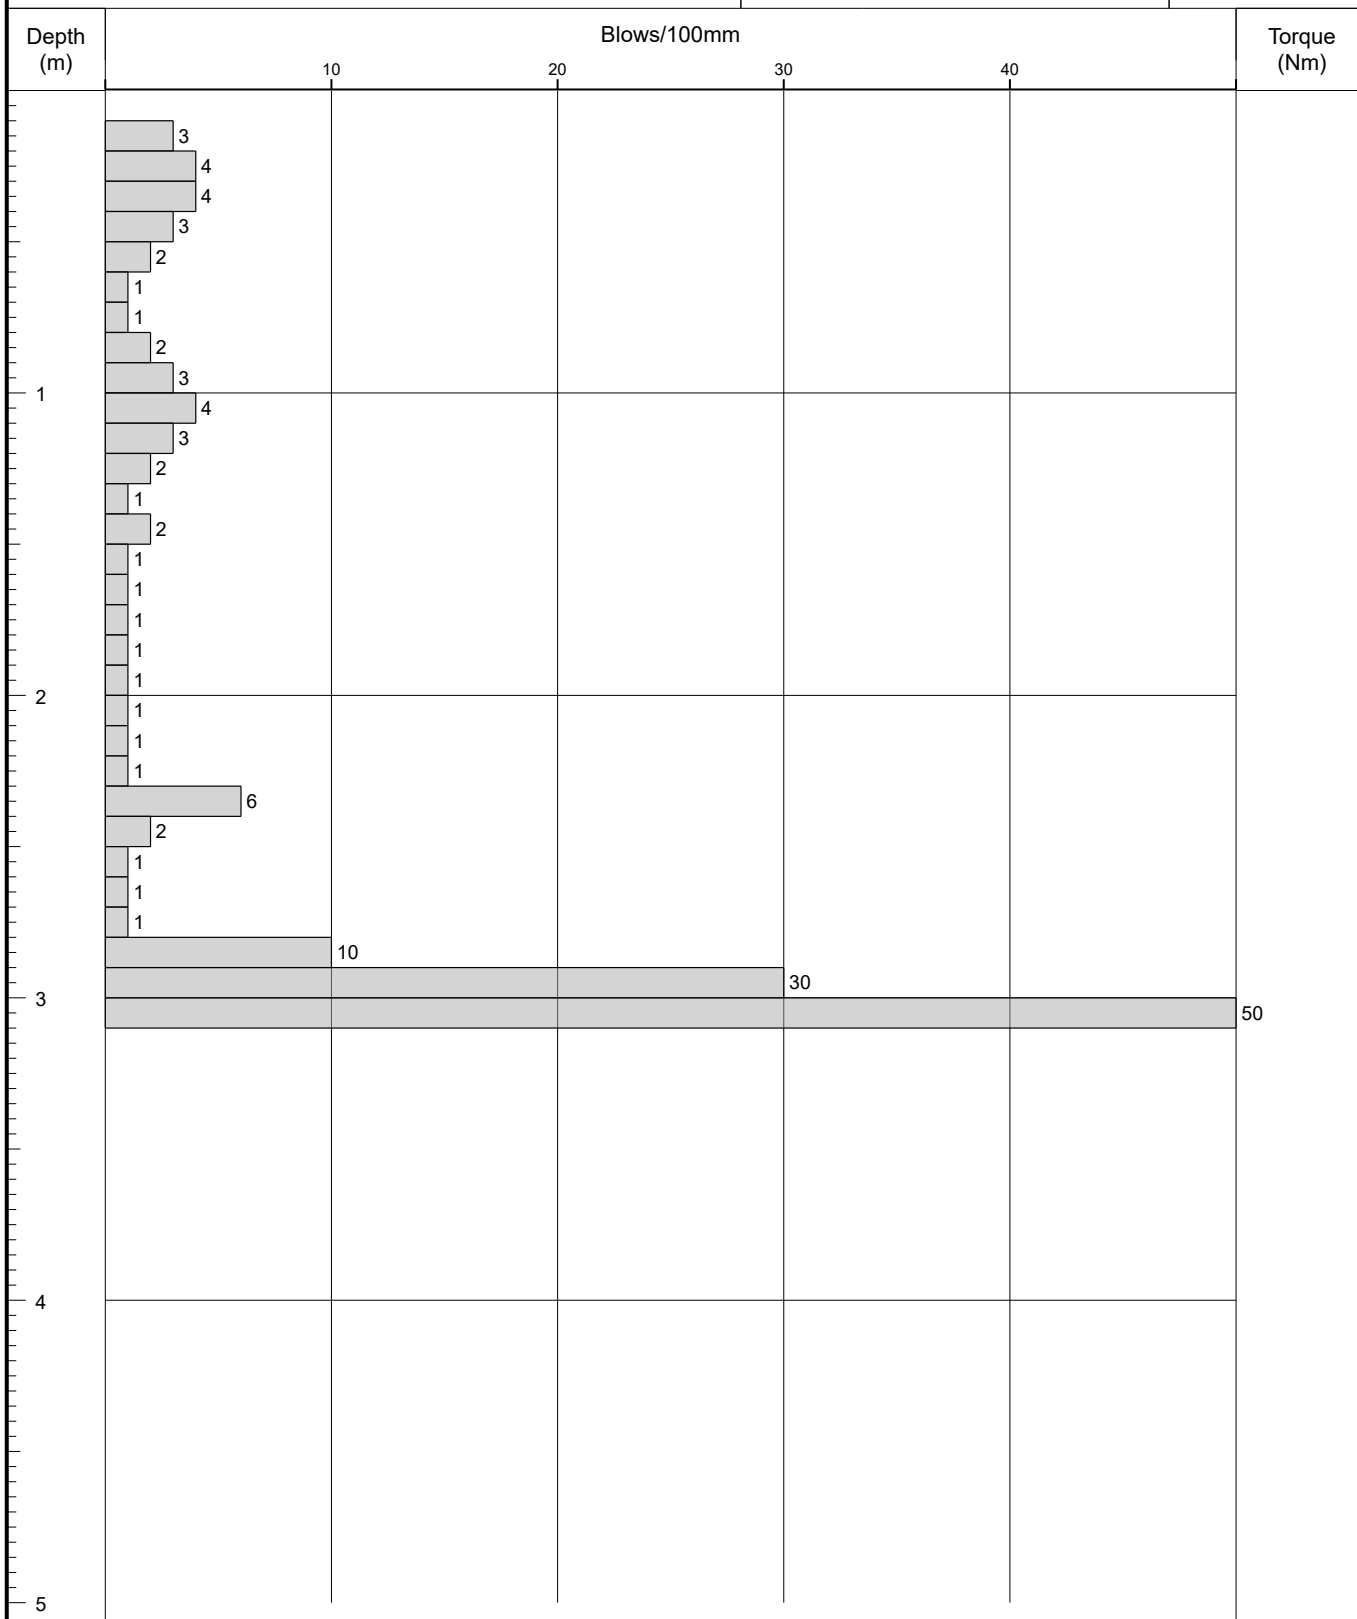
Located 1.50m off the wall
