**OPEN HEARTH, RINGLAND, NEWPORT**

**Outline Remediation Strategy Report**

14144/RH/26/ORS

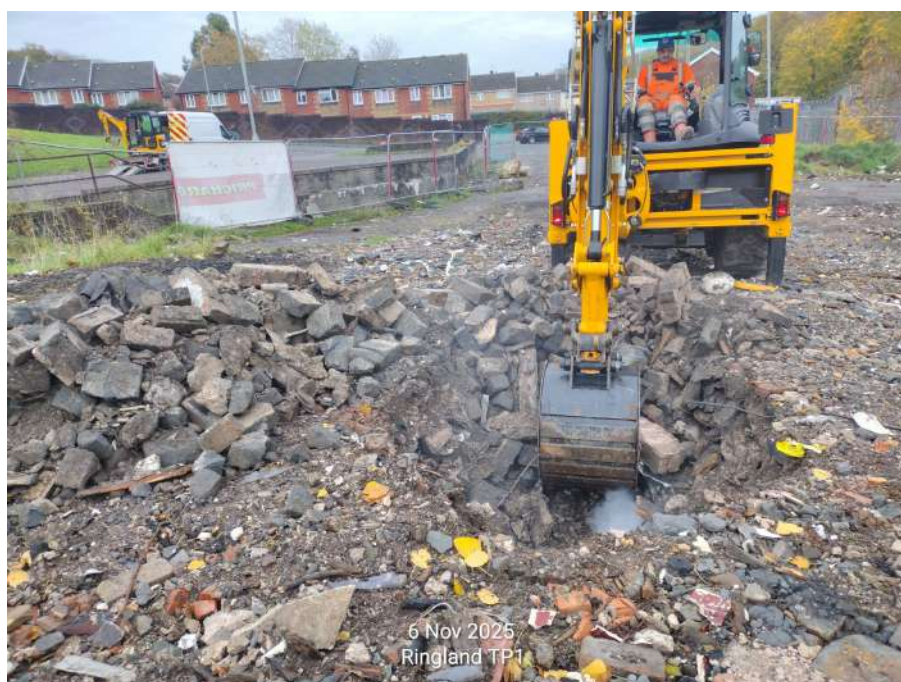
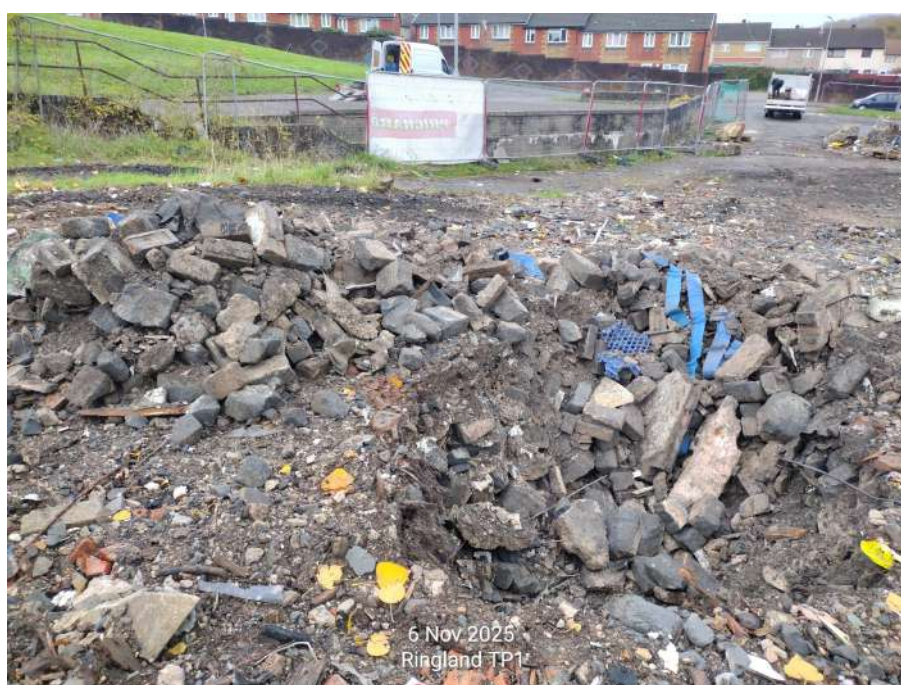
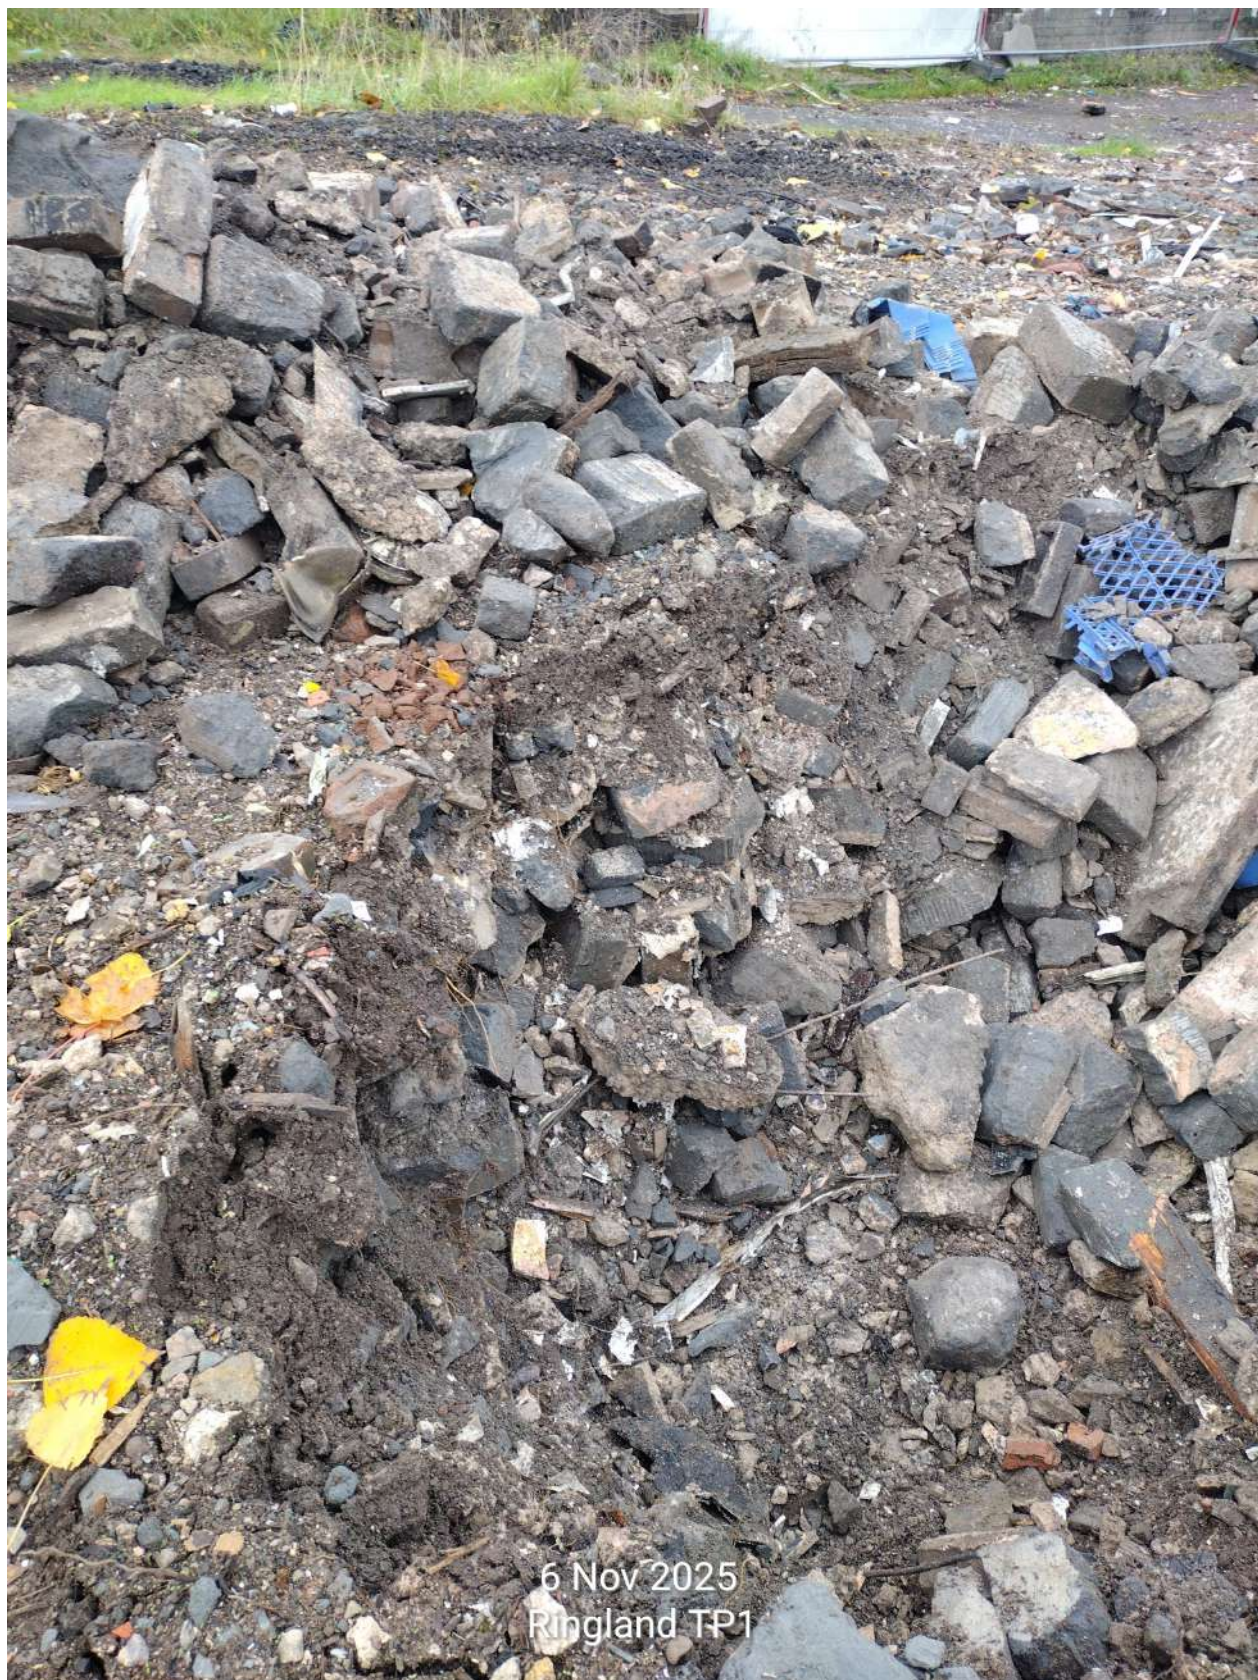
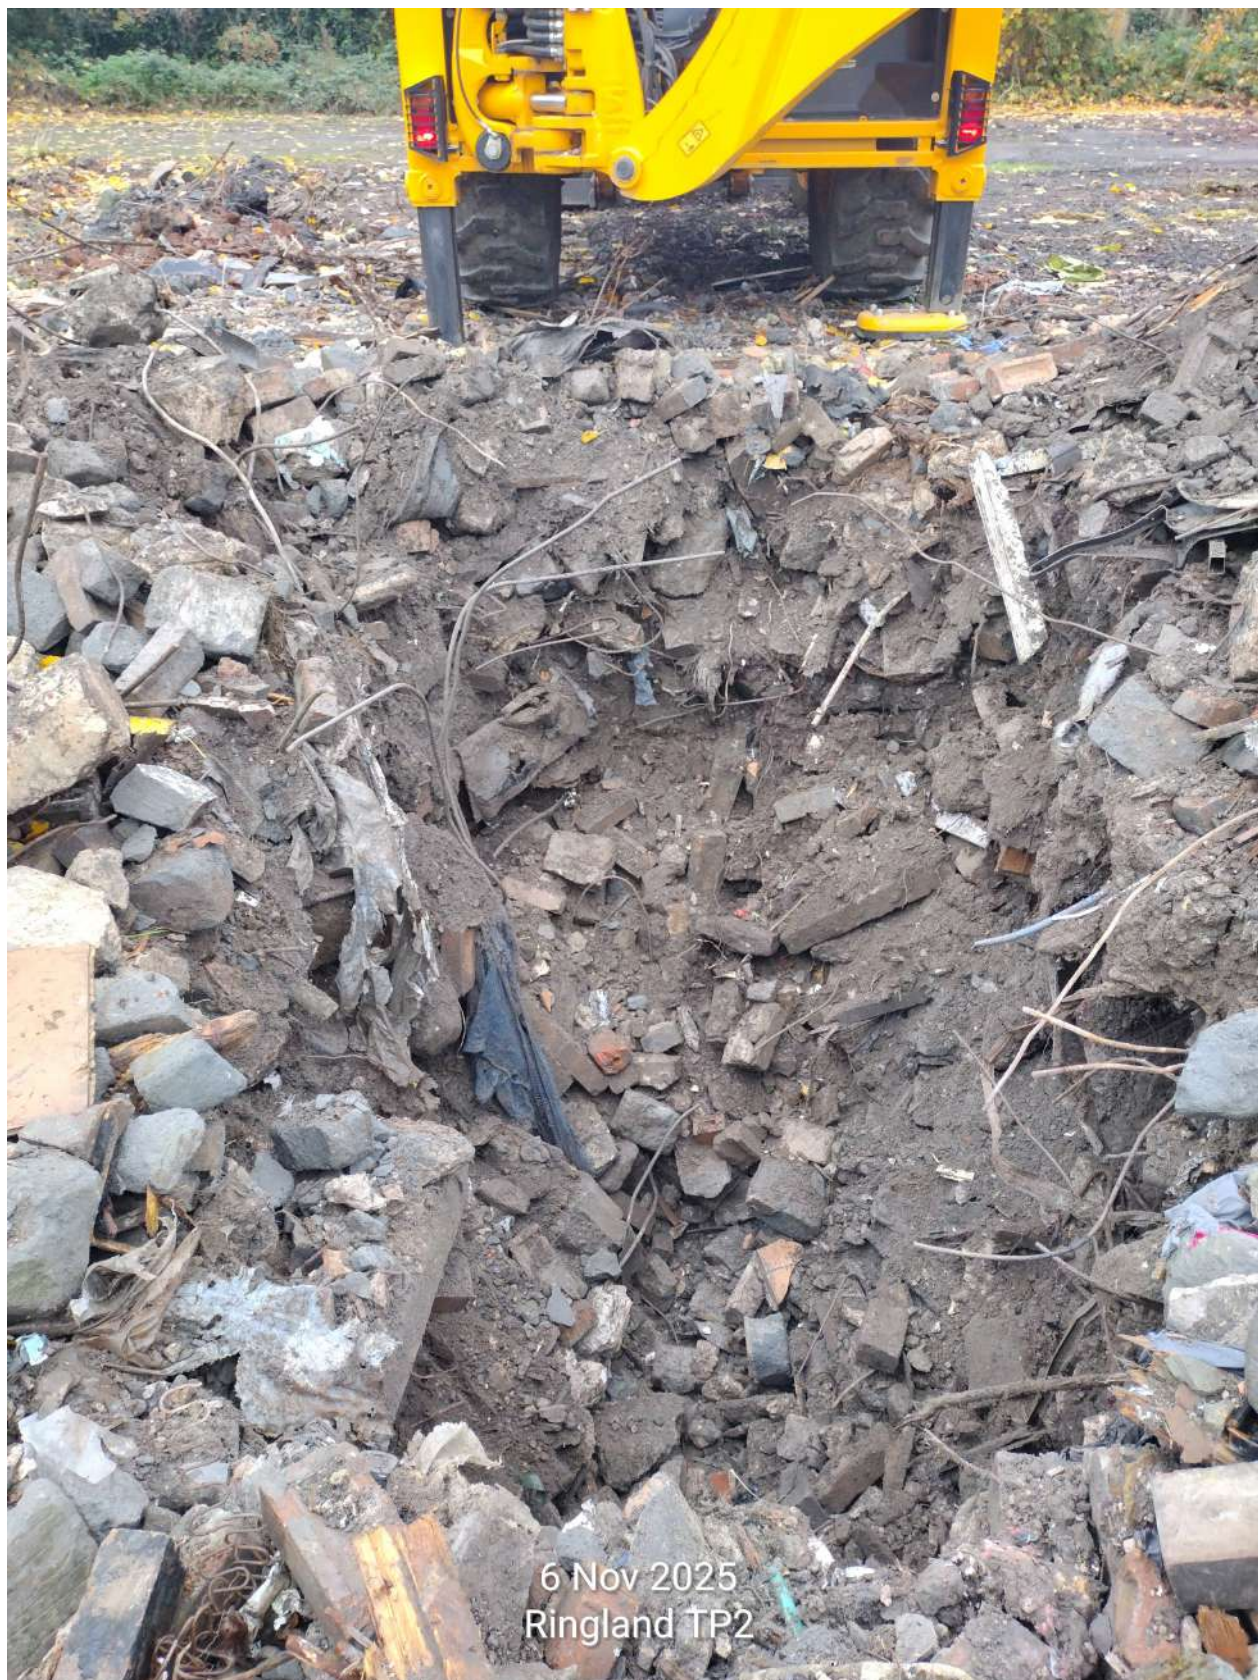
**TRIAL PIT PHOTOGRAPHS - TP01**

| | | | Stability: <b>Trial pit sides were stable in the short term.</b> | | | | | | |

A portion of the rubble materials was seen to remain across a small localised area directly north of the infilled basement, as observed in trial pit TP01, which was excavated to approximately 1.1m depth and terminated on a buried concrete slab.

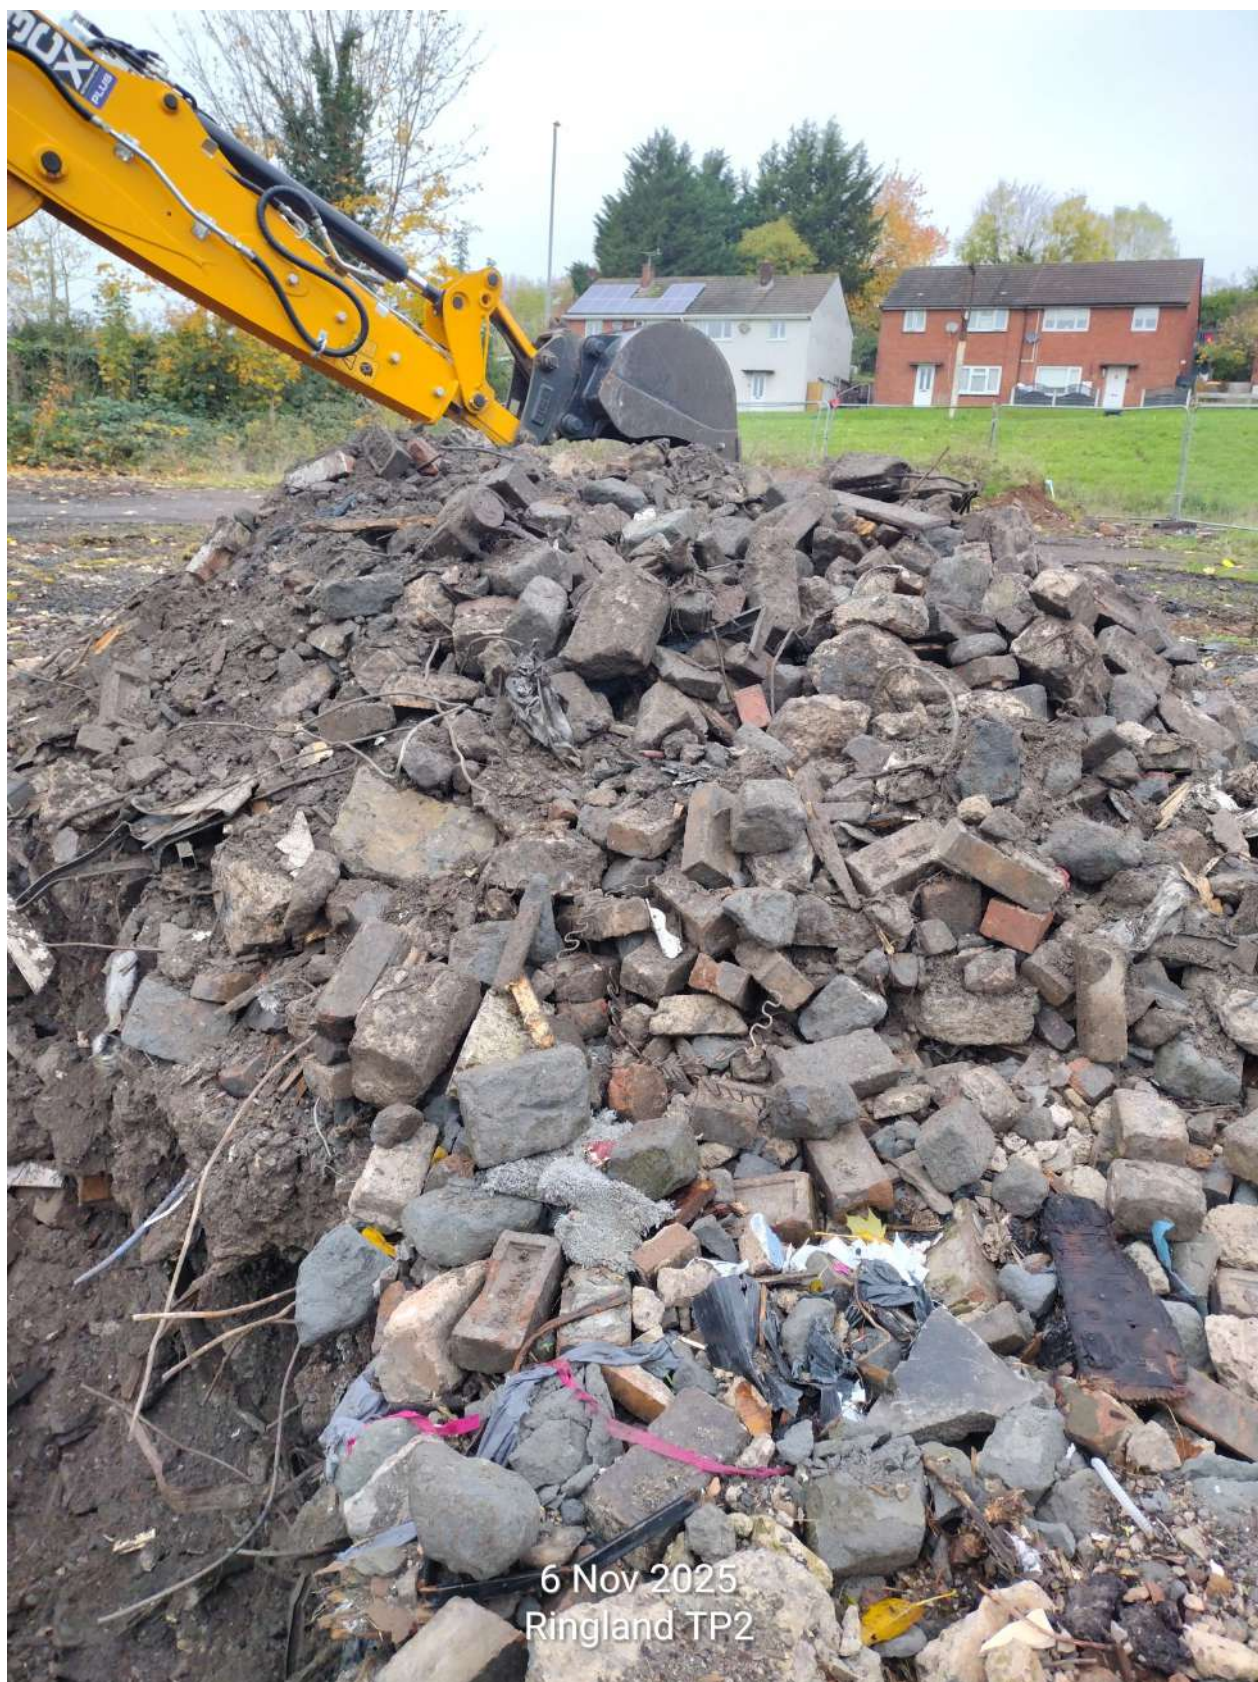
TRIAL PIT PHOTOGRAPHS - TP02

| 1.80 | ES | | 2.30 | | | Loose grey sandy fine to coarse angular GRAVEL and COBBLE of brick and concrete. Fragments of rebar, glass, plastic, wire tile and slate. (Building Rubble) (MADE GROUND) | | | |
| | | | | | | Stability: Pit unstable due to loose rubble material. Pit terminated at 2.3m depth due to instability. | | | |

Trial pit TP02 was excavated within the former basement. The basement has been infilled with rubble originating from the building's demolition. The infill has not been engineered, with no compaction, and visible voids in the backfill were observed. The rubble backfill was found to be comprised of grey sandy gravel and cobble sized fragments of brick and concrete, with the inclusion of numerous waste materials such as rebar, timber, glass, tiles, beer kegs and old pipework.

Excavation into the backfilled basement was undertaken in trial pit TP02. This pit extended to approximately 2.3m depth and terminated due to instability of the loose materials being excavated. The difference in ground level between TP02 and TP4 was not significant, which suggests that the depth of the basement floor could potentially be greater than observed in TP04.

A sample of the rubble material in the backfilled basement was found to contain loose fibrous debris containing amosite asbestos. Quantification testing revealed an asbestos content of 0.017%.

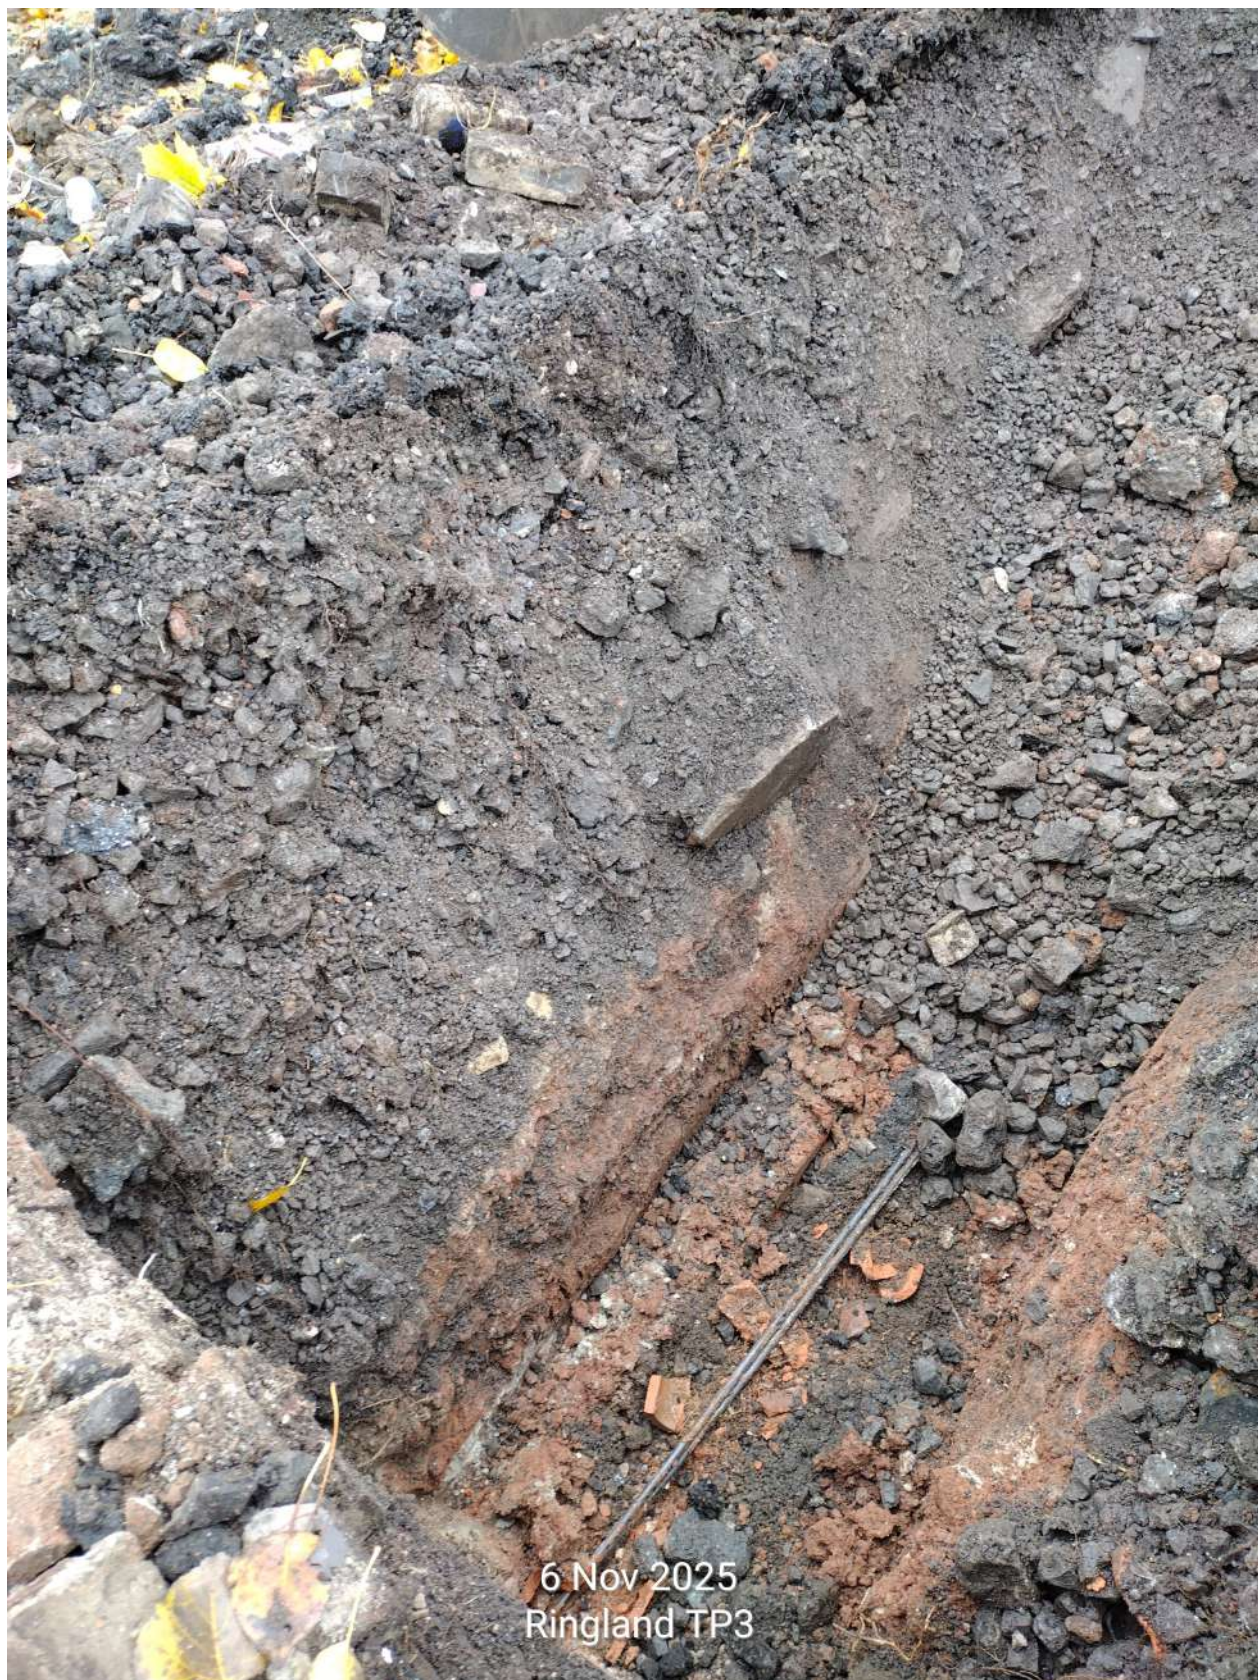
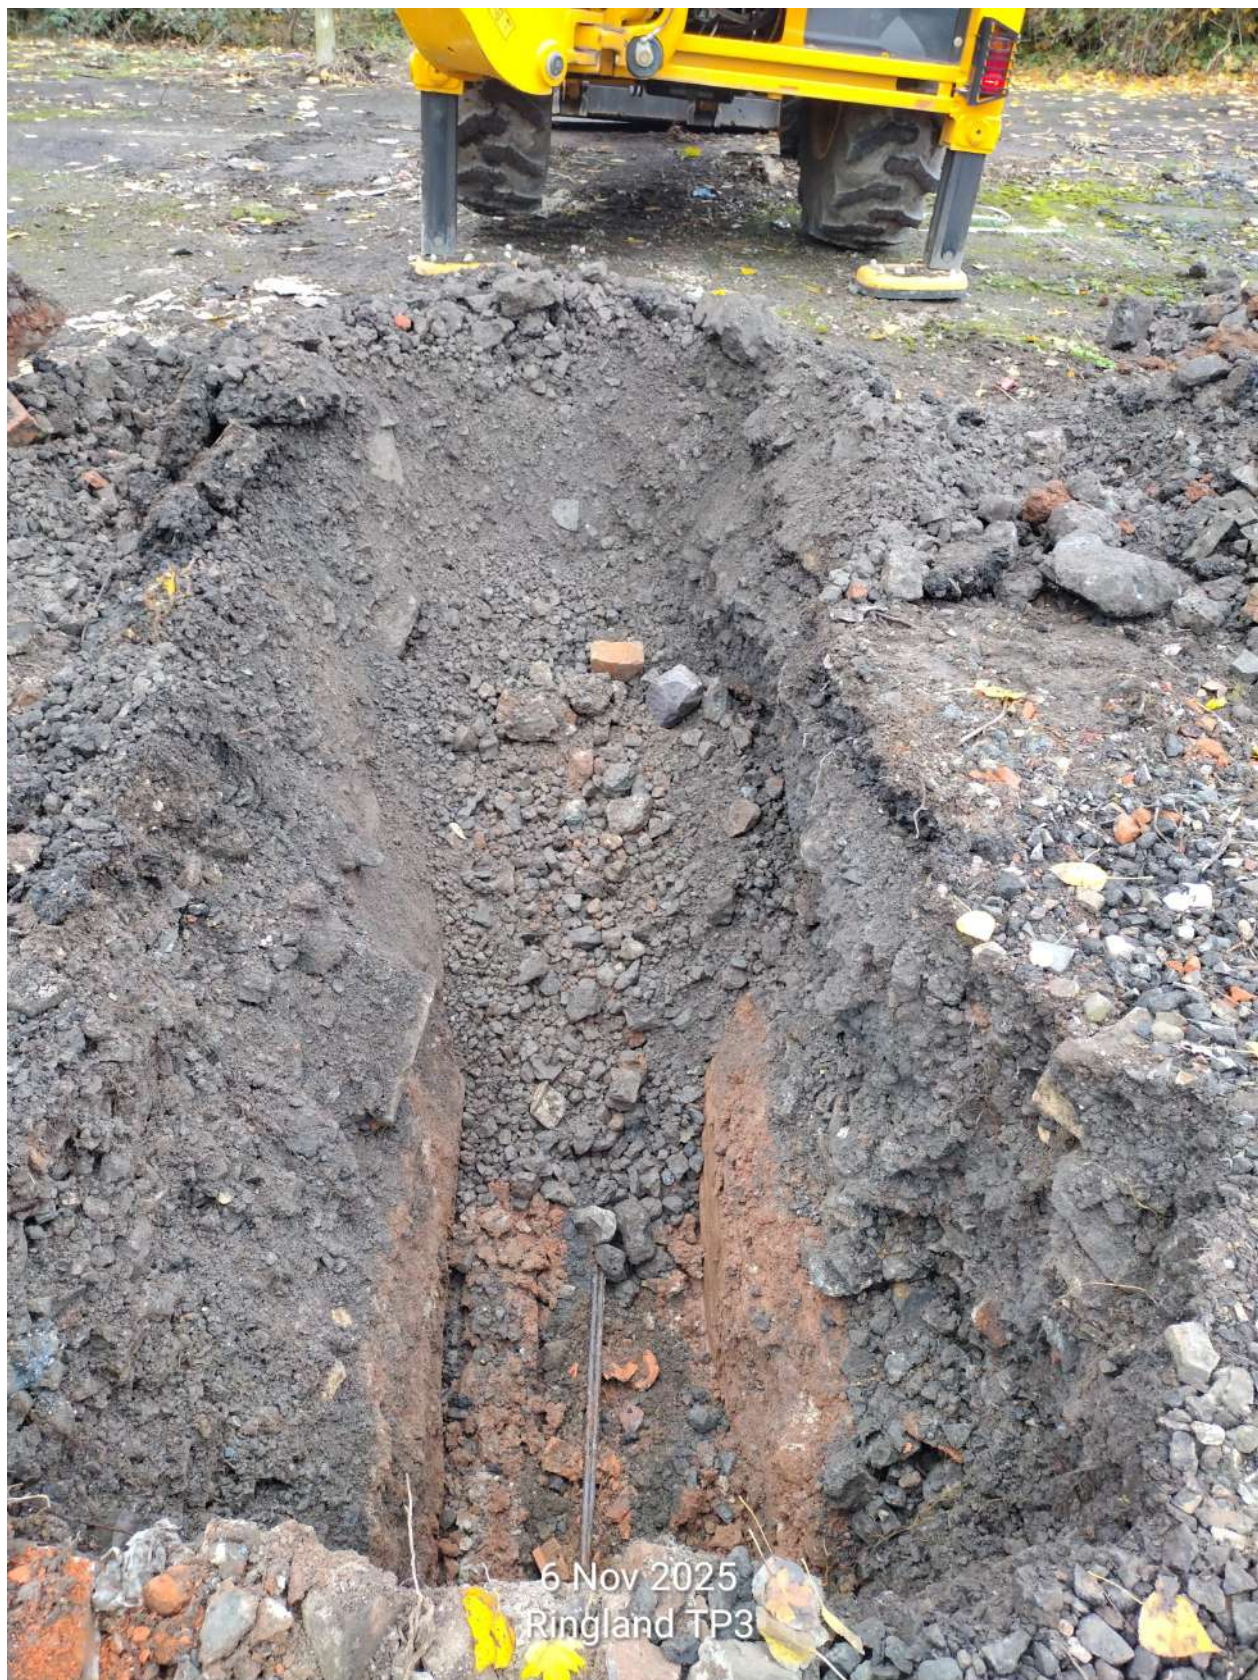
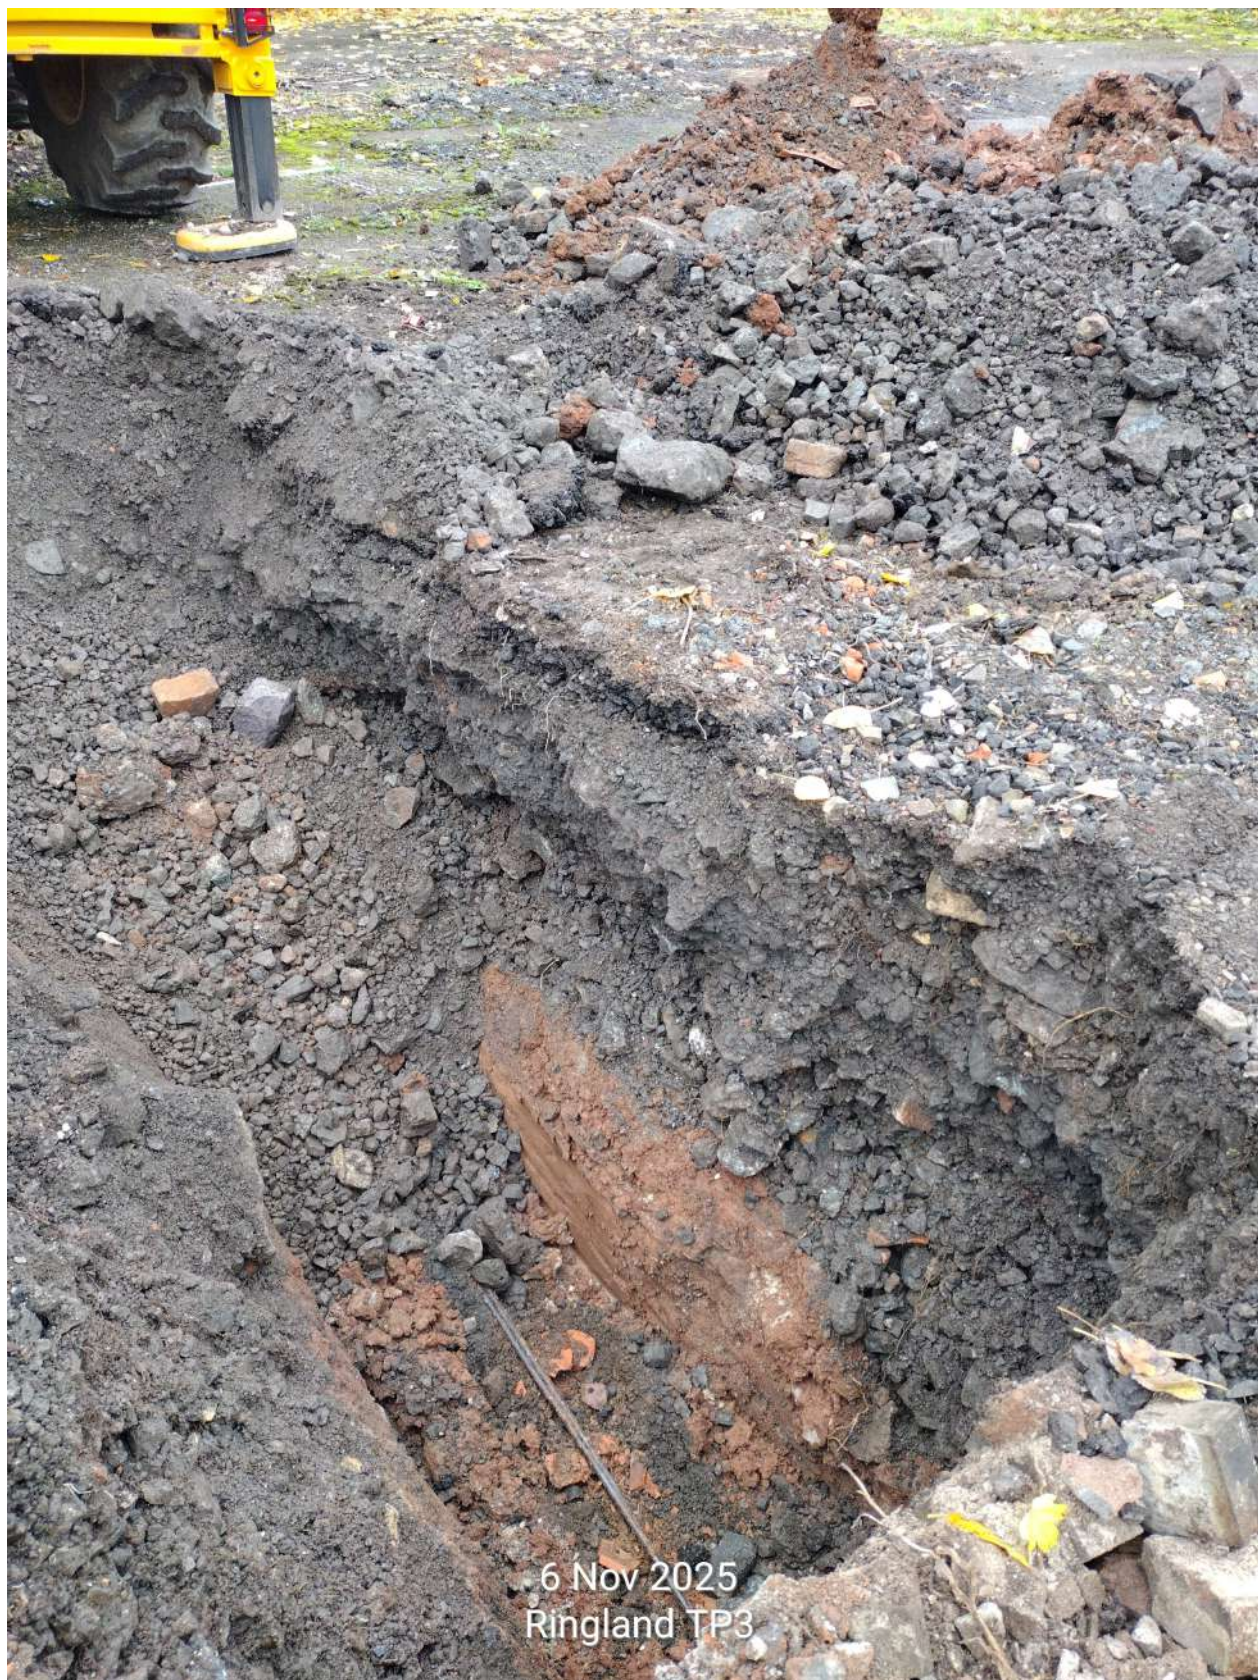
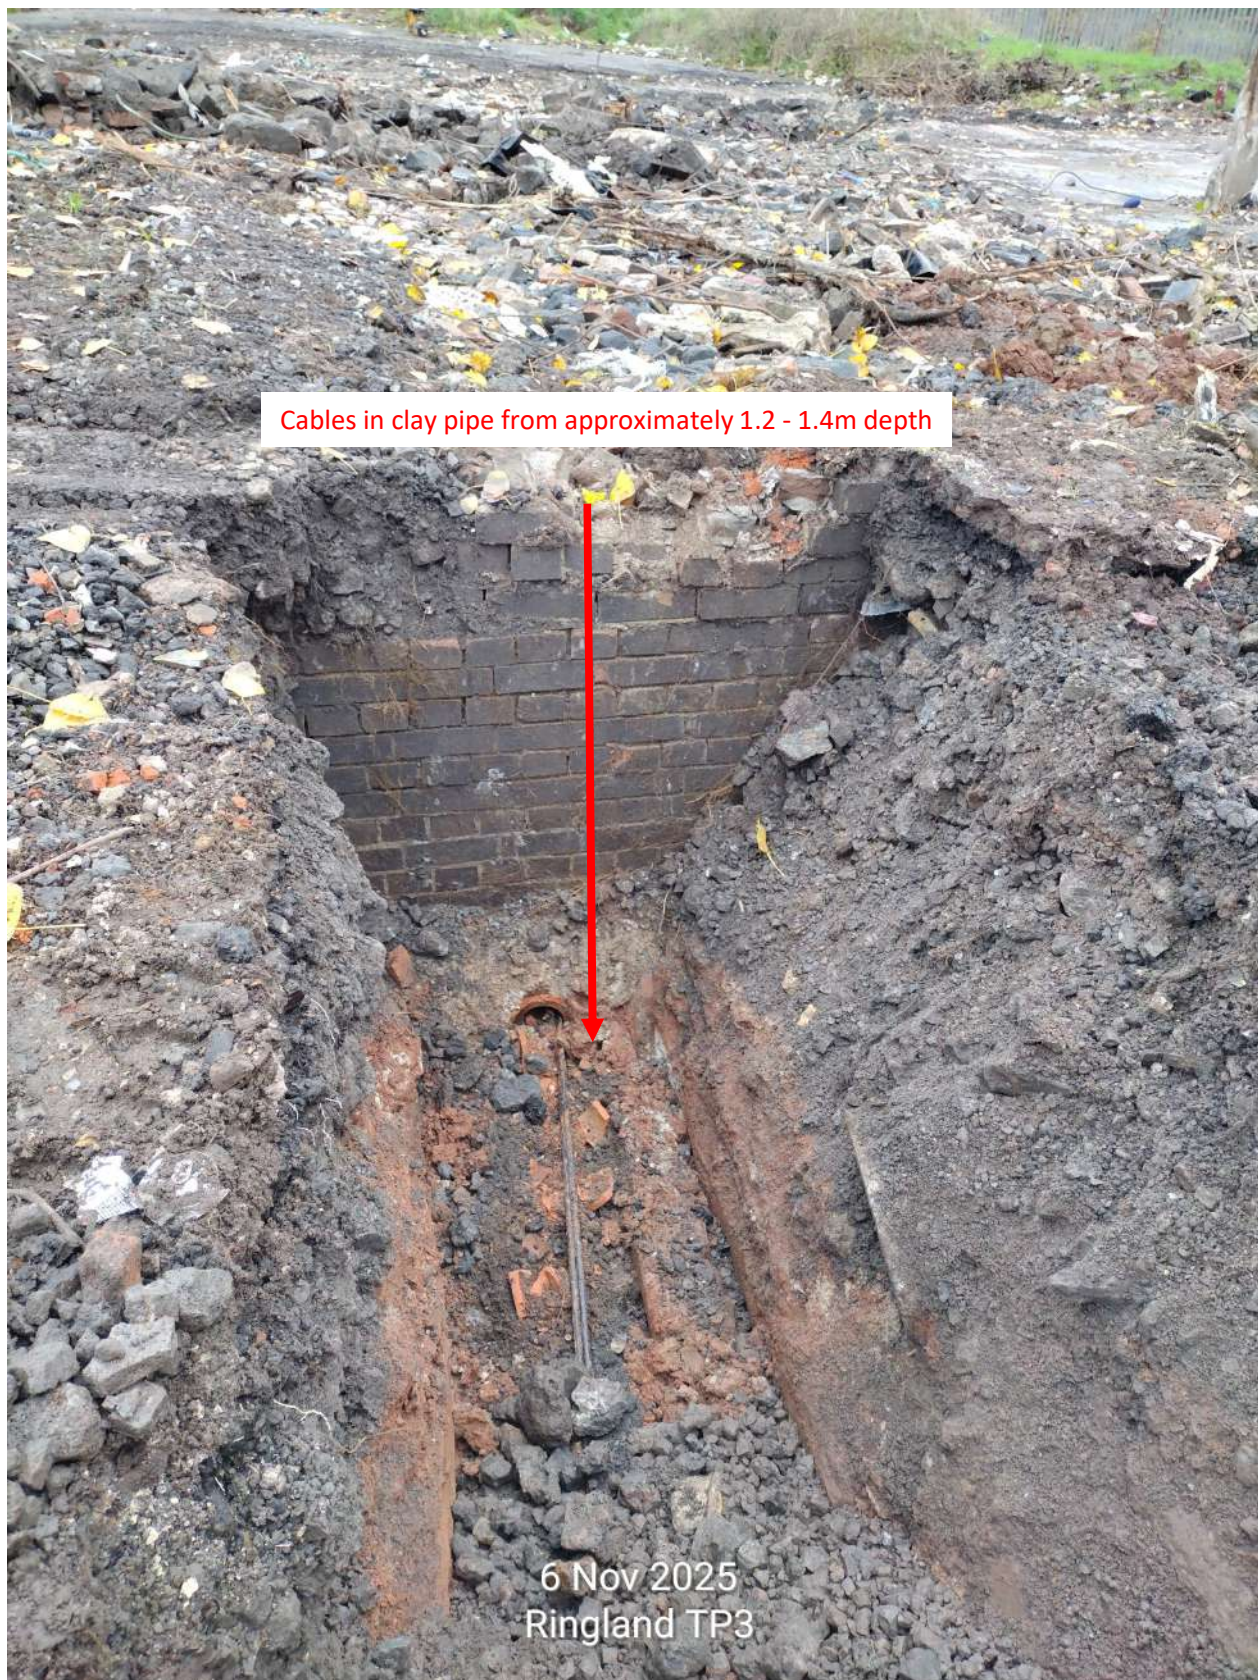
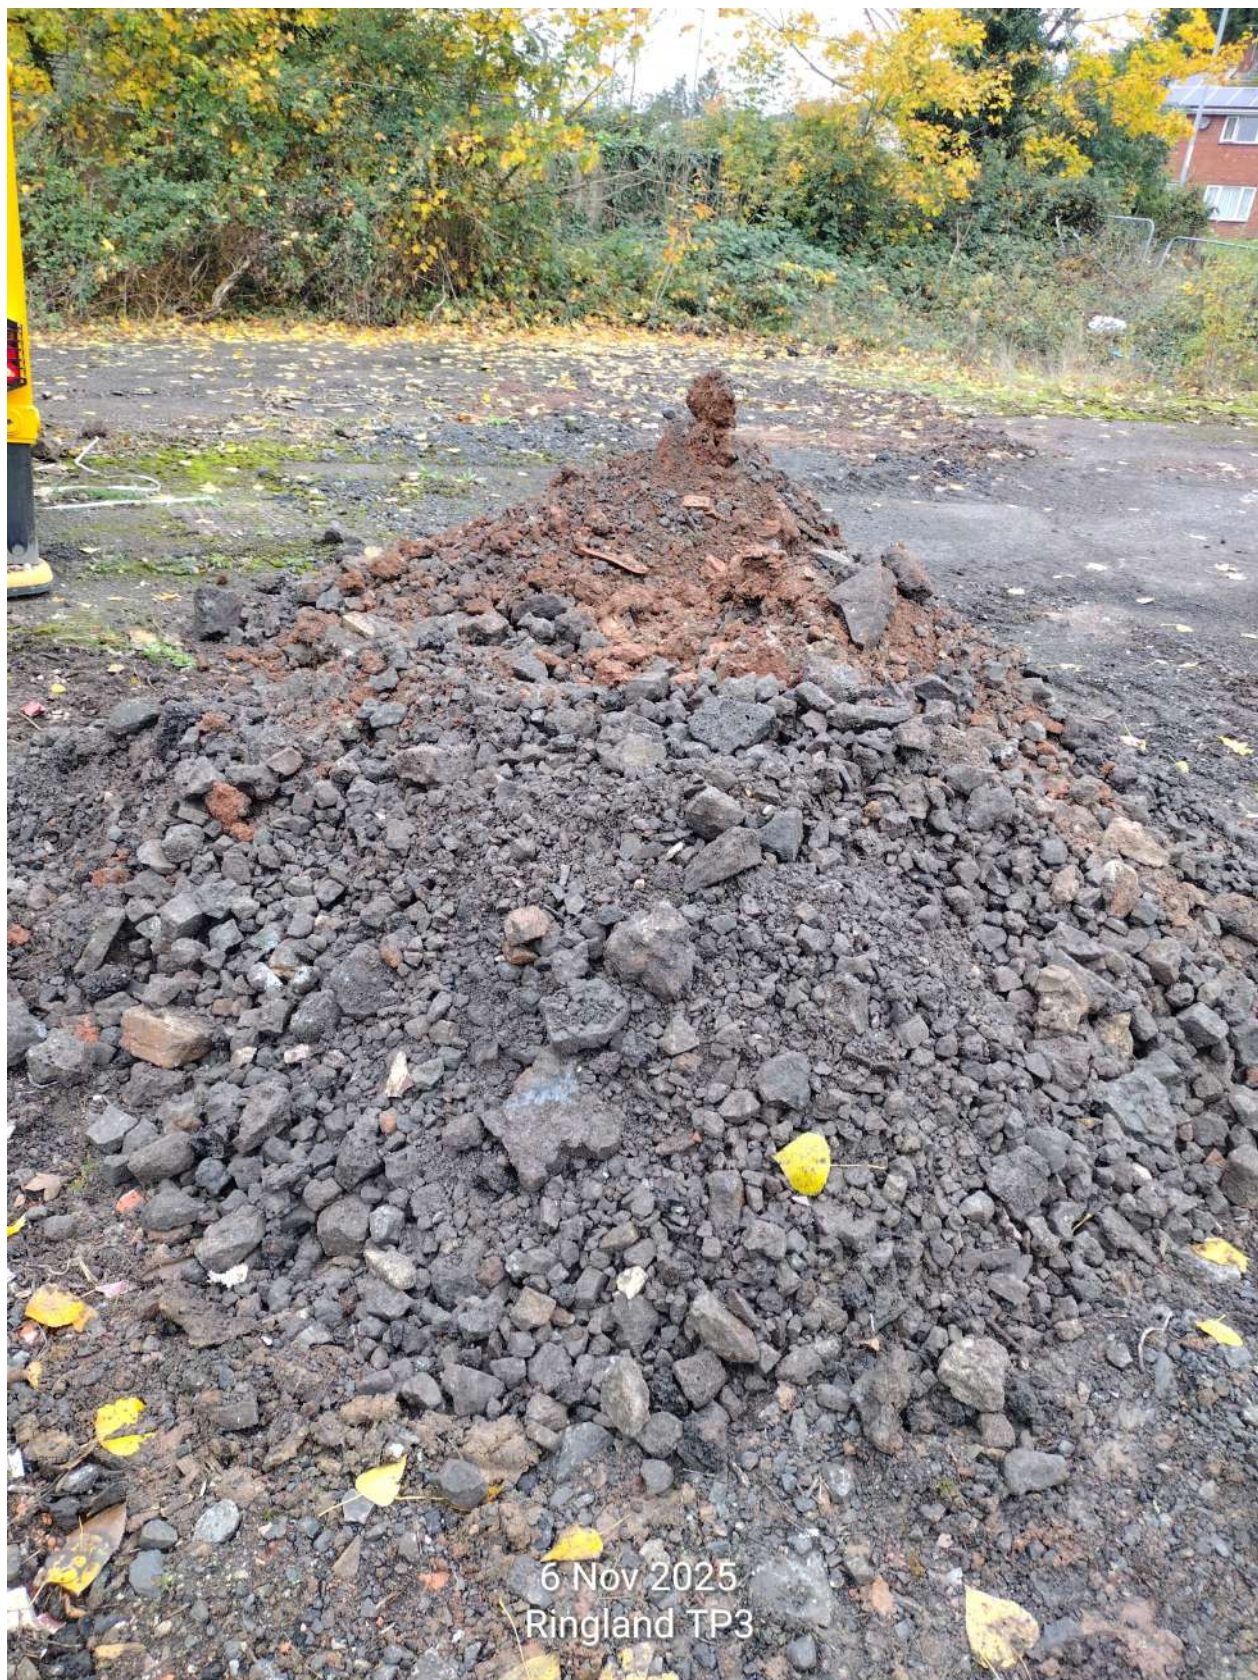
TRIAL PIT PHOTOGRAPHS - TP03

| Remarks:<br>1. Old electric cables within a clay pipe encountered between 1.2 - 1.4m depth. 2. Outer brick wall of former building extended to 1.2m depth. | | | Groundwater: No groundwater encountered. | | | Key:<br>D - Small disturbed sample<br>B - Bulk disturbed sample<br>ES - Environmental soil sample<br>W - Water sample | | | |

Trial pit TP03 was excavated directly adjacent to the outer wall of the former public house. Here, made ground extended to a depth of approximately 1.0m, which comprised backfill material to a service trench. Defunct cables were observed to enter the building channelled within a clay pipe lying between approximately 1.2m – 1.4m depth below existing ground level. The backfill material was composed of loose dark grey sandy gravel, where gravel was fine to coarse sub-angular to angular of limestone and slag, with inclusions of brick, ash and clinker.
