**OPEN HEARTH, RINGLAND, NEWPORT**

**Outline Remediation Strategy Report**

14144/RH/26/ORS

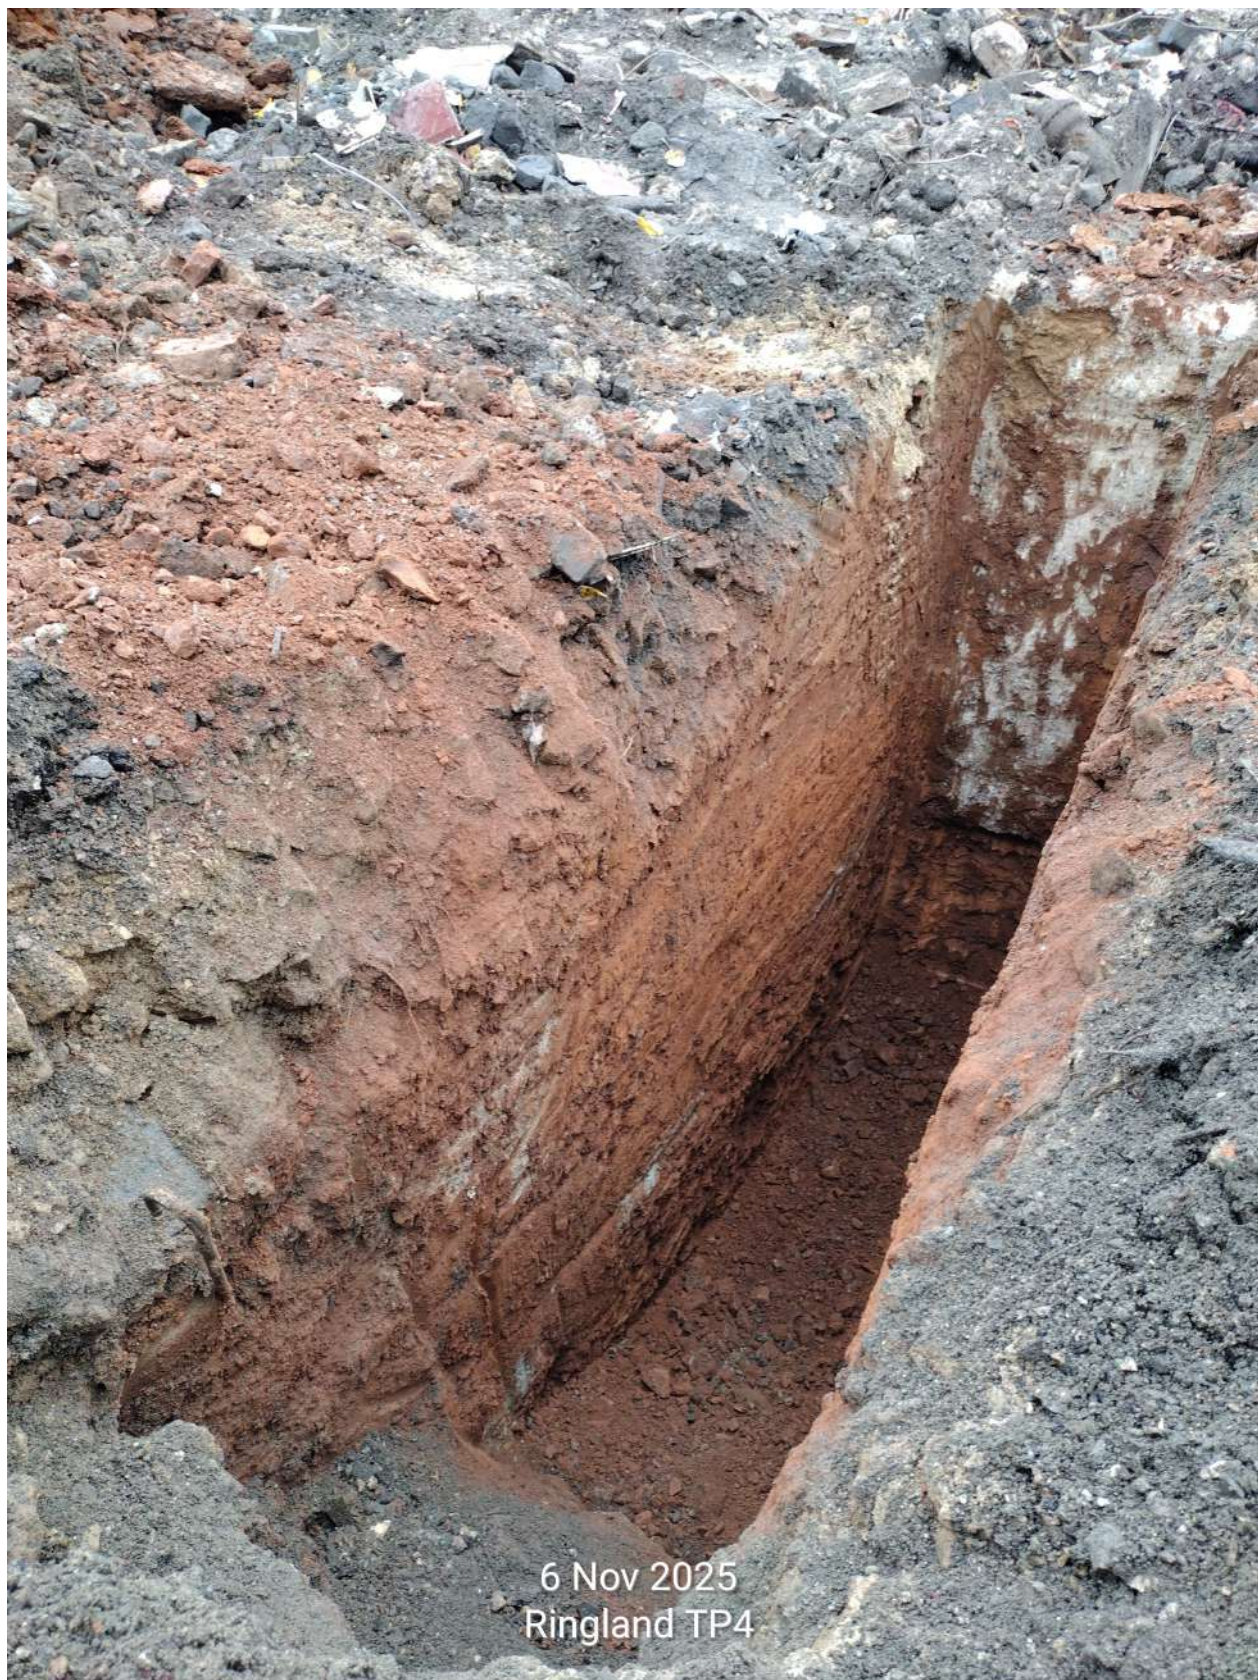
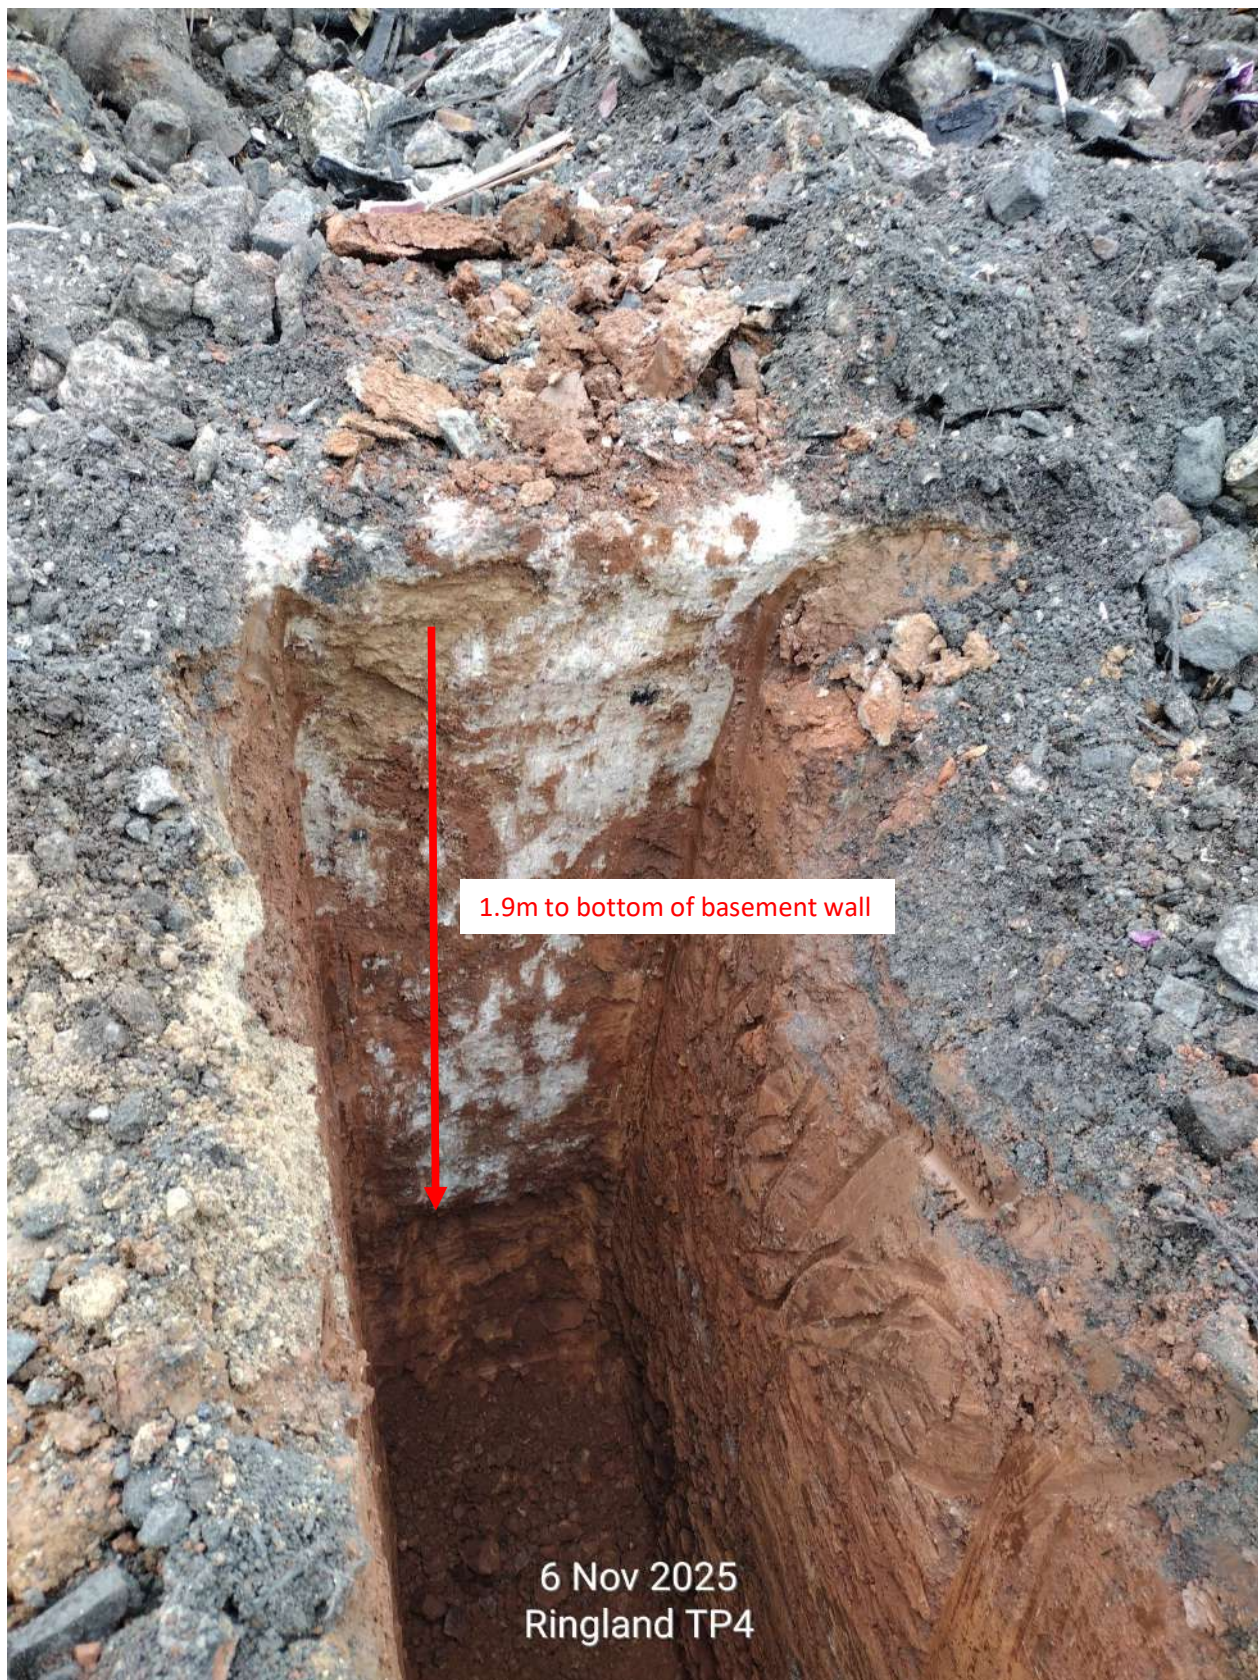
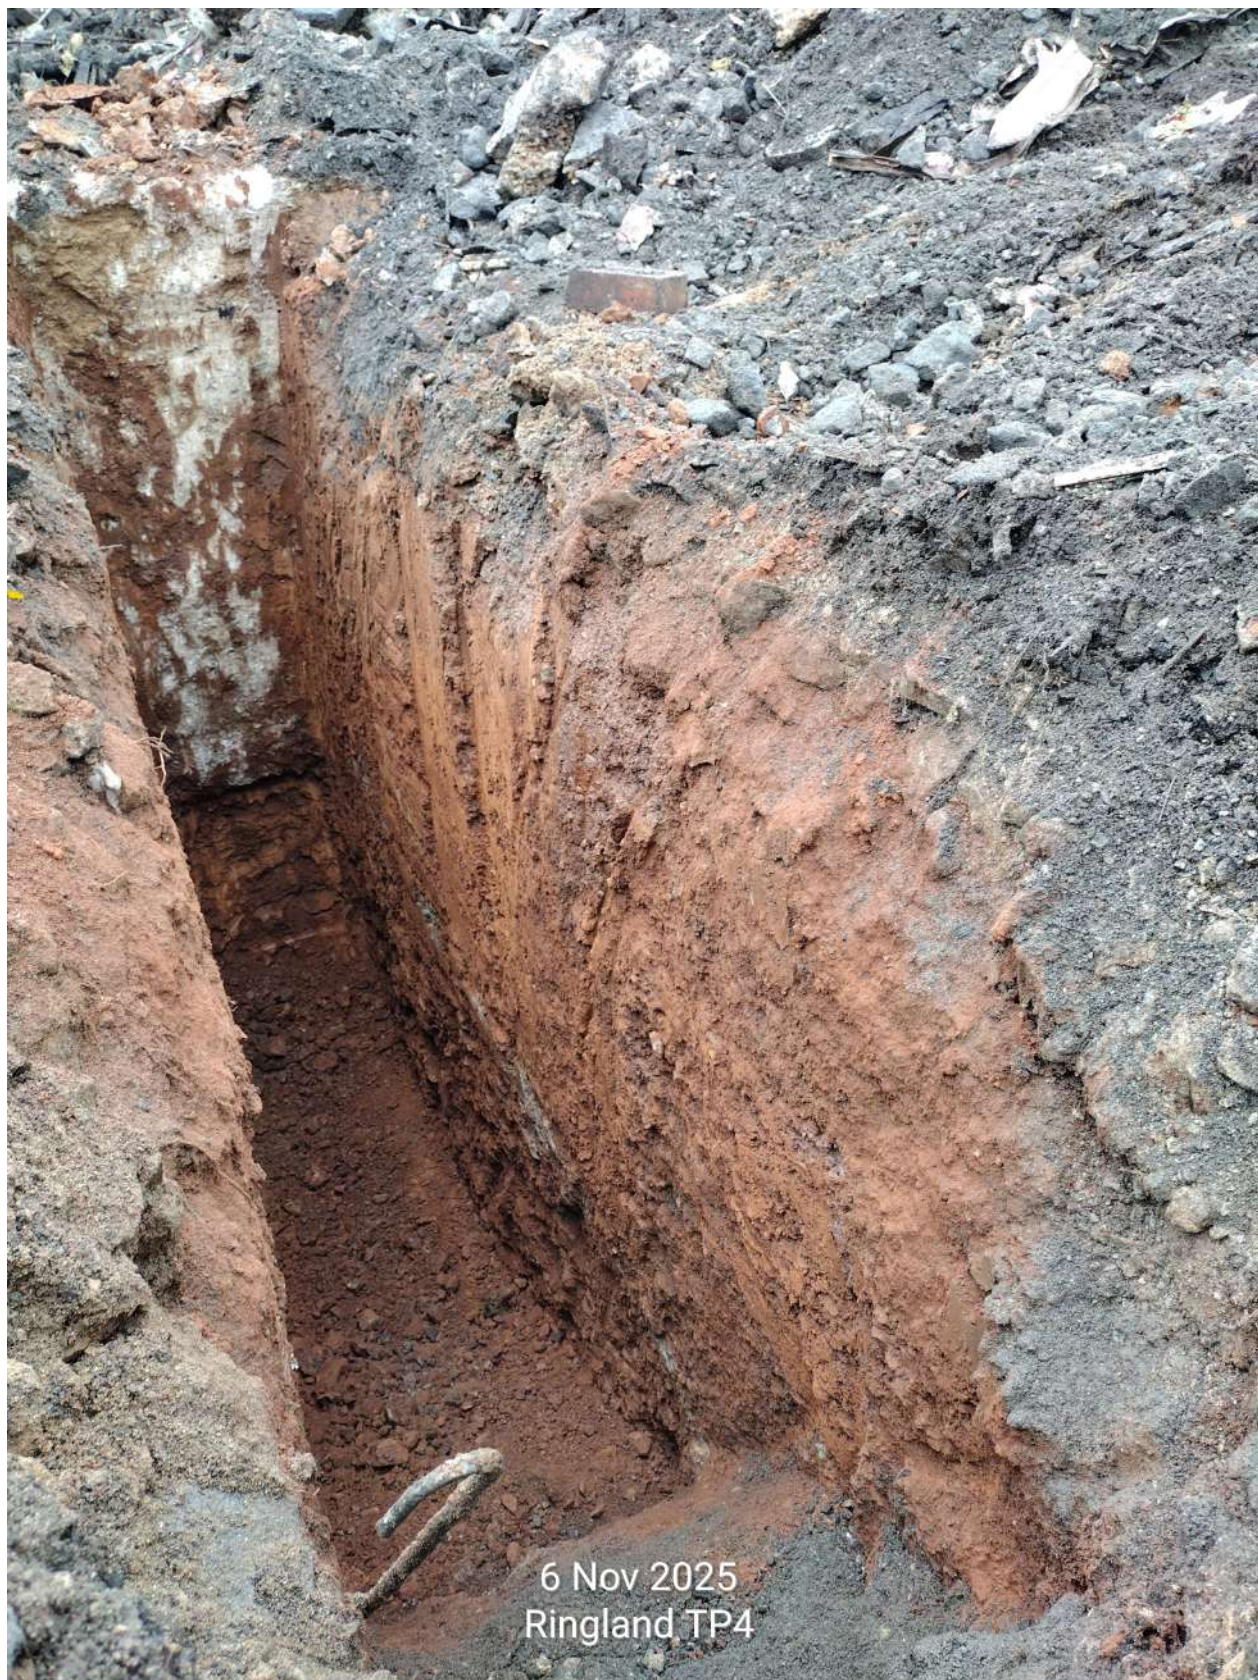
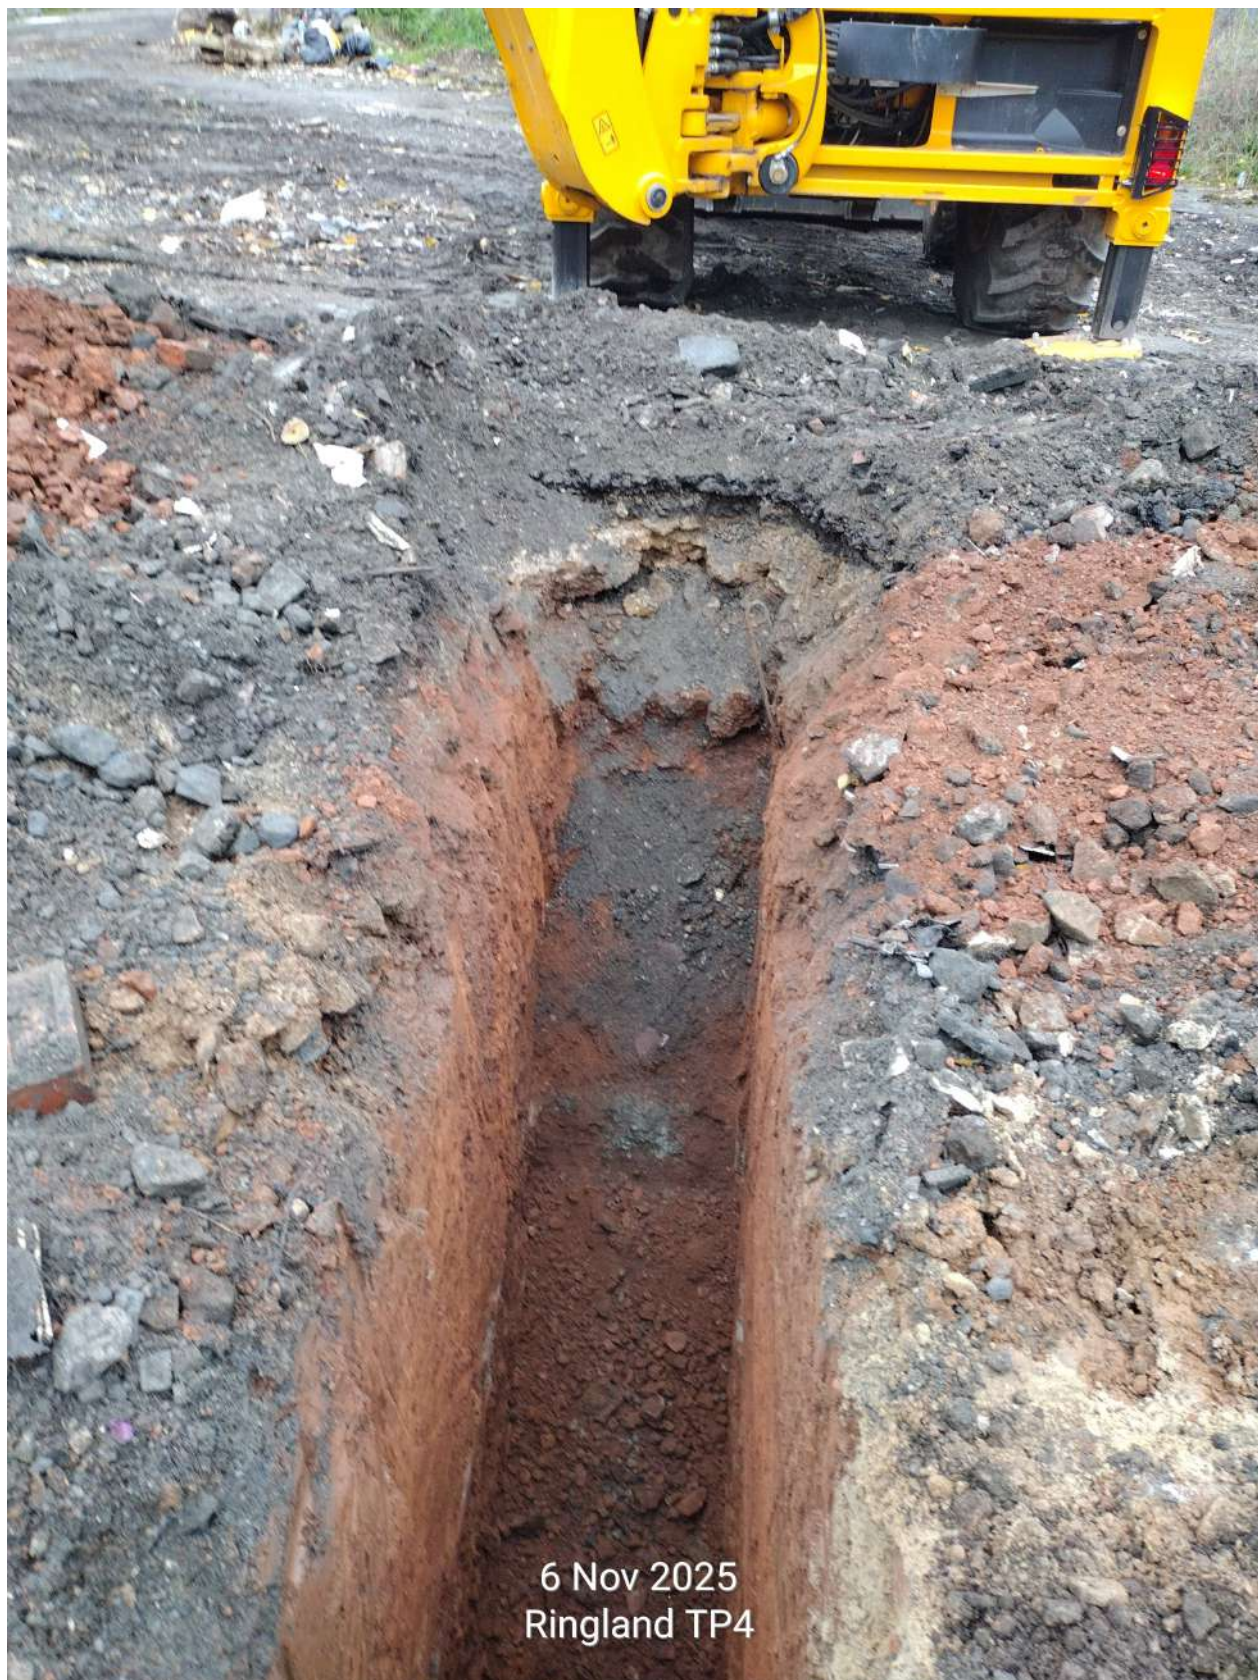
TRIAL PIT PHOTOGRAPHS - TP04

| Remarks:<br>1. Basement outer wall observed to terminate at 1.9m depth. | | | Groundwater: <b>No groundwater encountered.</b> | | | Key:<br>D - Small disturbed sample<br>B - Bulk disturbed sample<br>ES - Environmental soil sample<br>W - Water sample | | <div></div> | |

Trial pit TP04 was excavated alongside the exterior wall of the infilled basement of the former Open Hearth public house. The wall was found to extend to approximately 1.9m below existing ground level and appeared to be constructed of concrete.

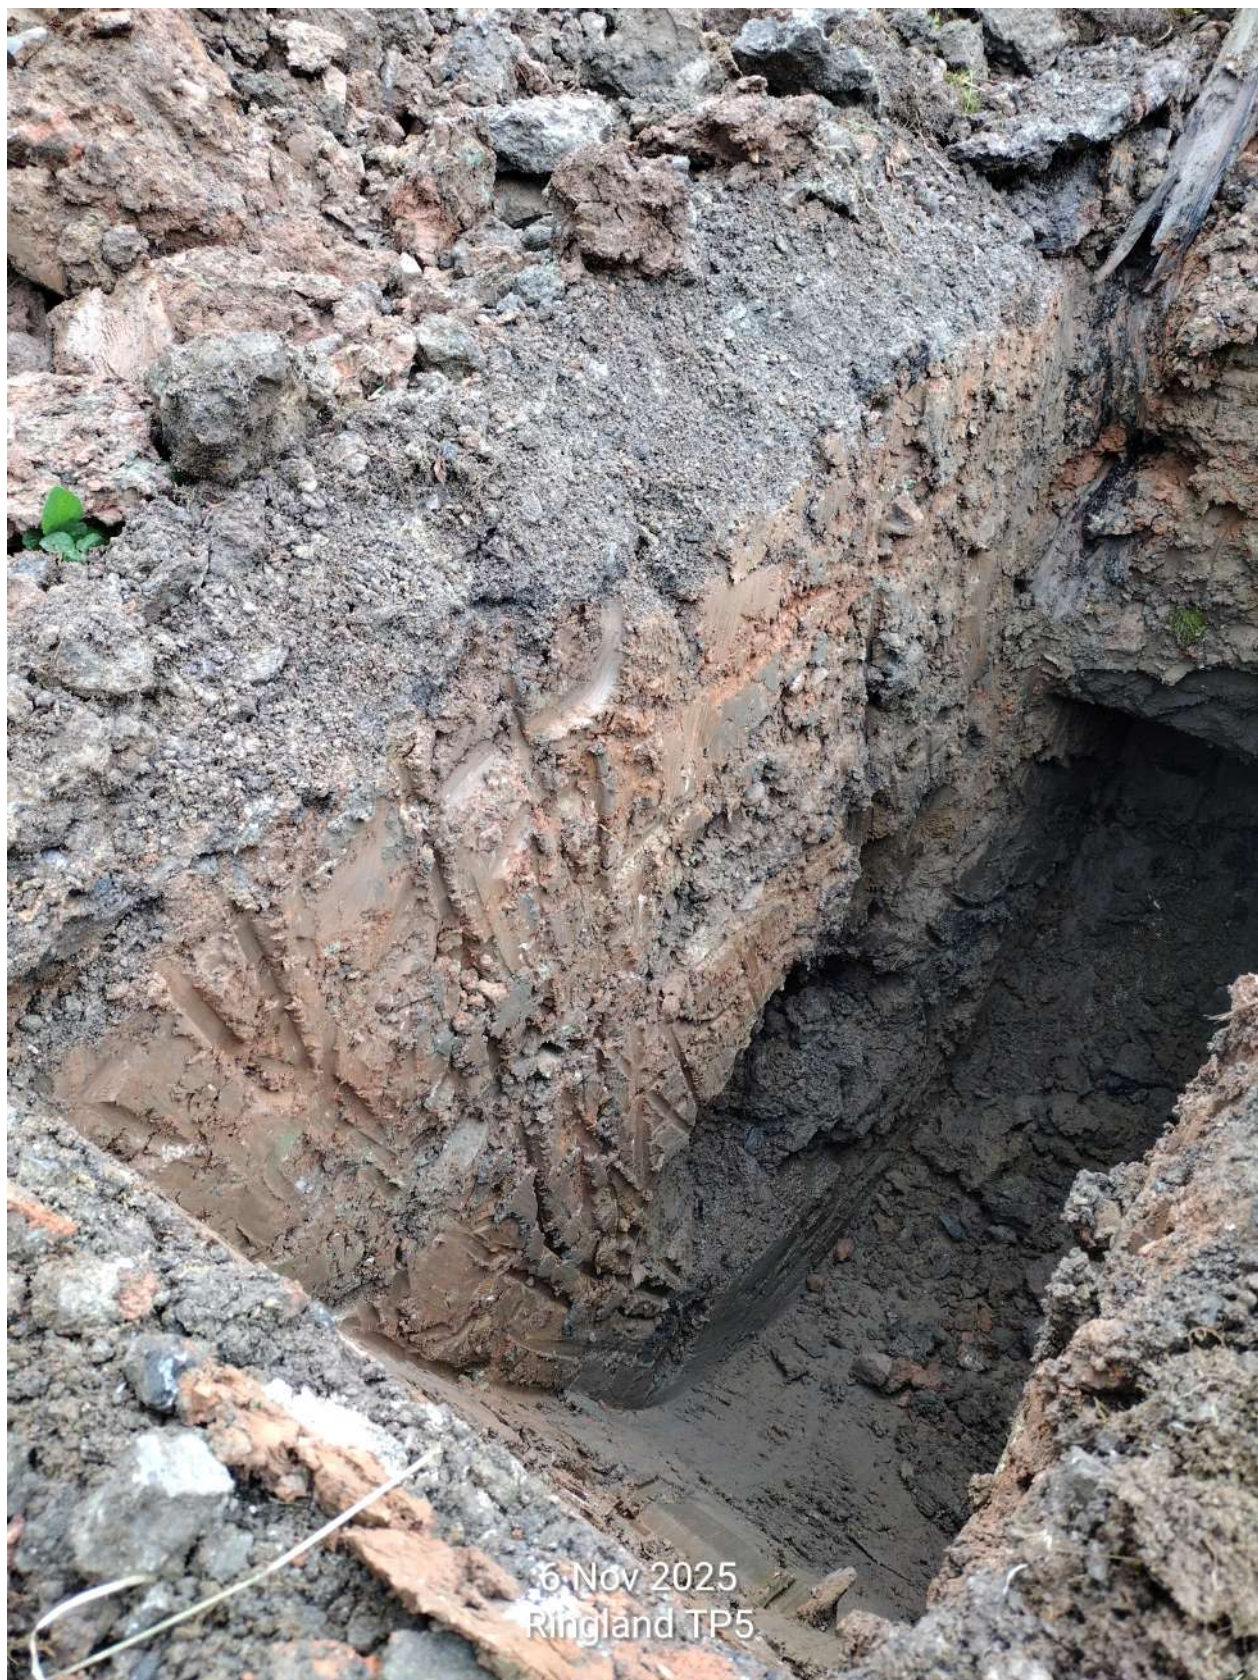
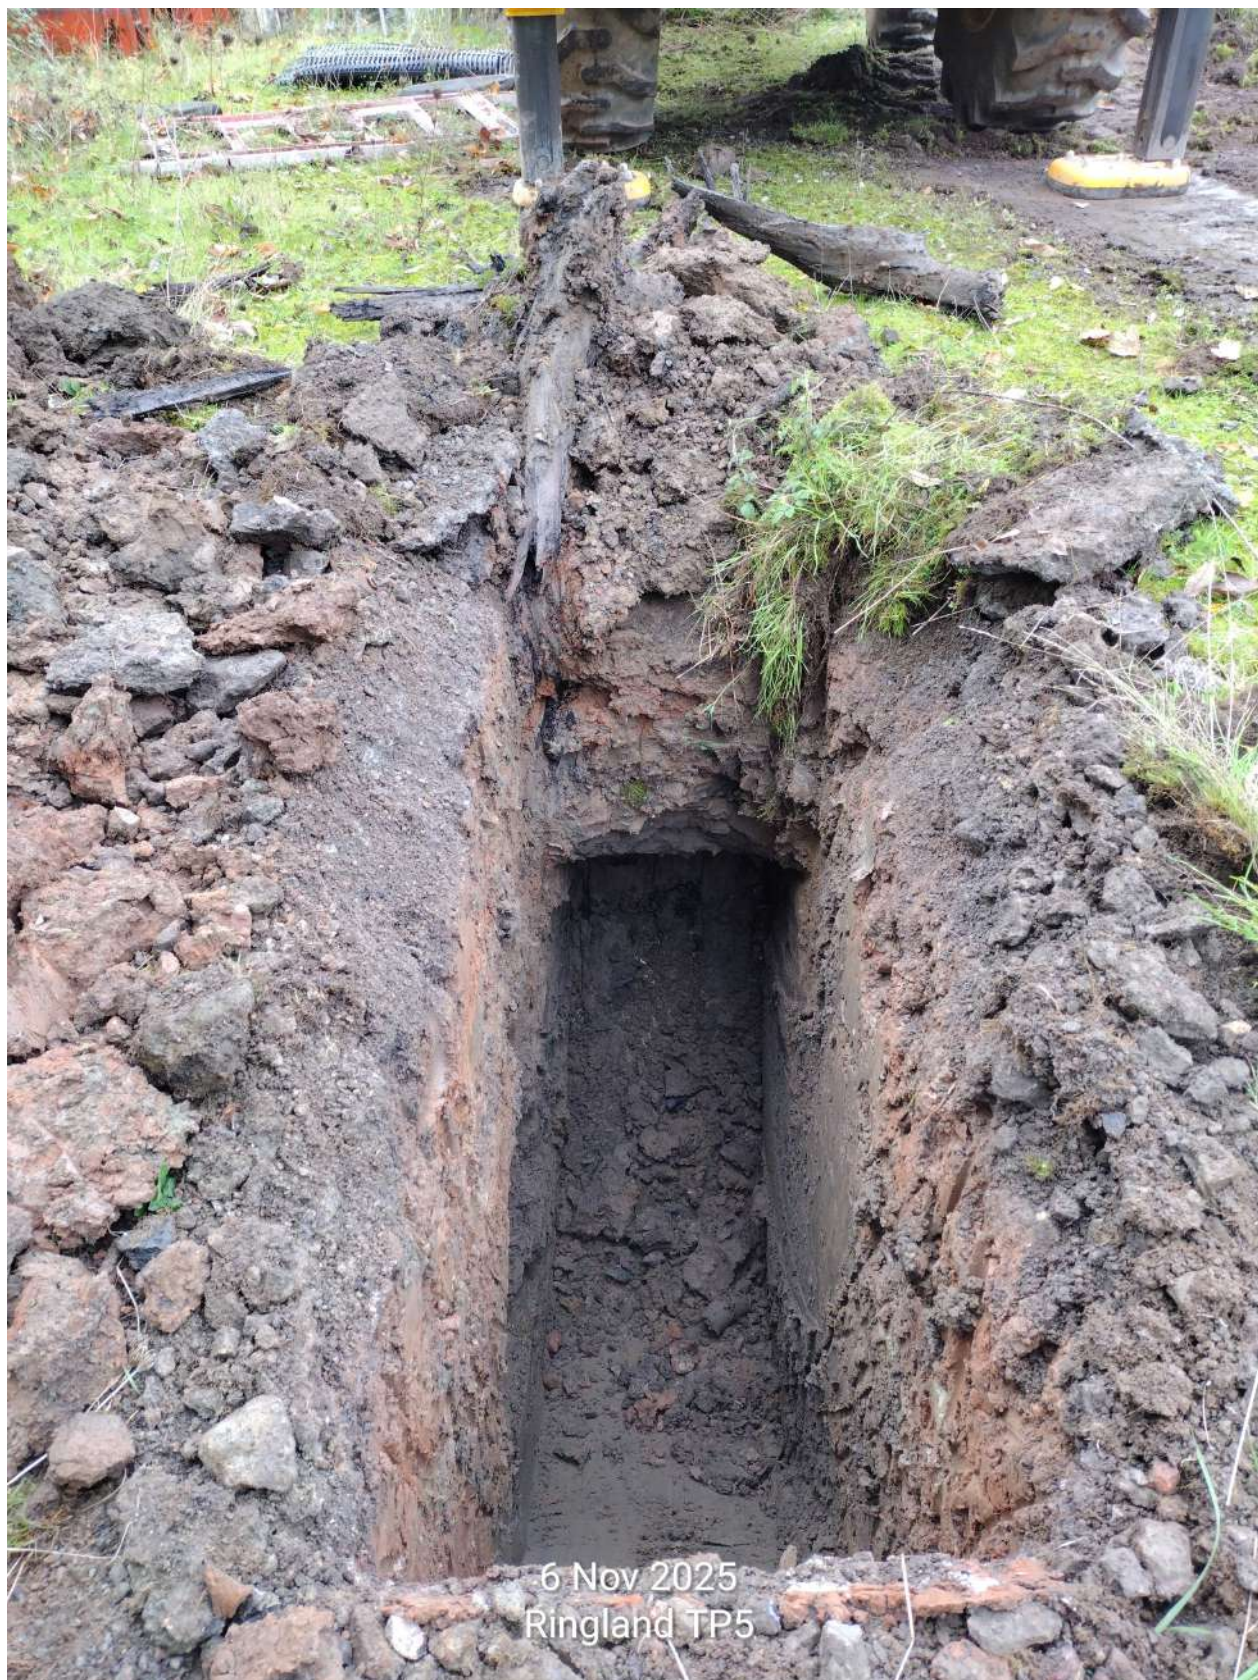
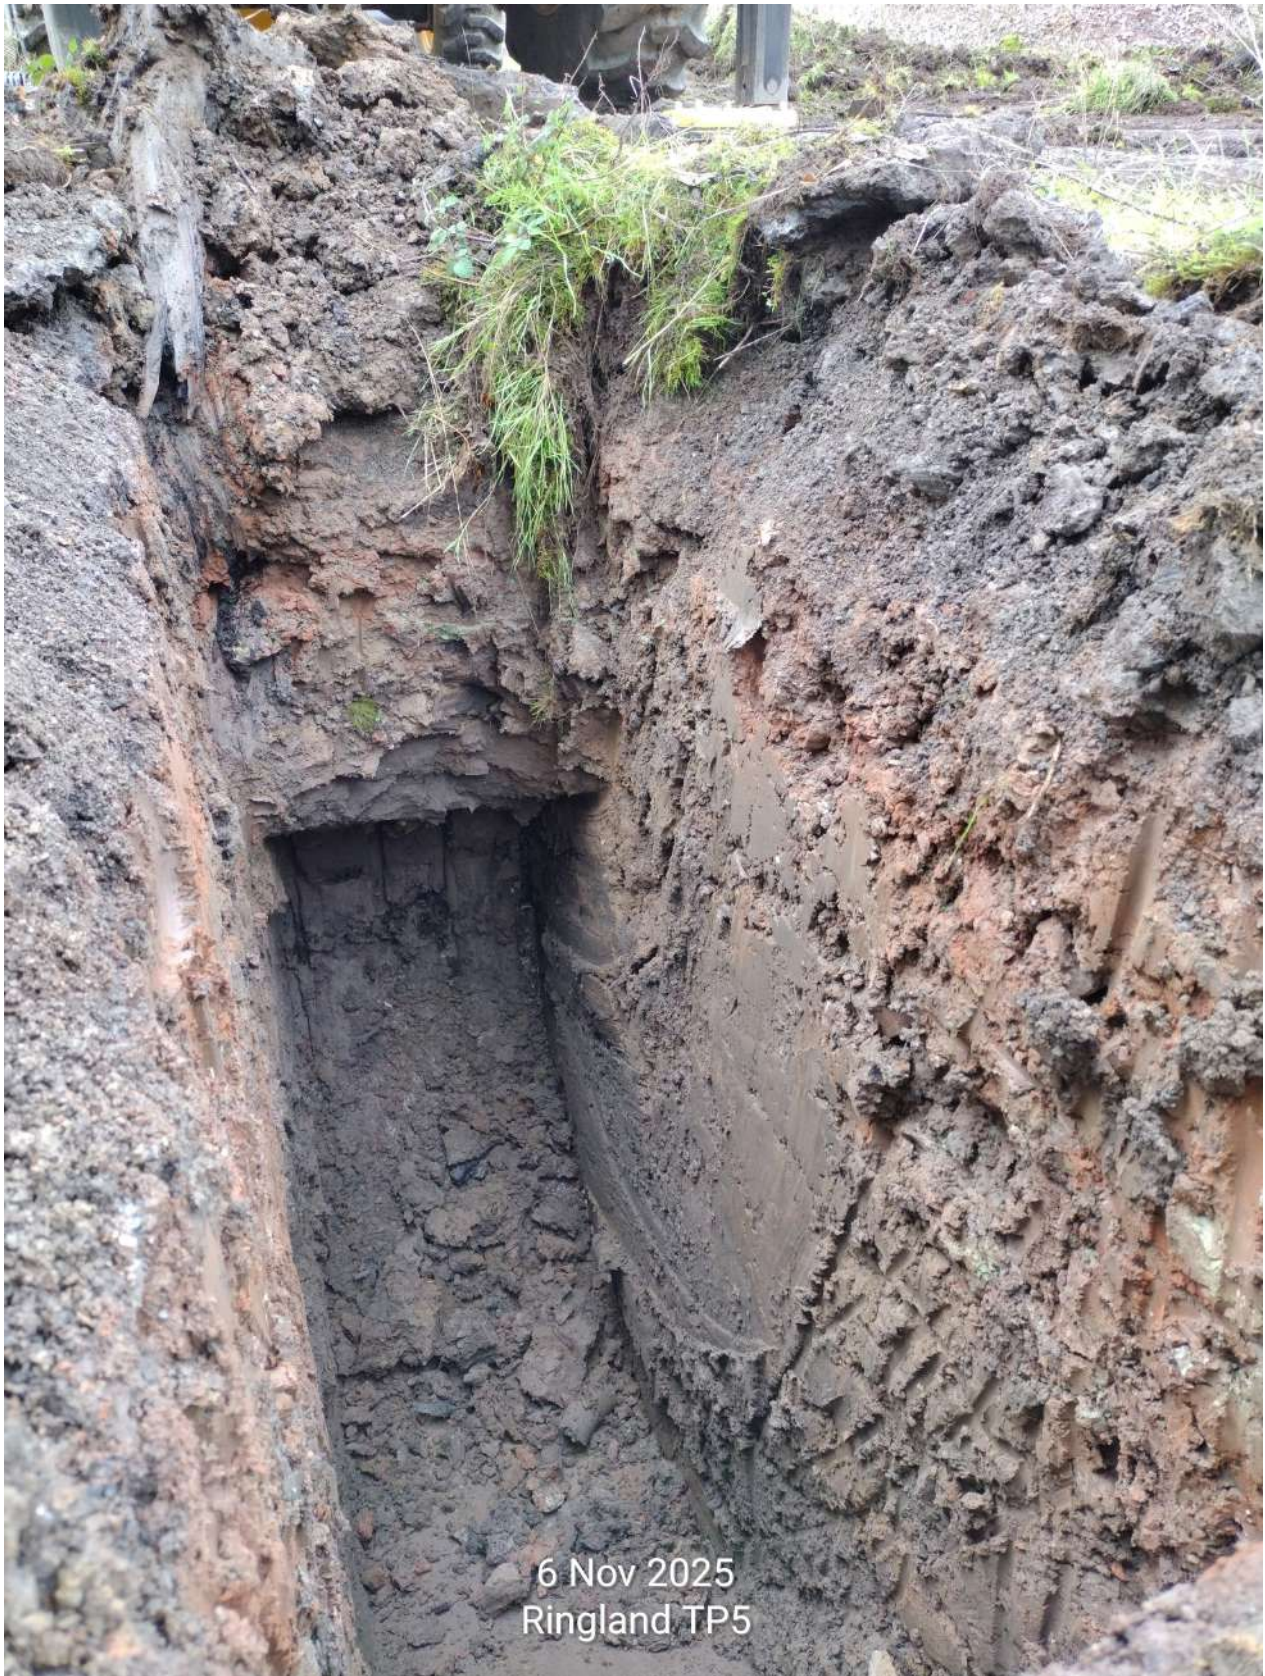
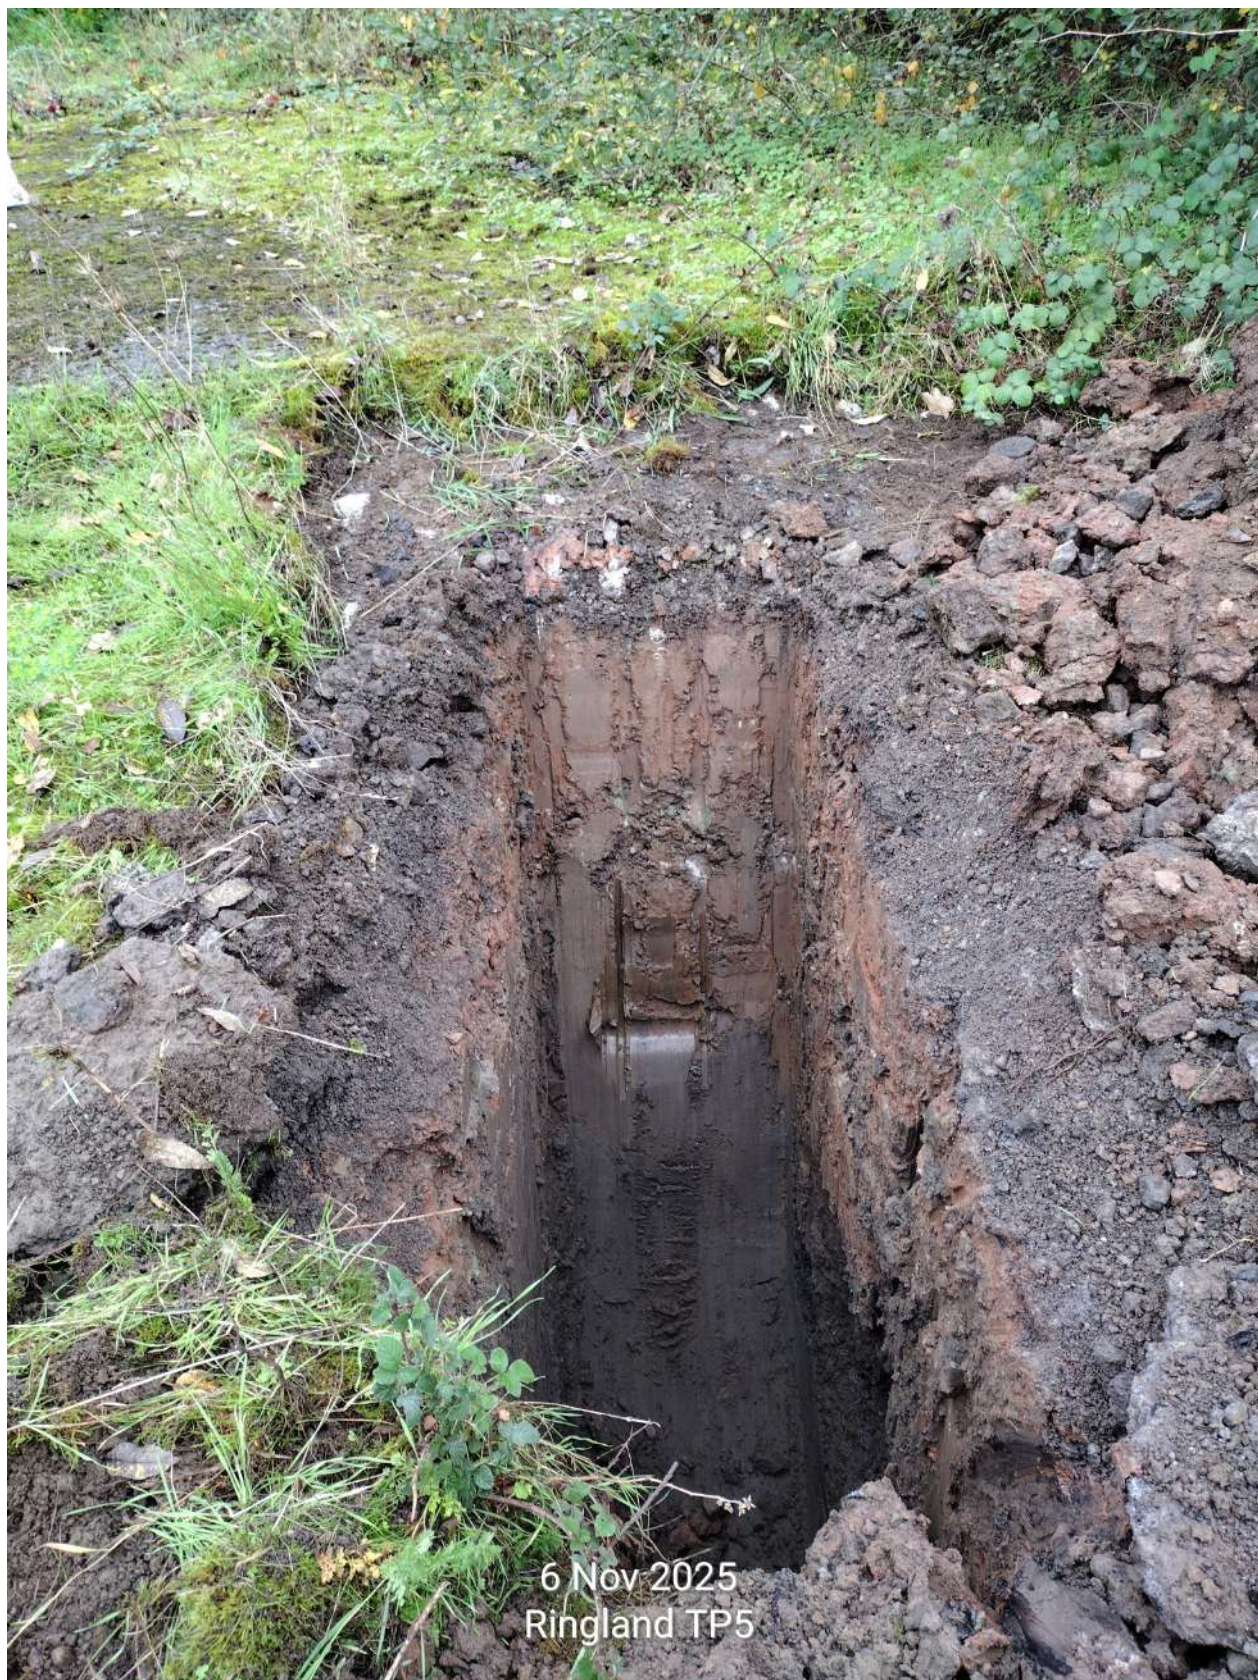
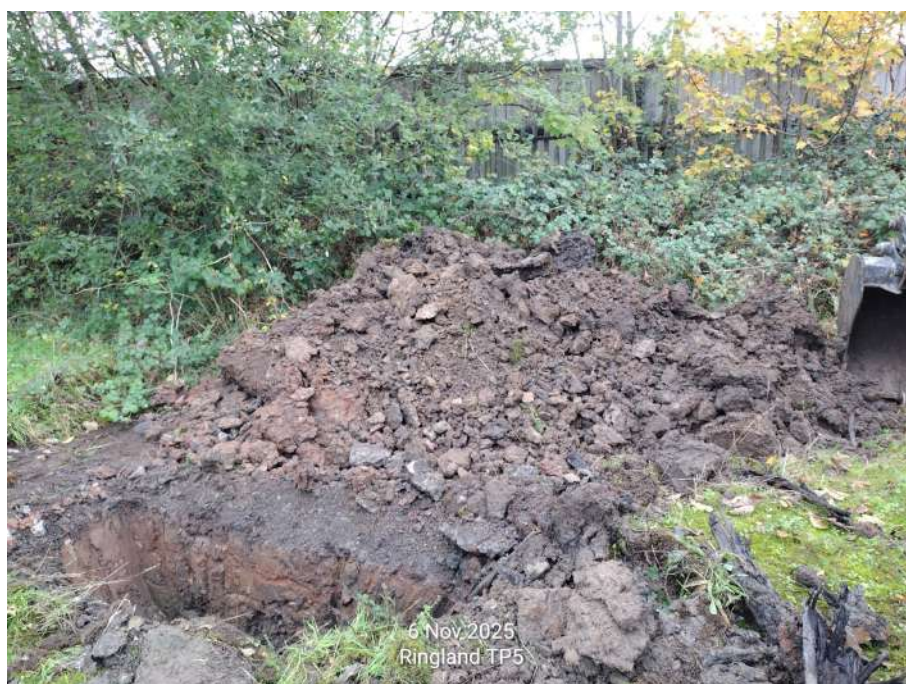
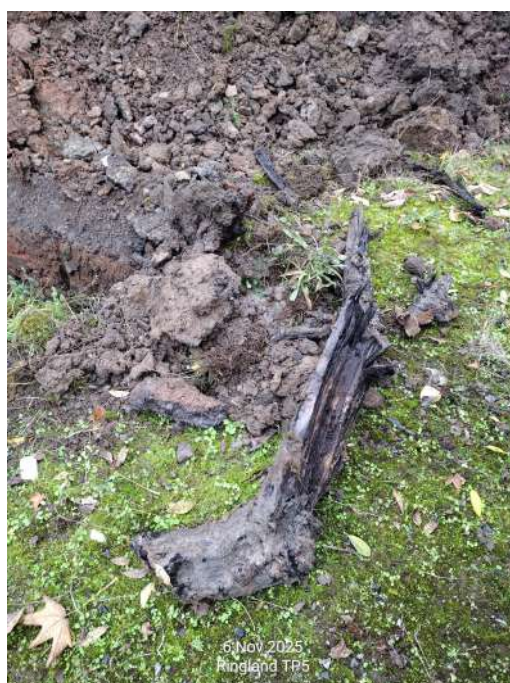
TRIAL PIT PHOTOGRAPHS - TP05

| Intégral House, 7 Beddau Way<br>Castlegate Business Park<br>Caerphilly CF83 2AX<br>Tel. 029 20807991<br>Fax. 029 20862176<br>mail@integralgeotec.com | | | Project Name:<br><b>Open Hearth, Ringland</b> | | | Project No.:<br><b>14144</b> | | Trial Pit No.:<br><b>TP05</b><br>Sheet 1 of 1 | |
|---|---|---|---|---|---|---|--|---|--|
| Remarks: | | | Groundwater: Slight groundwater seep at 2.0m depth. | | | Key: | | | |

Trial pit TP05 identified surface concrete over the same thin band of granular made ground observed in TP06. However, further underlying made ground extended to the maximum investigation depth of 2.3m, and was found to be comprised of stiff red and orangish red slightly gravelly clay with rare brick fragments to approximately 0.7m, over firm grey mottled reddish brown silty slightly gravelly clay with rare fragments of brick and china to approximately 1.0m depth, over firm becoming soft to firm brown silty clay with rare fragments of china, organic inclusions and small to large sections of tree branch.

A slight groundwater seepage was noted in TP05 at 2.0m depth within the made ground.
