# MIDDLE QUAY WAREHOUSES – ABP NEWPORT PRELIMINARY ROOST ASSESSMENT (PRA) AND ACTIVITY SURVEYS FOR BATS

| <b>TITLE:</b> | Preliminary Roost Assessment (PRA) and Activity Surveys for Bats |

| <b>PROJECT REF:</b> | 238-03-17-25 |
| <b>REPORT No.:</b> | 238-03-17.R1 |

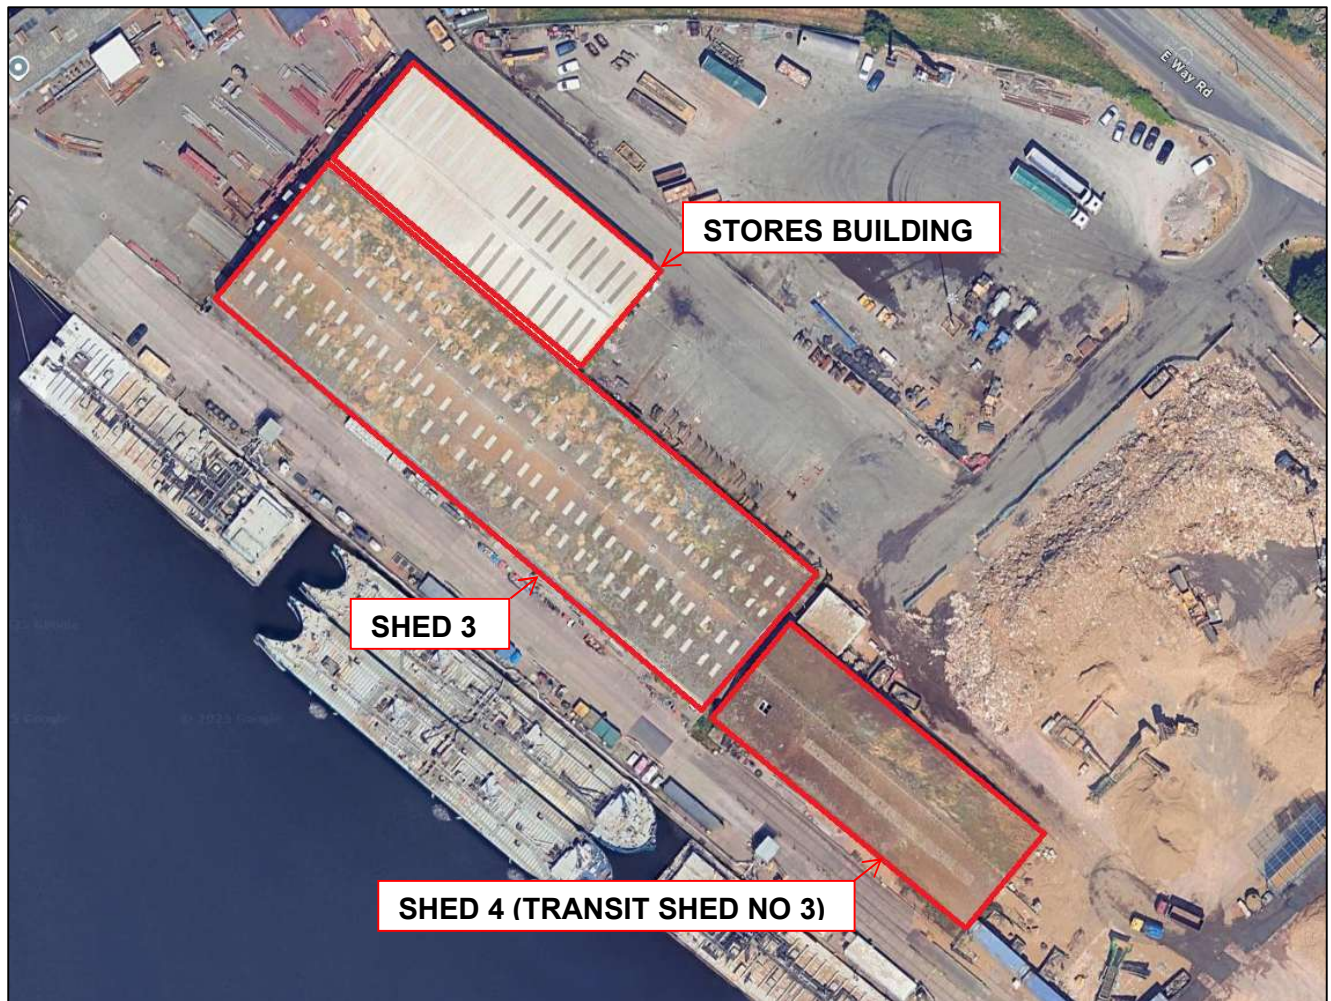
**Figure 3 – Survey Building Configuration and Designations**

The survey buildings are of generally rectangular shape, with Shed 3 and Shed 4 being affixed end-to-end with one another and a dedicated access point being located between the two buildings to allow internal access for both vehicles and pedestrians. Subsequently, the interior of both buildings creates a singular large space, divided by an open roller shutter / vehicular access ramp located at the south-eastern corner of Shed 3.

The Stores building meanwhile is connected to Shed 3, and is accessible via internal roller-shutter doors which were closed during the survey. Access to the Stores Building was subsequently made via an external roller-shutter door which is opened and closed as necessary for security purposes.

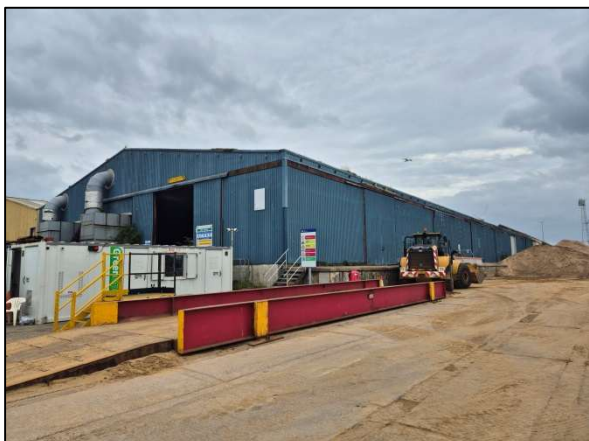
**Figure 4 – (NW) Corner of Shed 3 Looking (E)**

The exterior walls of both Shed 3 and the Stores building consist of corrugated steel cladding set intermittently on concrete plinths up to roof level, (as visible in Figures 4, 6 and 7).

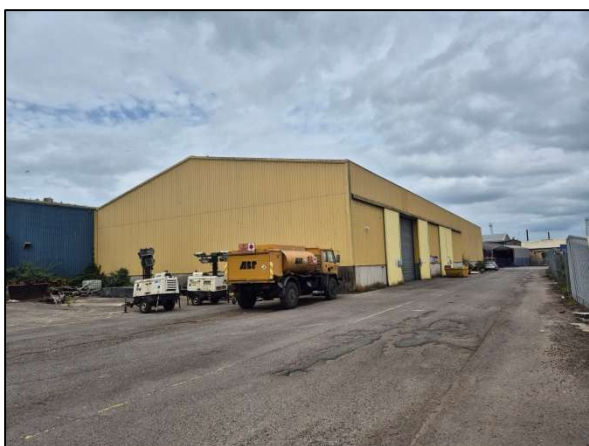
**Figure 6 – (SE) Corner of Stores, Looking (W)**

Although the cladding making up the walls of Shed 3 and the Stores building is single-skinned in nature, the cladding has been further covered with internal fibreglass or similar sheeting in some areas within both sheds, subsequently meaning that a void is present between the exterior and interior wall claddings which may offer roosting opportunity for crevice-dwelling bats in these locations.

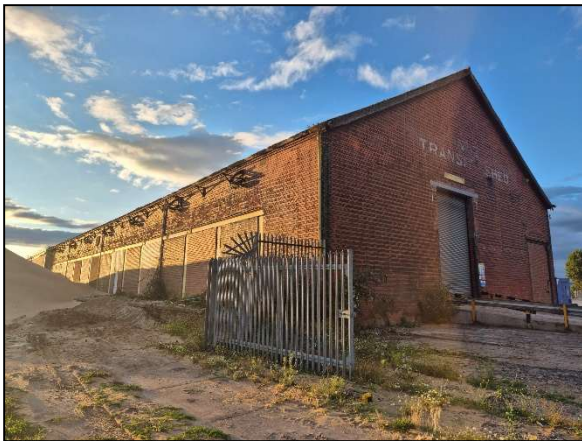
**Figure 8 – (SW) Corner of Shed 4, Looking (N)**

Shed 4 is constructed from engineering bricks, which were observed to be in generally excellent condition given the likely age of this section of the building. Small holes, cracks and missing bricks /mortar were recorded in some areas from the exterior of the building however, and these were assessed to potentially provide roosting opportunity for crevice-dwelling bats.

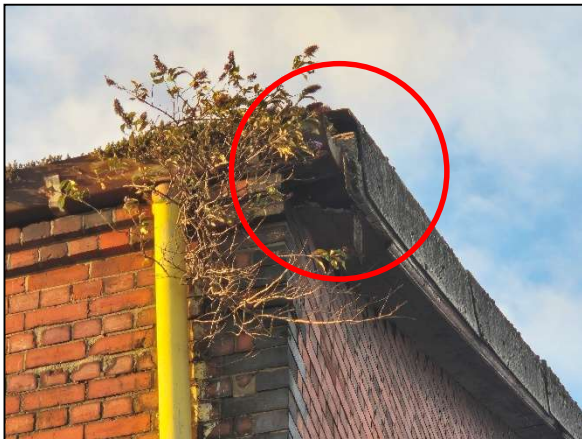
**Figure 10 – Damage to Timber Soffit on (SW) Corner of Shed 4, May Offer Potential Roosting Opportunity for Crevice-Dwelling Bats**

Significant damage was also recorded to the timber soffit boxes located on the south-eastern end of Shed 4, offering potential roosting opportunity for crevice-dwellers on this section of the building (as visible in Figure 10). It should be noted however that the areas of damage are considered substantial enough that limited protection from external elements would be afforded for bats within these timber features.

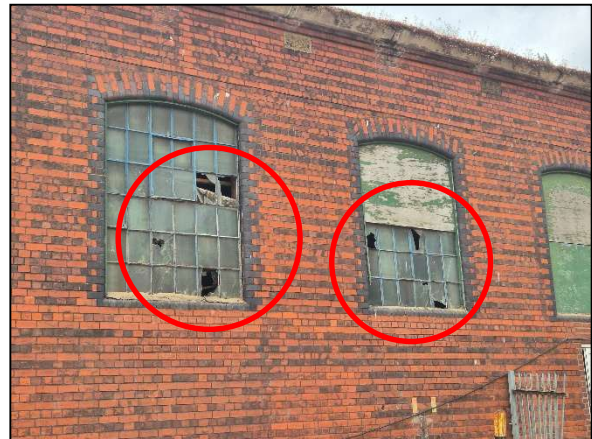
**Figure 11 – Damage to Windows on (NE) Wall of Shed 4, Offers Potential Access/Egress for both Crevice and Void-Dwelling Bats to Shed 4 Interior via these Areas**

Numerous windows are present on the eastern wall of Shed 4, with many having been boarded up with timber. Some of the windows are however exposed, and damage to the glass panes was recorded (as visible in Figure 11) which may afford the free access/egress of both crevice and void-dwelling bats to the building interior via these avenues. Small gaps present between the timber boarding and windows were assessed to potentially offer some roosting potential for opportunistic crevice-dwellers.

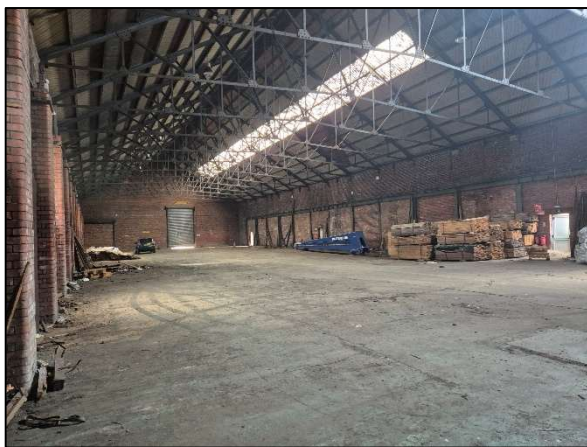
**Figure 12 – Shed 4 Interior, Looking (SE)**

The roofs consists of corrugated asbestos / steel sheets interlaced with numerous skylights, some of which were found to be damaged allowing the ingress of water and potential free access/egress of bats to the building interiors in some locations (particularly within Shed 4). Consequently, the building is very well lit by natural light throughout most areas of Shed 4 and the Stores building during daylight hours.

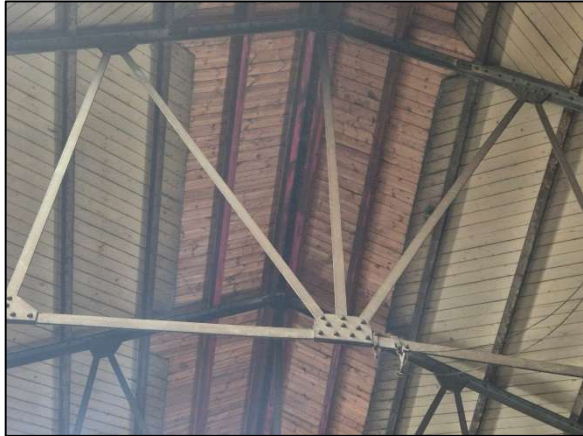
**Figure 14 – Tightly Sealed Timber Boards Affixed to Underside of Shed 4 Roof Panels**

- **Gaps between Roof Panels and Timber Interior Cladding in Shed 4:** A small gap / void is likely present between the exterior roof panels and internal timber cladding present beneath the panels in Shed 4. Although in generally good condition, there is the potential that crevice-dwelling bats may be able to access the void and associated PRFs via unrecorded areas of damage;

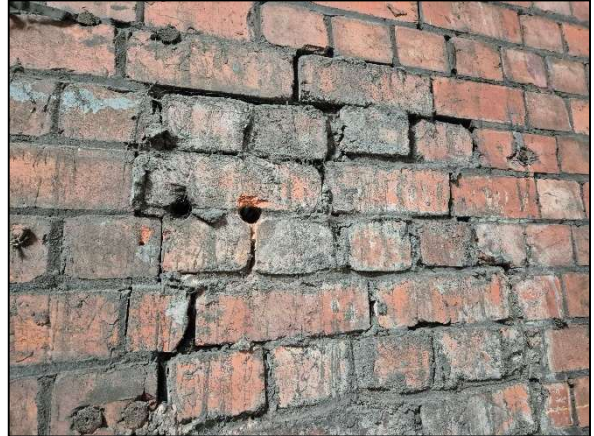
**Figure 15 – Small Cracks in Interior Brickwork of Shed 4 Offer Roosting Potential for Crevice-Dwelling Bats**

Small cracks within interior brickwork were identified to offer some potential to support crevice-dwelling bats, whilst there is likely a small void present between the interior timber cladding and exterior roof panels which may also offer further roosting potential for these species.

- **Small Cracks within the Brickwork of the Survey Buildings:** Small isolated cracks are located around the masonry of the building, particularly with respect to Shed 4, which may offer potential roosting opportunity for crevice dwelling bats;

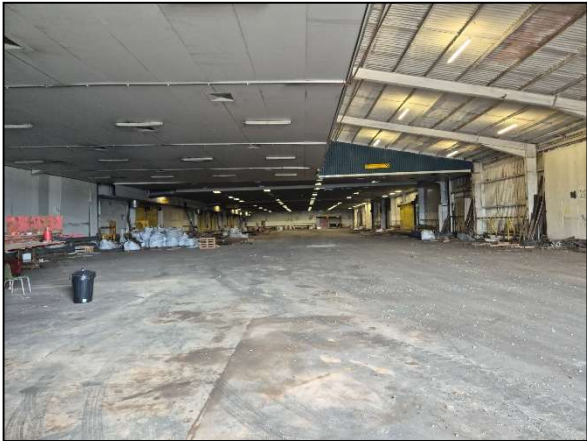
**Figure 16 – Shed 3 Interior, Looking (SE). Underside of Roof Visible on Right, but Covered by Cladding in Left of Image**

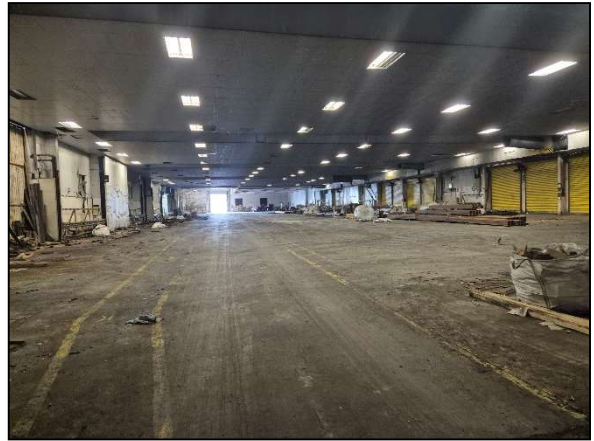
**Figure 17 – Shed 3 Interior, Looking (NW). Light Ingress via Open Roller-Shutter Door Visible, Enabling Free Access/Egress for Bats to Interior of Shed 4**

- **Open / Damaged Roller Shutter Doors and Pedestrian Accesses around Shed 3 & Shed 4** – A number of open and damaged doorways are located around Shed 3 and Shed 4. An open roller shutter door is present on the north-western side of Shed 3, permitting free access/egress for bats to the building interior via this avenue. Furthermore, damaged / slightly open pedestrian accesses are present on the southern walls of Shed 3 and Shed 4, enabling further potential access/egress to the respective building interiors in these locations. Gaps around the edges of closed doorways and between and above roller shutter doors were also recorded during the survey that would provide access opportunities even in the event that the doors are closed;

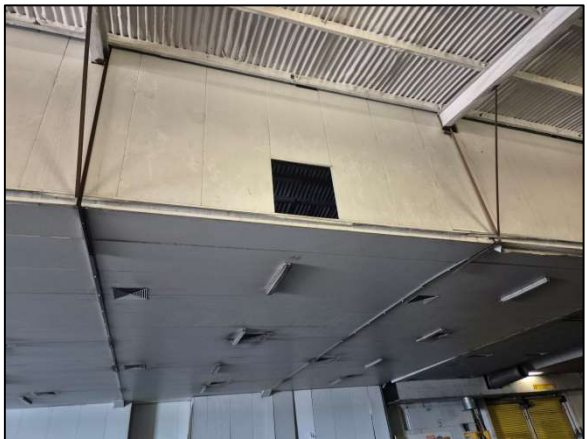
**Figure 18 – Cladding on Underside of Roof of Shed 4 Interior Creates Void, Offering Potential Roosting for Crevice and Void-Dwelling Bats. Missing Section Enables Potential Access / Egress for Bats**

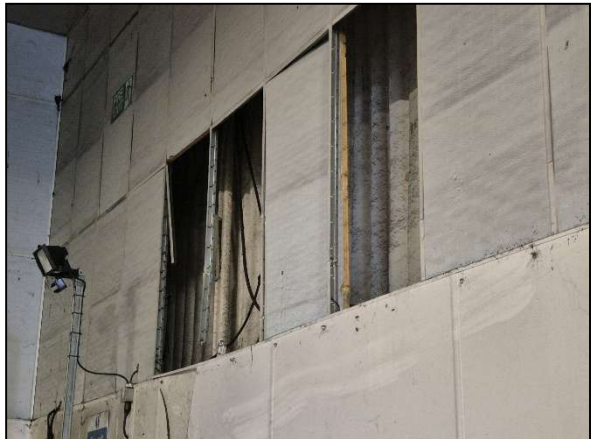
**Figure 19 – Cladding in (SW) Corner of Shed 3, Covering Interior Wall of Building. Void between External Panels Making up Shed Walls and Interior Cladding May Offer Potential Roosting Opportunity for Crevice and Void-Dwelling Bats. Damaged Panels Noted**

- **Void between Interior Ceiling and Wall Cladding / Insulation and Exterior Wall and Roof Panels in Shed 3:** Voids are present between interior cladding and exterior wall and roof panels within Shed 3. There is the potential that both crevice and void-dwelling bats may be able to access these void and associated PRFs via damaged areas of cladding / insulation;

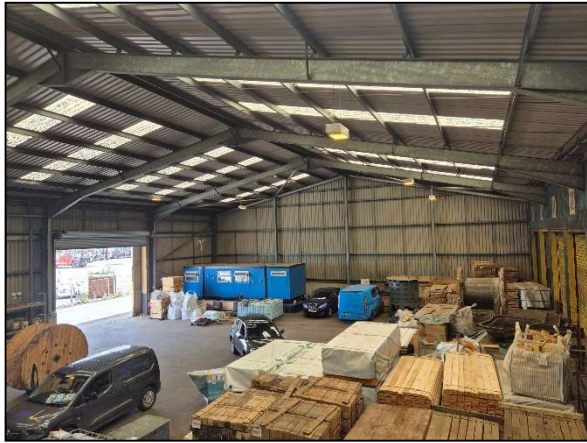
**Figure 20 – GF Stores. Interior, Looking (SE)**

All 3 of the buildings possess A-shaped gable roofs which are supported by steel I-beam framework and associated bracing beams, purlins and rafters.

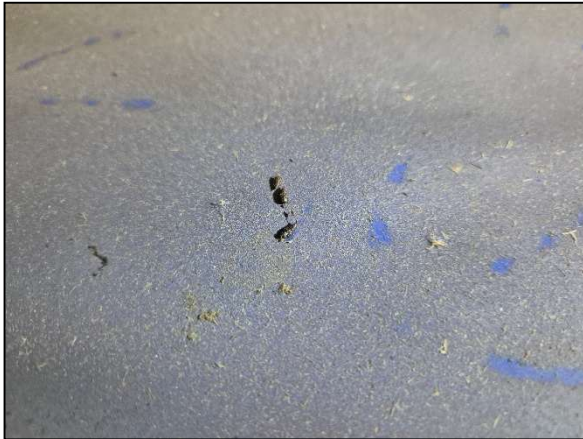
**Figure 22 – Bat Droppings on Equipment in Shed 4**

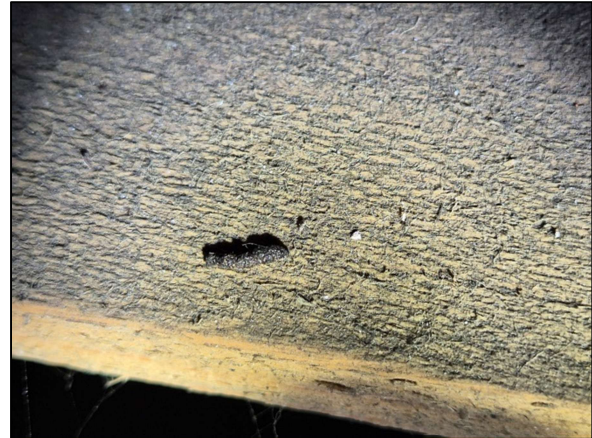
**Figure 23 – Bat Dropping on Timber Stored within Builder's Bag in Shed 3**

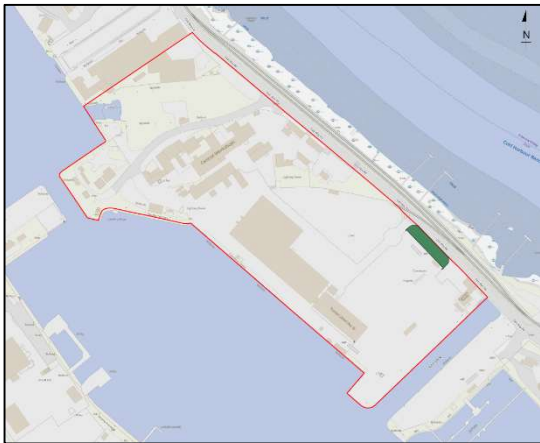
**Figure 24 – Location of Trees on Site, Highlighted in Green**

These are situated to the north-east of the survey buildings, and the location and images of the trees are visible in Figures 24 & 25 below: -
