# NEPTUNE WORKS WAREHOUSES – ABP NEWPORT PRELIMINARY ROOST ASSESSMENT (PRA) AND ACTIVITY SURVEYS FOR BATS

| <b>TITLE:</b> | Preliminary Roost Assessment (PRA) and Activity Surveys for Bats |

| <b>PROJECT REF:</b> | 238-03-32-25 |
| <b>REPORT No.:</b> | 238-03-32.R1 |

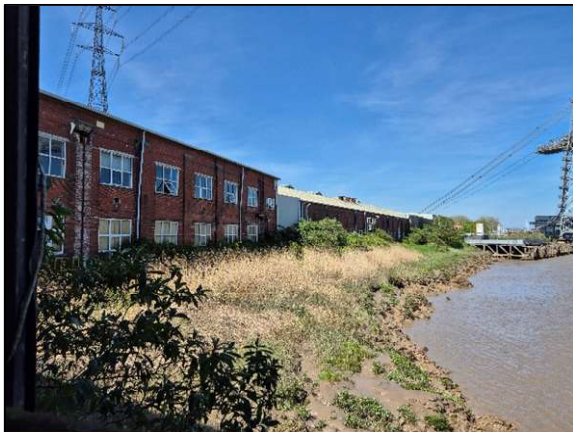
**Figure 11 – (E) Side of MSB. Small Holes Present in Brickwork along (E) Side of Bld.**

As discussed, brick walls are present along the eastern side of the building, whilst brickwork is also present along the western wall. The brickwork was observed to be in generally excellent condition given the likely age of the building. It should be noted however that small cracks and holes were recorded in some areas from the exterior of the building, particularly within along the eastern exterior wall of the building, which may offer both roosting potential and potential access/egress for bats to the building interior in these locations.

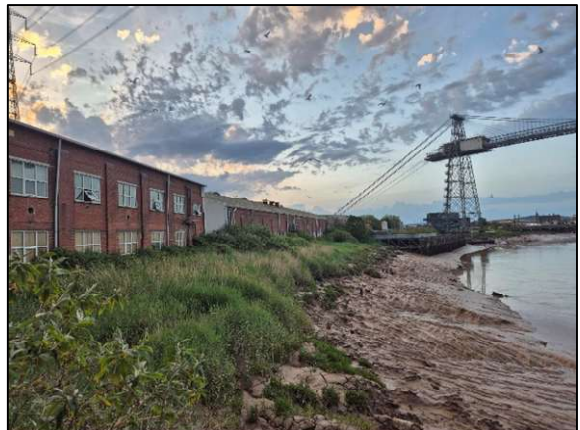
**Figure 12 – Additional view of (E) Side of MSB**

The Neptune Works warehouses are of approximate 265m x 75m dimension at its widest points, and consist largely of an industrial warehouse which has been affixed to a brick building (as visible in Figures 11 & 12) present on the eastern side of the complex.

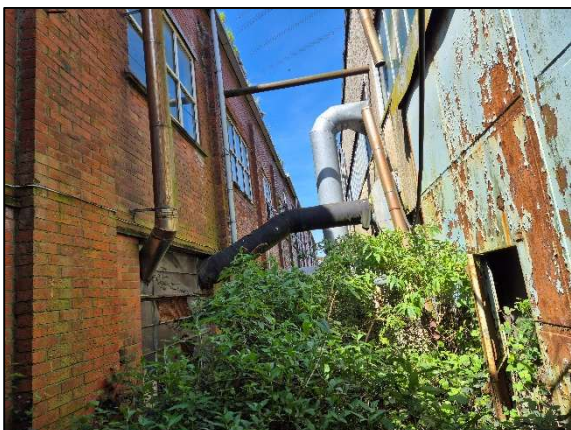
**Figure 13 – Buddleia Present along (E) Side of MSB, Looking (N)**

- Survey activity during both of the dusk emergence surveys was very low, likely owing to the industrial setting of the building. A small amount of buddleia scrub is present along the eastern side of the warehouses however, and bats were observed to utilise this scrub habitat for foraging purposes;

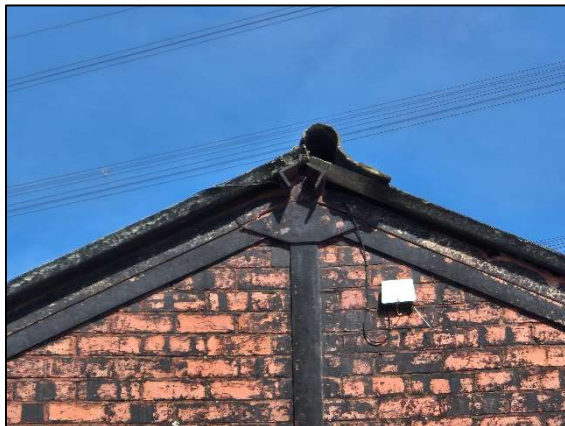
**Figure 14 – Gap beneath Ridge Tiles on Gable Roof May Permit Access to Loft**

As visible within Figures 14 & 15, small gaps are present beneath the ridge tiles of the gable roof present on the two-storey section of the brick standalone building which may permit access/egress for bats to the loft within this area, whilst the gap beneath the corrugated roof of the lean-to may also permit access/egress for crevice-dwelling bats to a void situated within this location.

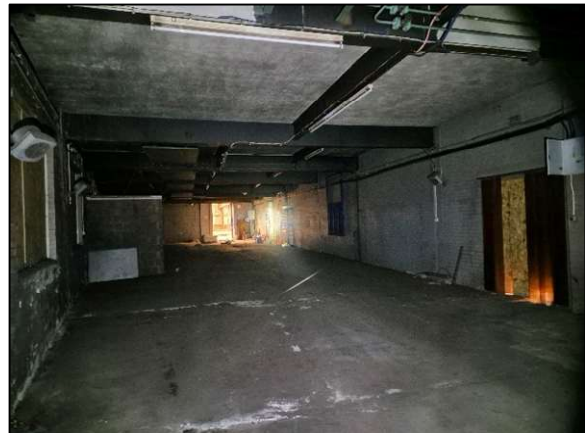
**Figure 19 – Interior of Ground Floor of Affixed Brick Building at (E) Side of MSB. The Room is Dark and Cooler than the Main Warehouse Building.**

The interior of the ground floor is very dark in nature, owing to the windows having been tightly boarded up on the eastern side of the building in this location. This area of the building is subsequently cooler than that exhibited in nearby areas. PRFs within the ground floor were however limited, and although steel girders at roof level offer some roosting potential for free-hanging bats, general PRFs were limited, and no evidence of bats was identified within this area of the building.

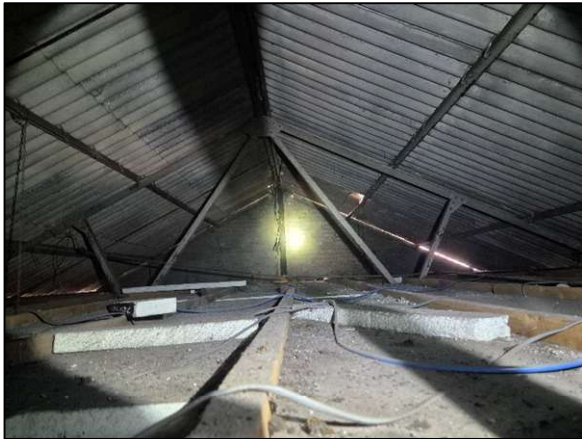
**Figure 26 – Interior of Loft of at (S) End of Brick Building. Exposed Steel Framework visible, suitable for Free-Hanging Bats**

Although a loft is present within the brick building, interior conditions are suboptimal for bats. The single-skinned asbestos roof is set on a steel framework, which may offer some limited potential for free-hanging bats. However, the brick walls at either end of the loft were observed to be in good condition, with limited PRFs for crevice-dwelling bats being noted.

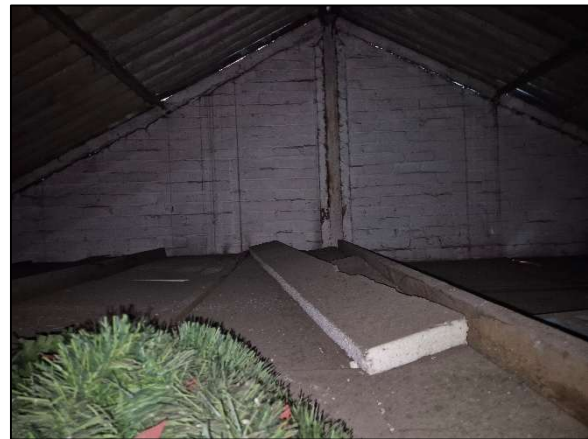
**Figure 27 – Brick Wall at (S) End of Loft Interior. Brickwork in Generally Good Condition, Reducing Potential for Crevice-Dwellers**

- **Brick / Block Walls in Loft Space** – Small brick walls are present within the loft space above the standalone brick building. Although in generally good condition, small gaps may be present which could offer potential roosting for crevice-dwelling bats;
