**Geotechnical & Geoenvironmental  
Site Investigation Report:** Proposed  
Residential Development, Proposed  
Residential Development, Land at  
Marayat Walk, Gaer, Newport

**Prepared For:  
Mews Estates Limited**

**September 2020**

**Job No: 16204-1**

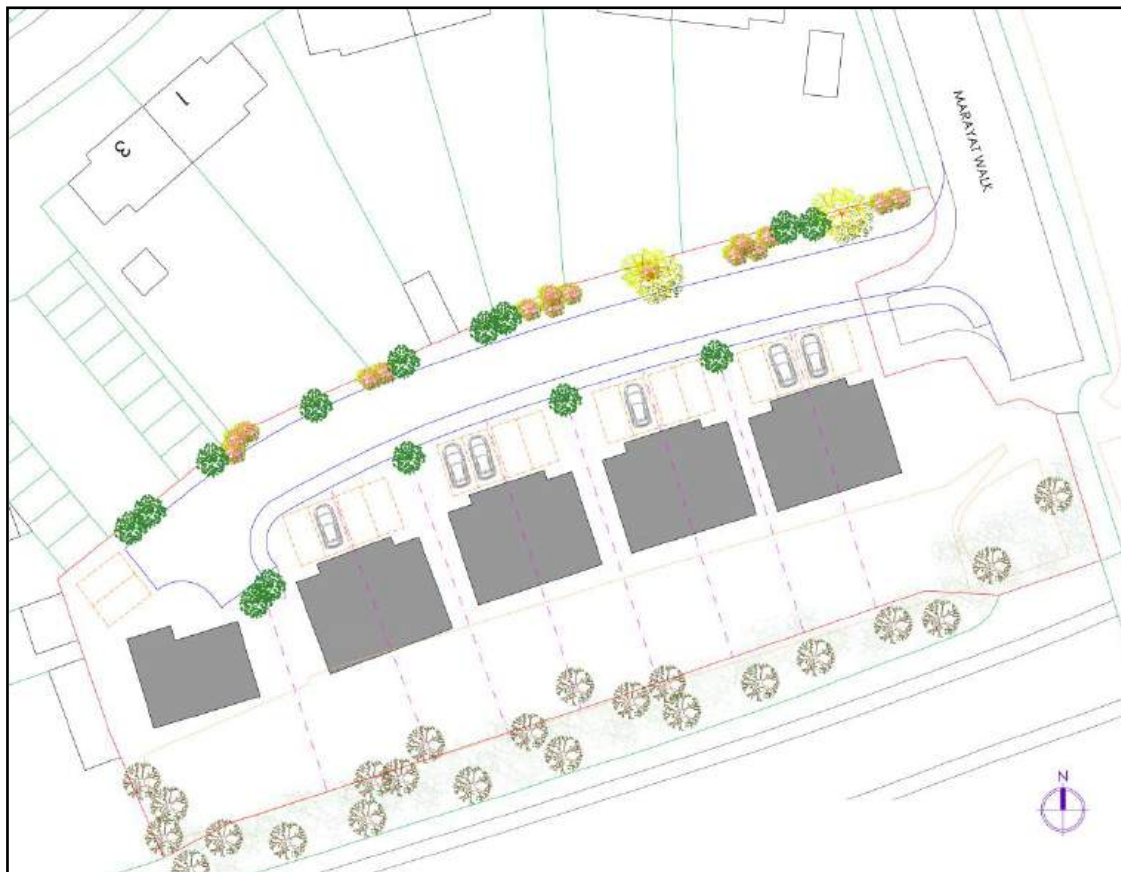
**Figure 1.1** Proposed Site Layout

Mews Estates Limited is proposing a residential development on land located to the west of Marayat Walk, Gaer, Newport. The proposed development comprises a total of nine houses with eight semi-detached and one detached served by an access road along the northern boundary. The houses have driveways, gardens, and areas of hard and soft landscaping.
