| Customer Reference: | 16204 - Marayat Walk |

Marayat Walk, Newport

**ANNEX C**  
**Risk Assessment Definitions**

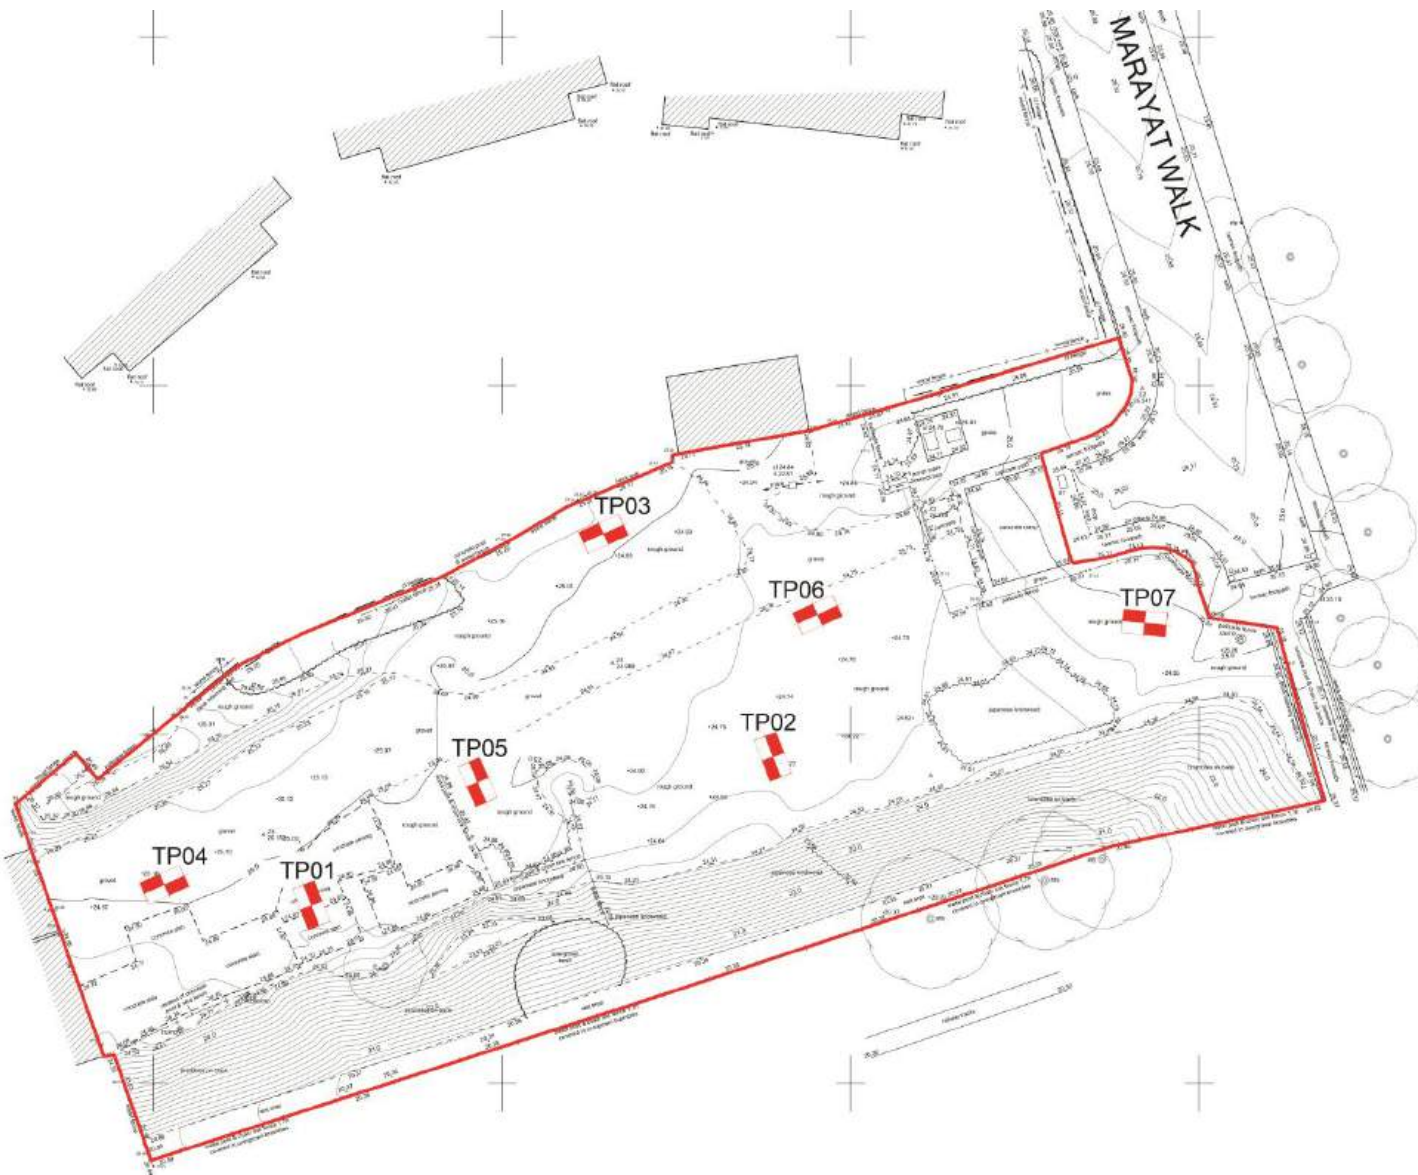
**DRAWINGS**

TP01 Approximate position of machine excavated trial pit
